EP-344/2009 – New Sewage Pumping Stations Serving KTD and  
EP-337/2009 – New Distributor Roads Serving the Planned KTD

Contract No. KL/2012/03  
Kai Tak Development –Stage 4 Infrastructure at  
Former North Apron Area

Monthly EM&A Report

January 2015

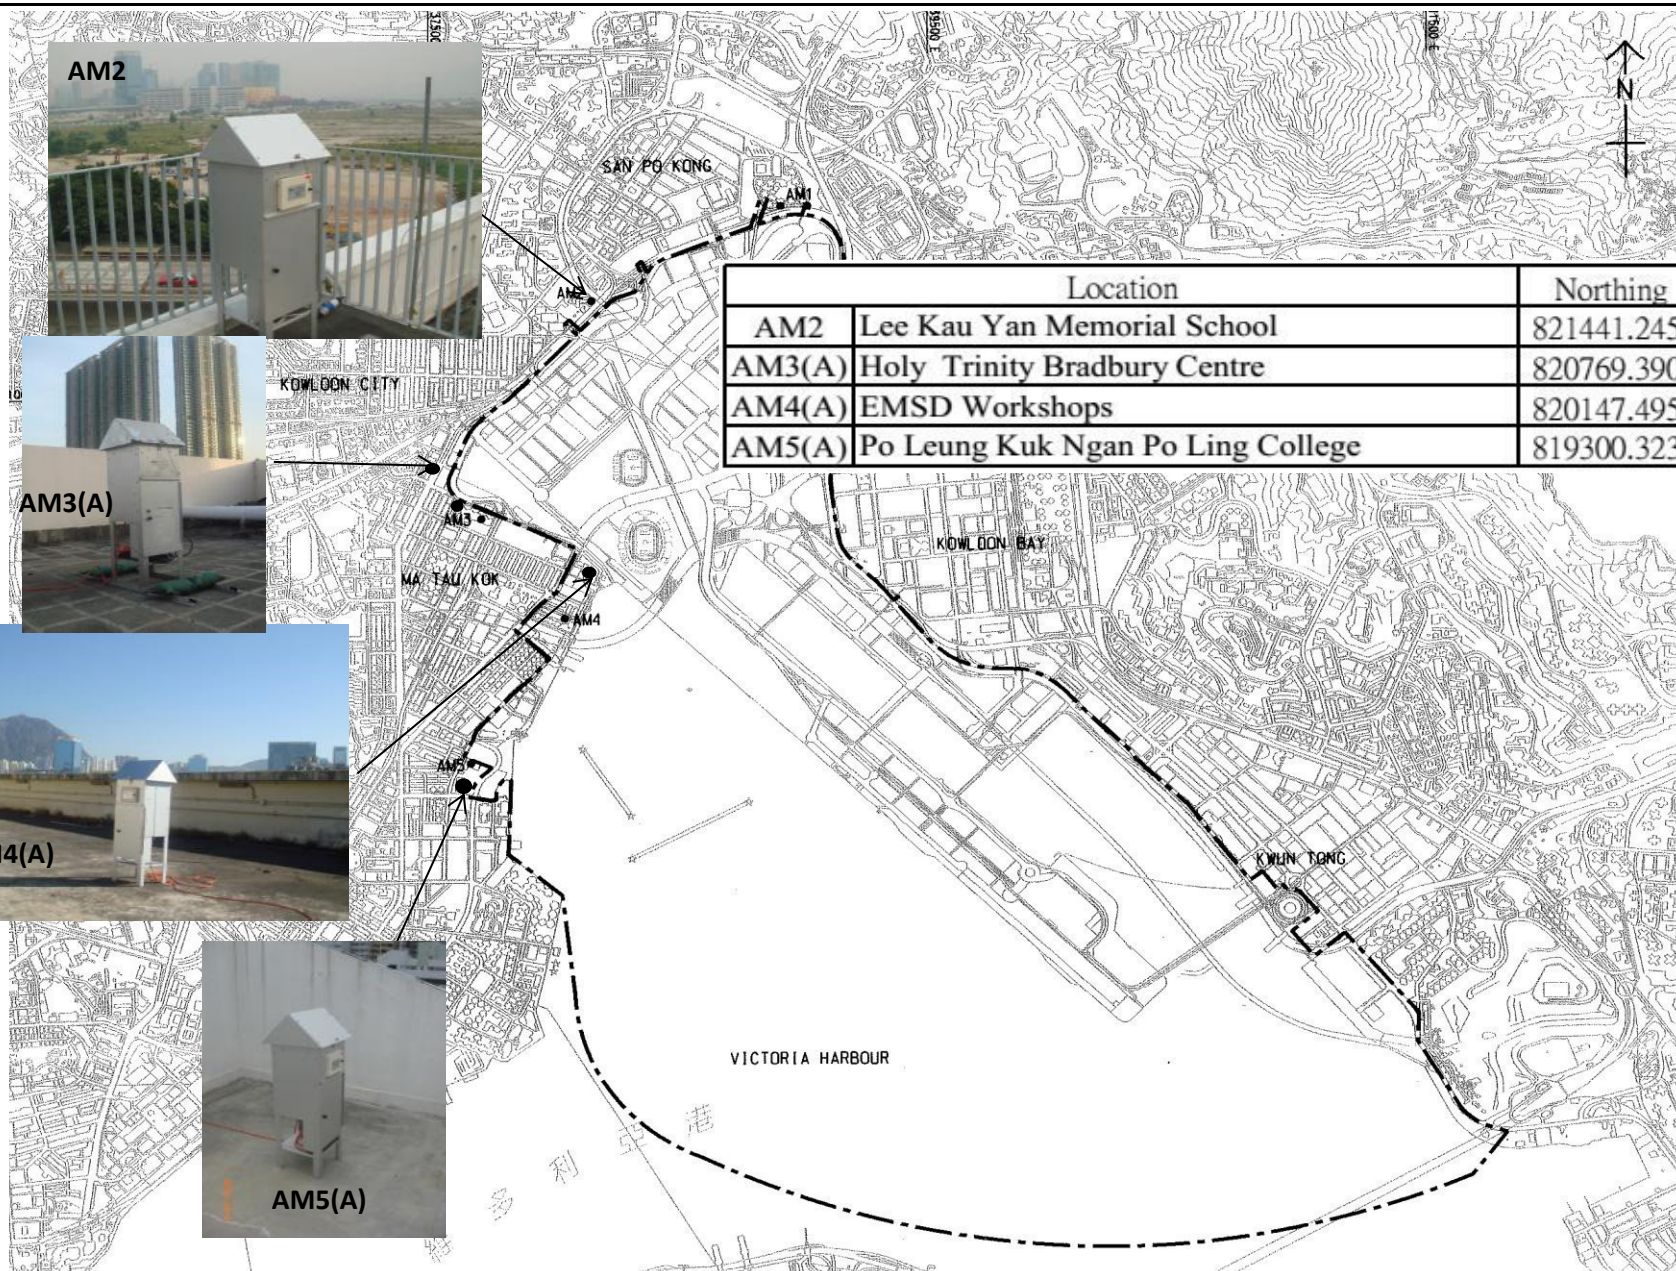
Scale	N.T.S	Project No.	MA13056
Date	Jan-14	Figure	2

Location		Northing	Easting
AM2	Lee Kau Yan Memorial School	821441.245	838153.917
AM3(A)	Holy Trinity Bradbury Centre	820769.390	837522.115
AM4(A)	EMSD Workshops	820147.495	838155.791
AM5(A)	Po Leung Kuk Ngan Po Ling College	819300.323	837659.613

Title Contract No. KL/2012/03  
 Kai Tak Development –Stage 4 Infrastructure at Former North Apron Area  
 Air Quality Monitoring Stations under this Project

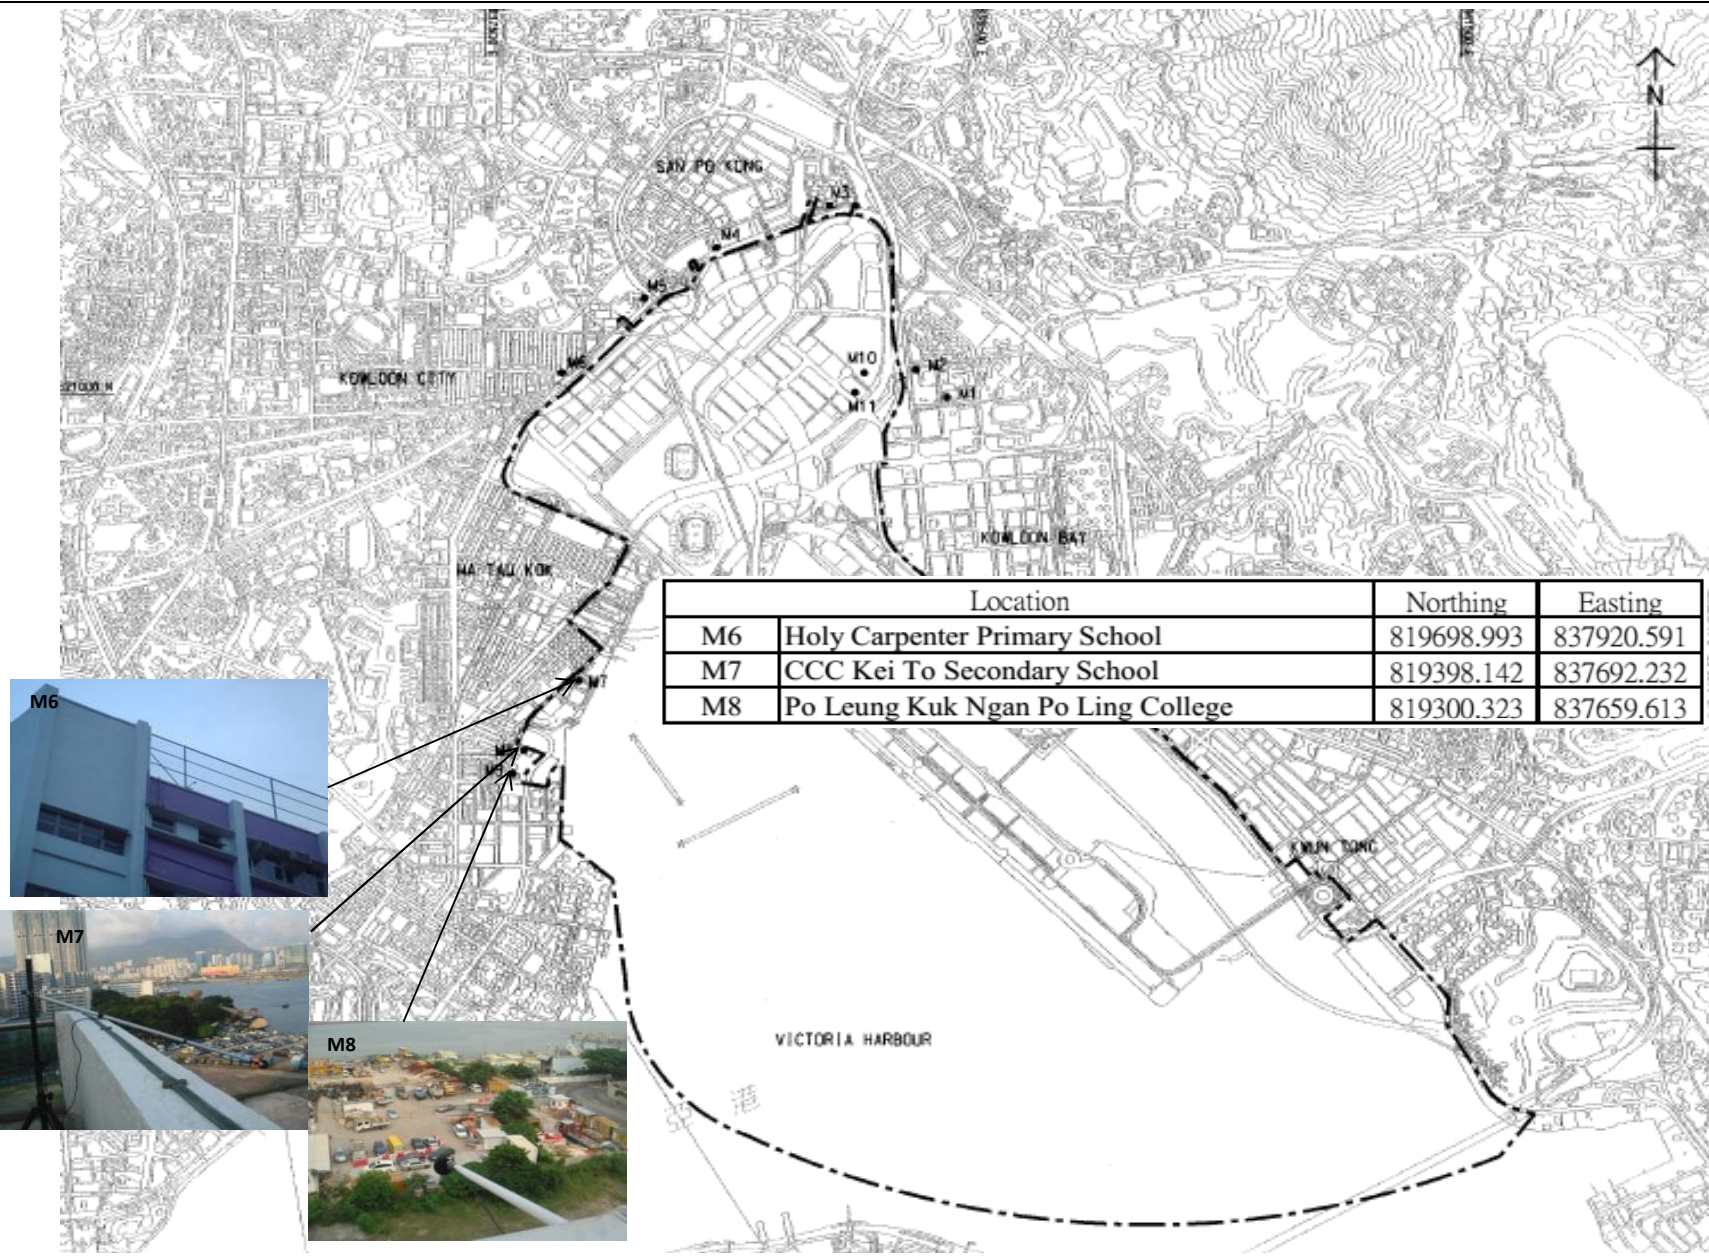
Scale	N.T.S	Project No.	MA13056
Date	Dec-13	Figure	3

Title Contract No. KL/2012/03  
 Kai Tak Development –Stage 4 Infrastructure at Former North Apron Area  
 Noise Monitoring Stations under this Project

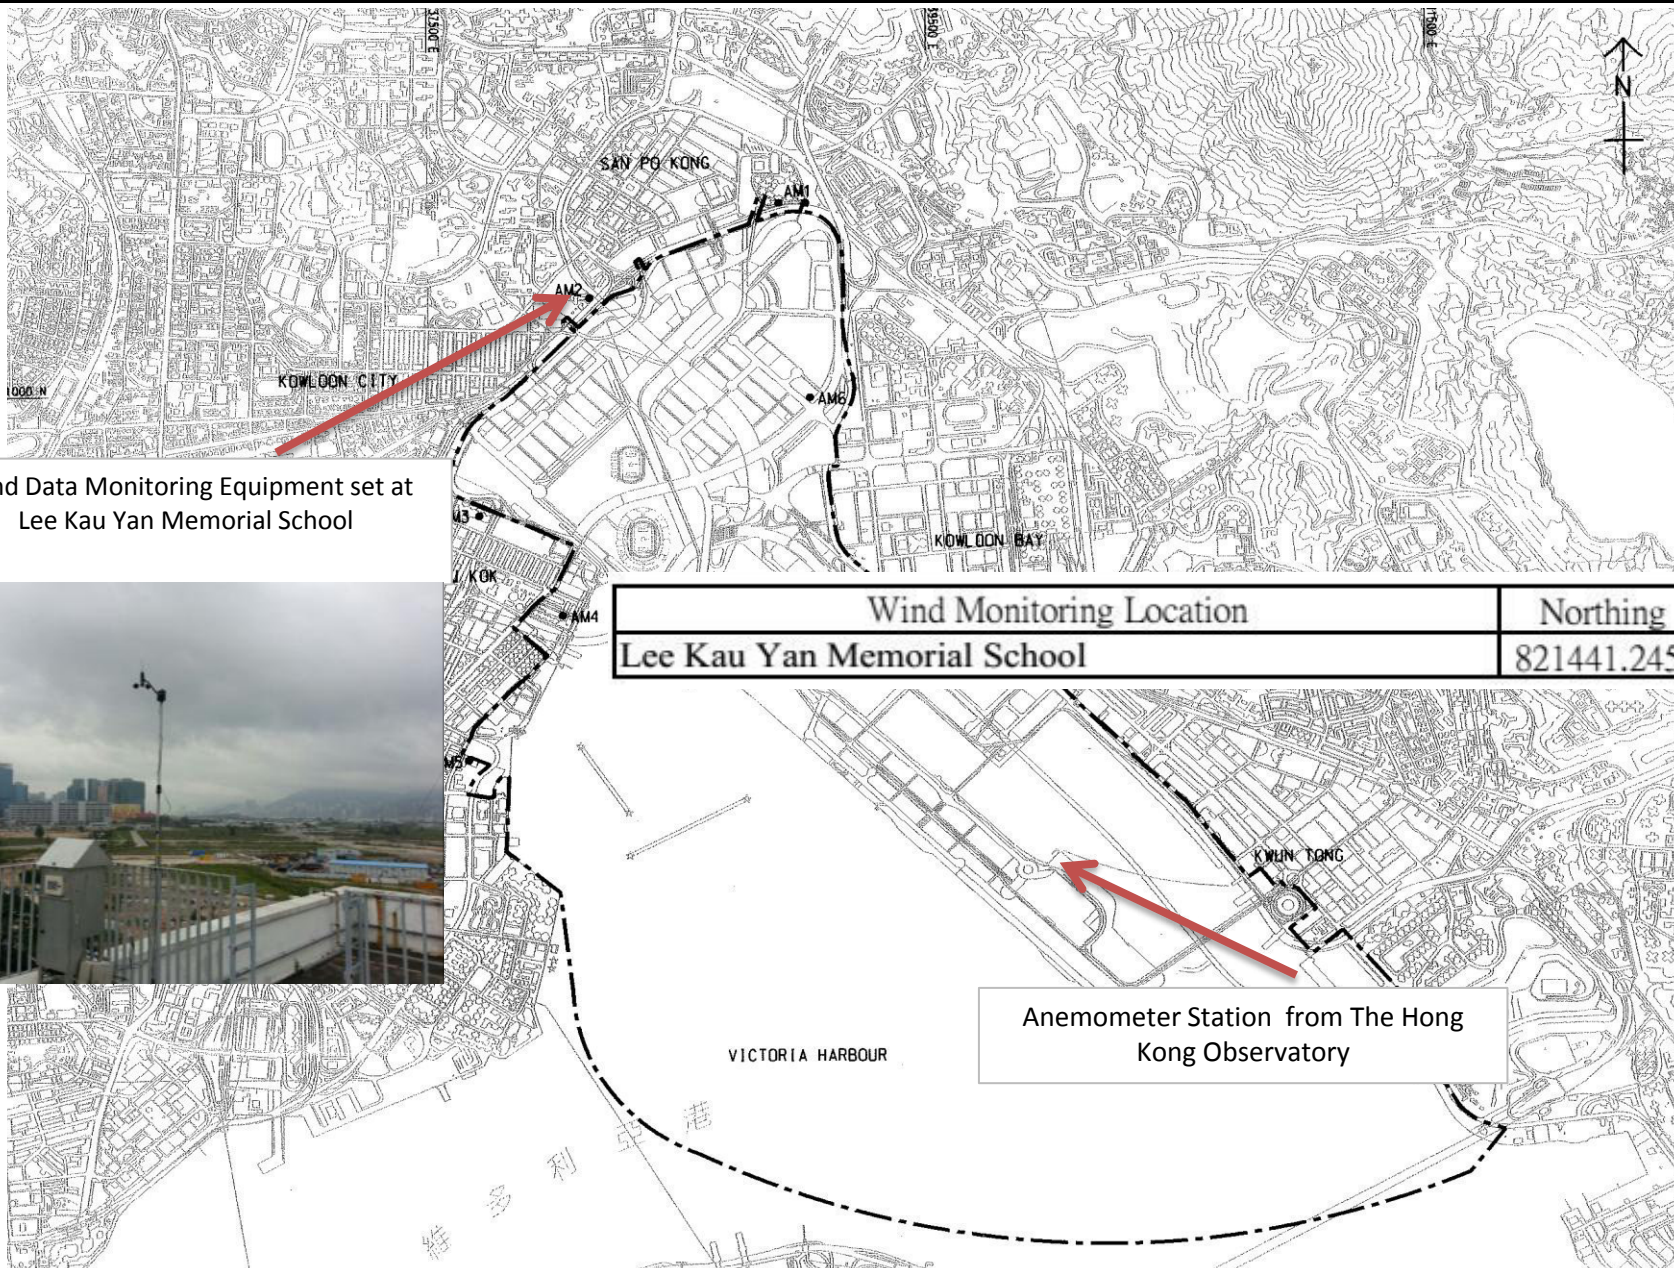
Scale	N.T.S	Project No.	MA13056
Date	Dec-13	Figure	4

Wind Data Monitoring Equipment set at  
Lee Kau Yan Memorial School

Wind Monitoring Location	Northing	Easting
Lee Kau Yan Memorial School	821441.245	838153.917

Anemometer Station from The Hong  
Kong Observatory

- 2.21 The air temperature, precipitation and the relative humidity data were obtained from Hong Kong Observatory where the wind speed and wind direction were recorded by the installed Wind Anemometer set at rooftop (about 8/F) Lee Kau Yan Memorial School. The location is shown in **Figure 4**. This weather information for the reporting month is summarized in **Appendix C**.

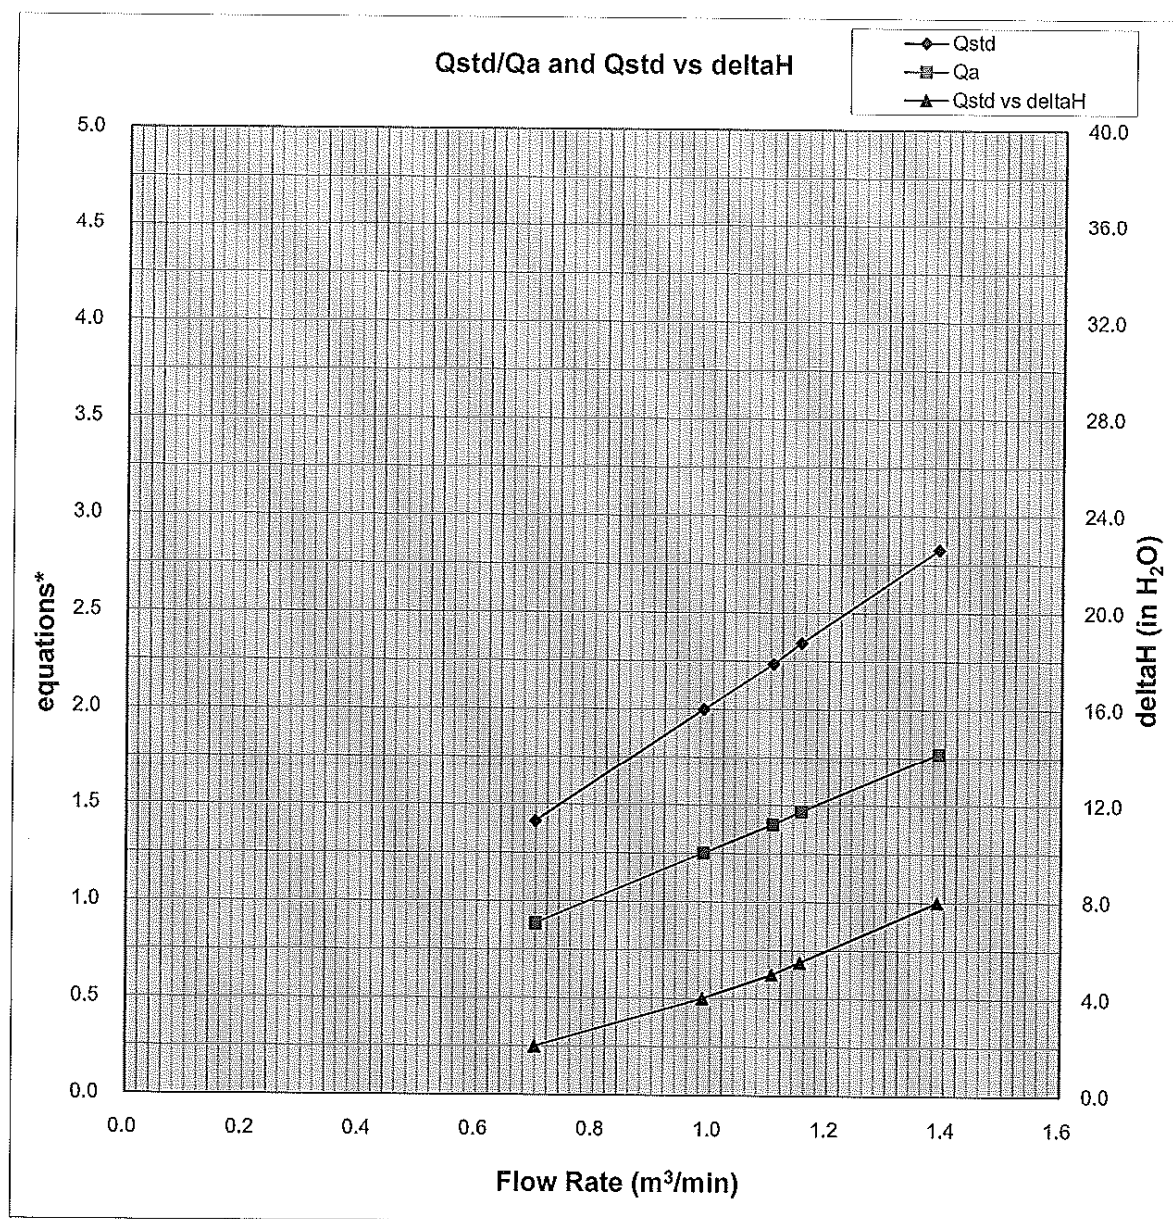
Y-axis equations:

Qstd series:  $\text{SQRT}[\Delta H(Pa/Pstd)(Tstd/Ta)]$

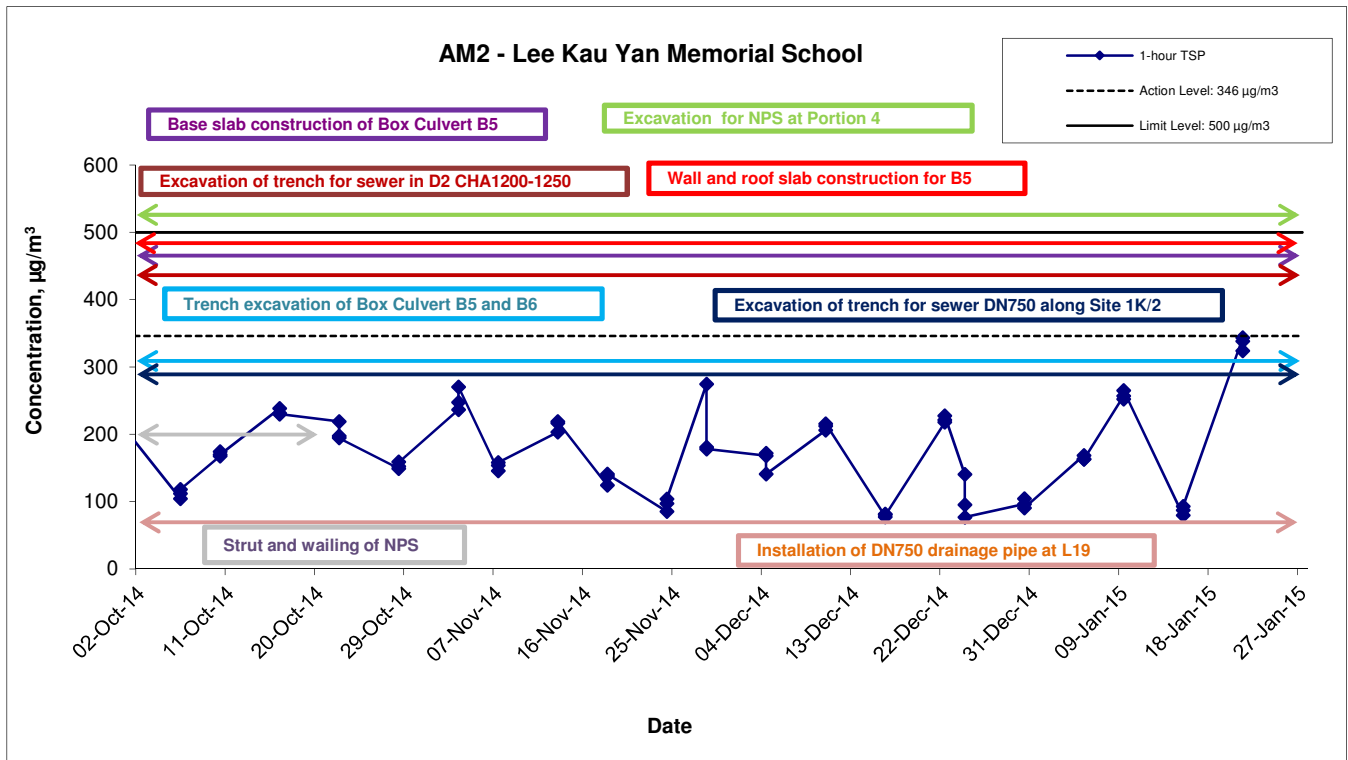
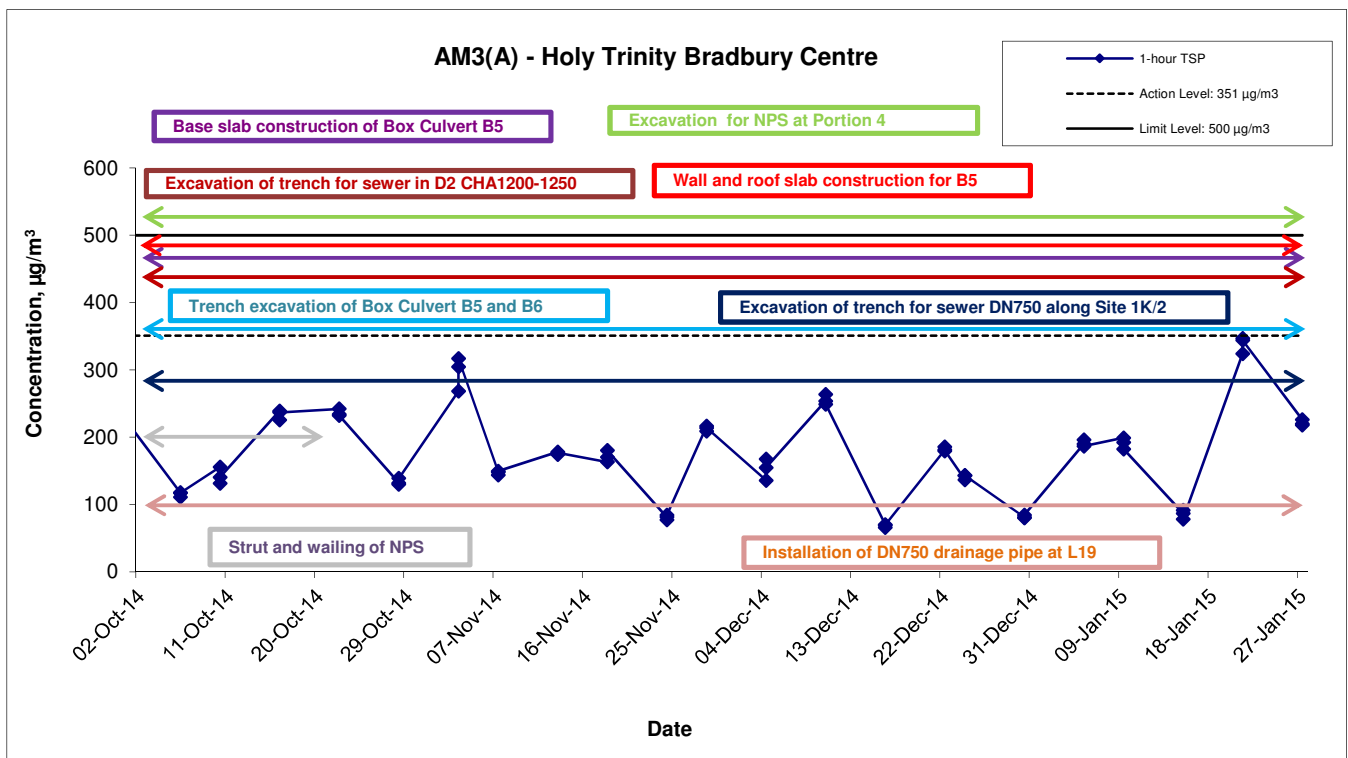
## 1-hr TSP Concentration Levels

<b>Title</b> Contract No. KL/2012/03 Kai Tak Development –Stage 4 Infrastructure at Former North Apron Area  Graphical Presentation of 1-hour TSP Monitoring Results	<b>Scale</b> N.T.S	<b>Project No.</b> MA13056	
	<b>Date</b> Jan 15	<b>Appendix</b> E

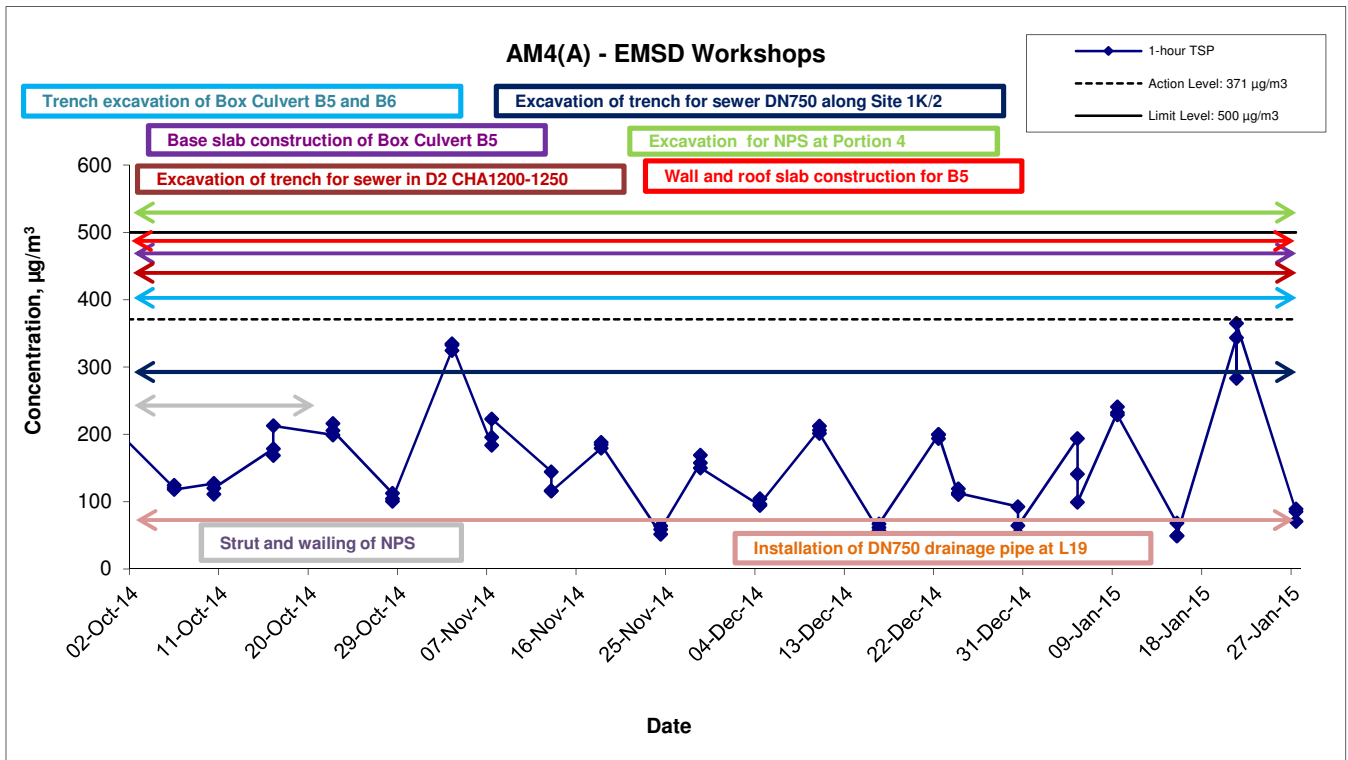
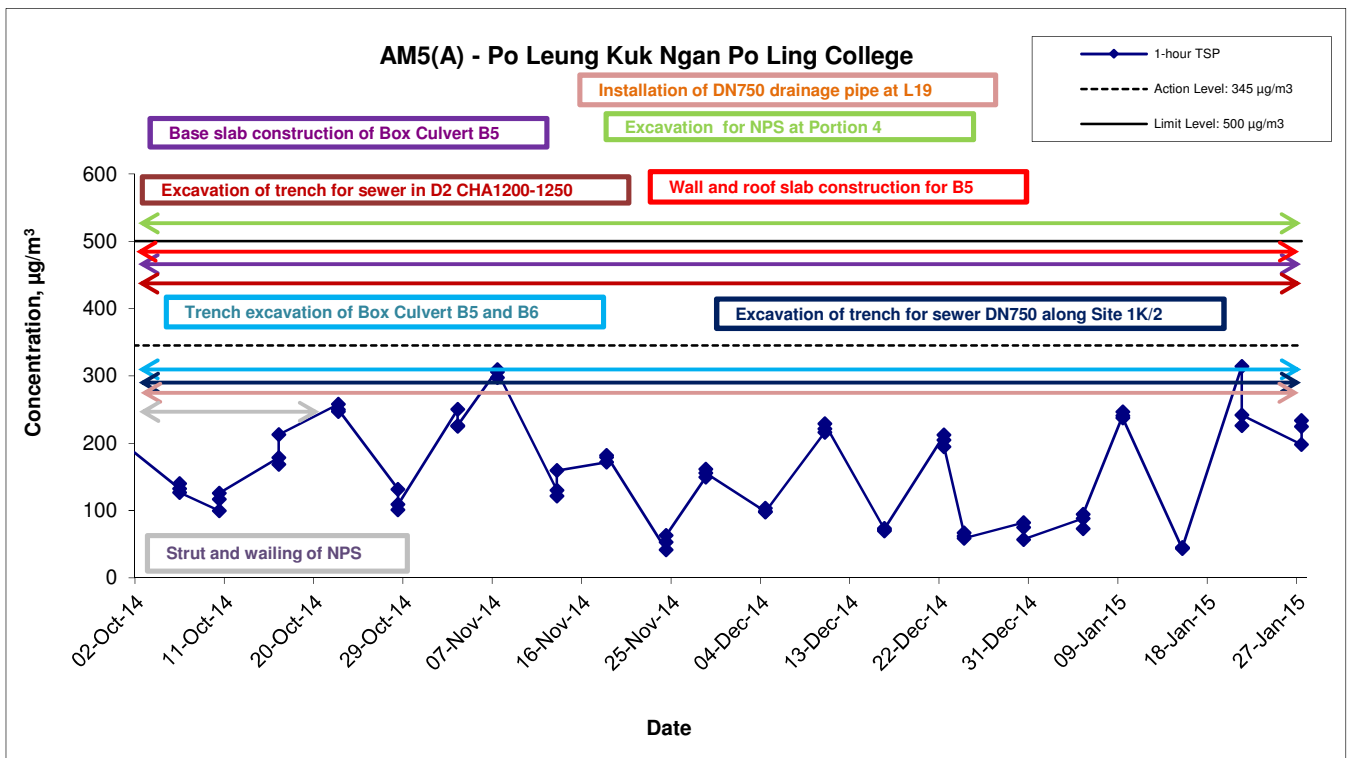
## 1-hr TSP Concentration Levels

<b>Title</b> Contract No. KL/2012/03 Kai Tak Development –Stage 4 Infrastructure at Former North Apron Area  Graphical Presentation of 1-hour TSP Monitoring Results	<b>Scale</b> N.T.S	<b>Project No.</b> MA13056	
	<b>Date</b> Jan 15	<b>Appendix</b> E

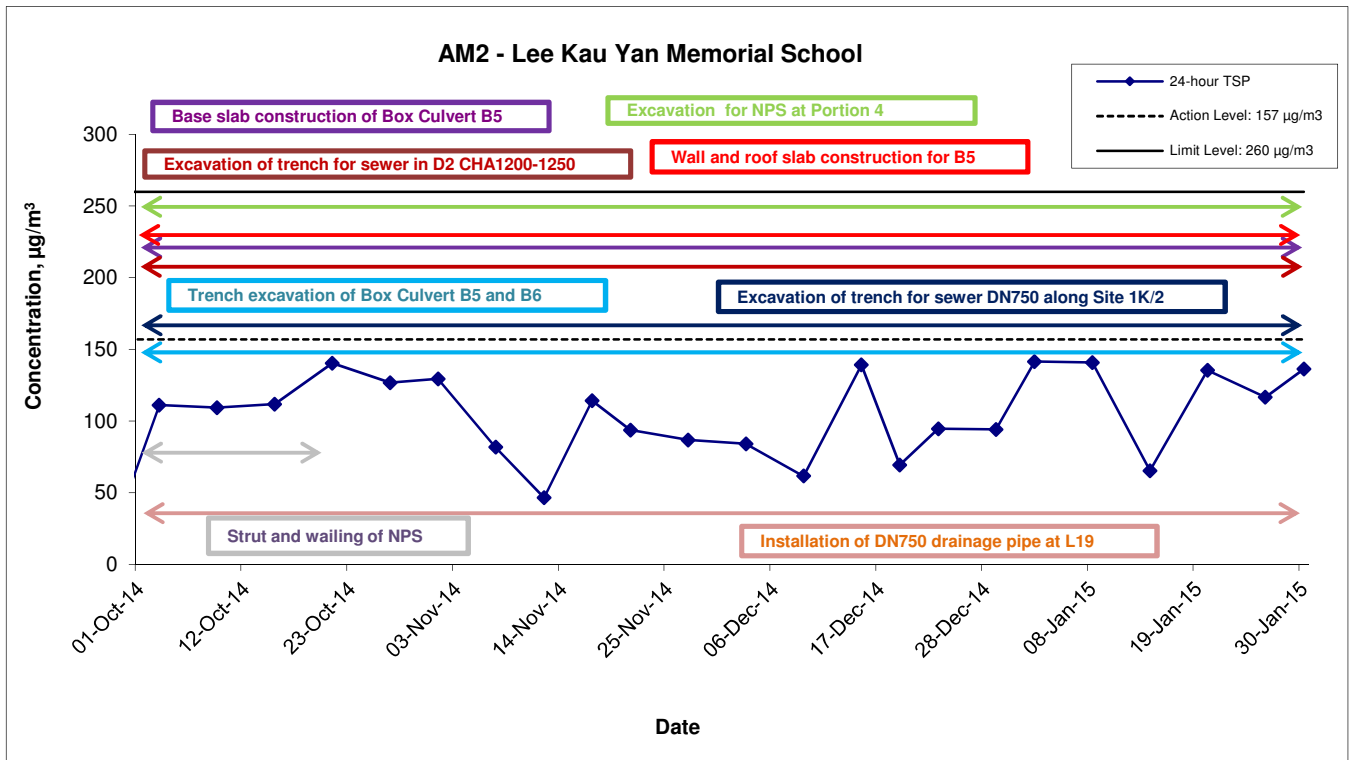
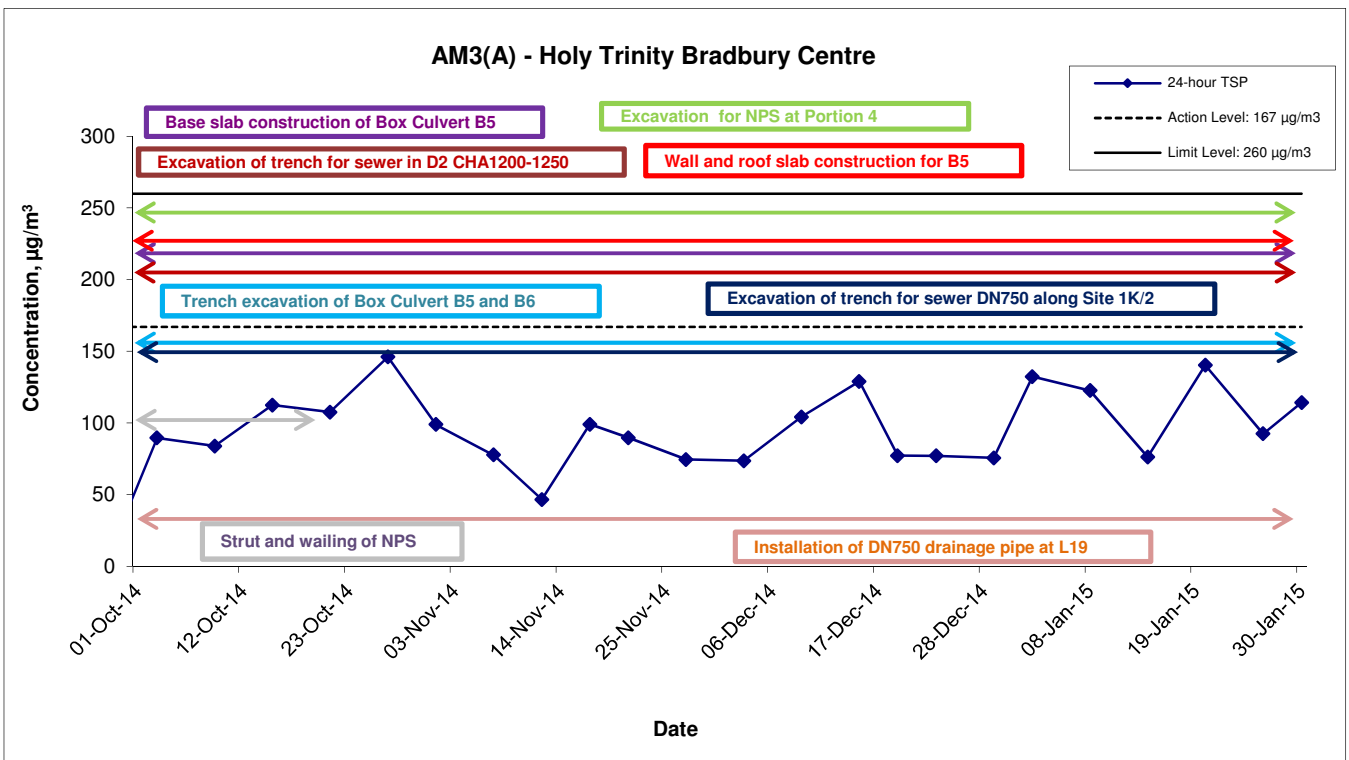
## 24-hr TSP Concentration Levels

<b>Title</b> Contract No. KL/2012/03 Kai Tak Development –Stage 4 Infrastructure at Former North Apron Area Graphical Presentation of 24-hour TSP Monitoring Results	<b>Scale</b>	<b>Project</b>	<b>CINOTECH</b>
	N.T.S	No. MA13056	
	Date Jan 15	Appendix F

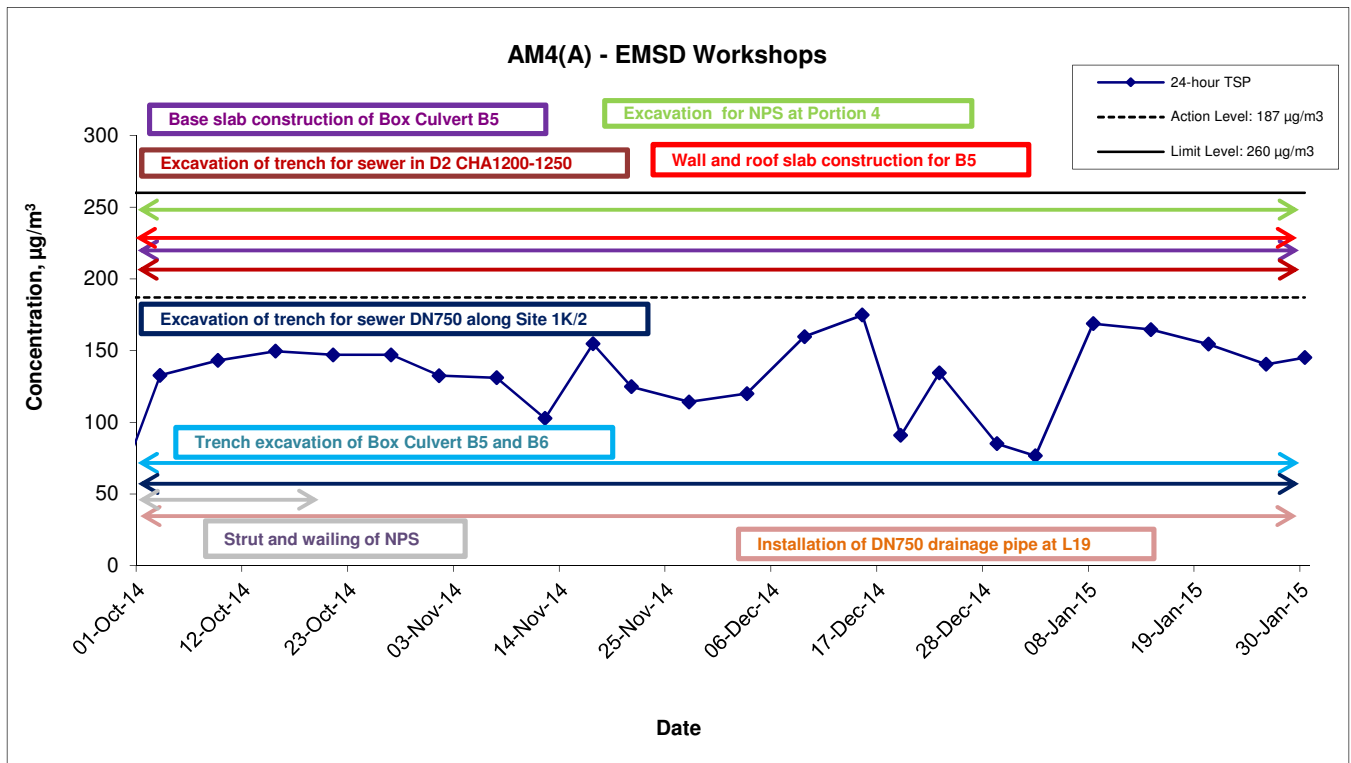
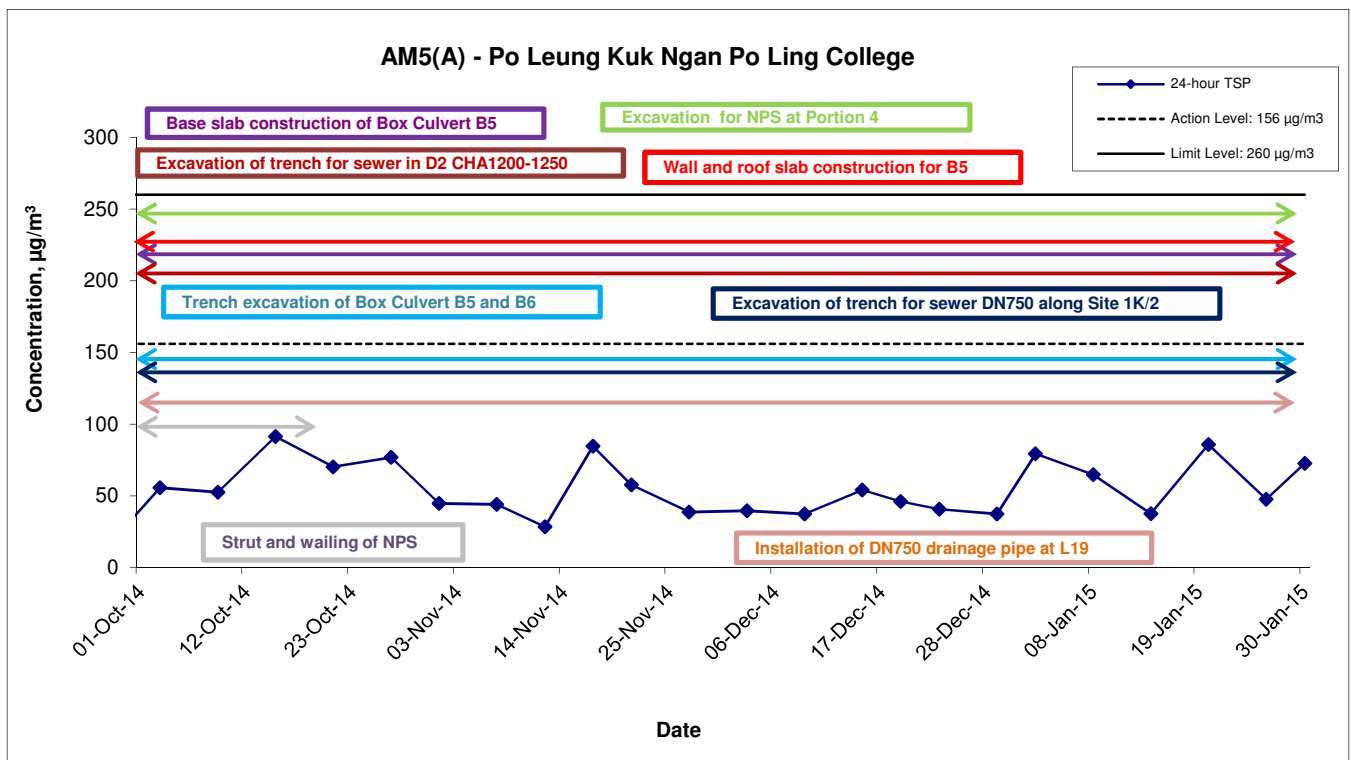
## 24-hr TSP Concentration Levels

<b>Title</b> Contract No. KL/2012/03 Kai Tak Development –Stage 4 Infrastructure at Former North Apron Area Graphical Presentation of 24-hour TSP Monitoring Results	<b>Scale</b>	<b>Project</b>

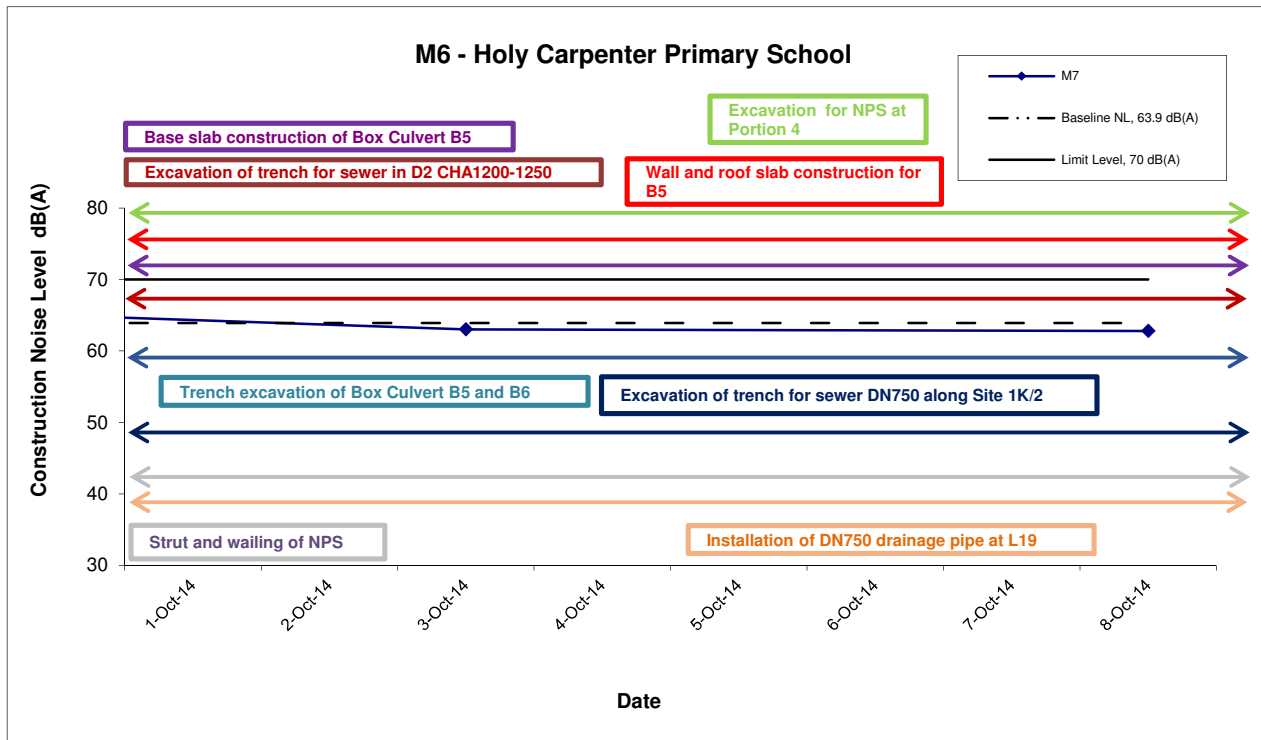
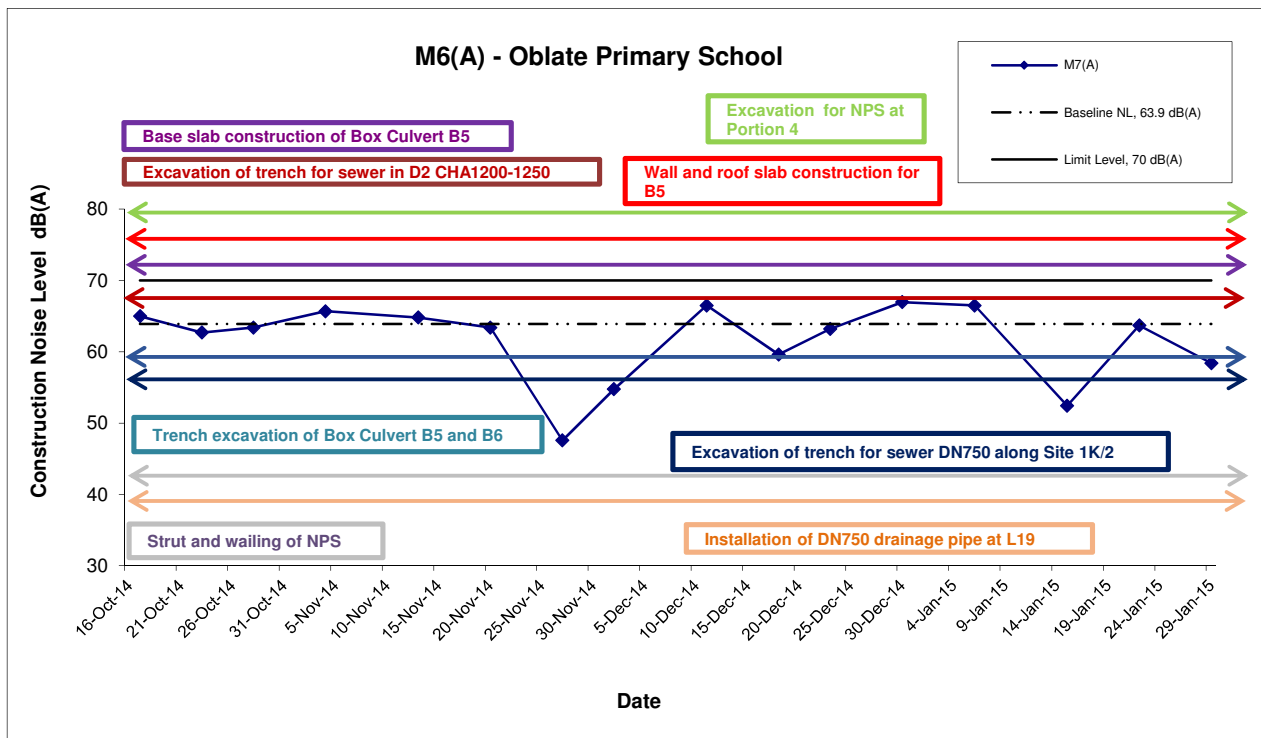
## Noise Levels

Remarks: M1 and M2: The construction noise levels in the Tables in Appendix G were adopted for plotting the graphs  
M3: The measured noise levels in the Table in Appendix G were adopted for plotting the graphs

<b>Title</b> Contract No. KL/2012/03 Kai Tak Development –Stage 4 Infrastructure at Former North Apron Area  Graphical Presentation of Construction Noise Monitoring Results	<b>Scale</b>  N.T.S	<b>Project No.</b>  MA13056	
	<b>Date</b>  Jan 15	<b>Appendix</b>  G

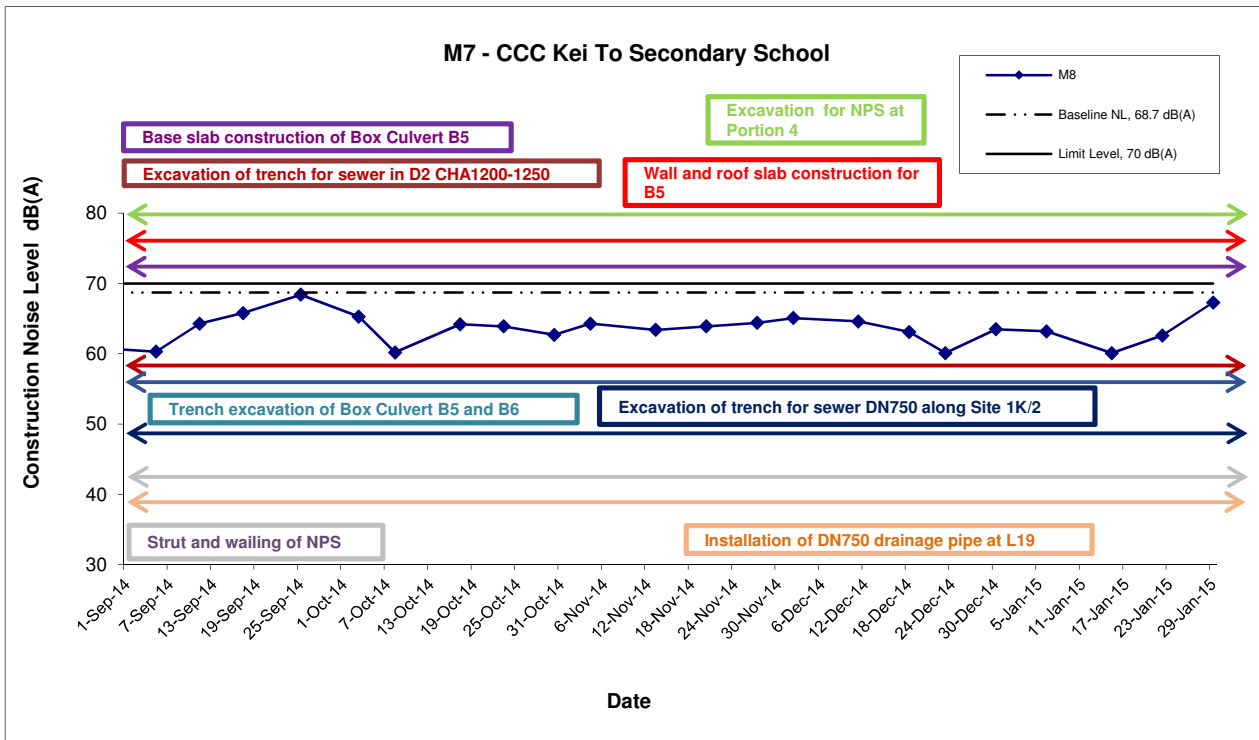
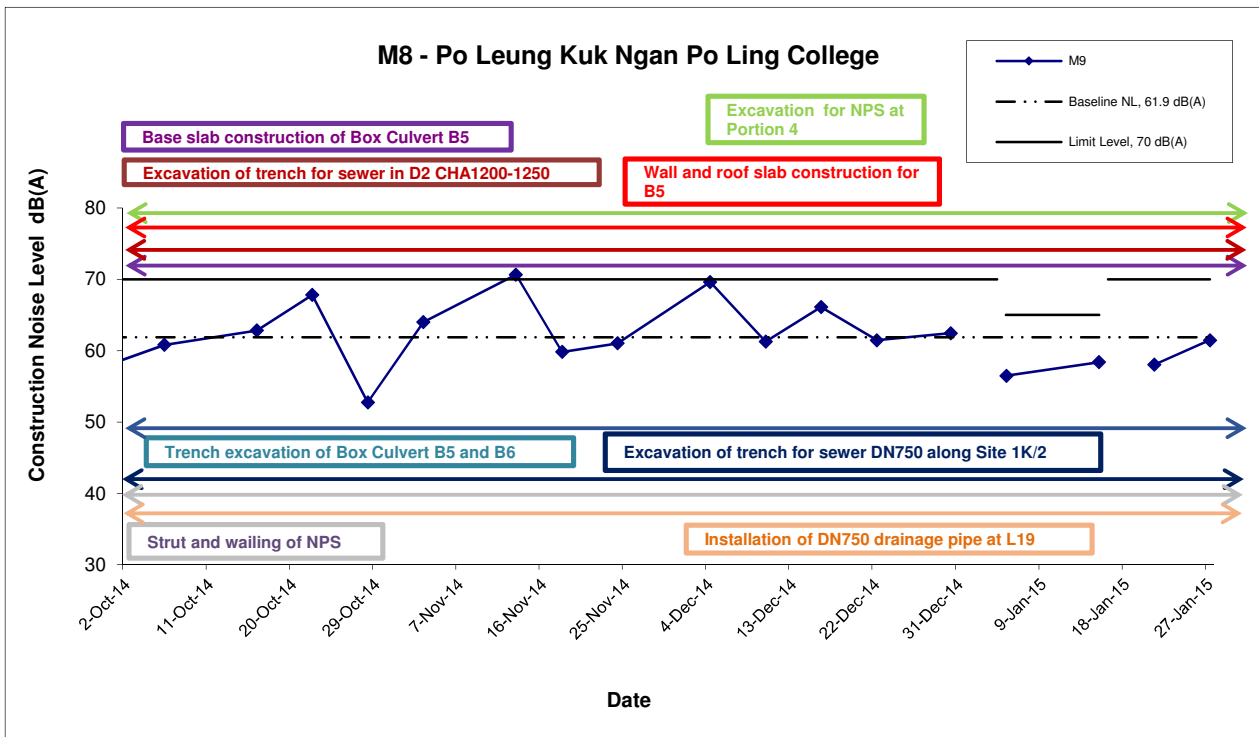
## Noise Levels

Remarks: The construction noise levels in the Tables in Appendix G were adopted for plotting the graphs

Title Contract No. KL/2012/03 Kai Tak Development –Stage 4 Infrastructure at Former North Apron Area  Graphical Presentation of Construction Noise Monitoring Results	Scale	Project	<b>CINOTECH</b>
	N.T.S	No. MA13056	
	Date	Appendix	
	Jan 15	G

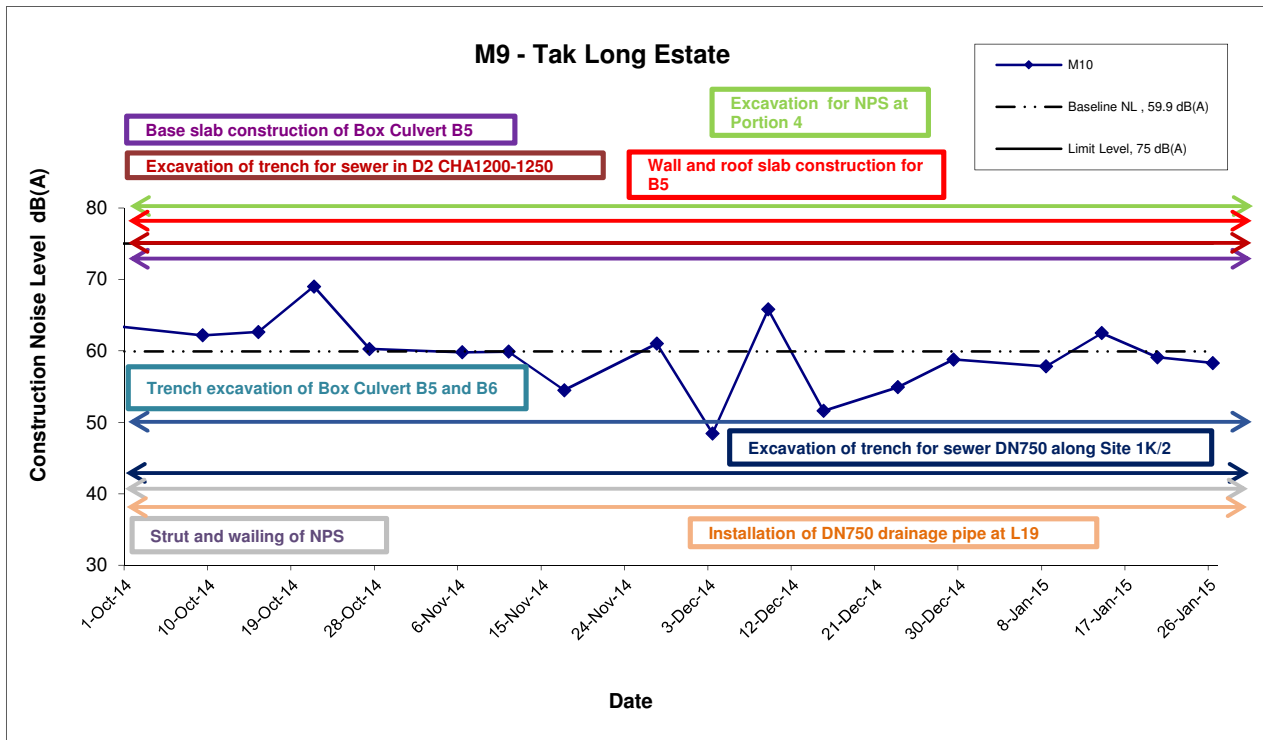
## Noise Levels

Remarks: The construction noise levels in the Tables in Appendix G were adopted for plotting the graphs

<b>Title</b> Contract No. KL/2012/03 Kai Tak Development –Stage 4 Infrastructure at Former North Apron Area  Graphical Presentation of Construction Noise Monitoring Results	<b>Scale</b>  N.T.S	<b>Project No.</b>  MA13056	
	<b>Date</b>  Jan 15	<b>Appendix</b>  G
