EP-344/2009 – New Sewage Pumping Stations Serving KTD and
EP-337/2009 – New Distributor Roads Serving the Planned KTD

Contract No. KL/2012/03
Kai Tak Development –Stage 4 Infrastructure at
Former North Apron Area

Monthly EM&A Report

February 2015

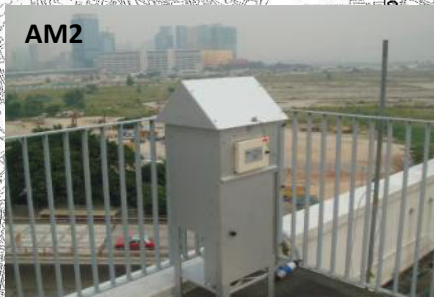
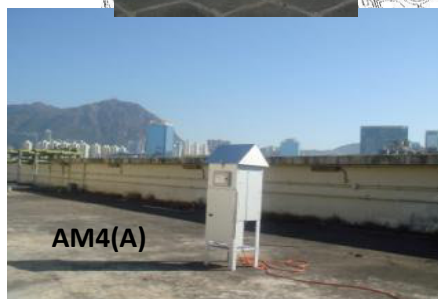
Scale	N.T.S	Project No.	MA13056
Date	Jan-14	Figure	2

Location		Northing	Easting
AM2	Lee Kau Yan Memorial School	821441.245	838153.917
AM3(A)	Holy Trinity Bradbury Centre	820769.390	837522.115
AM4(A)	EMSD Workshops	820147.495	838155.791
AM5(A)	Po Leung Kuk Ngan Po Ling College	819300.323	837659.613

Title Contract No. KL/2012/03
 Kai Tak Development –Stage 4 Infrastructure at Former North Apron Area
 Air Quality Monitoring Stations under this Project

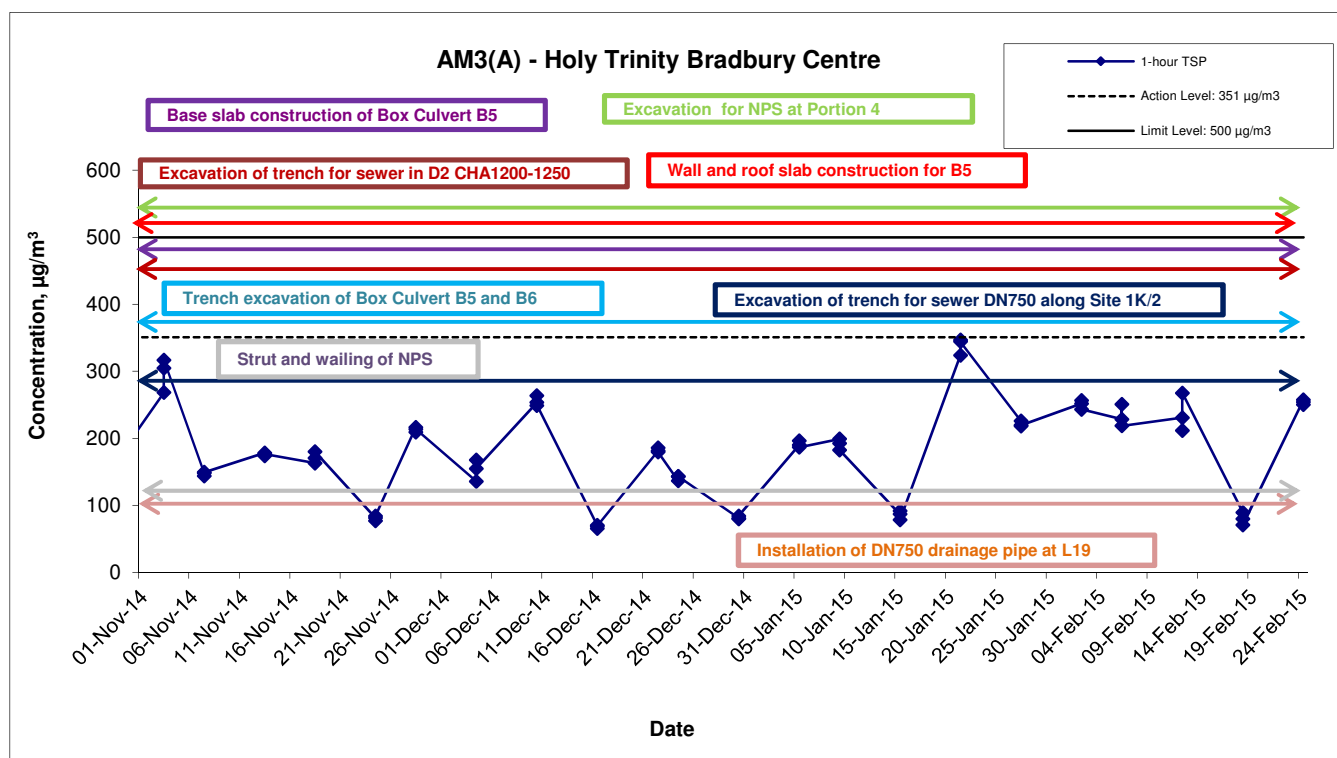
1-hr TSP Concentration Levels

Title	Contract No. KL/2012/03	Scale	Project No.	CINOTECH
	Kai Tak Development –Stage 4 Infrastructure at Former North Apron Area	N.T.S	MA13056	
Graphical Presentation of 1-hour TSP Monitoring Results		Date	Appendix	
		Feb 15	E

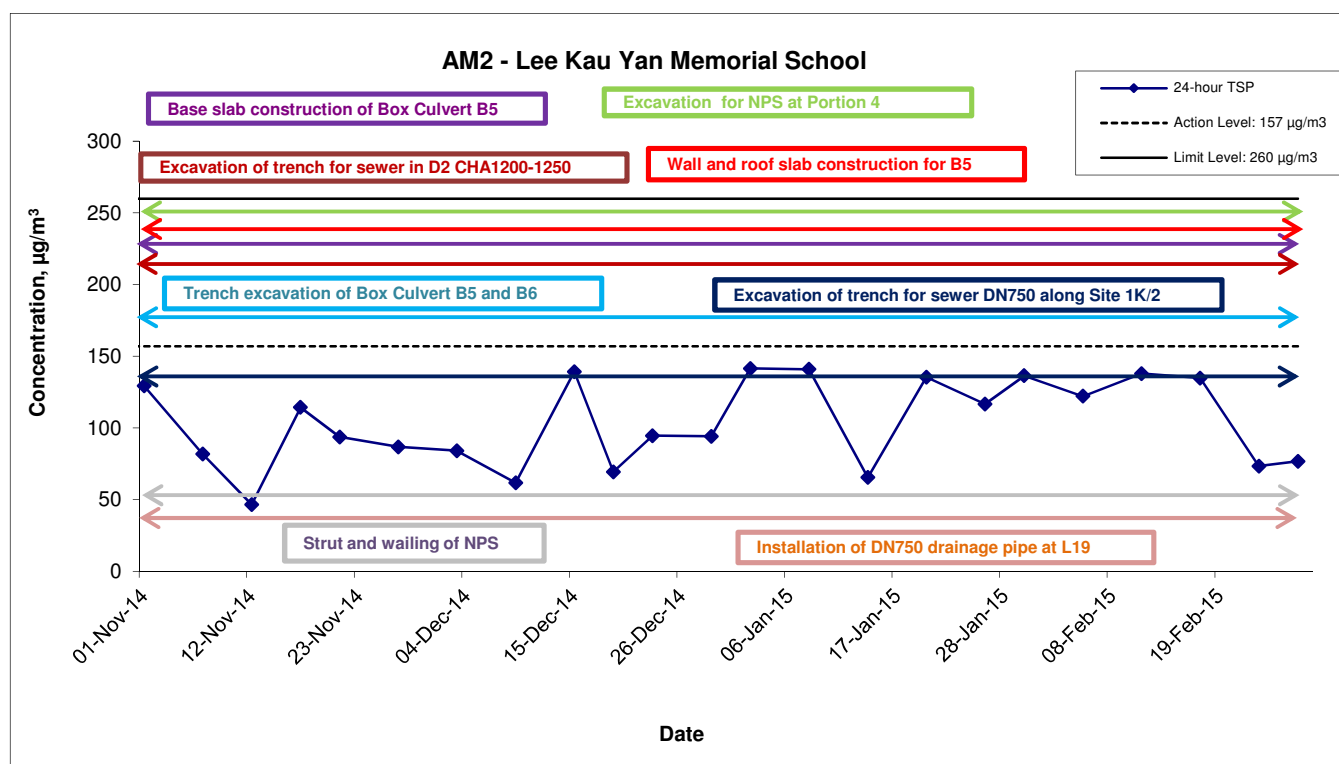
24-hr TSP Concentration Levels

Title Contract No. KL/2012/03 Kai Tak Development –Stage 4 Infrastructure at Former North Apron Area Graphical Presentation of 24-hour TSP Monitoring Results	Scale N.T.S	Project No. MA13056	CINOTECH
	Date Feb 15	Appendix F

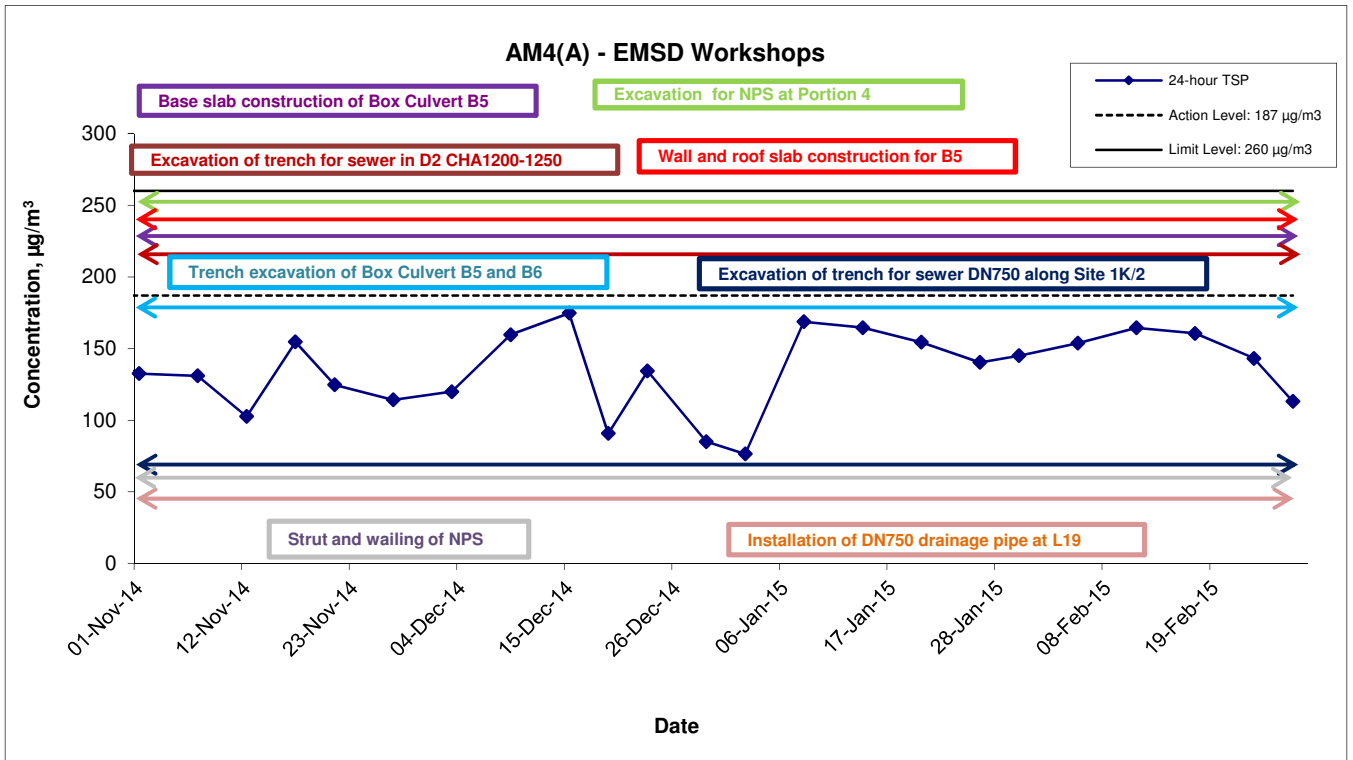
24-hr TSP Concentration Levels

Title Contract No. KL/2012/03 Kai Tak Development –Stage 4 Infrastructure at Former North Apron Area Graphical Presentation of 24-hour TSP Monitoring Results	Scale N.T.S	Project No. MA13056	CINOTECH
	Date Feb 15	Appendix F

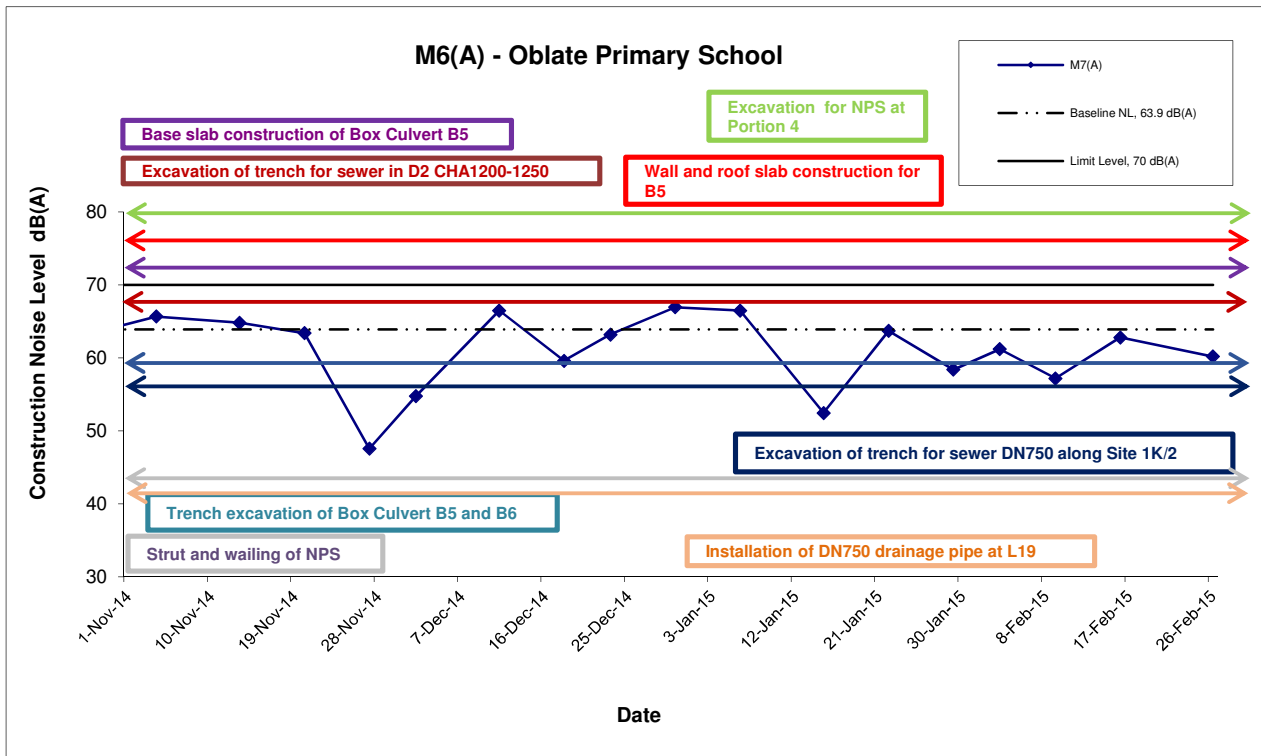
Remarks: The construction noise levels in the Tables in Appendix G were adopted for plotting the graphs

Title Contract No. KL/2012/03 Kai Tak Development –Stage 4 Infrastructure at Former North Apron Area Graphical Presentation of Construction Noise Monitoring Results	Scale N.T.S	Project No. MA13056	
	Date Feb 15	Appendix G
