EP-344/2009 – New Sewage Pumping Stations Serving KTD and  
EP-337/2009 – New Distributor Roads Serving the Planned KTD

Contract No. KL/2010/03

Kai Tak Development - Stage 2 infrastructure works at north  
apron area of Kai Tak Airport for residential development  
and government, institution or community facilities

Monthly EM&A Report  
March 2015  
(Version 1.0)

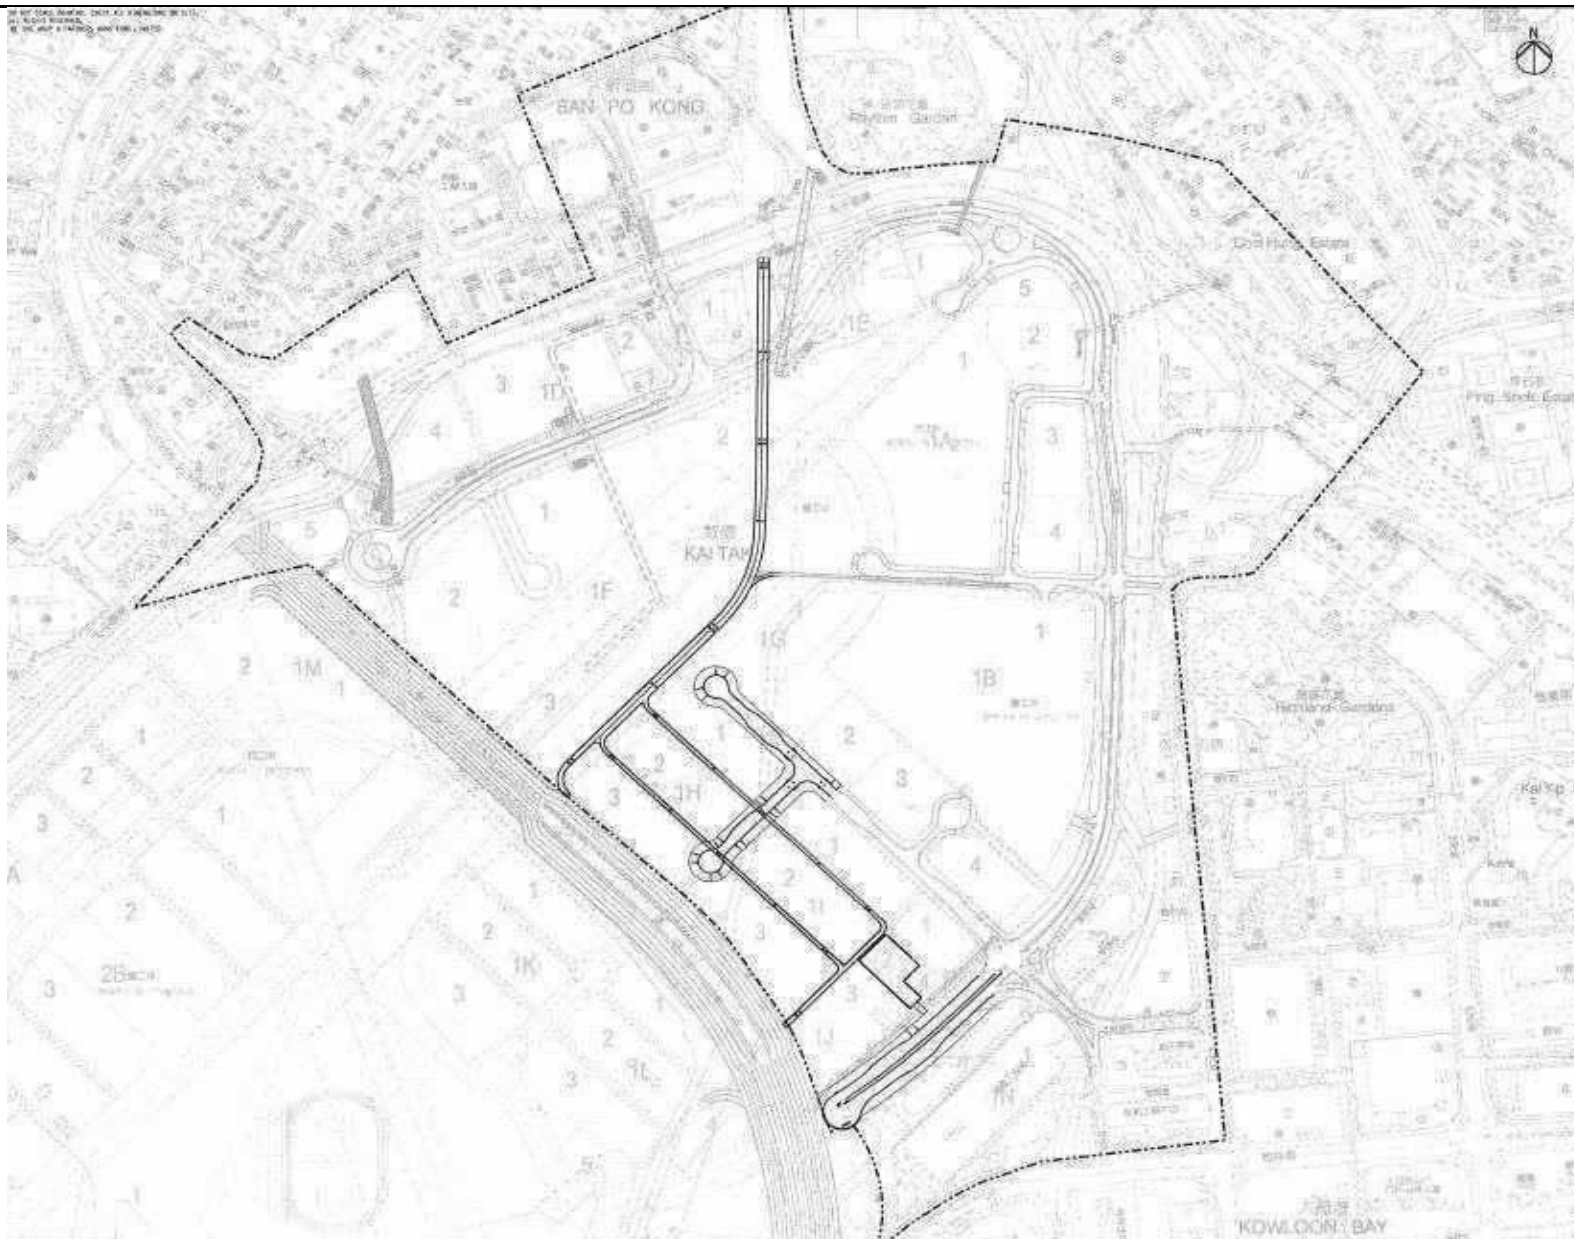
Title	EP-344/2009 – New Sewage Pumping Stations Serving KTD and EP-337/2009 – New Distributor Roads Serving the Planned KTD	Scale	Project	CINOTECH
		N.T.S	No. MA11038	
		Date	Figure	
	Site Layout Plan	Sep-11	1

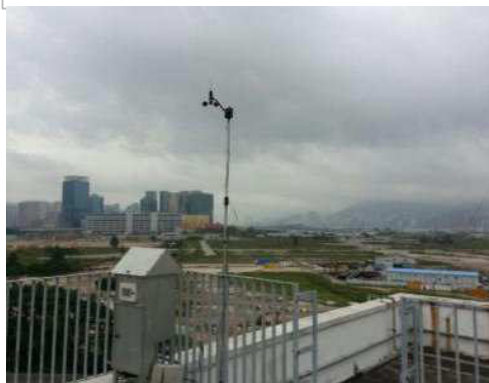
Wind Data Monitoring Equipment set at  
Kai Tak Operational Base  
[Original Location]
