EP-344/2009 – New Sewage Pumping Stations Serving KTD and
EP-337/2009 – New Distributor Roads Serving the Planned KTD

Contract No. KL/2012/03
Kai Tak Development –Stage 4 Infrastructure at
Former North Apron Area

Monthly EM&A Report

May 2015

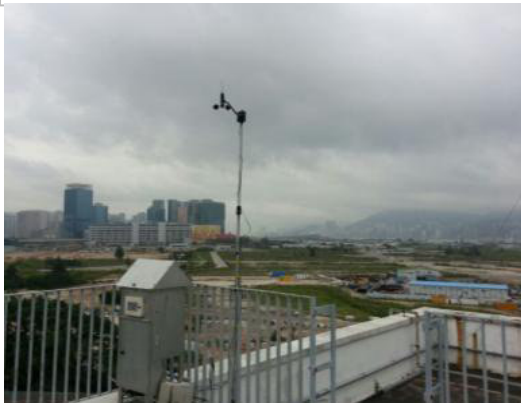
Wind Data Monitoring Equipment set at Lee Kau Yan Memorial School

Wind Monitoring Location	Northing	Easting
Lee Kau Yan Memorial School	821441.245	838153.917

Anemometer Station from The Hong Kong Observatory

Title	Contract No. KL/2012/03		Scale	Project		CINOTECH
	Kai Tak Development –Stage 4 Infrastructure at Former North Apron Area		N.T.S	No.	MA13056	
	Location of Wind Data Monitoring Equipment		Date	Figure	4	
			Dec-13

- 2.21 The air temperature, precipitation and the relative humidity data were obtained from Hong Kong Observatory where the wind speed and wind direction were recorded by the installed Wind Anemometer set at rooftop (about 8/F) Lee Kau Yan Memorial School. The location is shown in **Figure 4**. This weather information for the reporting month is summarized in **Appendix C**.

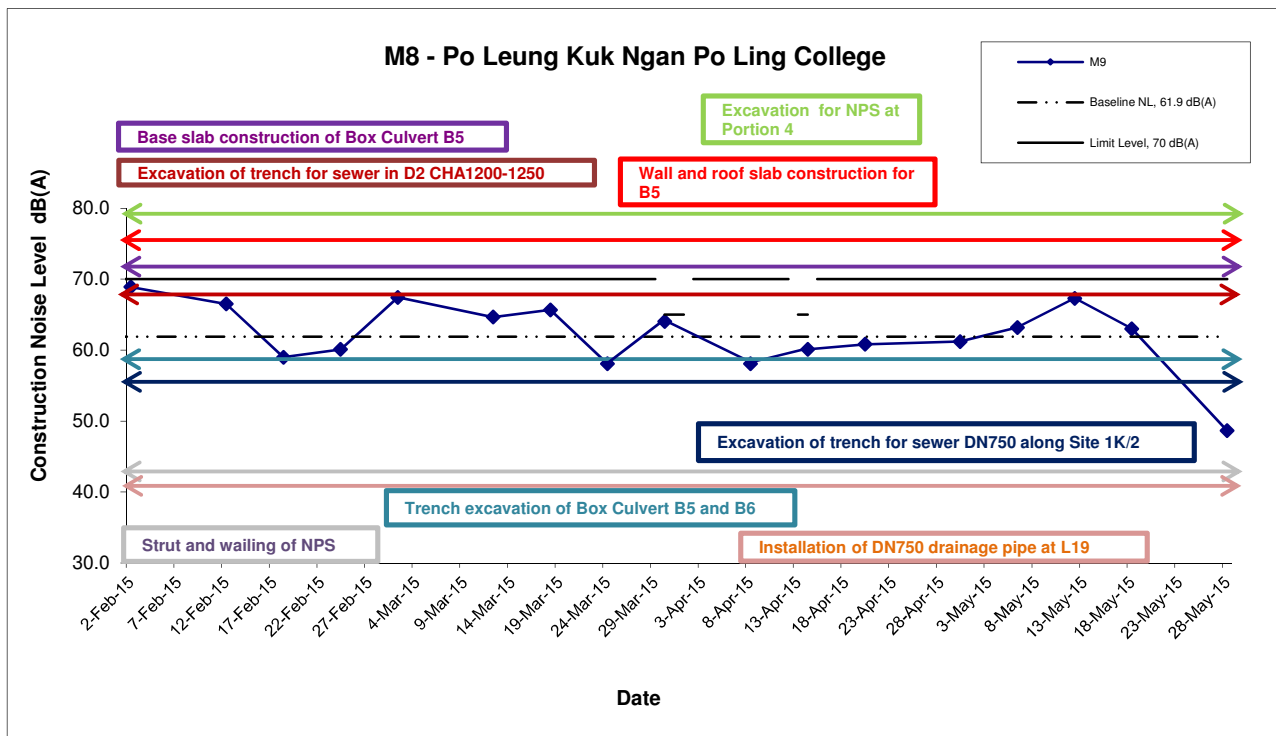
Noise Levels

Remarks: The construction noise levels in the Tables in Appendix G were adopted for plotting the graphs

Title Contract No. KLN/2010/04 Environmental Monitoring Works for Kai Tak Development Graphical Presentation of Construction Noise Monitoring Results	Scale N.T.S	Project No. MA13056	CINOTECH
	Date May 15	Appendix G

Title Contract No. KLN/2013/16 Environmental Monitoring Works for Kai Tak Development Graphical Presentation of Construction Noise Monitoring Results	Scale N.T.S	Project No. MA13056	CINOTECH
	Date May 15	Appendix G
