EP-344/2009 – New Sewage Pumping Stations Serving KTD and
EP-337/2009 – New Distributor Roads Serving the Planned KTD

Contract No. KL/2012/03
Kai Tak Development –Stage 4 Infrastructure at
Former North Apron Area

Monthly EM&A Report

June 2015

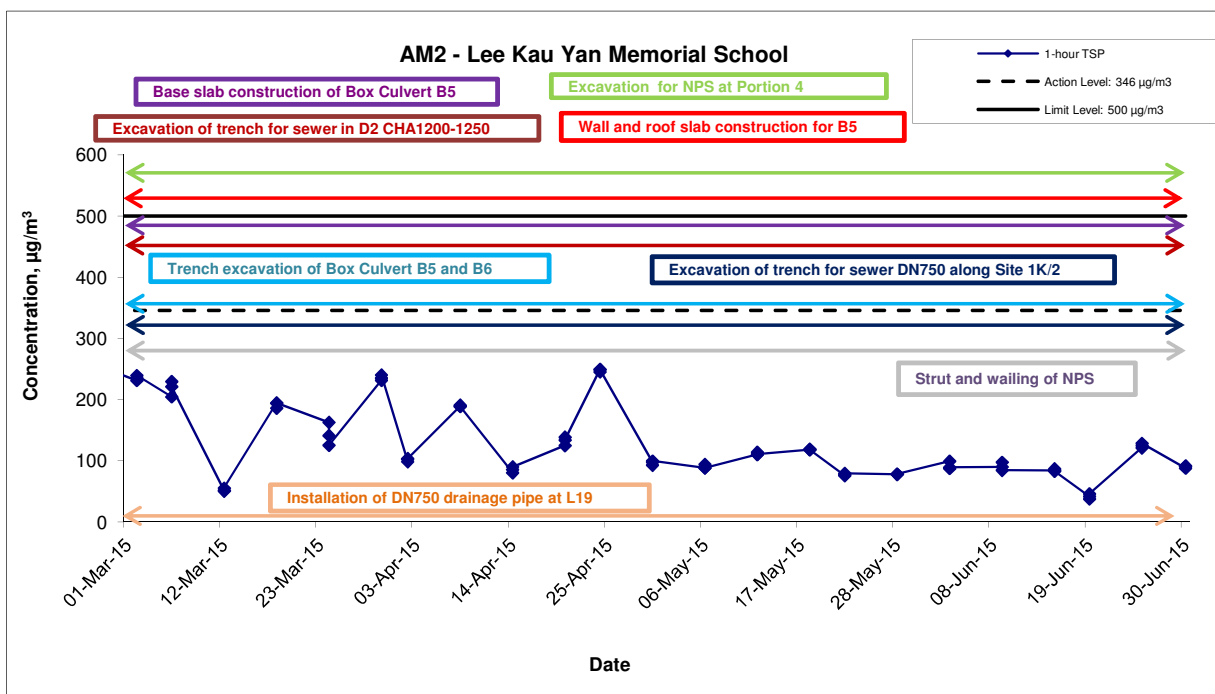
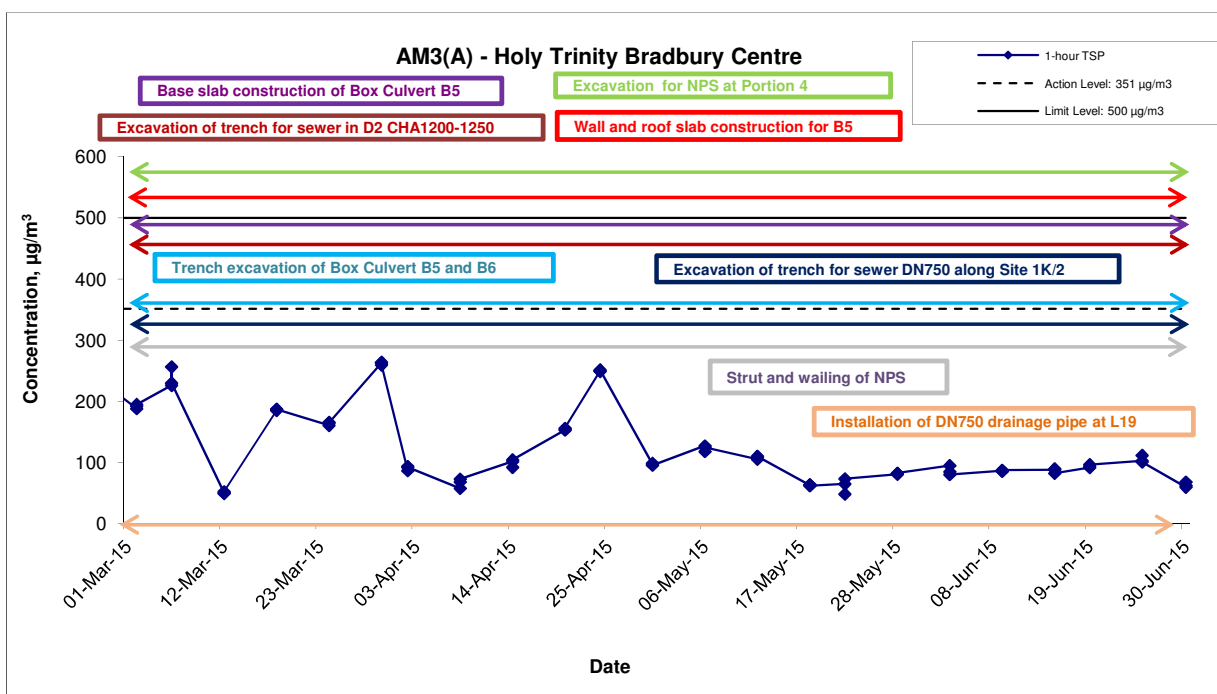
1-hr TSP Concentration Levels

Title	Contract No. KL/2012/03	Scale	Project No.	CINOTECH
	Kai Tak Development –Stage 4 Infrastructure at Former North Apron Area	N.T.S	MA13056	
Graphical Presentation of 1-hour TSP Monitoring Results		Date	Appendix	
		Jun 15	E

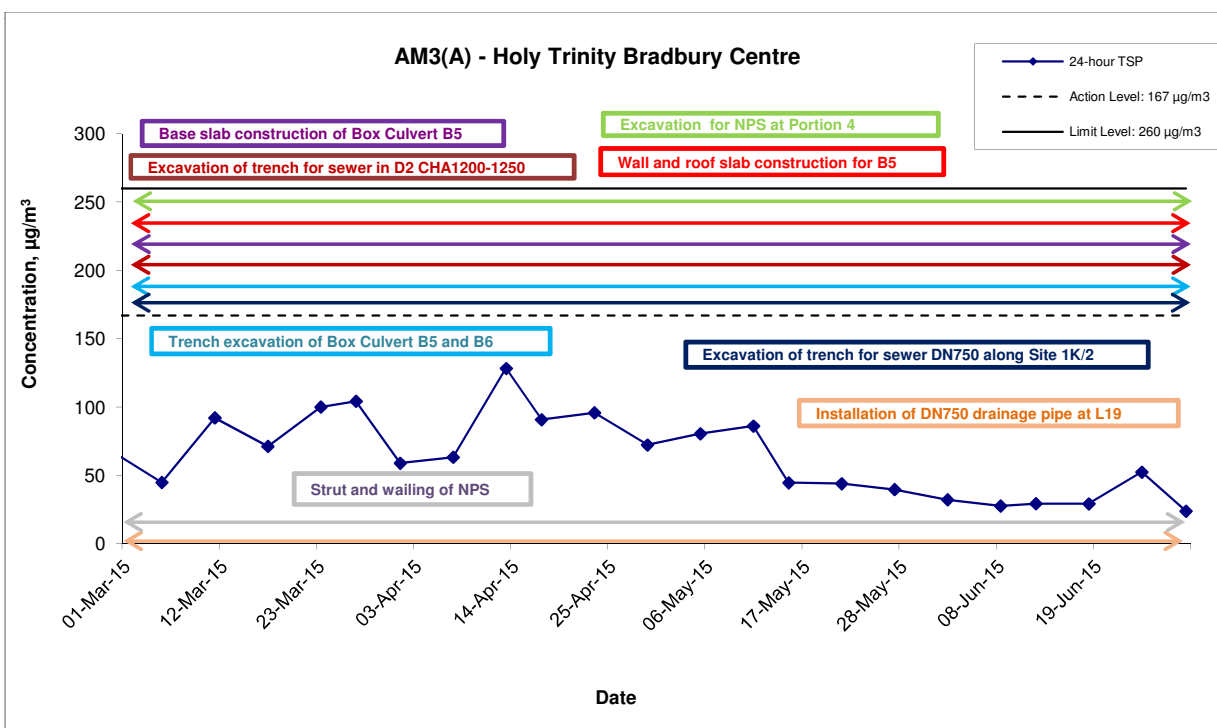
24-hr TSP Concentration Levels

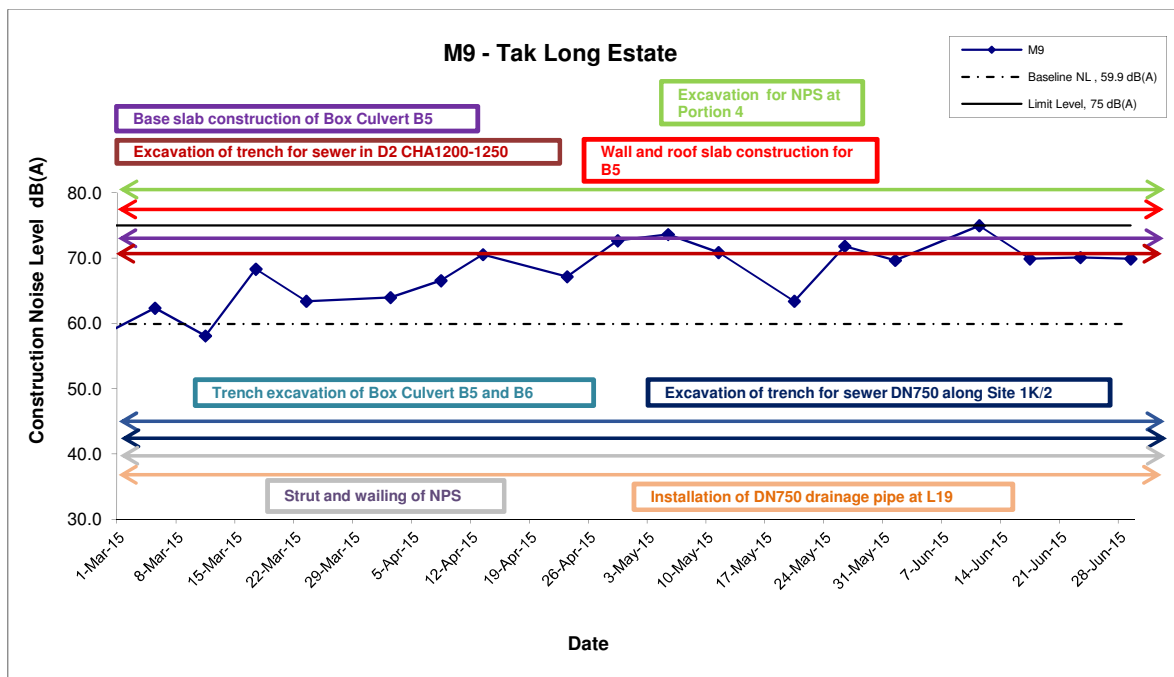
Noise Levels

Remarks: The construction noise levels in the Tables in Appendix G were adopted for plotting the graphs

Title	Contract No. KL/2012/03	Scale	Project No.	CINOTECH
	Kai Tak Development –Stage 4 Infrastructure at Former North Apron Area	N.T.S	MA13056	
Graphical Presentation of Construction Noise Monitoring Results		Date	Appendix	
		Jun 15	G
