EP-344/2009 – New Sewage Pumping Stations Serving KTD and  
EP-337/2009 – New Distributor Roads Serving the Planned KTD

**Contract No. KL/2012/03**  
**Kai Tak Development –Stage 4 Infrastructure at**  
**Former North Apron Area**

Monthly EM&A Report

August 2015

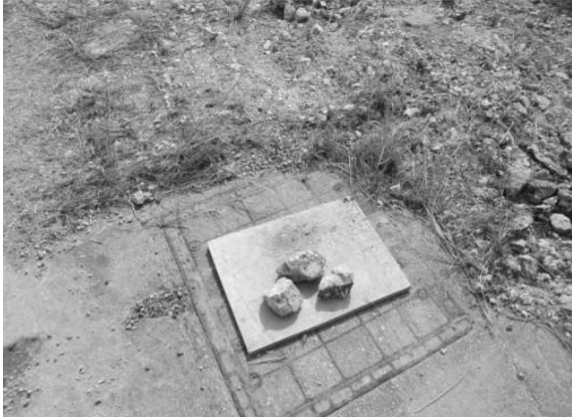
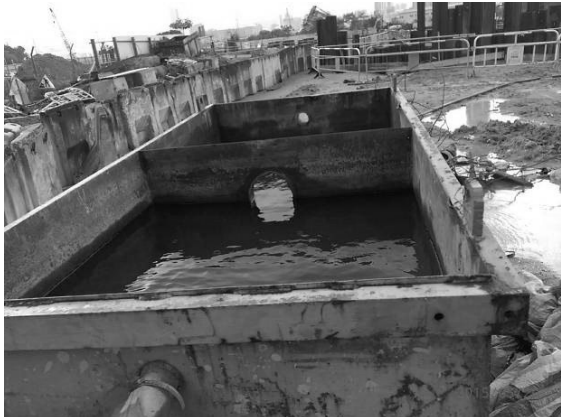
To prevent any surface runoff discharge into any stream course.	Follow-up measure(s) after identification of wastewater discharges from site.

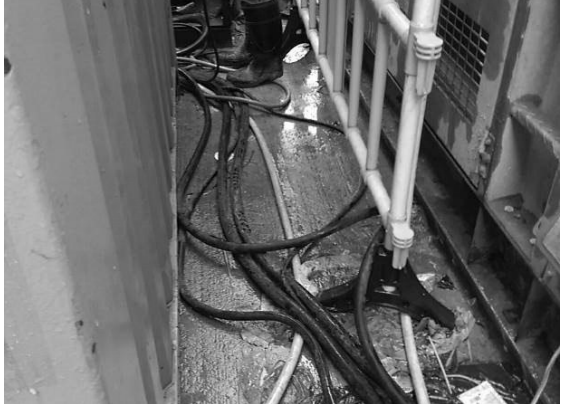
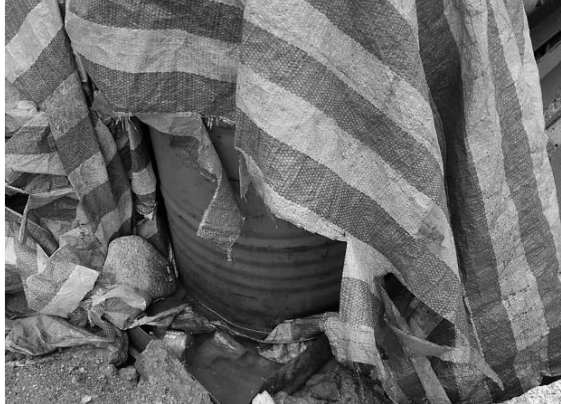
To avoid any discharge or accidental spillage of chemical waste or oil directly from the site	To avoid improper handling or storage of oil drum on site

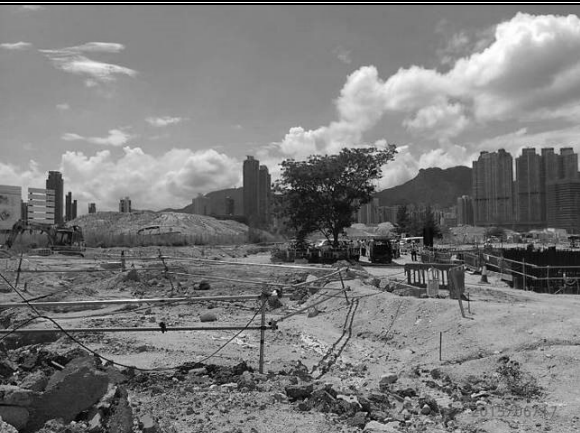
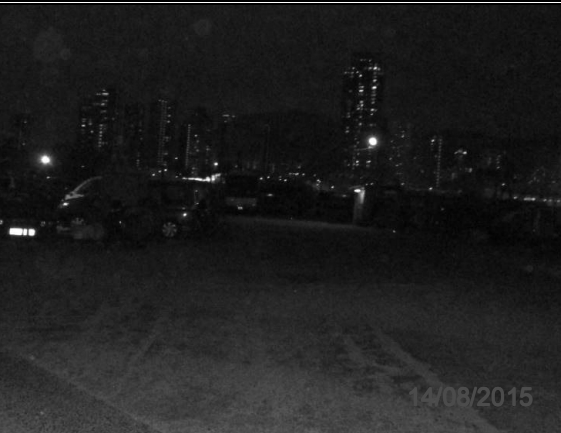
To protect the existing trees to be retained	To control of night-time lighting

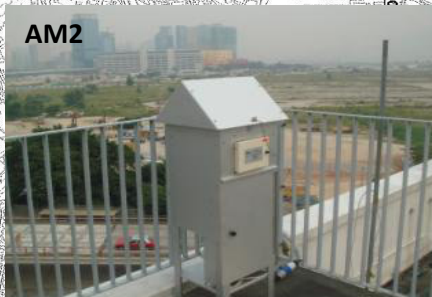
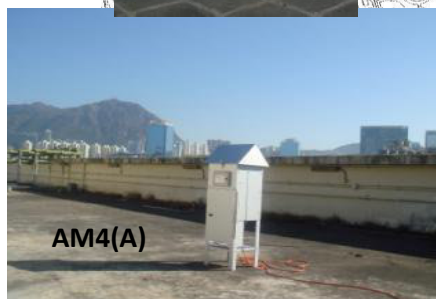
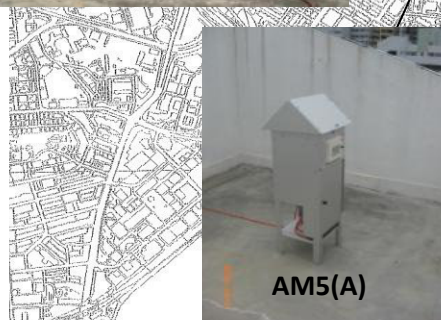
Location		Northing	Easting
AM2	Lee Kau Yan Memorial School	821441.245	838153.917
AM3(A)	Holy Trinity Bradbury Centre	820769.390	837522.115
AM4(A)	EMSD Workshops	820147.495	838155.791
AM5(A)	Po Leung Kuk Ngan Po Ling College	819300.323	837659.613

Title Contract No. KL/2012/03  
 Kai Tak Development –Stage 4 Infrastructure at Former North Apron Area  
 Air Quality Monitoring Stations under this Project
