EP-344/2009 – New Sewage Pumping Stations Serving KTD and
EP-337/2009 – New Distributor Roads Serving the Planned KTD

Contract No. KL/2012/03
Kai Tak Development –Stage 4 Infrastructure at
Former North Apron Area

Monthly EM&A Report

September 2015

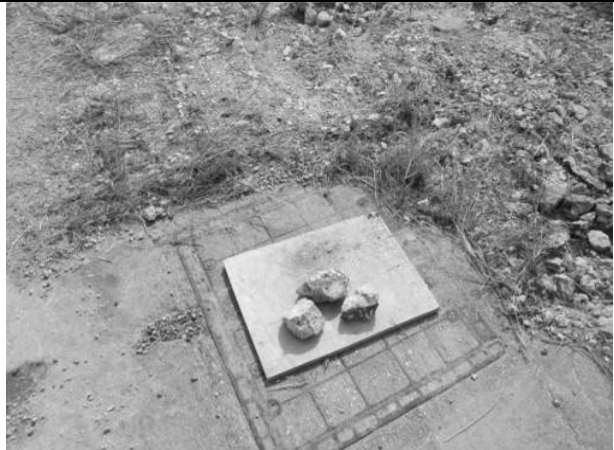
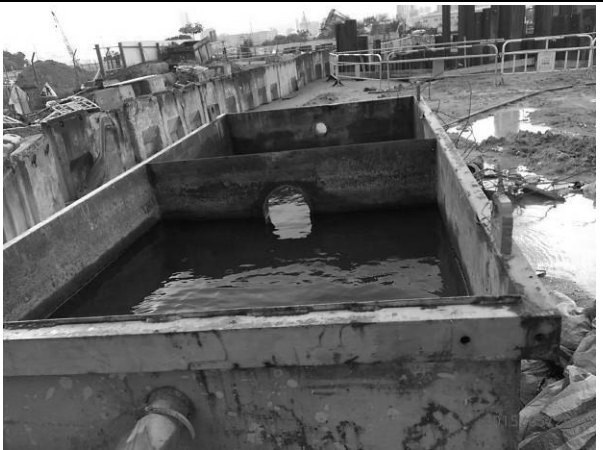
<p>To prevent any surface runoff discharge into any stream course.</p>	<p>Follow-up measure(s) after identification of wastewater discharges from site.</p>

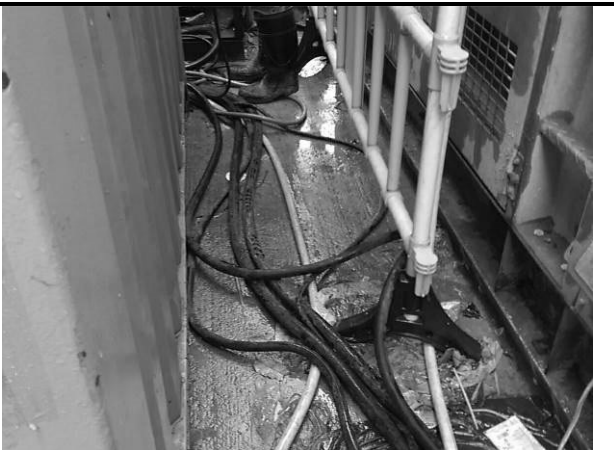
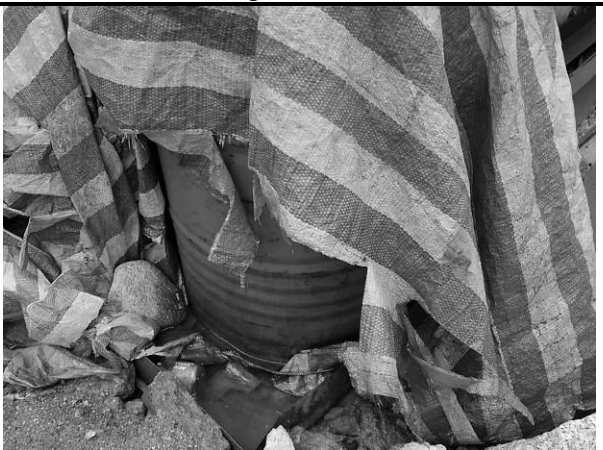
<p>To avoid any discharge or accidental spillage of chemical waste or oil directly from the site</p>	<p>To avoid improper handling or storage of oil drum on site</p>

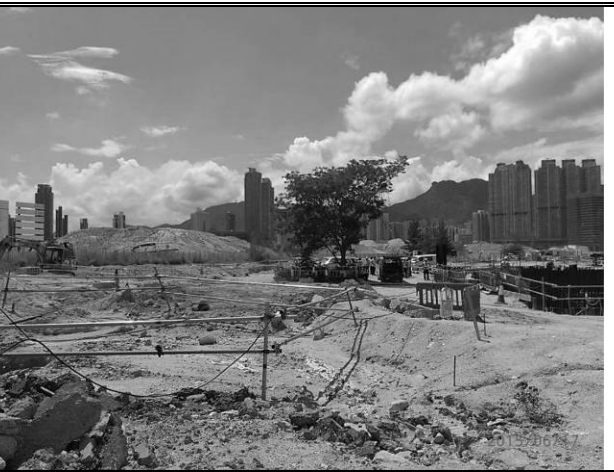
<p>To protect the existing trees to be retained</p>	<p>To control of night-time lighting</p>

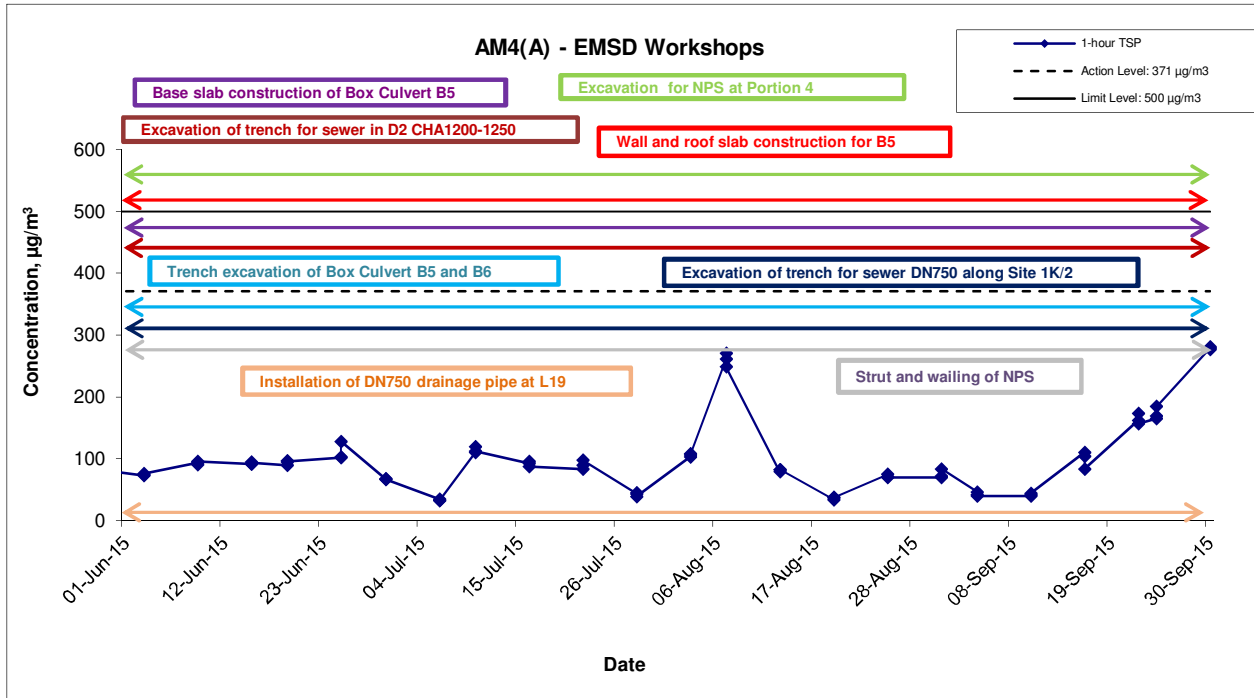
Title	Contract No. KL/2012/03	Scale	Project No.	CINOTECH
	Kai Tak Development –Stage 4 Infrastructure at Former North Apron Area	N.T.S	MA13056	
	Graphical Presentation of 1-hour TSP Monitoring Results	Date	Appendix	
		Sep 15	E
