EP-344/2009 – New Sewage Pumping Stations Serving KTD and
EP-337/2009 – New Distributor Roads Serving the Planned KTD

Contract No. KL/2012/03
Kai Tak Development –Stage 4 Infrastructure at
Former North Apron Area

Monthly EM&A Report

November 2015

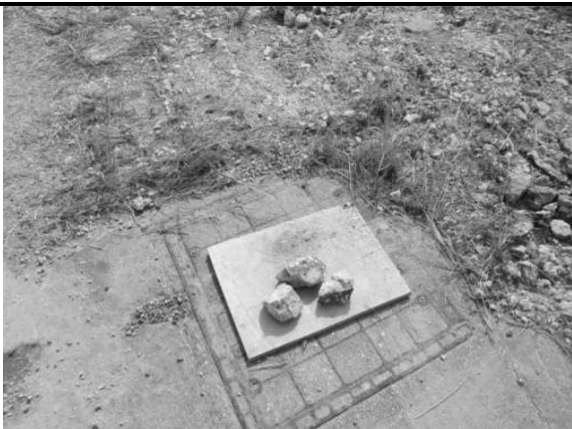
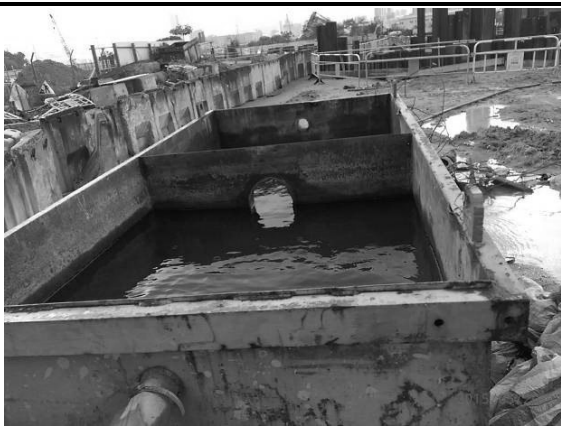
To prevent any surface runoff discharge into any stream course.	Follow-up measure(s) after identification of wastewater discharges from site.

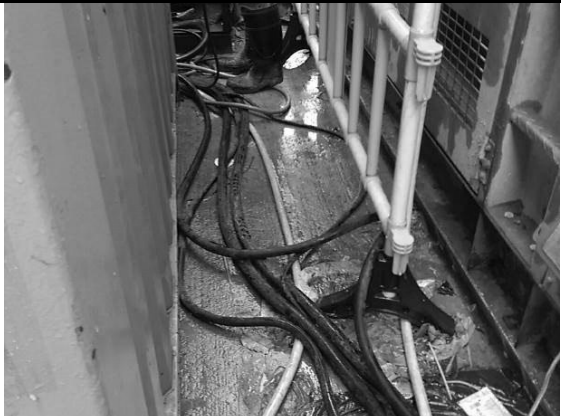
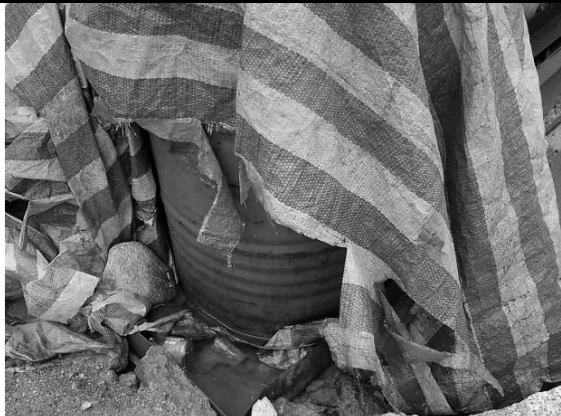
To avoid any discharge or accidental spillage of chemical waste or oil directly from the site	To avoid improper handling or storage of oil drum on site
