EP-344/2009 – New Sewage Pumping Stations Serving KTD and
EP-337/2009 – New Distributor Roads Serving the Planned KTD

Contract No. KL/2012/03
Kai Tak Development –Stage 4 Infrastructure at
Former North Apron Area

Monthly EM&A Report

December 2015

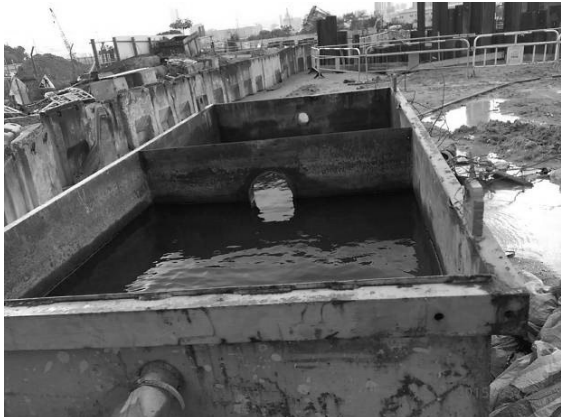
To prevent any surface runoff discharge into any stream course.	Follow-up measure(s) after identification of wastewater discharges from site.

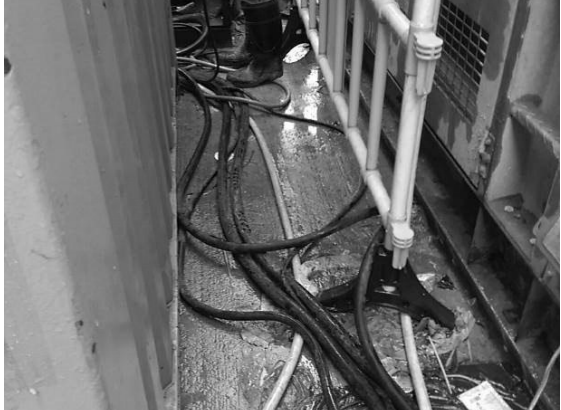
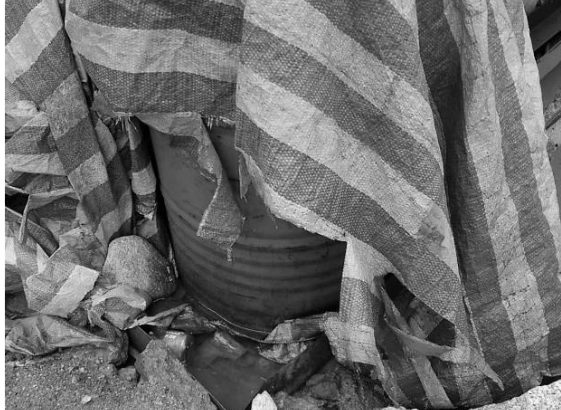
To avoid any discharge or accidental spillage of chemical waste or oil directly from the site	To avoid improper handling or storage of oil drum on site

- Kerosine in drum was observed beside a generator within PS2. Storage in chemical store or drip tray is reminded.

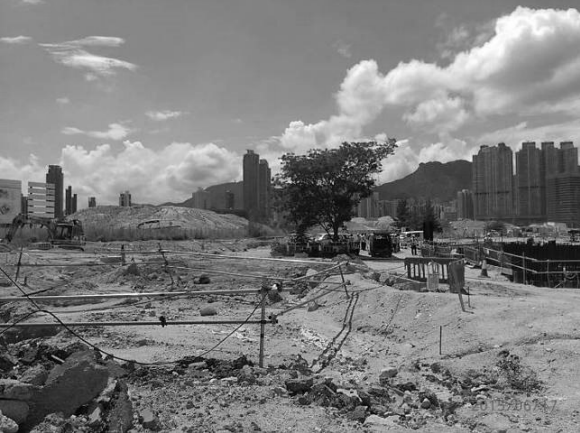
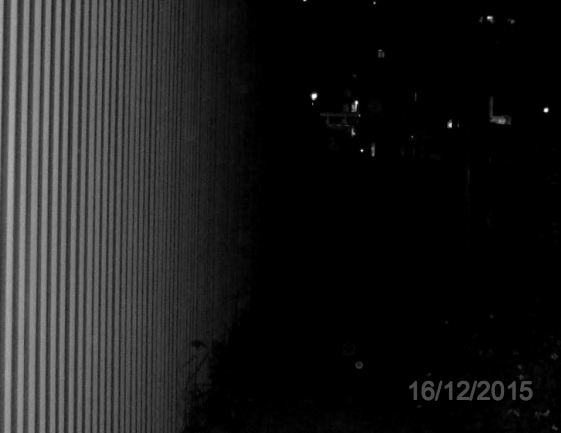
To protect the existing trees to be retained	To control of night-time lighting
