EP-344/2009 – New Sewage Pumping Stations Serving KTD and
EP-337/2009 – New Distributor Roads Serving the Planned KTD

Contract No. KL/2012/03
Kai Tak Development –Stage 4 Infrastructure at
Former North Apron Area

Monthly EM&A Report

February 2016

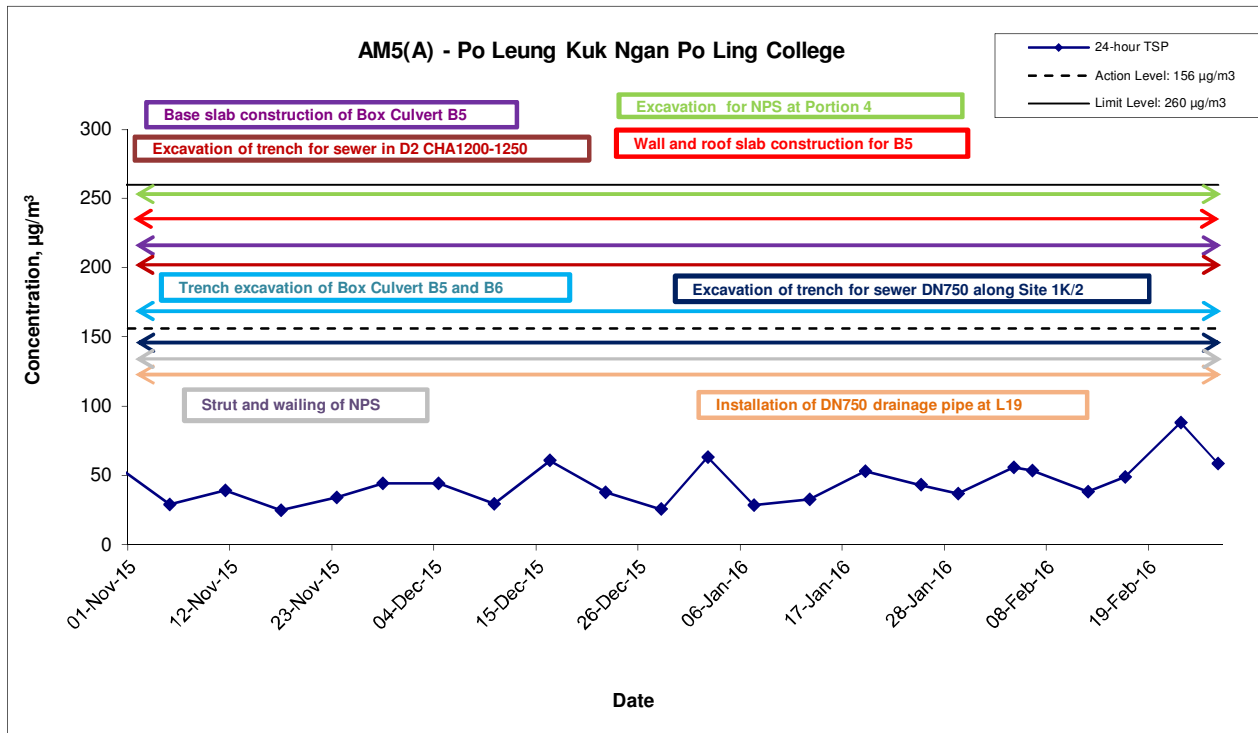
Date Feb 16	Appendix F

Title Contract No. KL/2012/03 Kai Tak Development –Stage 4 Infrastructure at Former North Apron Area Graphical Presentation of 24-hour TSP Monitoring Results	Scale N.T.S	Project No. MA13056

24-hr TSP Concentration Levels
