**EP-344/2009 – New Sewage Pumping Stations
Serving KTD EP-337/2009 – New Distributor
Roads Serving the Planned KTD**

**Contract No. KL/2012/03
Kai Tak Development –Stage 4 Infrastructure
at Former North Apron Area**

Monthly EM&A Report

November 2016

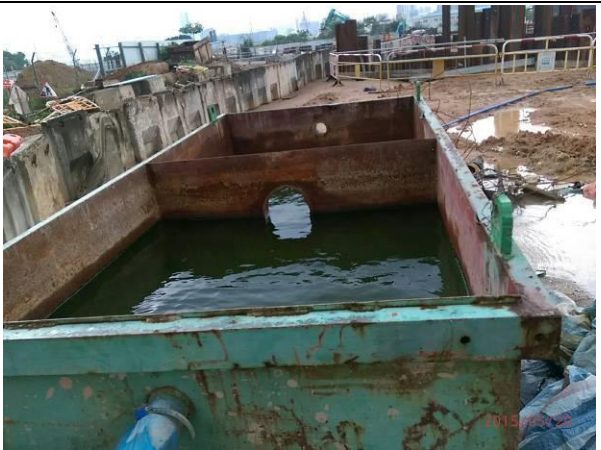
To prevent any surface runoff discharge into any stream course.	Follow-up measure(s) after identification of wastewater discharges from site.

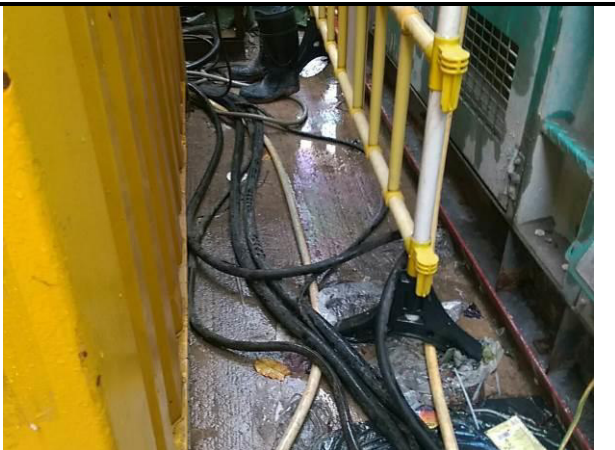
To avoid any discharge or accidental spillage of chemical waste or oil directly from the site	To avoid improper handling or storage of oil drum on site

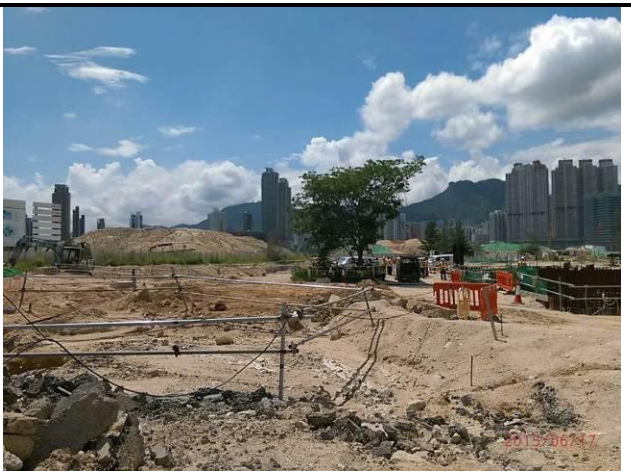
To protect the existing trees to be retained	To control of night-time lighting

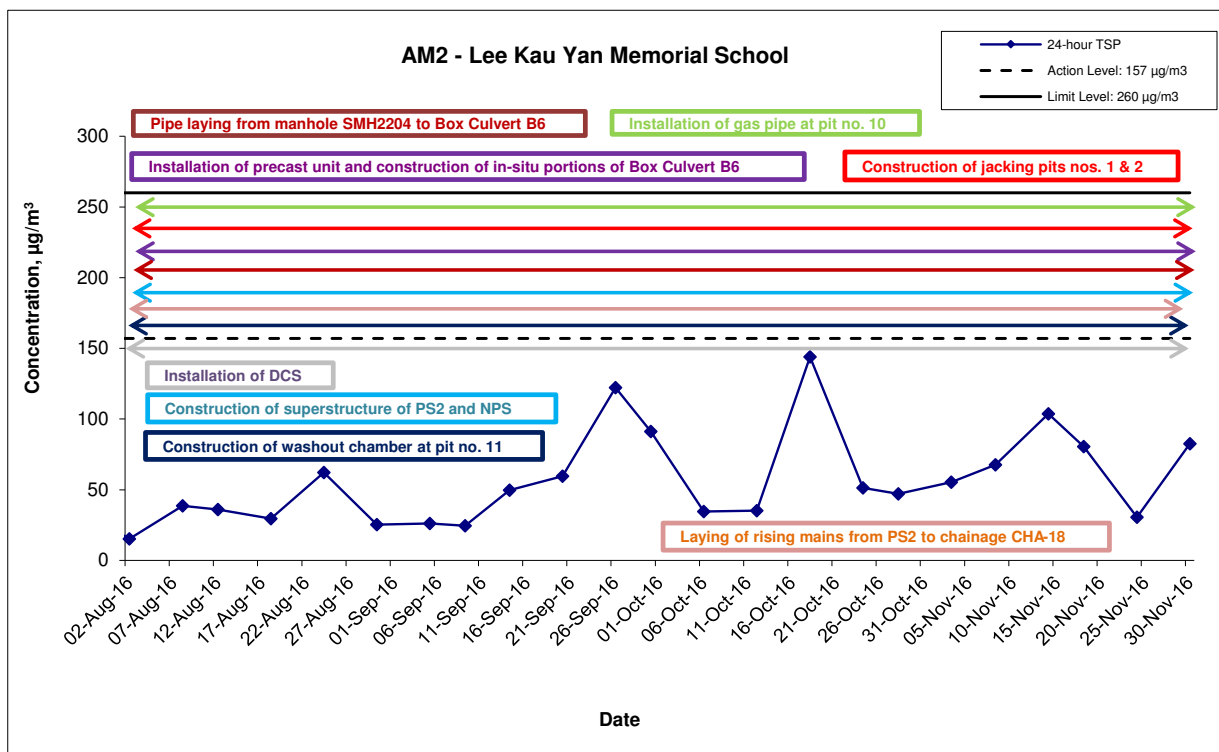
Title	Contract No. KL/2012/03		Scale	Project
	Kai Tak Development –Stage 4 Infrastructure at Former North Apron Area		N.T.S	No. MA13056
	Graphical Presentation of 24-hour TSP Monitoring Results		Date	Appendix
			Nov 16	F

24-hr TSP Concentration Levels
