**EP-344/2009 – New Sewage Pumping Stations
Serving KTD
EP-337/2009 – New Distributor Roads Serving
the Planned KTD**

**Contract No. KL/2012/03
Kai Tak Development –Stage 4 Infrastructure
at Former North Apron Area**

Monthly EM&A Report

December 2016

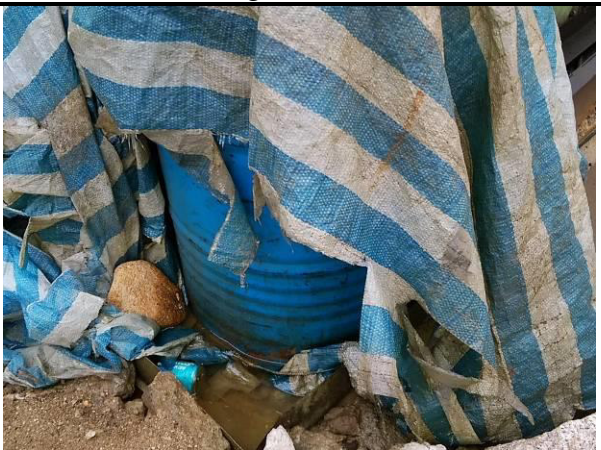
To avoid any discharge or accidental spillage of chemical waste or oil directly from the site	To avoid improper handling or storage of oil drum on site

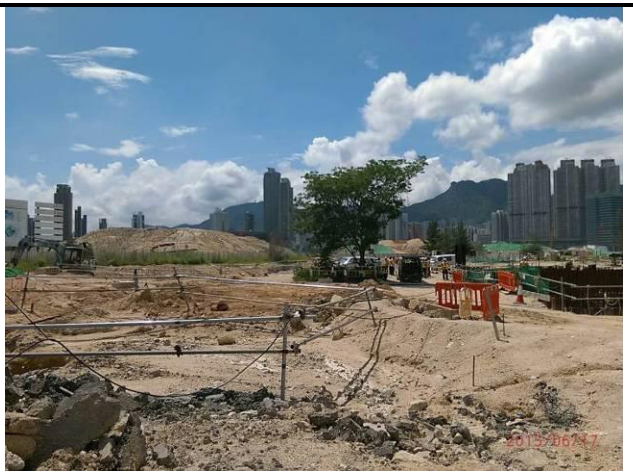
To protect the existing trees to be retained	To control of night-time lighting
