**EP-344/2009 – New Sewage Pumping Stations
Serving KTD
EP-337/2009 – New Distributor Roads Serving
the Planned KTD**

**Contract No. KL/2012/03
Kai Tak Development –Stage 4 Infrastructure
at Former North Apron Area**

Monthly EM&A Report

January 2017

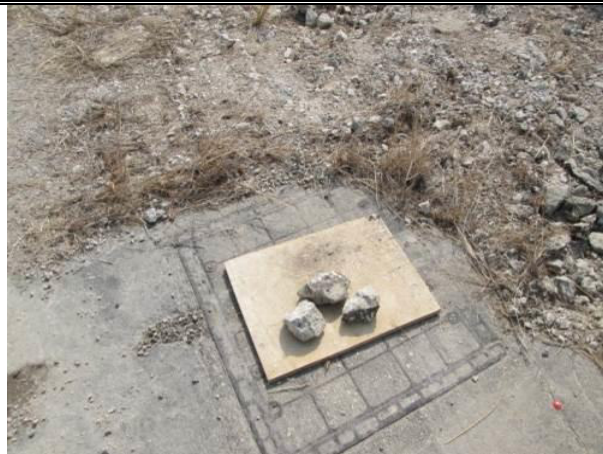
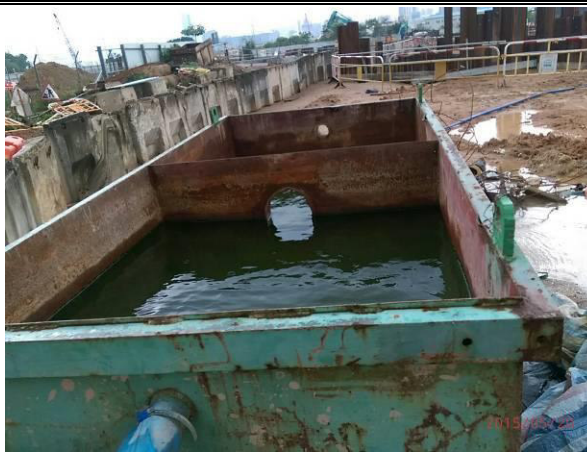
<p>To prevent any surface runoff discharge into any stream course.</p>	<p>Follow-up measure(s) after identification of wastewater discharges from site.</p>

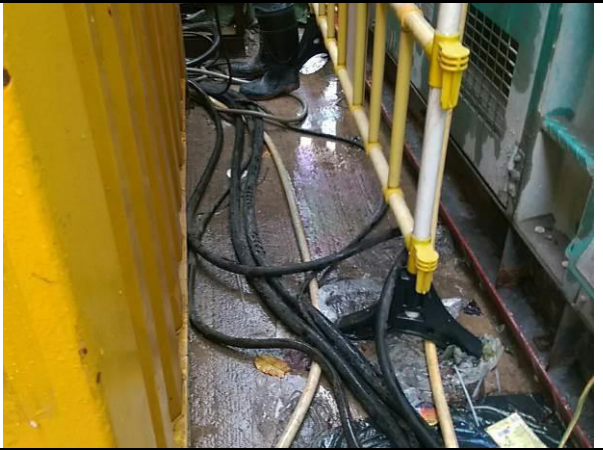
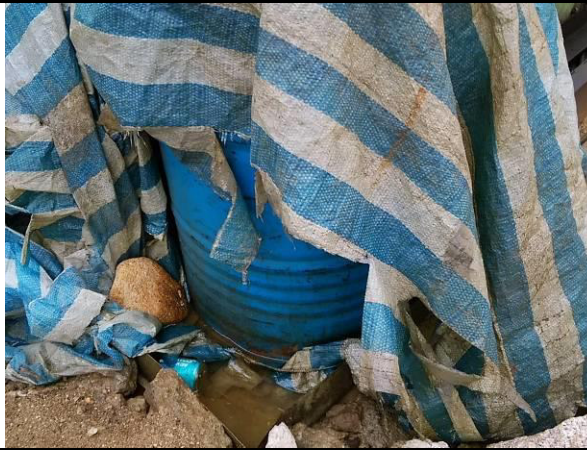
<p>To avoid any discharge or accidental spillage of chemical waste or oil directly from the site</p>	<p>To avoid improper handling or storage of oil drum on site</p>
