**EP-344/2009 – New Sewage Pumping Stations  
Serving KTD  
EP-337/2009 – New Distributor Roads Serving the  
Planned KTD**

**Contract No. KL/2012/03  
Kai Tak Development –Stage 4 Infrastructure at  
Former North Apron Area**

Monthly EM&A Report

December 2017

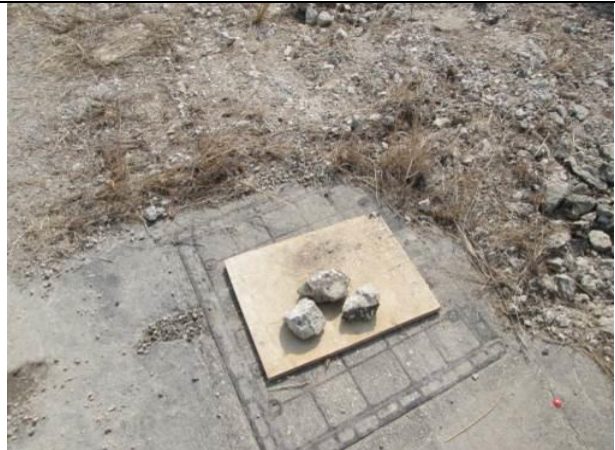
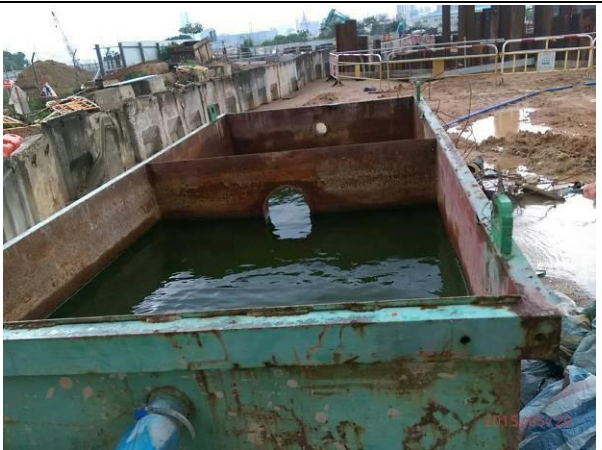
To prevent any surface runoff discharge into any stream course.	Follow-up measure(s) after identification of wastewater discharges from site.

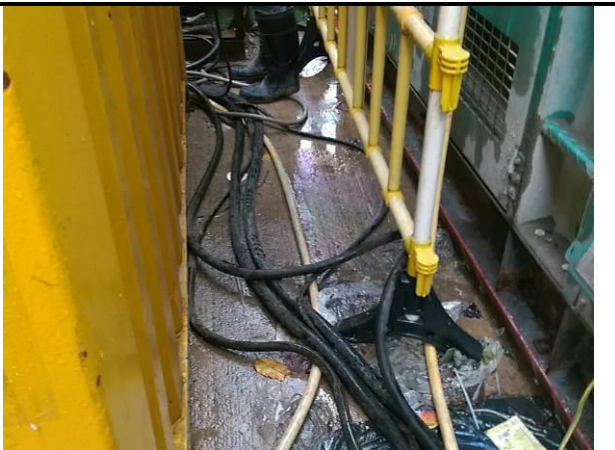
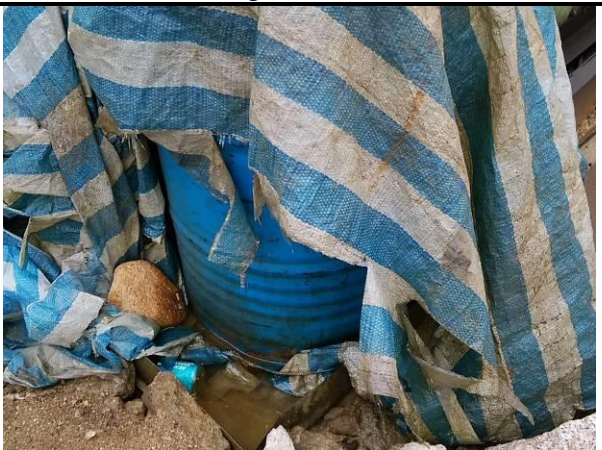
To avoid any discharge or accidental spillage of chemical waste or oil directly from the site	To avoid improper handling or storage of oil drum on site
