**EP-344/2009 – New Sewage Pumping Stations
Serving KTD
EP-337/2009 – New Distributor Roads Serving the
Planned KTD**

**Contract No. KL/2012/03
Kai Tak Development –Stage 4 Infrastructure at
Former North Apron Area**

Monthly EM&A Report

January 2018

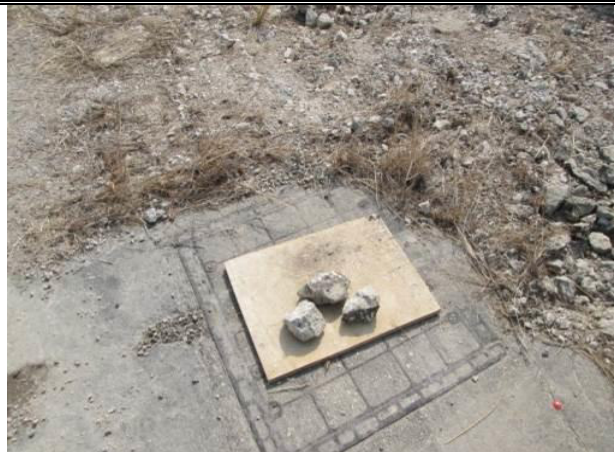
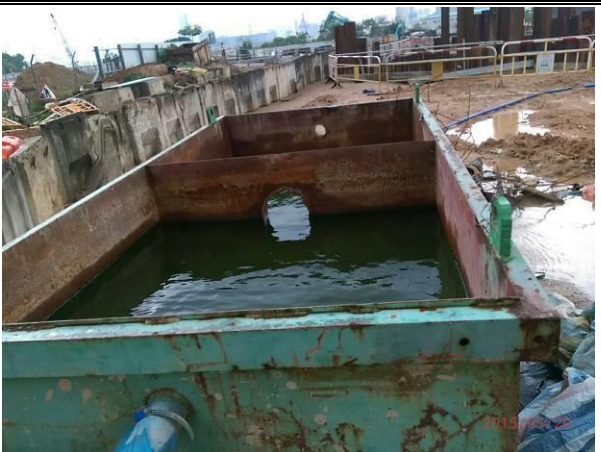
<p>To prevent any surface runoff discharge into any stream course.</p>	<p>Follow-up measure(s) after identification of wastewater discharges from site.</p>

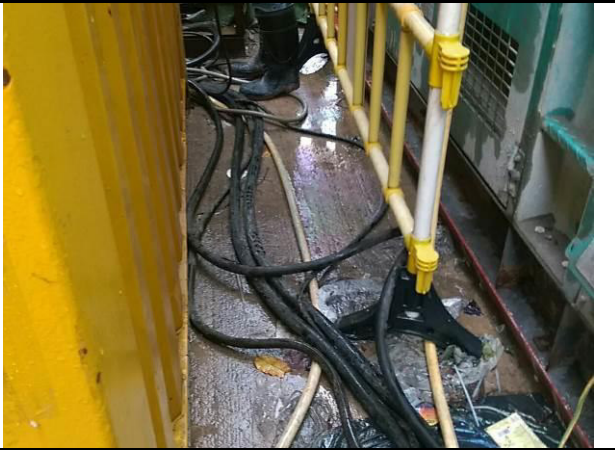
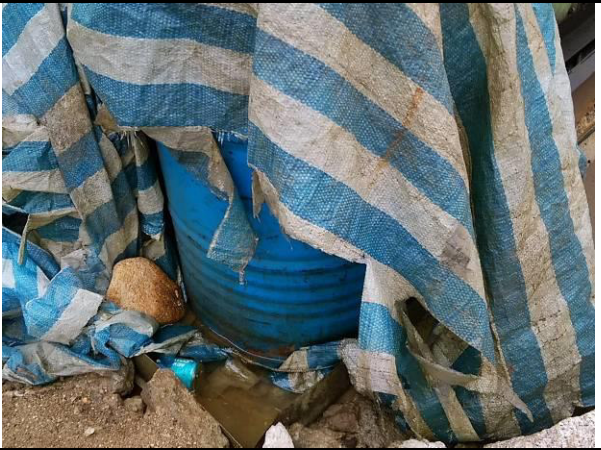
<p>To avoid any discharge or accidental spillage of chemical waste or oil directly from the site</p>	<p>To avoid improper handling or storage of oil drum on site</p>

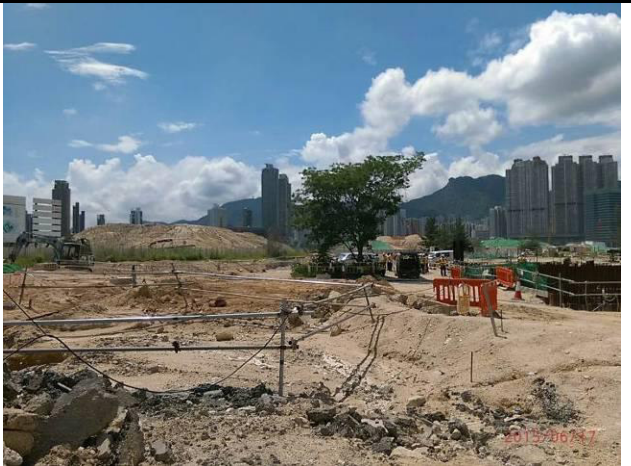
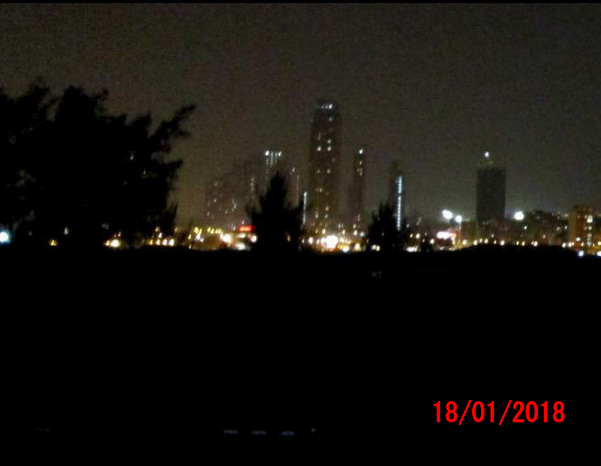
<p>To protect the existing trees to be retained</p>	<p>To control of night-time lighting</p>

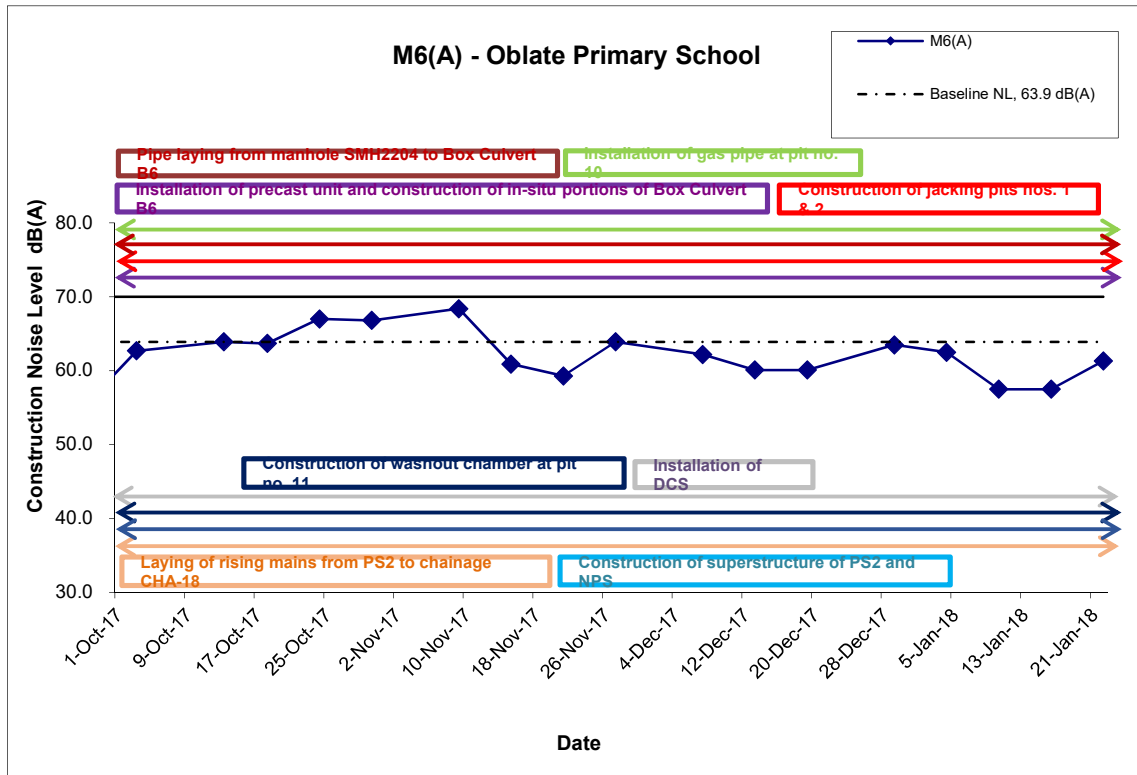
Noise Levels

Remarks: The construction noise levels in the Tables in Appendix G were adopted for plotting the graphs

Title Contract No. KL/2012/03 Kai Tak Development –Stage 4 Infrastructure at Former North Apron Area Graphical Presentation of Construction Noise Monitoring Results	Scale N.T.S	Project No. VA13056	
	Date Jan 18	Appendix G

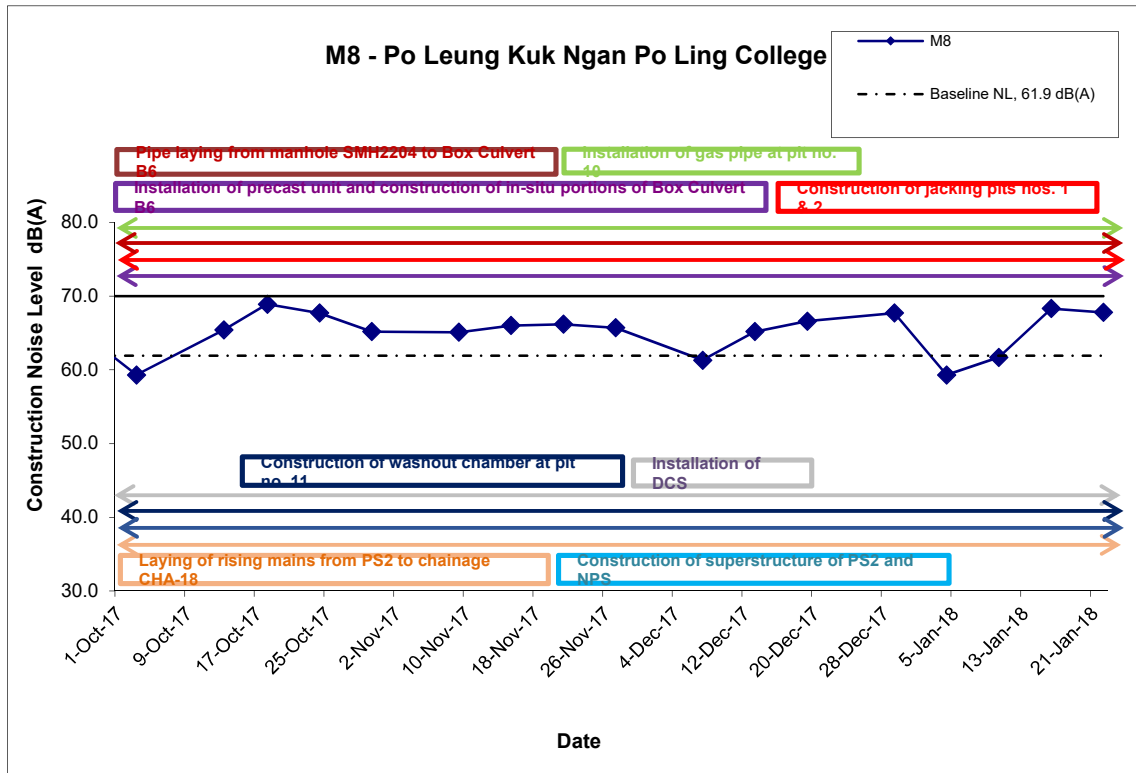
Noise Levels

Remarks: The construction noise levels in the Tables in Appendix G were adopted for plotting the graphs

Title	Contract No. KL/2012/03		Scale	Project No.	CINOTECH
	Kai Tak Development –Stage 4 Infrastructure at Former North Apron Area		N.T.S	VA13056	
Graphical Presentation of Construction Noise Monitoring Results			Date	Appendix	G
			Jan 18
