**EP-344/2009 – New Sewage Pumping Stations
Serving KTD
EP-337/2009 – New Distributor Roads Serving the
Planned KTD**

**Contract No. KL/2012/03
Kai Tak Development –Stage 4 Infrastructure at
Former North Apron Area**

Monthly EM&A Report

February 2018

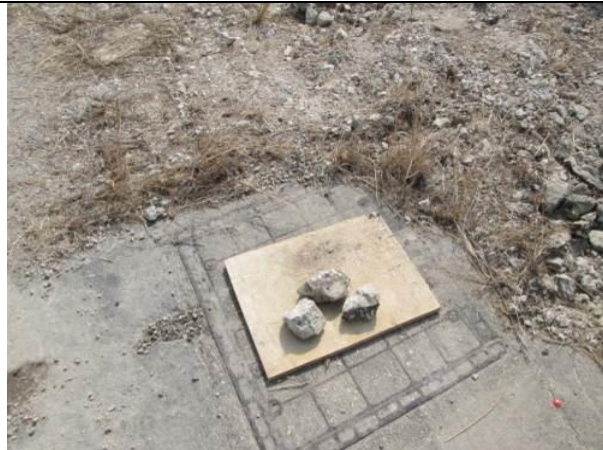
| To prevent any surface runoff discharge into any stream course. | Follow-up measure(s) after identification of wastewater discharges from site. |

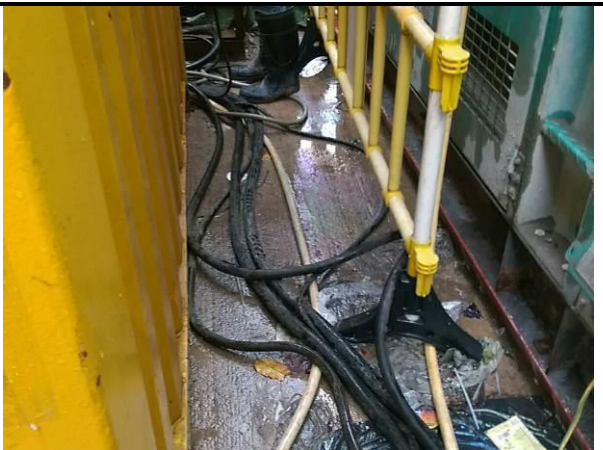
| To avoid any discharge or accidental spillage of chemical waste or oil directly from the site | To avoid improper handling or storage of oil drum on site |
