**EP-344/2009 – New Sewage Pumping Stations  
Serving KTD  
EP-337/2009 – New Distributor Roads Serving the  
Planned KTD**

**Contract No. KL/2012/03  
Kai Tak Development –Stage 4 Infrastructure at  
Former North Apron Area**

Monthly EM&A Report

March 2018

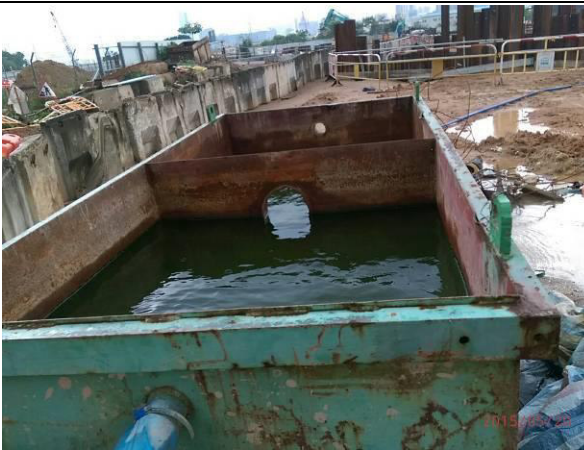
To prevent any surface runoff discharge into any stream course.	Follow-up measure(s) after identification of wastewater discharges from site.

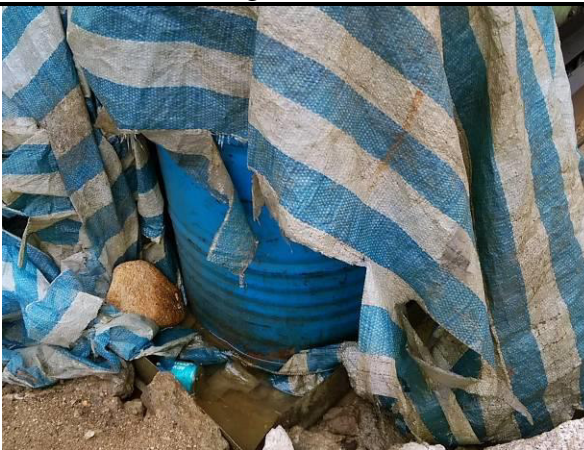
To avoid any discharge or accidental spillage of chemical waste or oil directly from the site	To avoid improper handling or storage of oil drum on site
