**EP-344/2009 – New Sewage Pumping Stations
Serving KTD
EP-337/2009 – New Distributor Roads Serving the
Planned KTD**

**Contract No. KL/2012/03
Kai Tak Development –Stage 4 Infrastructure at
Former North Apron Area**

Monthly EM&A Report

April 2018

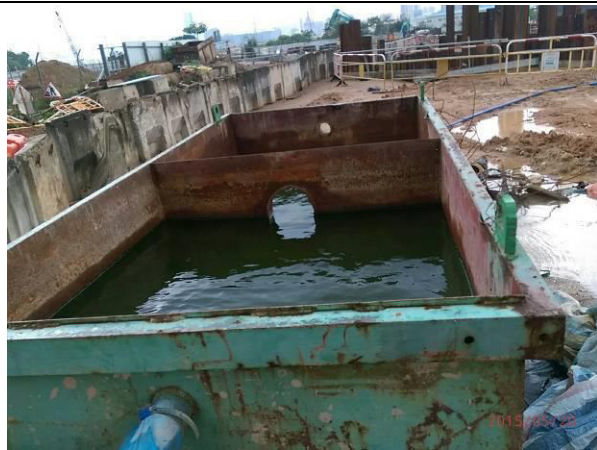
<p>To prevent any surface runoff discharge into any stream course.</p>	<p>Follow-up measure(s) after identification of wastewater discharges from site.</p>

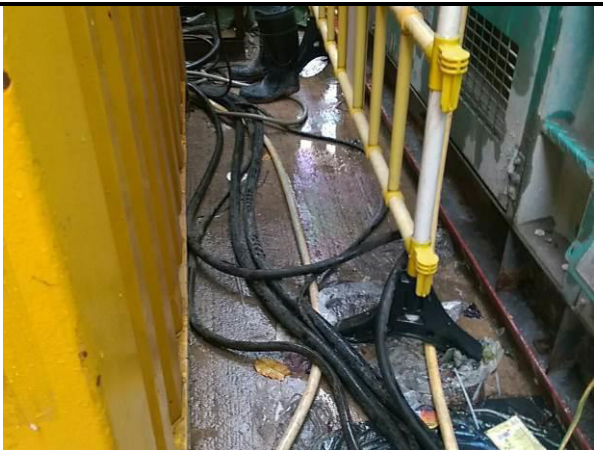
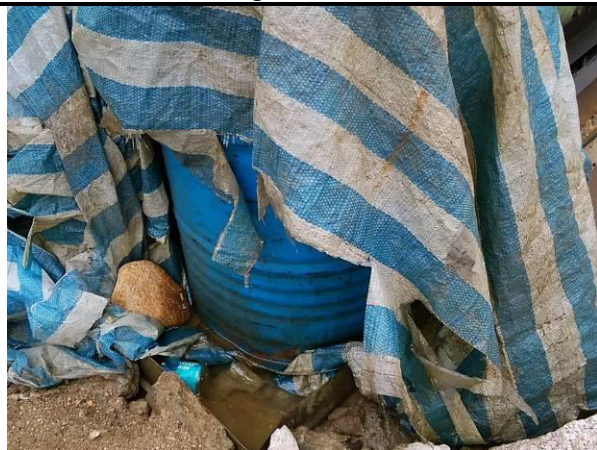
<p>To avoid any discharge or accidental spillage of chemical waste or oil directly from the site</p>	<p>To avoid improper handling or storage of oil drum on site</p>

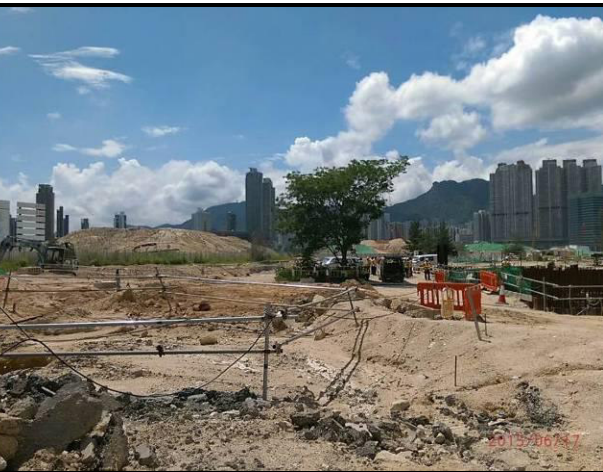
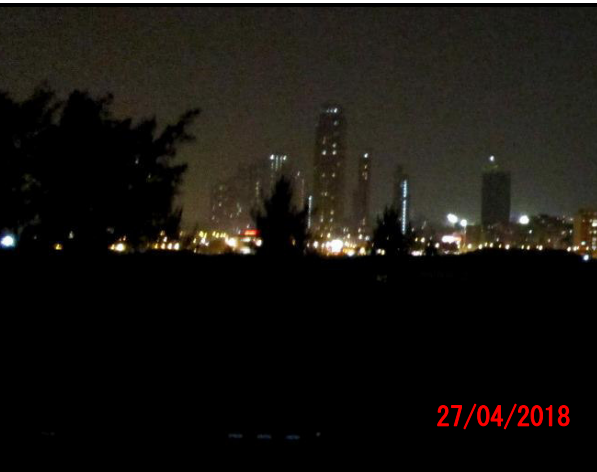
<p>To protect the existing trees to be retained</p>	<p>To control of night-time lighting</p>

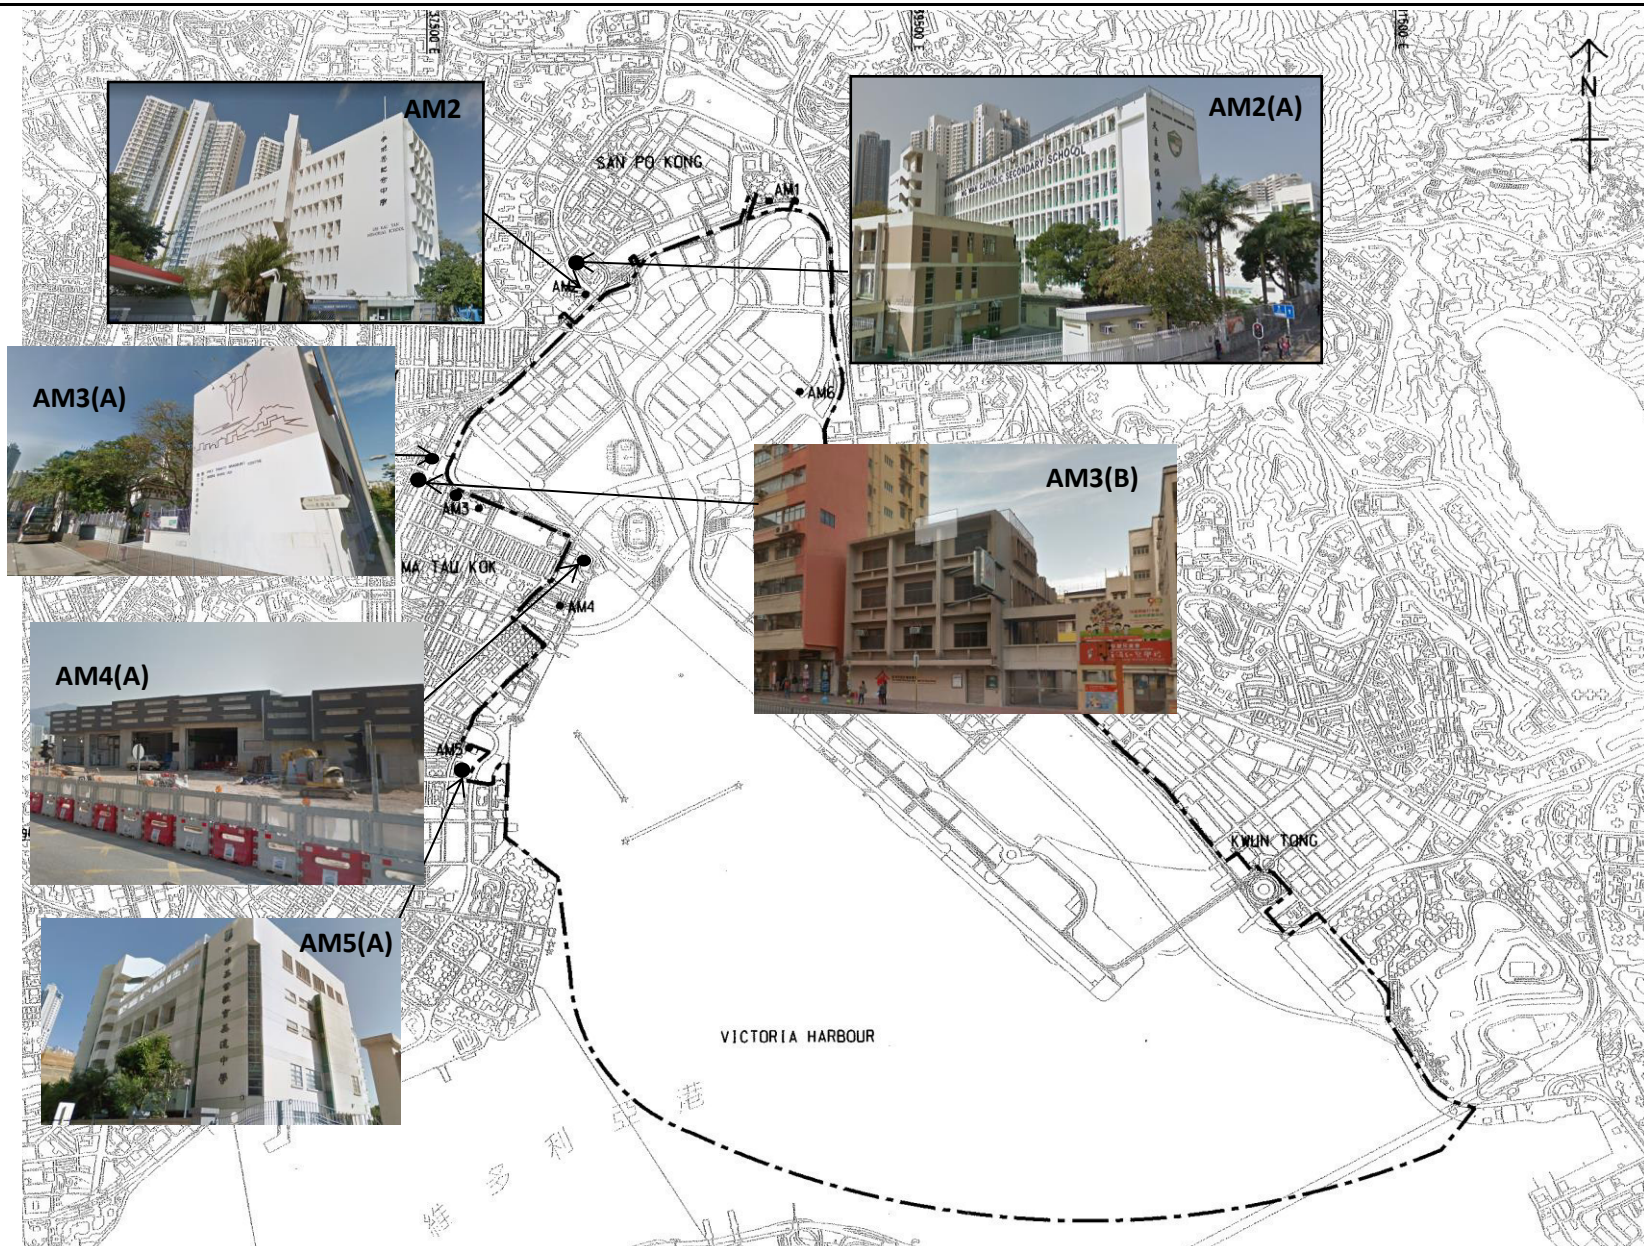
Contract No. KL/2012/03
 Kai Tak Development –Stage 4 Infrastructure at Former North Apron Area
 Air Quality Monitoring Stations under this Project

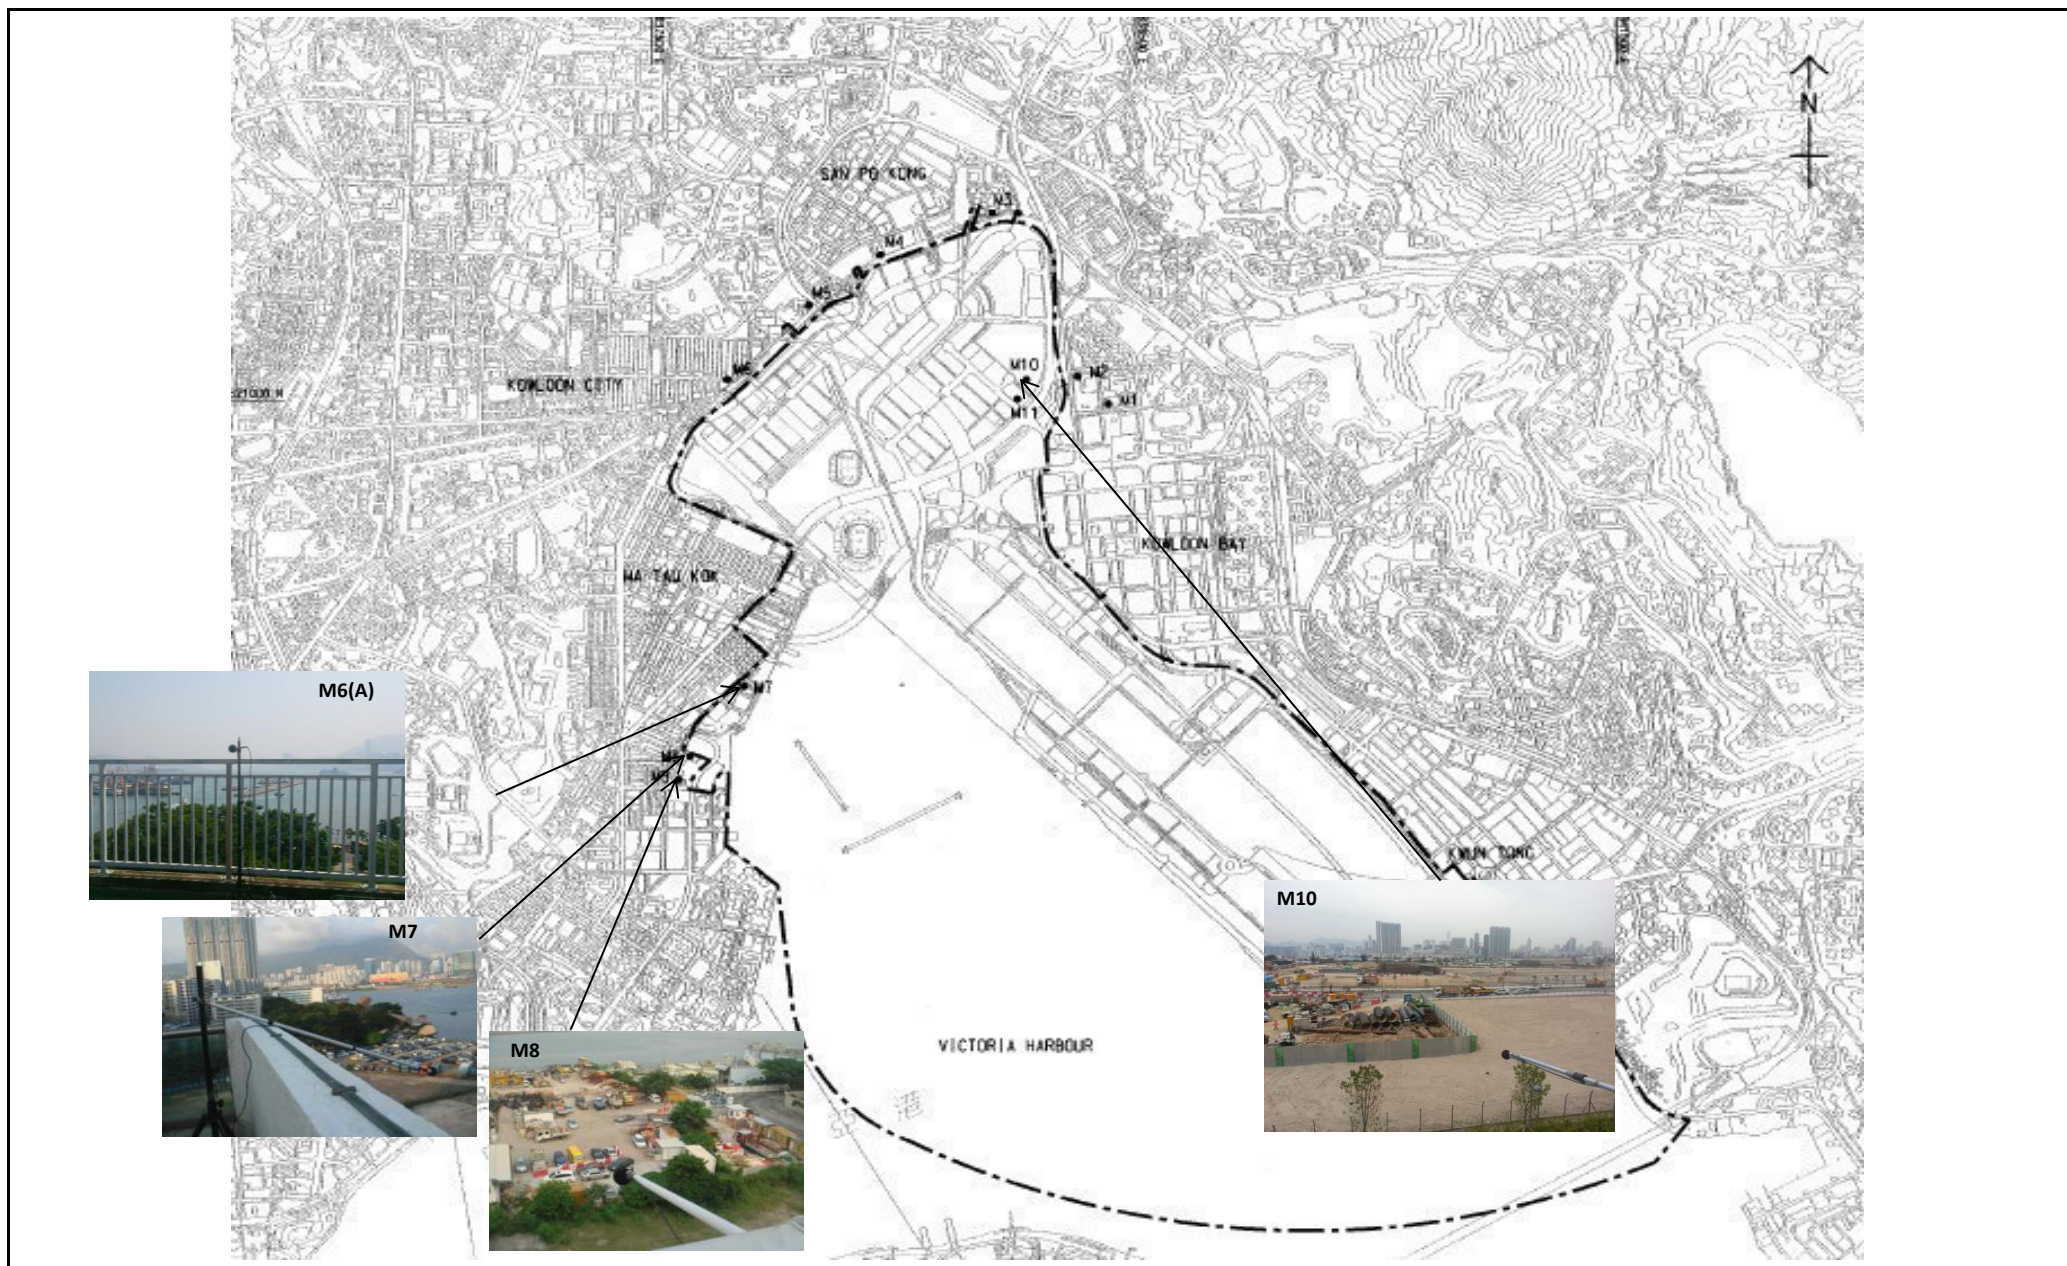
Title	Contract No. KL/2012/03		Scale	Project
	Kai Tak Development –Stage 4 Infrastructure at Former North Apron Area		N.T.S	No. MA13056
	Noise Monitoring Stations under this Project		Date	Figure
			Dec-16	3

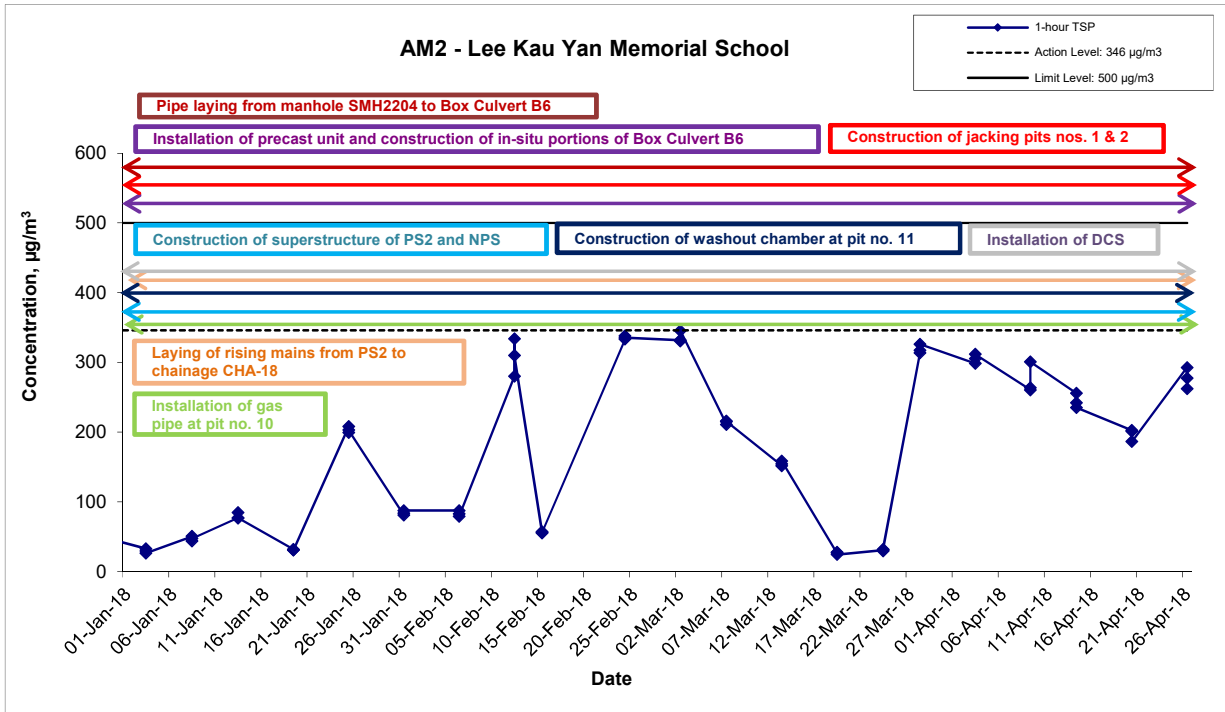
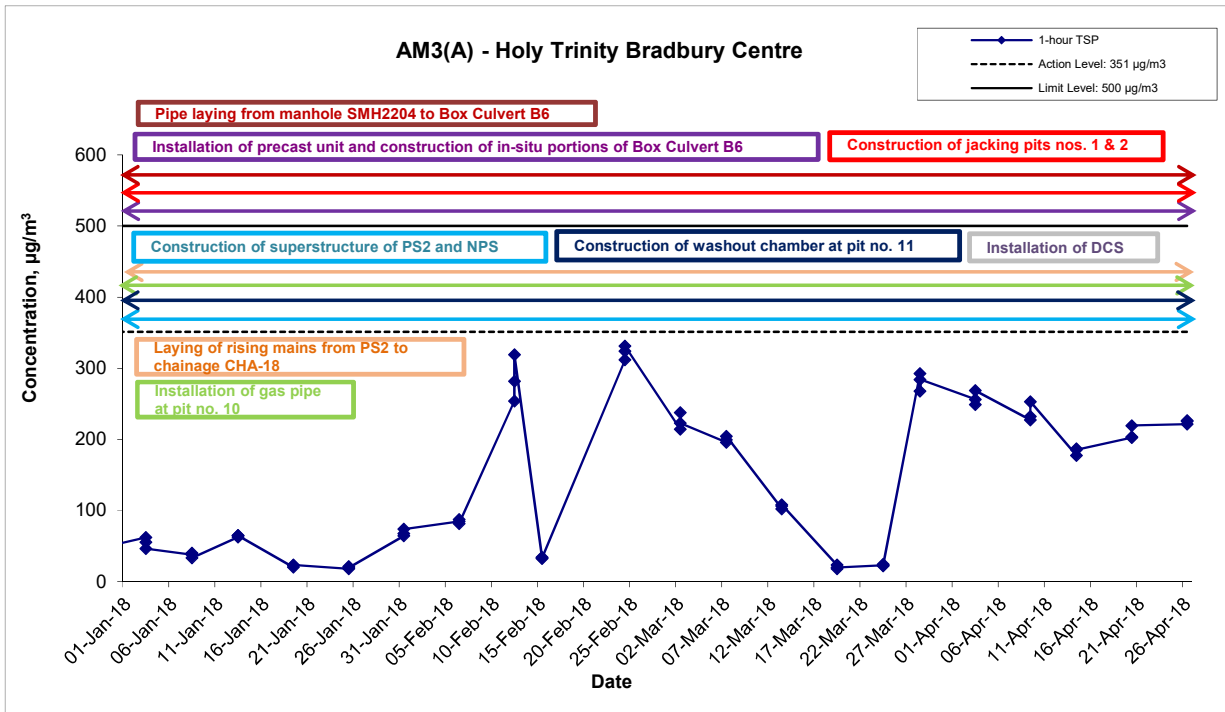
1-hr TSP Concentration Levels

Title	Contract No. KL/2012/03	Scale	Project No.	CINOTECH
	Kai Tak Development –Stage 4 Infrastructure at Former North Apron Area	N.T.S	MA13056	
Graphical Presentation of 1-hour TSP Monitoring Results		Date	Appendix	
		Apr 18	E

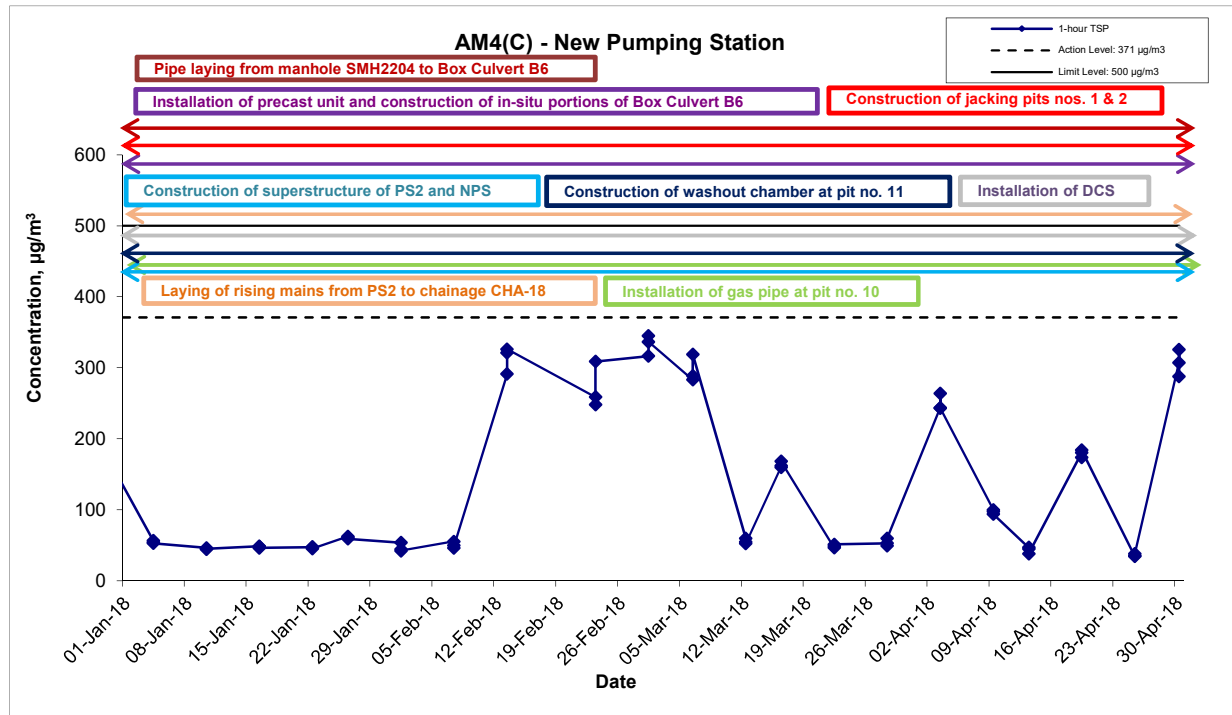
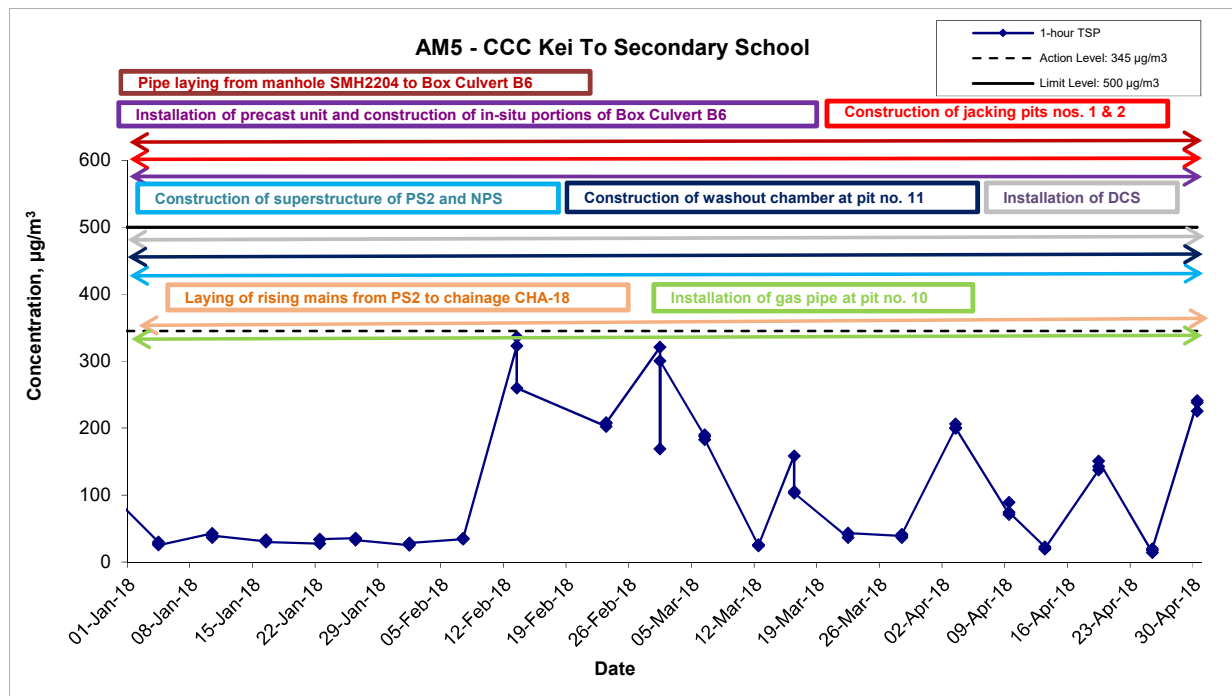
1-hr TSP Concentration Levels

Title	Contract No. KL/2012/03	Scale	Project No.	CINOTECH
	Kai Tak Development –Stage 4 Infrastructure at Former North Apron Area	N.T.S	MA13056	
Graphical Presentation of 1-hour TSP Monitoring Results		Date	Appendix	
		Apr 18	E

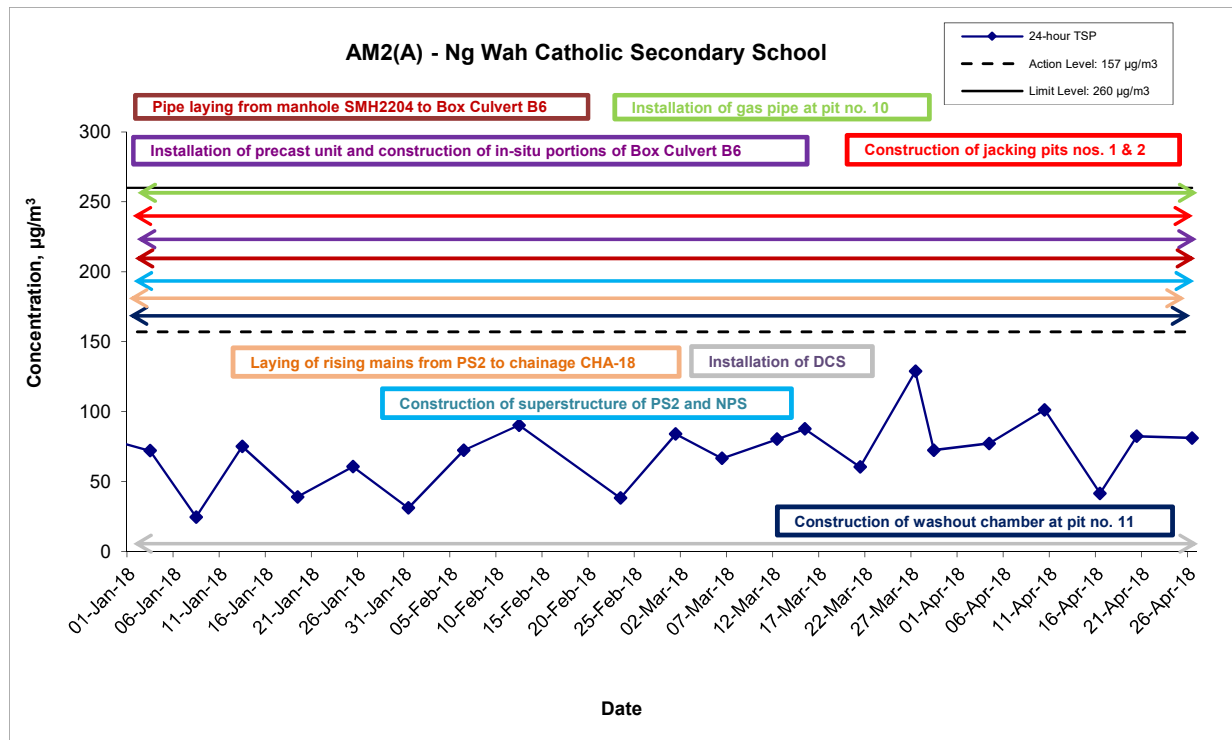
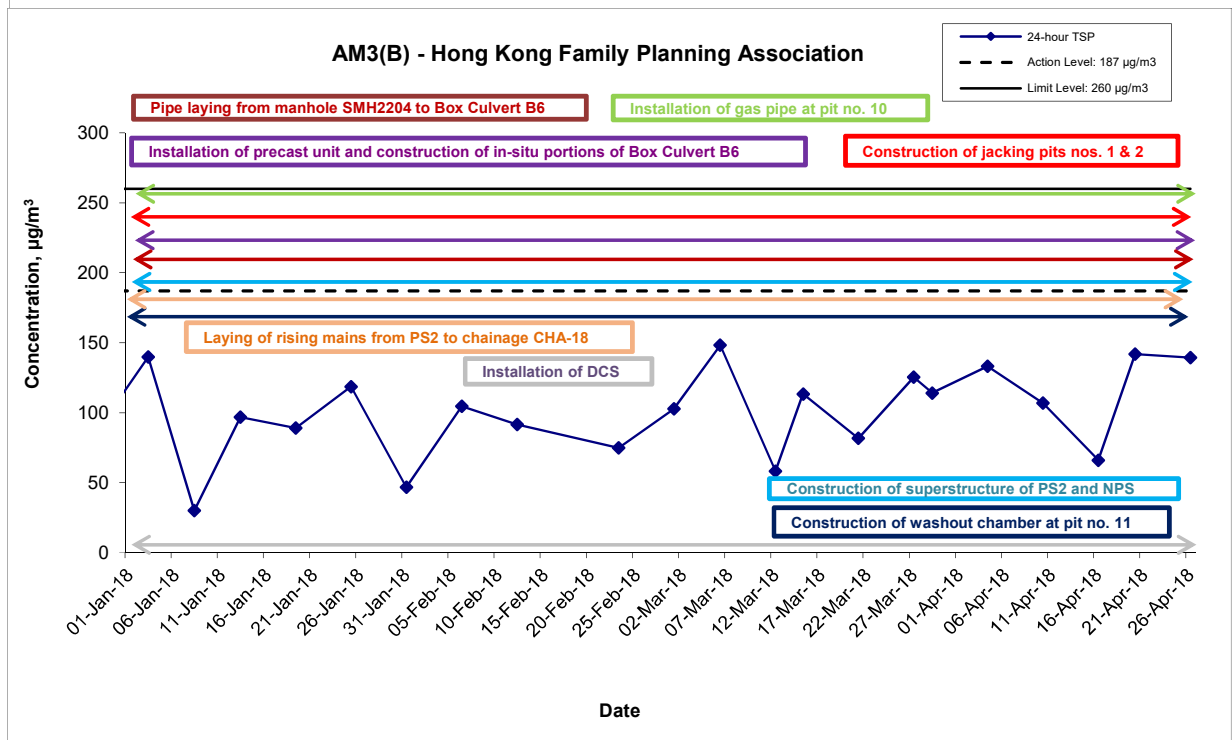
24-hr TSP Concentration Levels

Title Contract No. KL/2012/03 Kai Tak Development –Stage 4 Infrastructure at Former North Apron Area Graphical Presentation of 24-hour TSP Monitoring Results	Scale N.T.S	Project No. MA13056	CINOTECH
	Date Apr 18	Appendix F

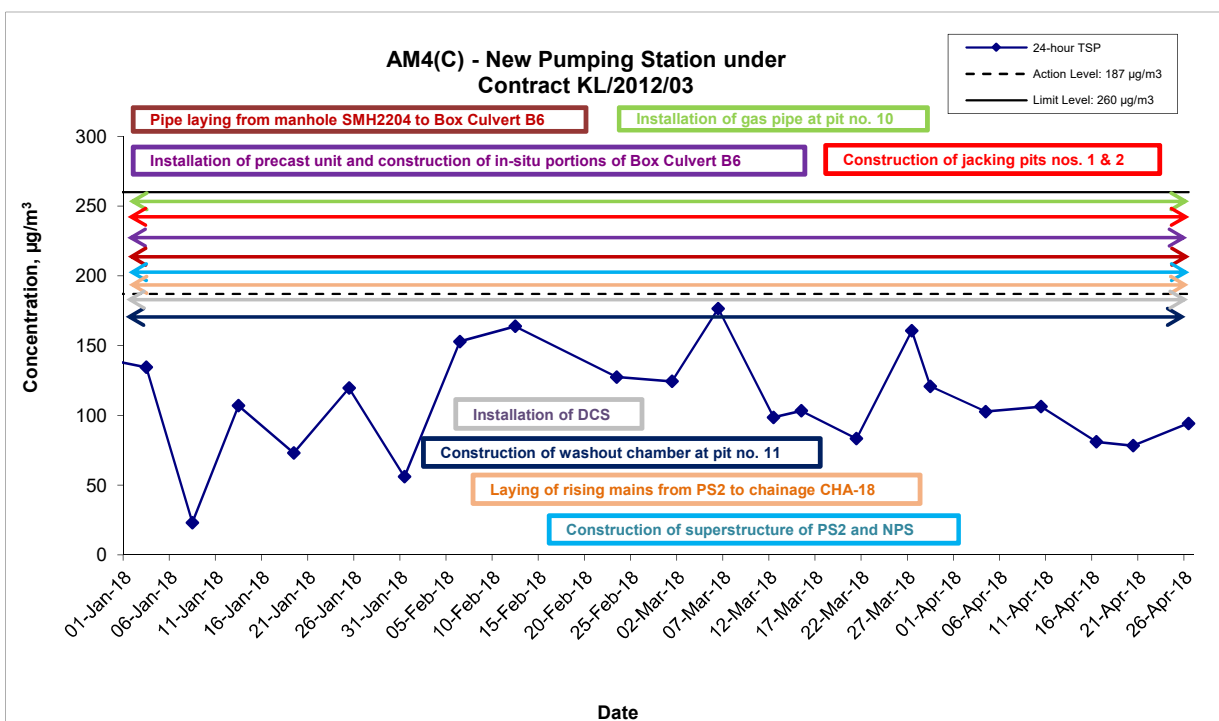
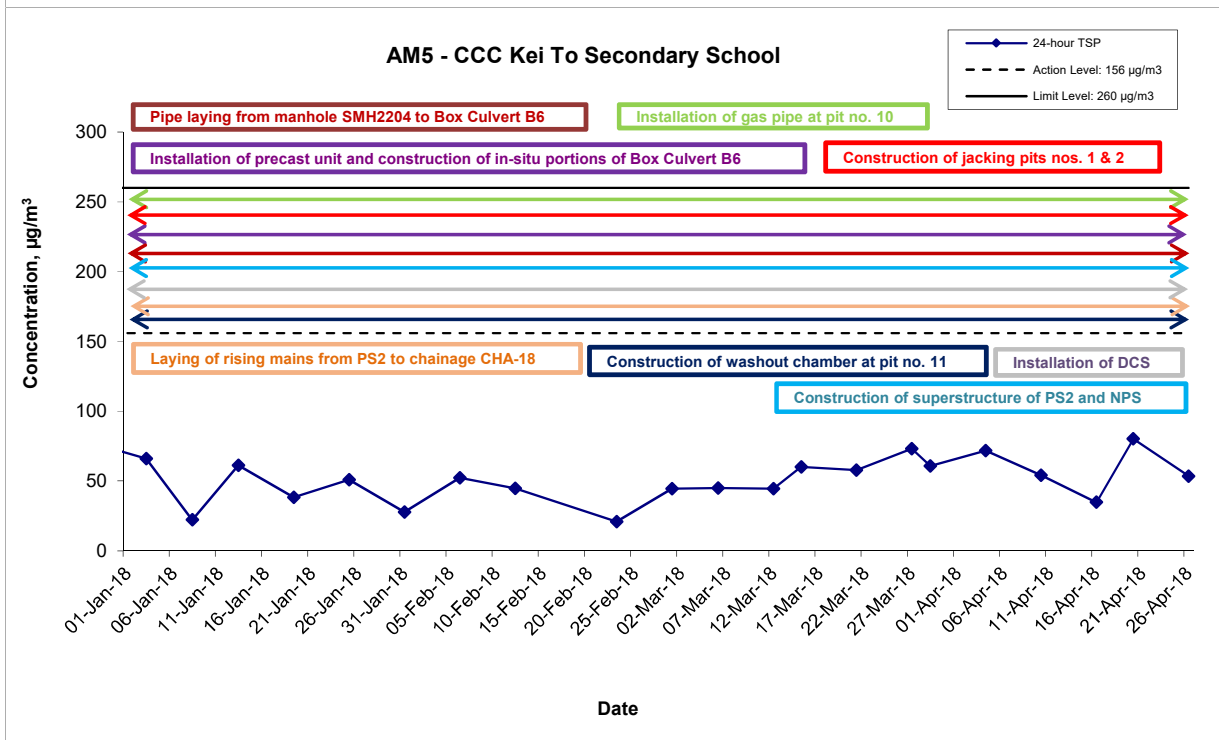
24-hr TSP Concentration Levels

Title	Contract No. KL/2012/03	Scale	Project	CINOTECH
	Kai Tak Development –Stage 4 Infrastructure at Former North Apron Area	N.T.S	No. MA13056	
Graphical Presentation of 24-hour TSP Monitoring Results		Date	Appendix	F

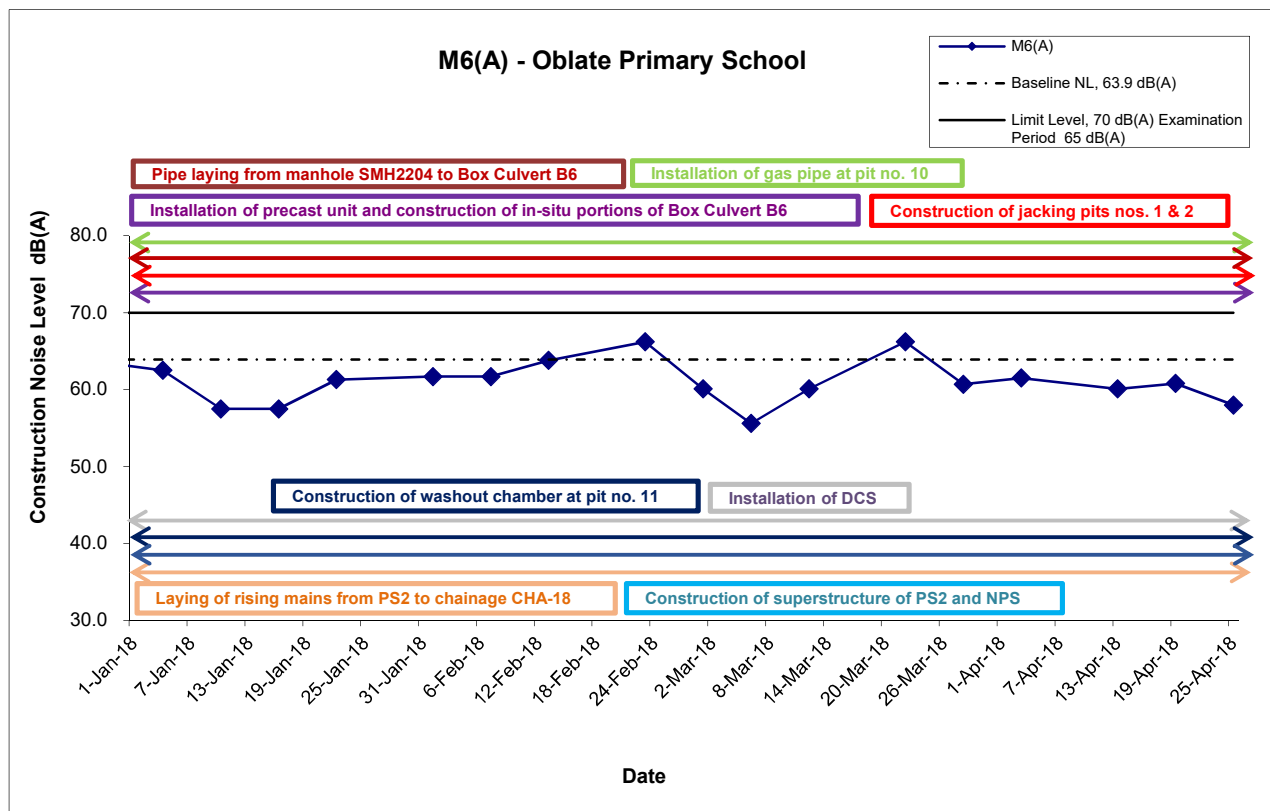
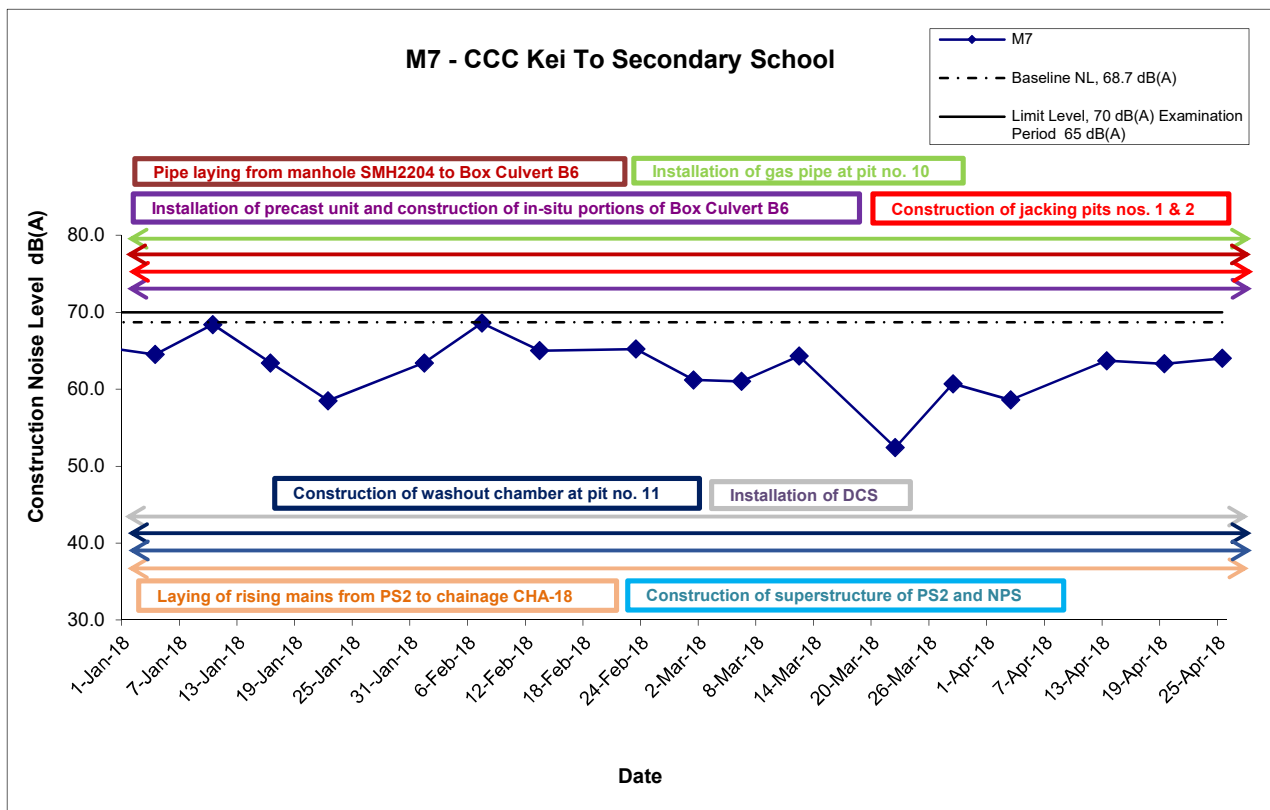
Noise Levels

Remarks: The construction noise levels in the Tables in Appendix G were adopted for plotting the graphs

Title Contract No. KL/2012/03 Kai Tak Development –Stage 4 Infrastructure at Former North Apron Area Graphical Presentation of Construction Noise Monitoring Results	Scale N.T.S	Project No. MA13056	CINOTECH
	Date Apr 18	Appendix G

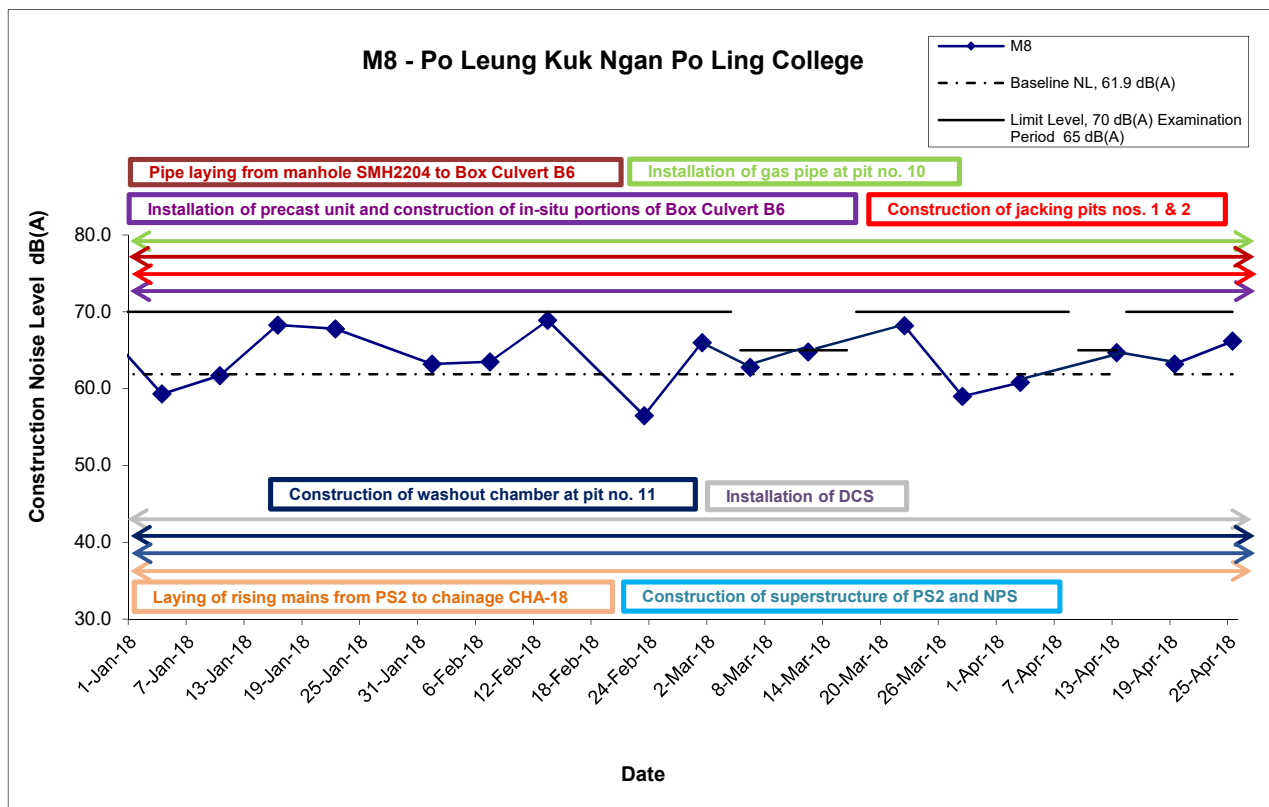
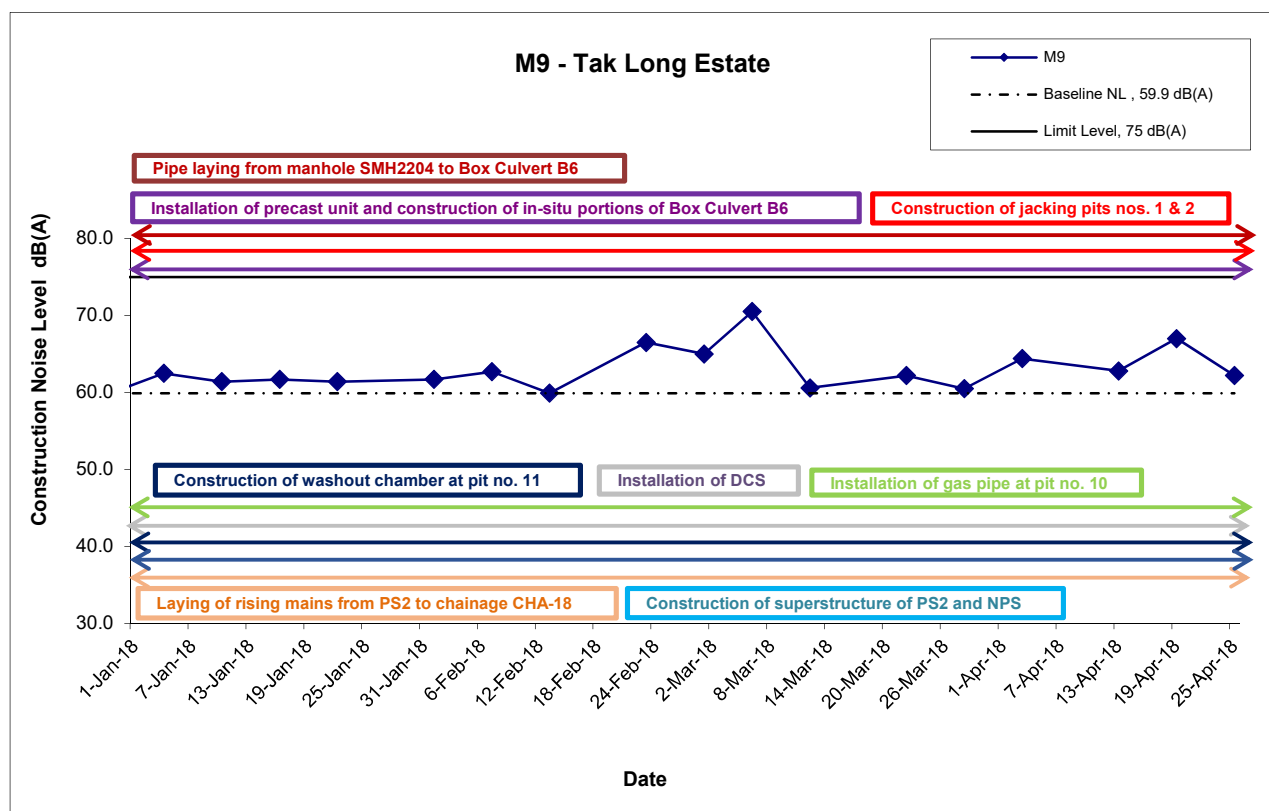
Noise Levels

Remarks: The construction noise levels in the Tables in Appendix G were adopted for plotting the graphs

Title Contract No. KL/2012/03 Kai Tak Development –Stage 4 Infrastructure at Former North Apron Area Graphical Presentation of Construction Noise Monitoring Results	Scale N.T.S	Project No. MA13056	CINOTECH
	Date Apr 18	Appendix G
