**EP-344/2009 – New Sewage Pumping Stations  
Serving KTD  
EP-337/2009 – New Distributor Roads Serving the  
Planned KTD**

**Contract No. KL/2012/03  
Kai Tak Development –Stage 4 Infrastructure at  
Former North Apron Area**

Monthly EM&A Report

May 2018

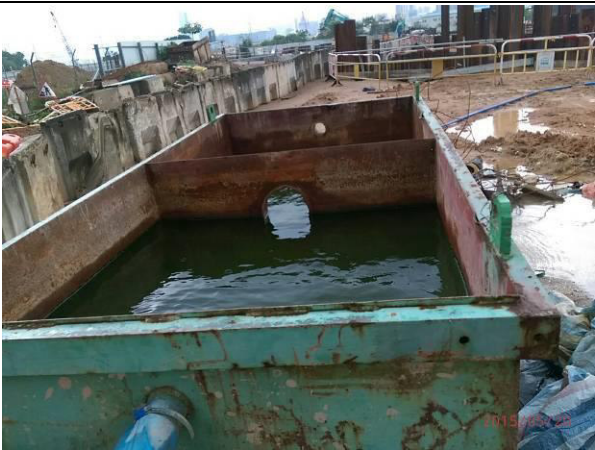
To prevent any surface runoff discharge into any stream course.	Follow-up measure(s) after identification of wastewater discharges from site.

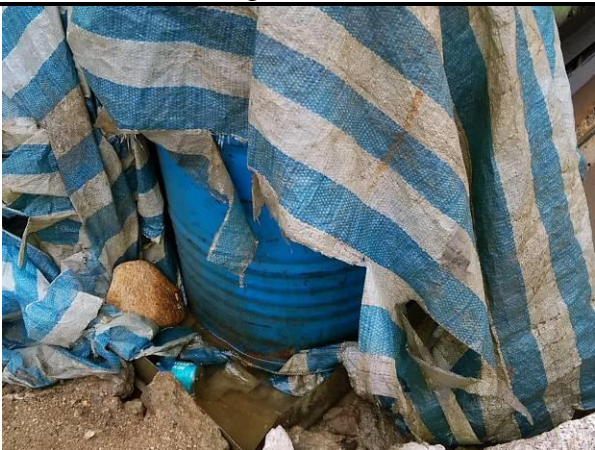
To avoid any discharge or accidental spillage of chemical waste or oil directly from the site	To avoid improper handling or storage of oil drum on site

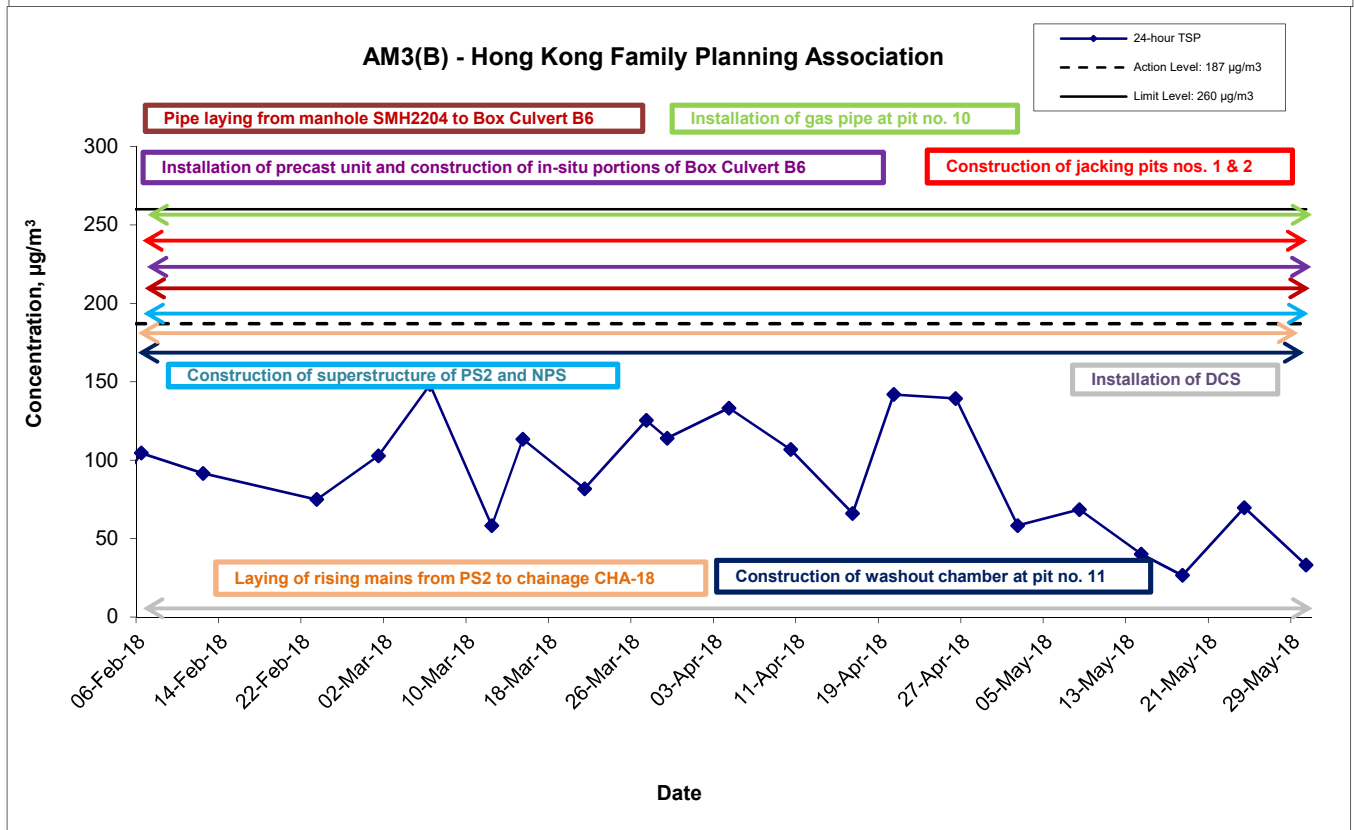
<b>Title</b> Contract No. KL/2012/03 Kai Tak Development –Stage 4 Infrastructure at Former North Apron Area  Graphical Presentation of 24-hour TSP Monitoring Results	<b>Scale</b>  N.T.S	<b>Project</b>  No. MA13056	<b>CINOTECH</b>
	<b>Date</b>  May 18	<b>Appendix</b>  F
