**EP-344/2009 – New Sewage Pumping Stations
Serving KTD
EP-337/2009 – New Distributor Roads Serving the
Planned KTD**

**Contract No. KL/2012/03
Kai Tak Development –Stage 4 Infrastructure at
Former North Apron Area**

Monthly EM&A Report

July 2018

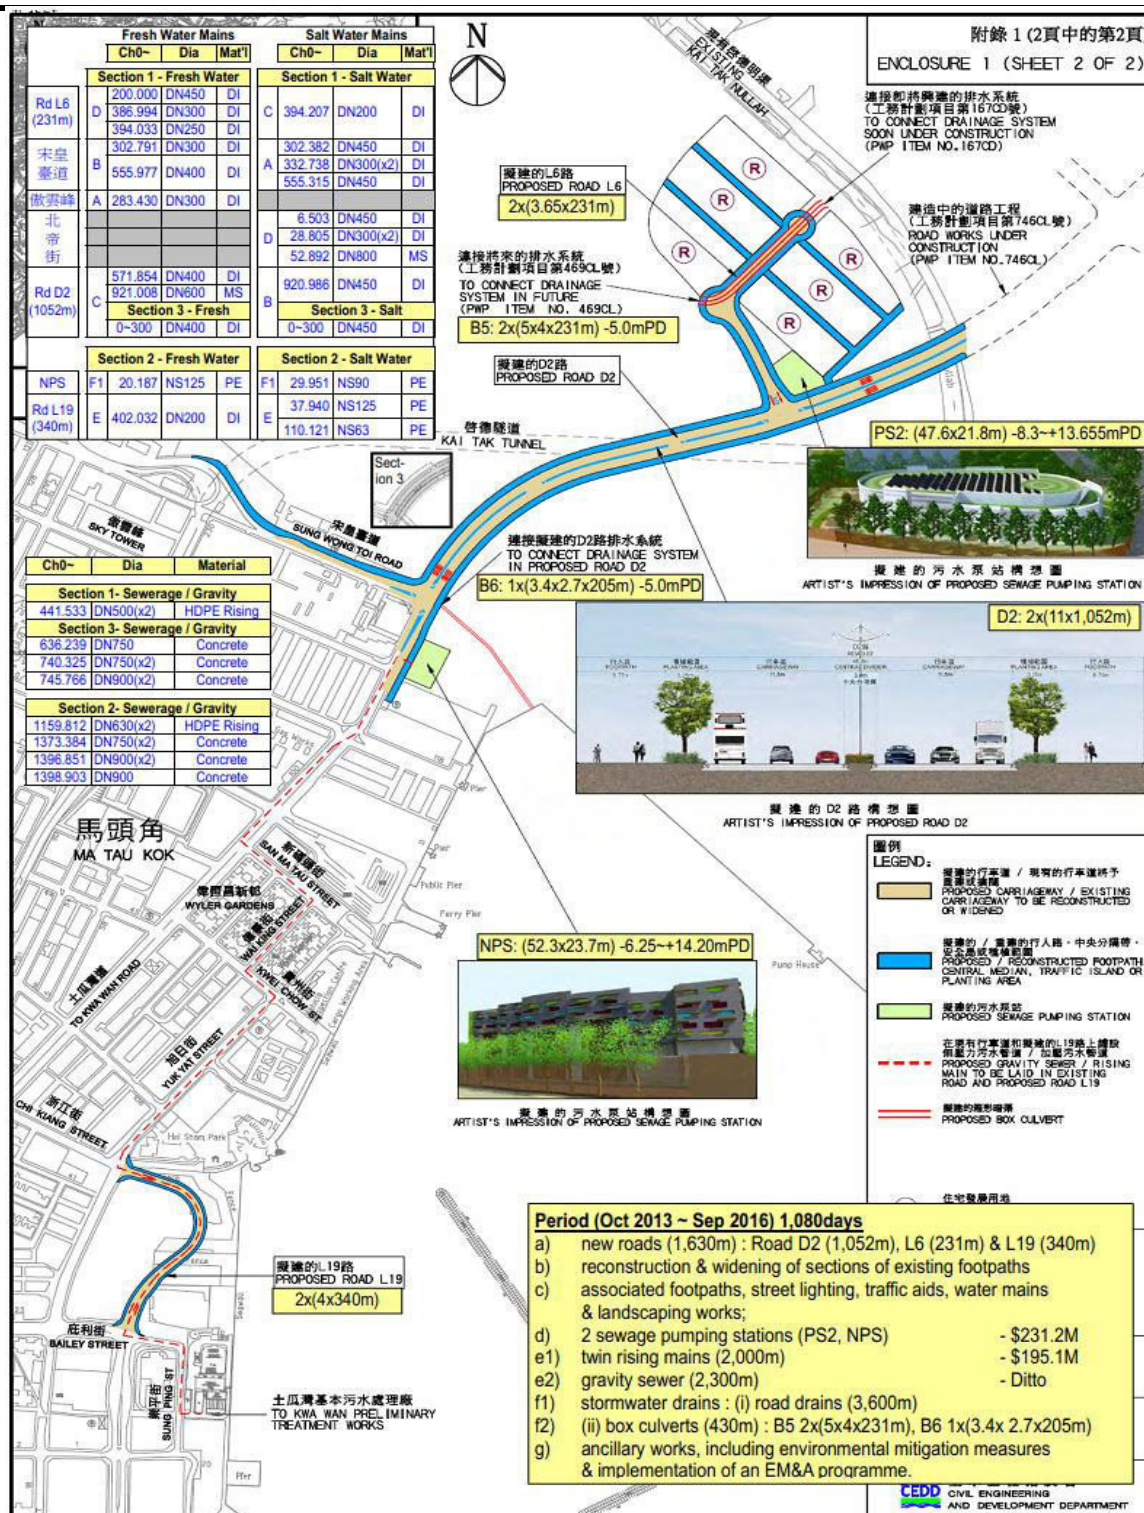
Title	KL/2012/03 - Kai Tak Development -Stage 4 Infrastructure at Former North Apron Area	Scale	N.T.S	Project No.	MA13056	CINOTECH
	Site Layout Plan	Date	Sep-13	Figure	1

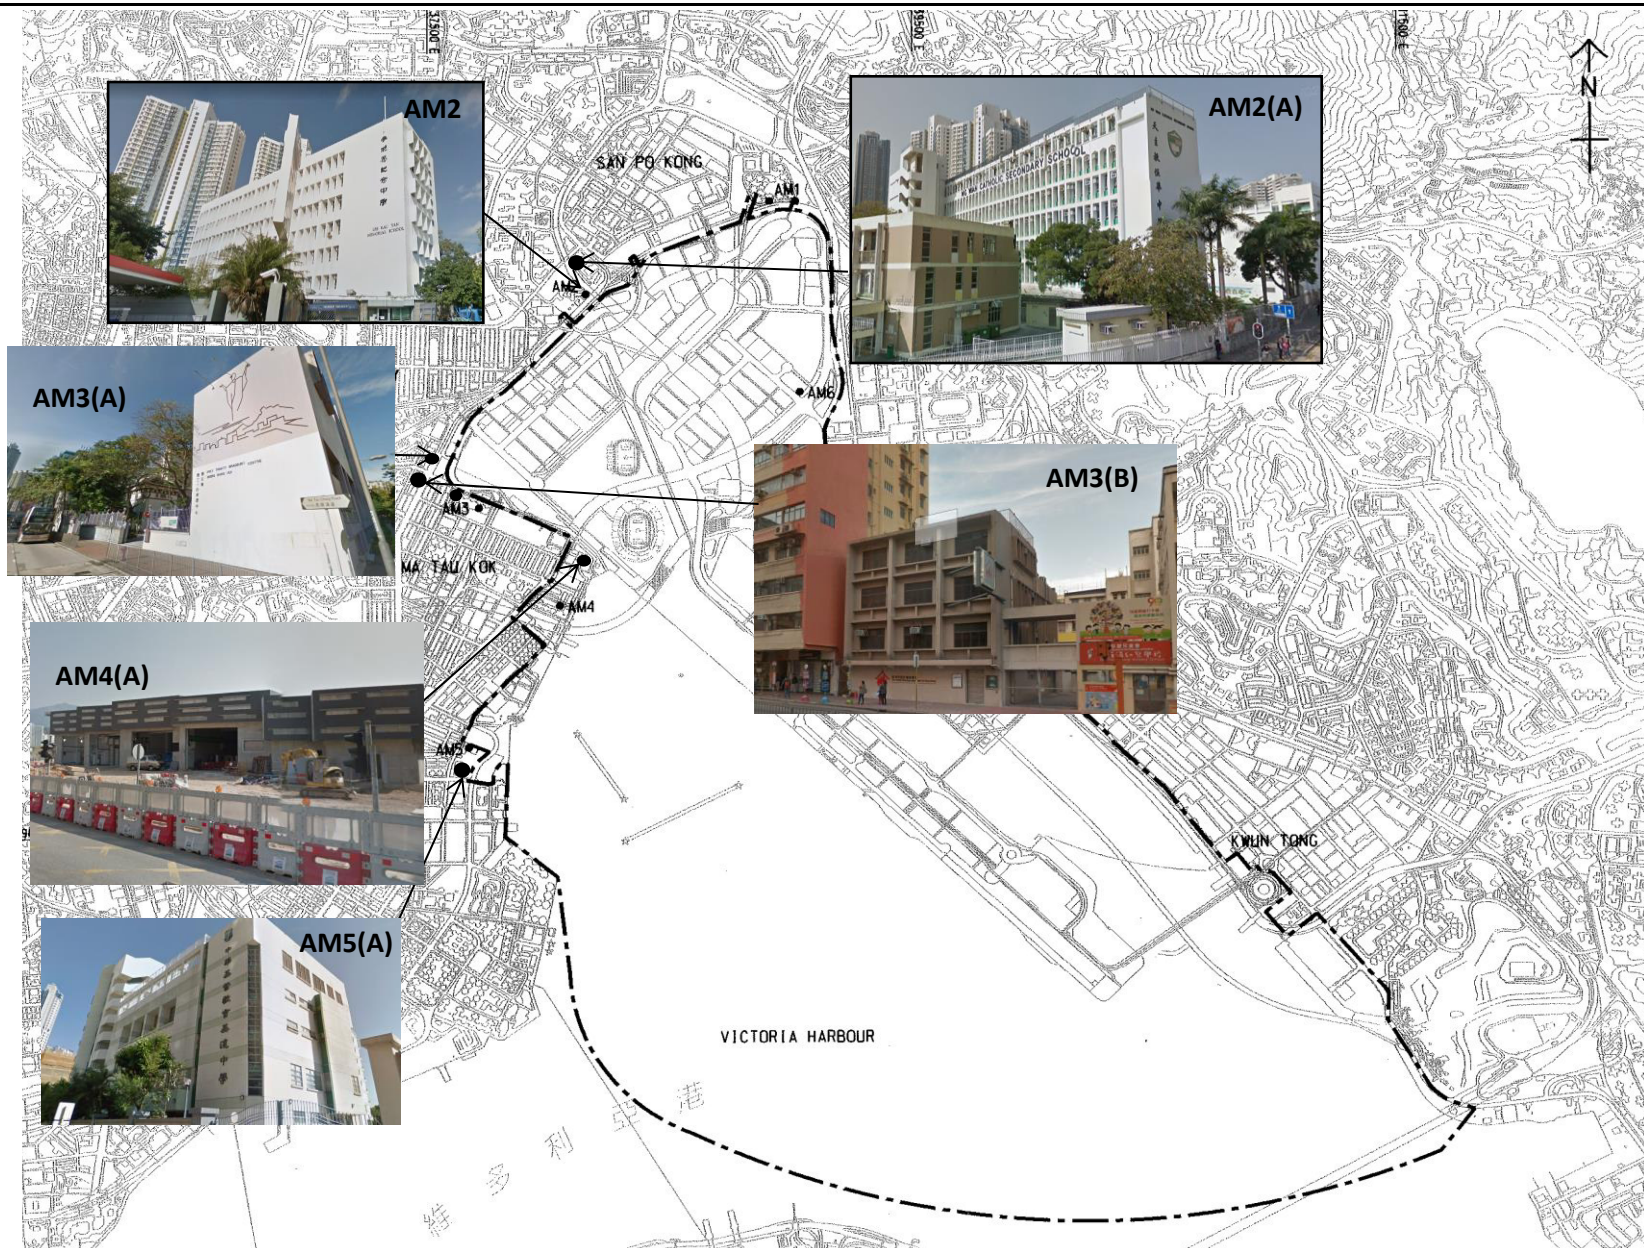
Contract No. KL/2012/03
 Kai Tak Development –Stage 4 Infrastructure at Former North Apron Area
 Air Quality Monitoring Stations under this Project

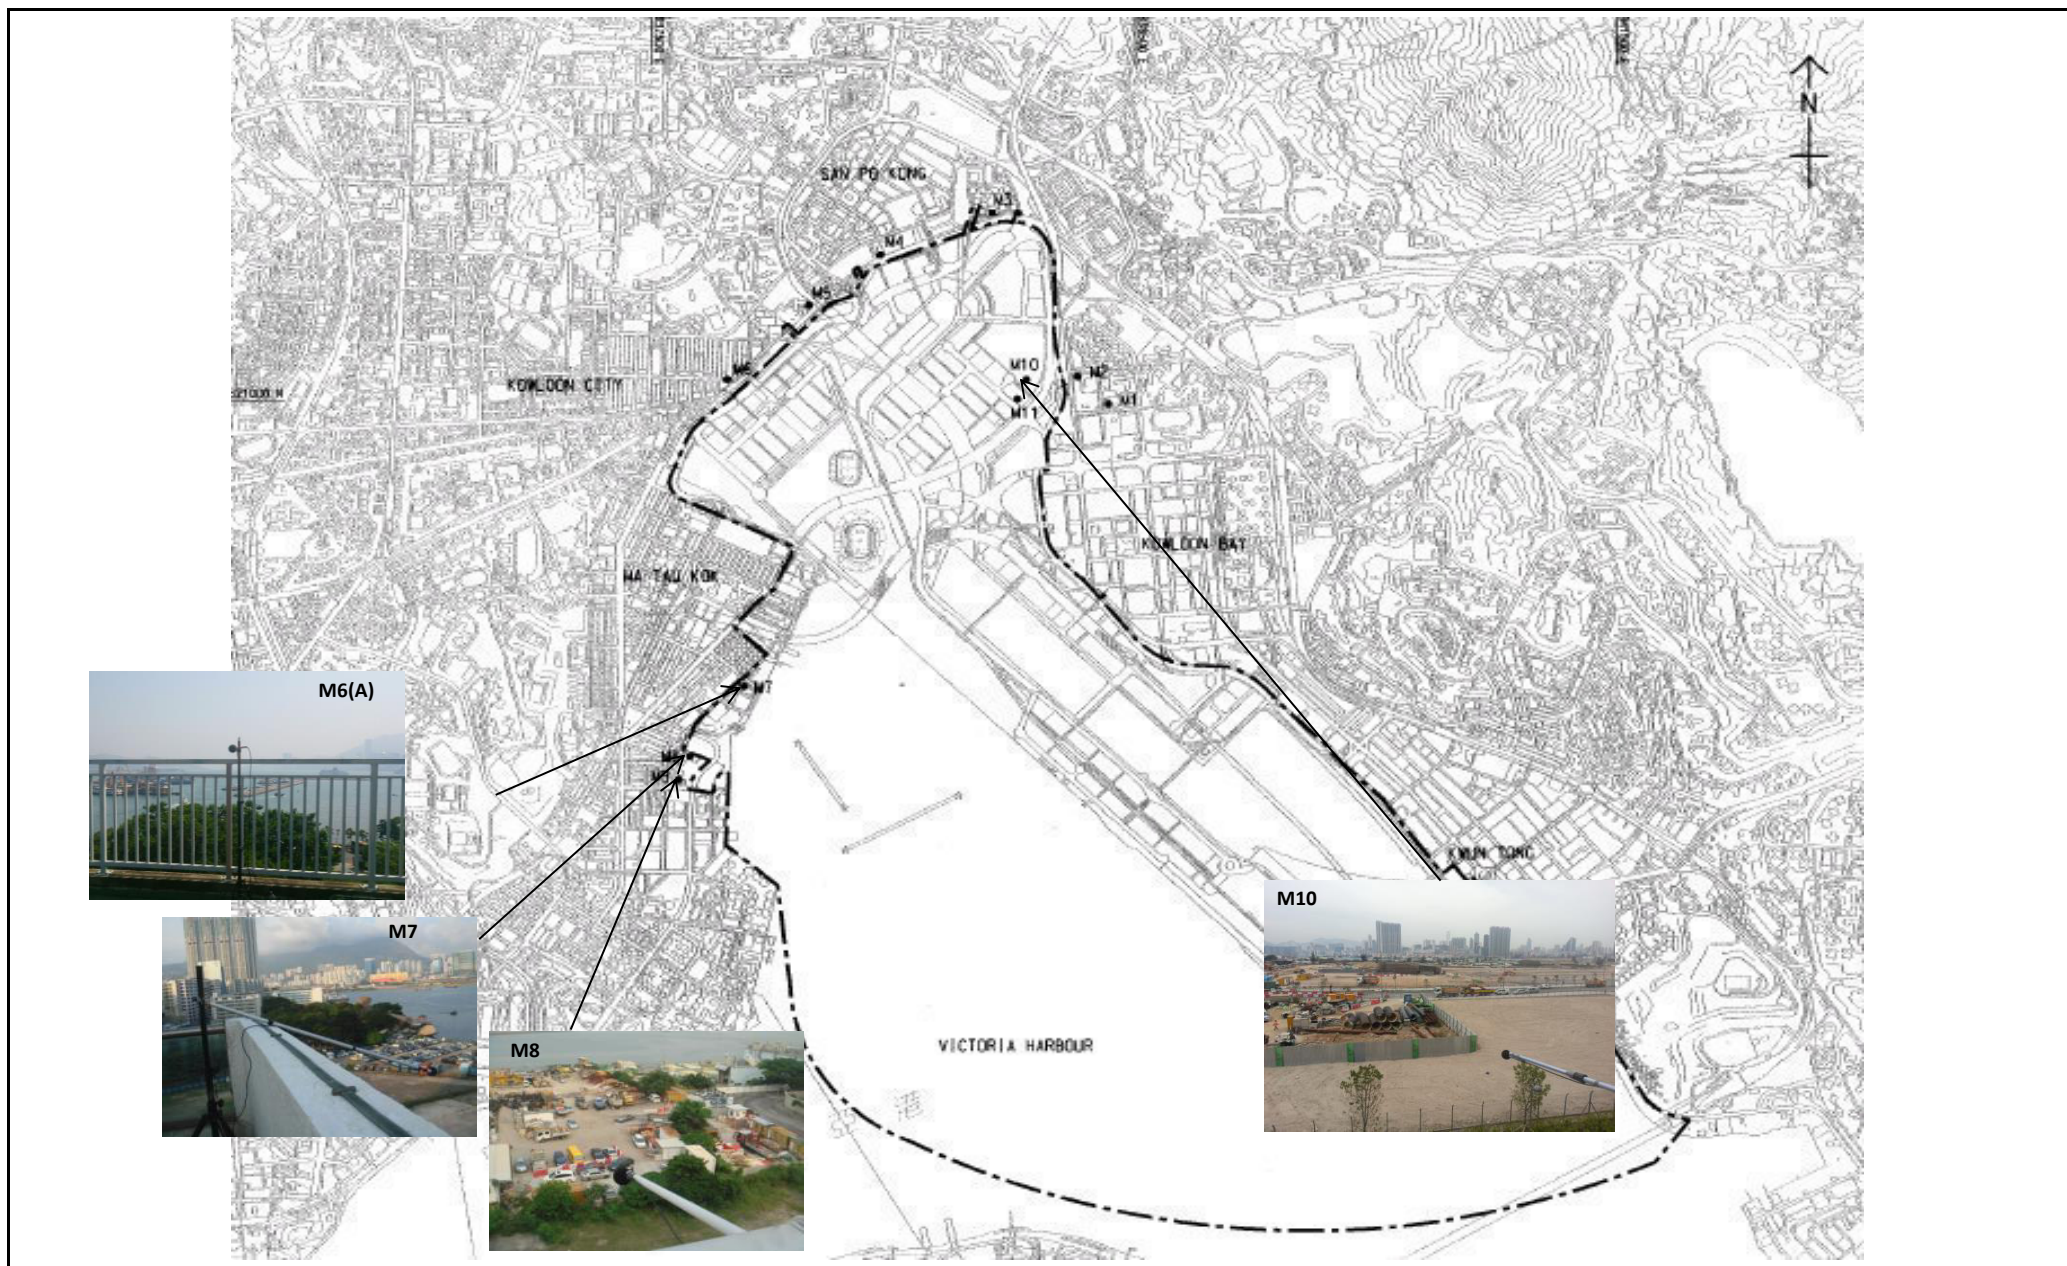
Title	Contract No. KL/2012/03		Scale	Project
	Kai Tak Development –Stage 4 Infrastructure at Former North Apron Area		N.T.S	No. MA13056
	Noise Monitoring Stations under this Project		Date	Figure
			Dec-16	3

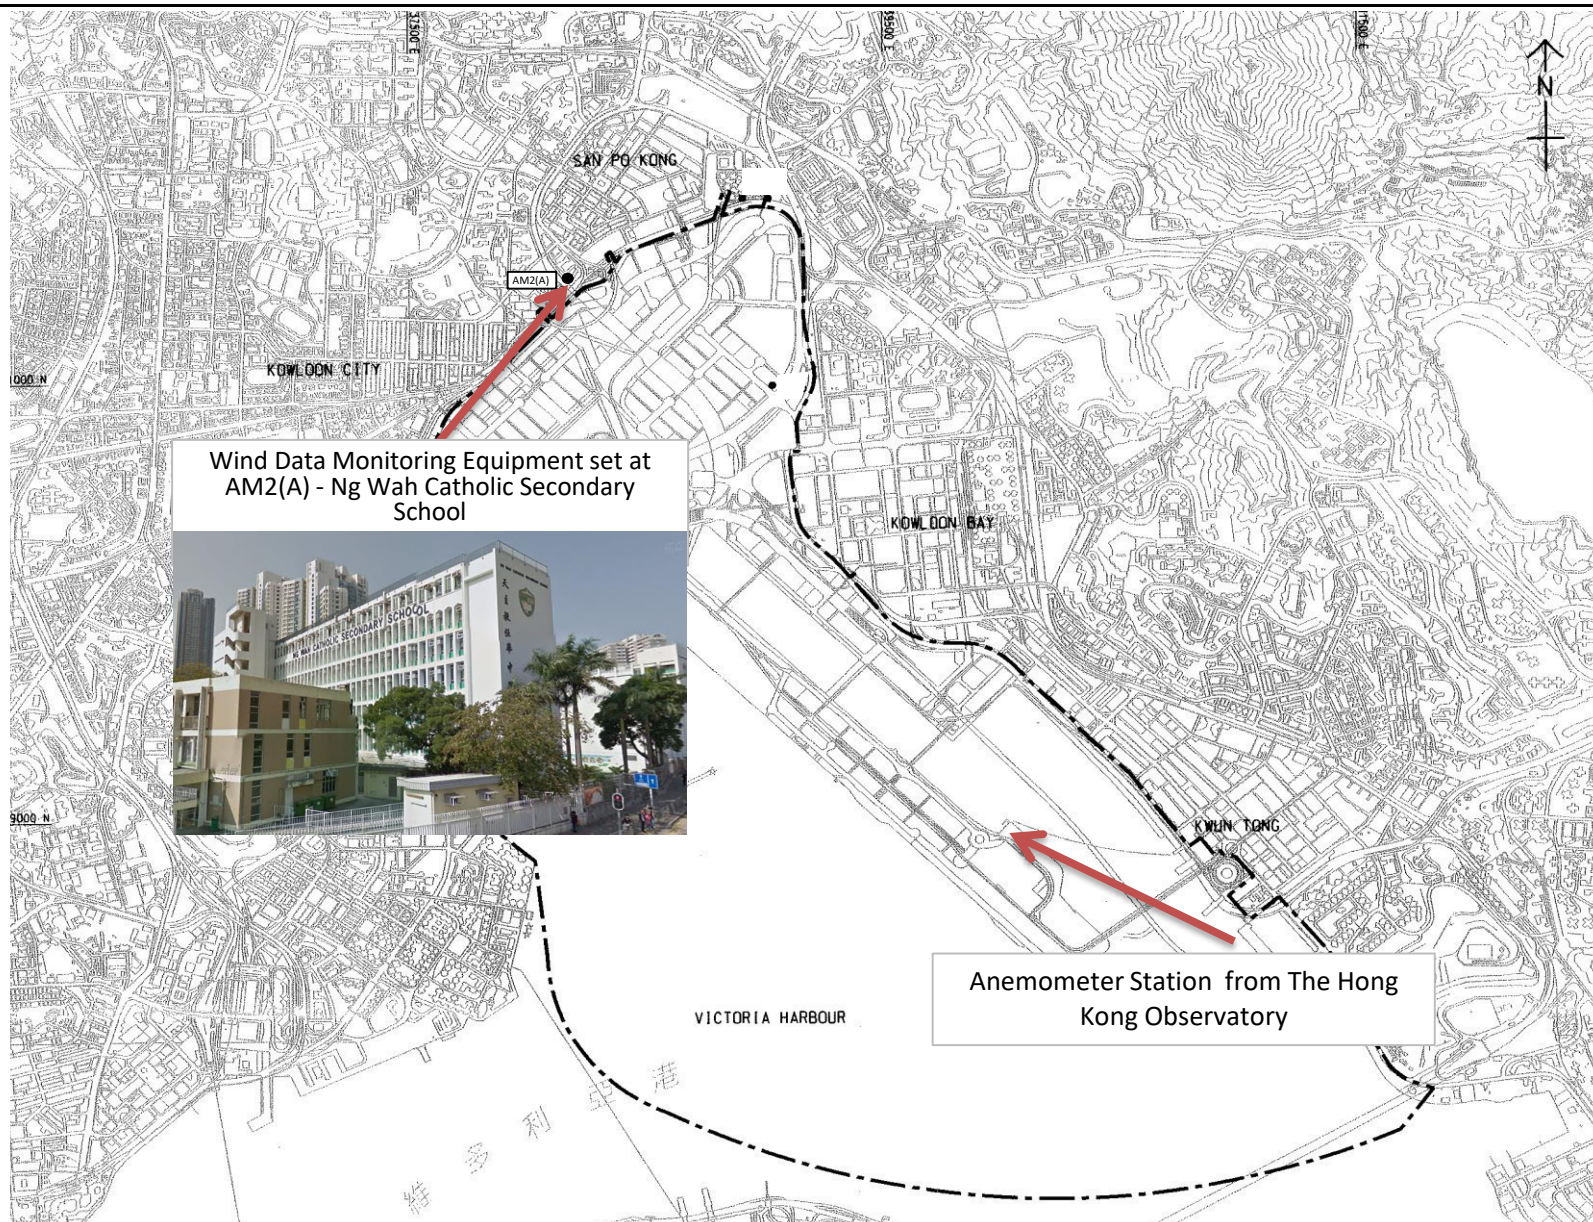
Title	Contract No. KL/2012/03		Scale	Project	CINOTECH
	Kai Tak Development –Stage 4 Infrastructure at Former North Apron Area		N.T.S	No. MA13056	
	Location of Wind Data Monitoring Equipment		Date	Figure	
			Aug-17	4

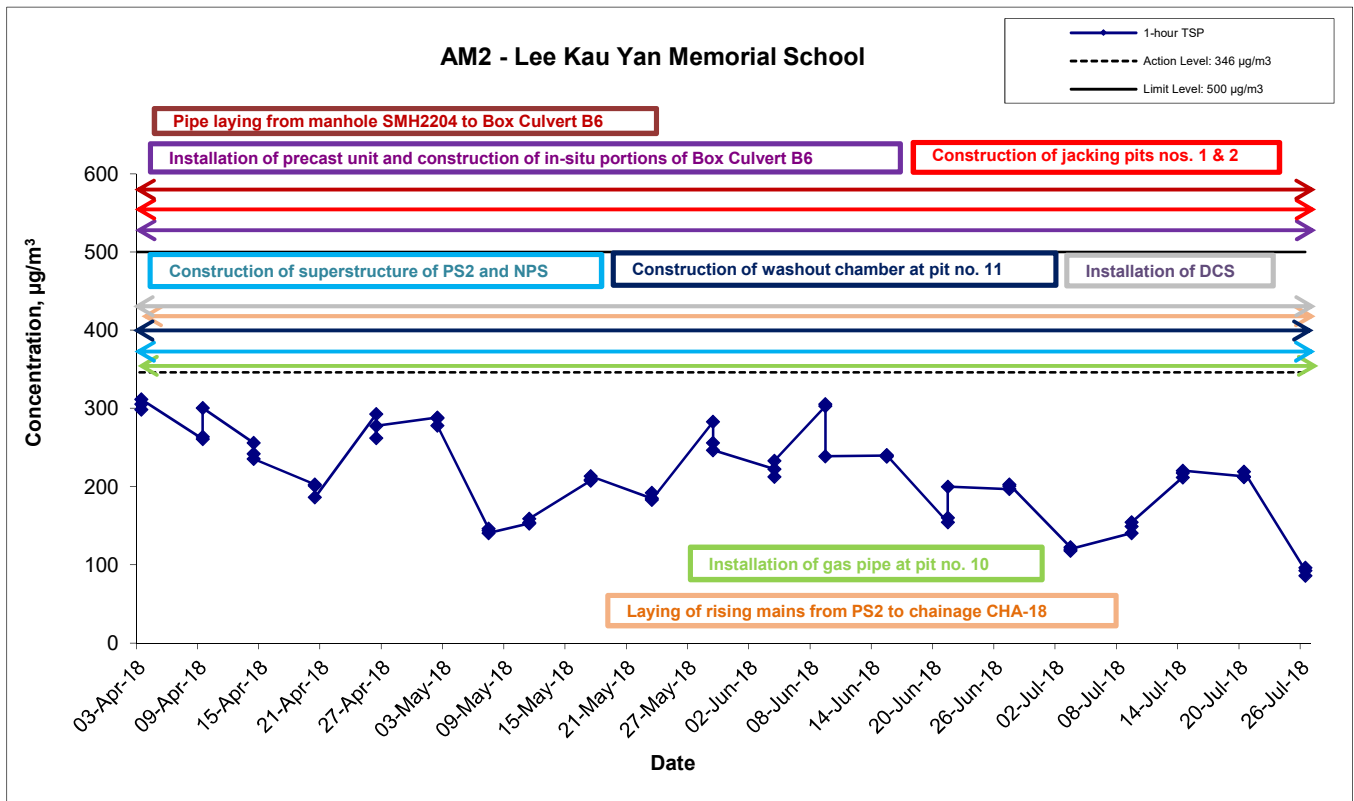
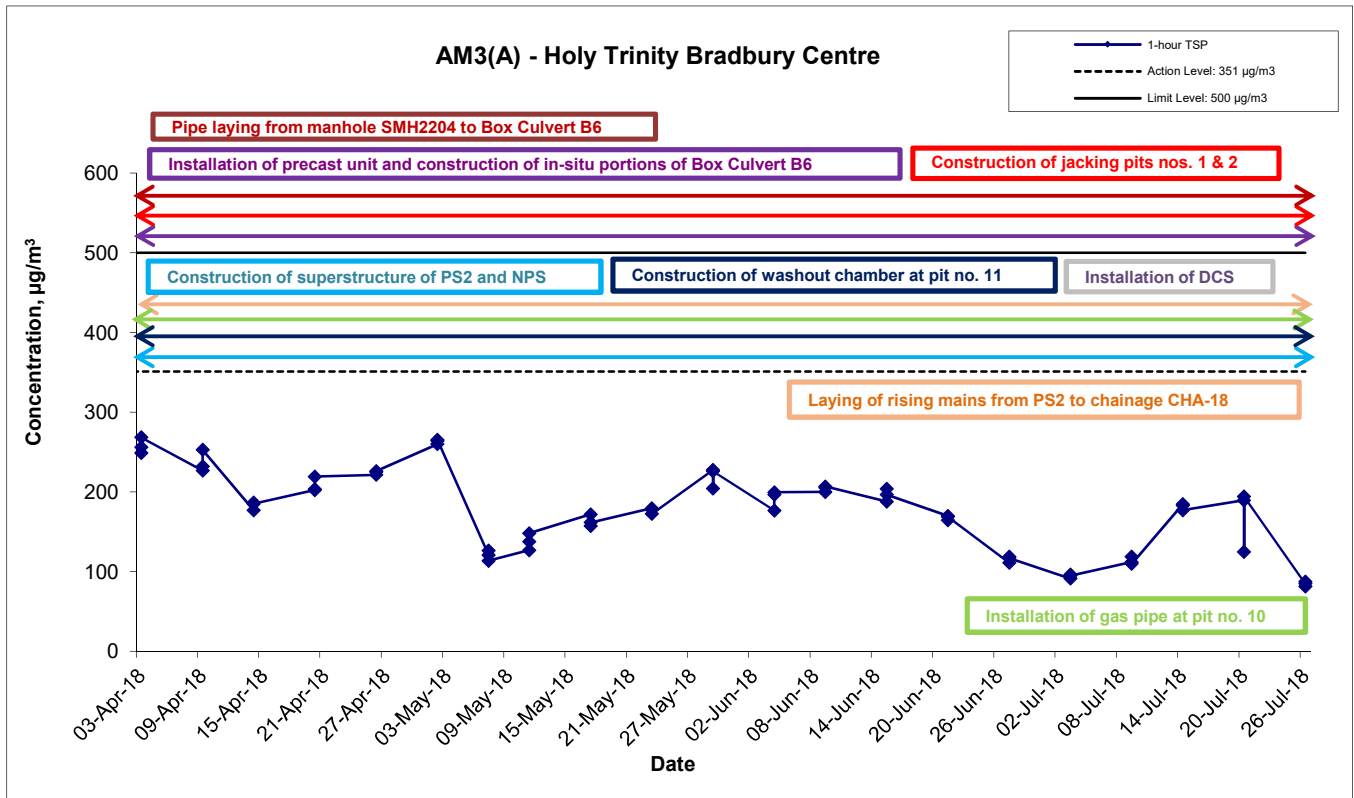
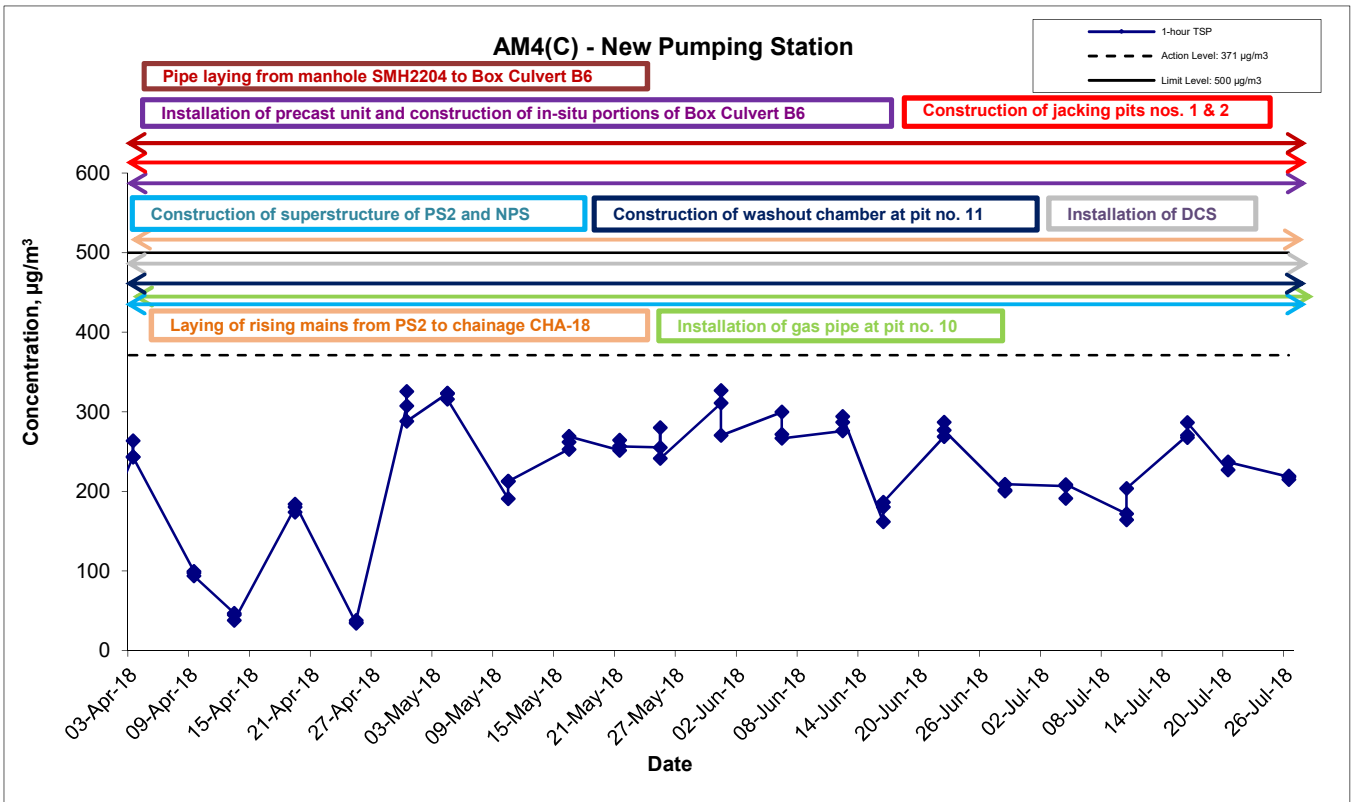
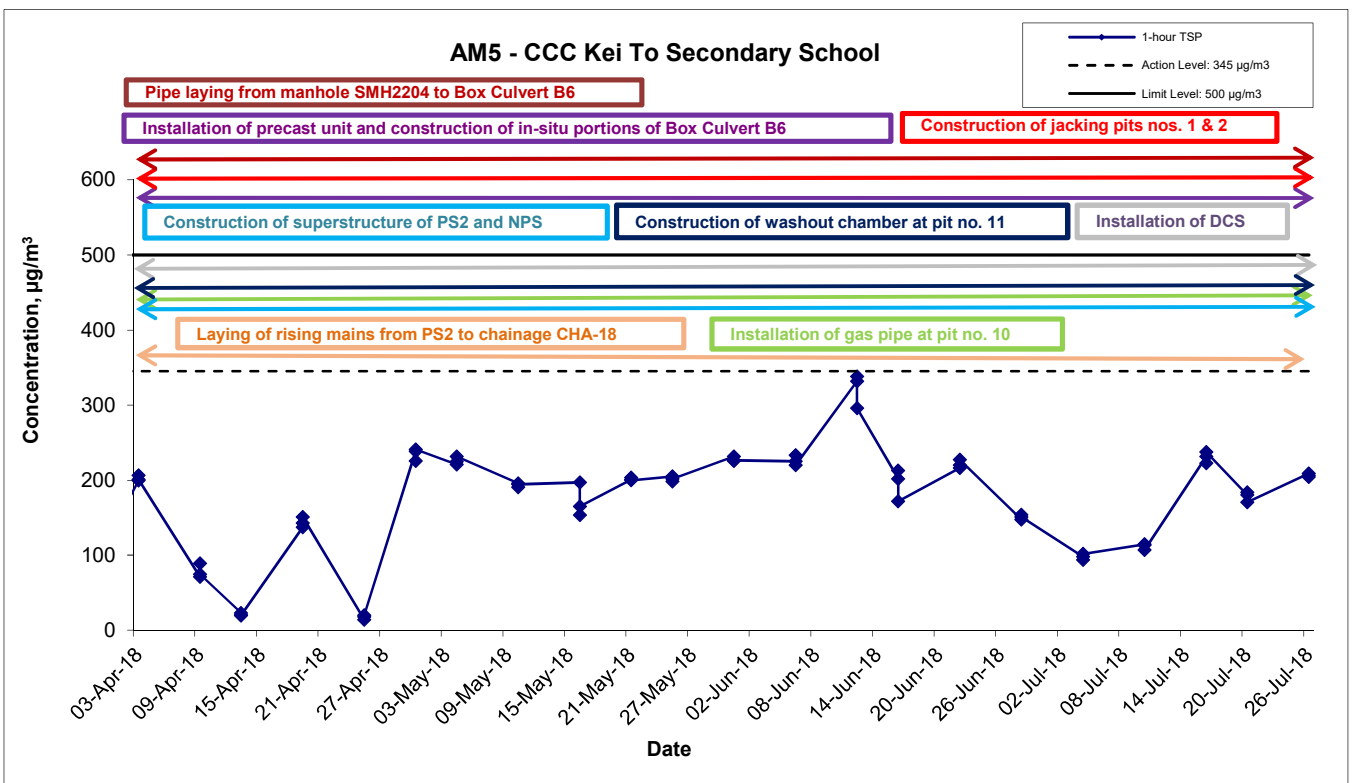
1-hr TSP Concentration Levels

Title	Contract No. KL/2012/03	Scale	Project No.	CINOTECH
	Kai Tak Development –Stage 4 Infrastructure at Former North Apron Area	N.T.S	MA13056	
Graphical Presentation of 1-hour TSP Monitoring Results		Date	Appendix	
		Jul 18	E

Title Kai Tak Development –Stage 4 Infrastructure at Former North Apron Area Graphical Presentation of 1-hour TSP Monitoring Results	Contract No. KL/2012/03	Scale N.T.S	Project No. MA13056	CINOTECH
		Date Jul 18	Appendix E

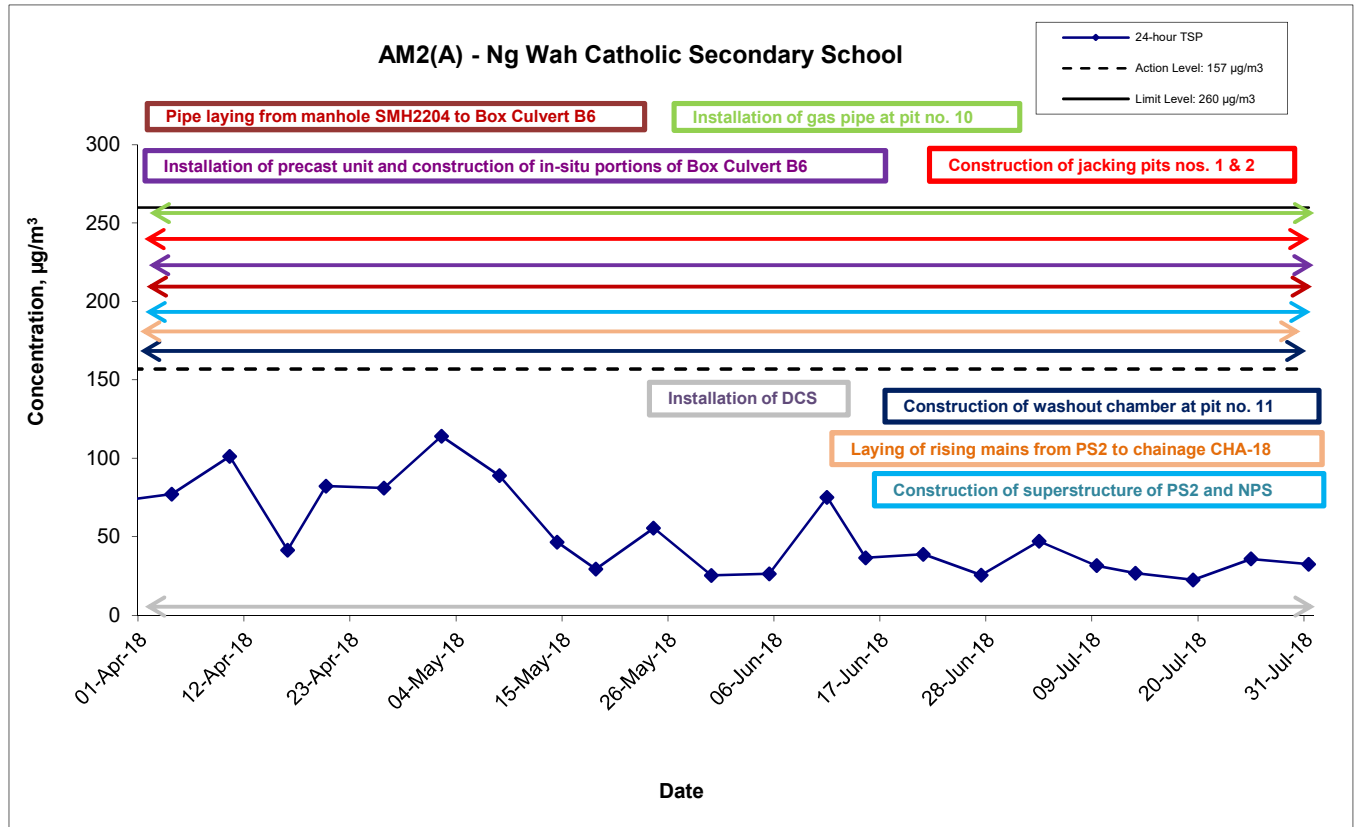
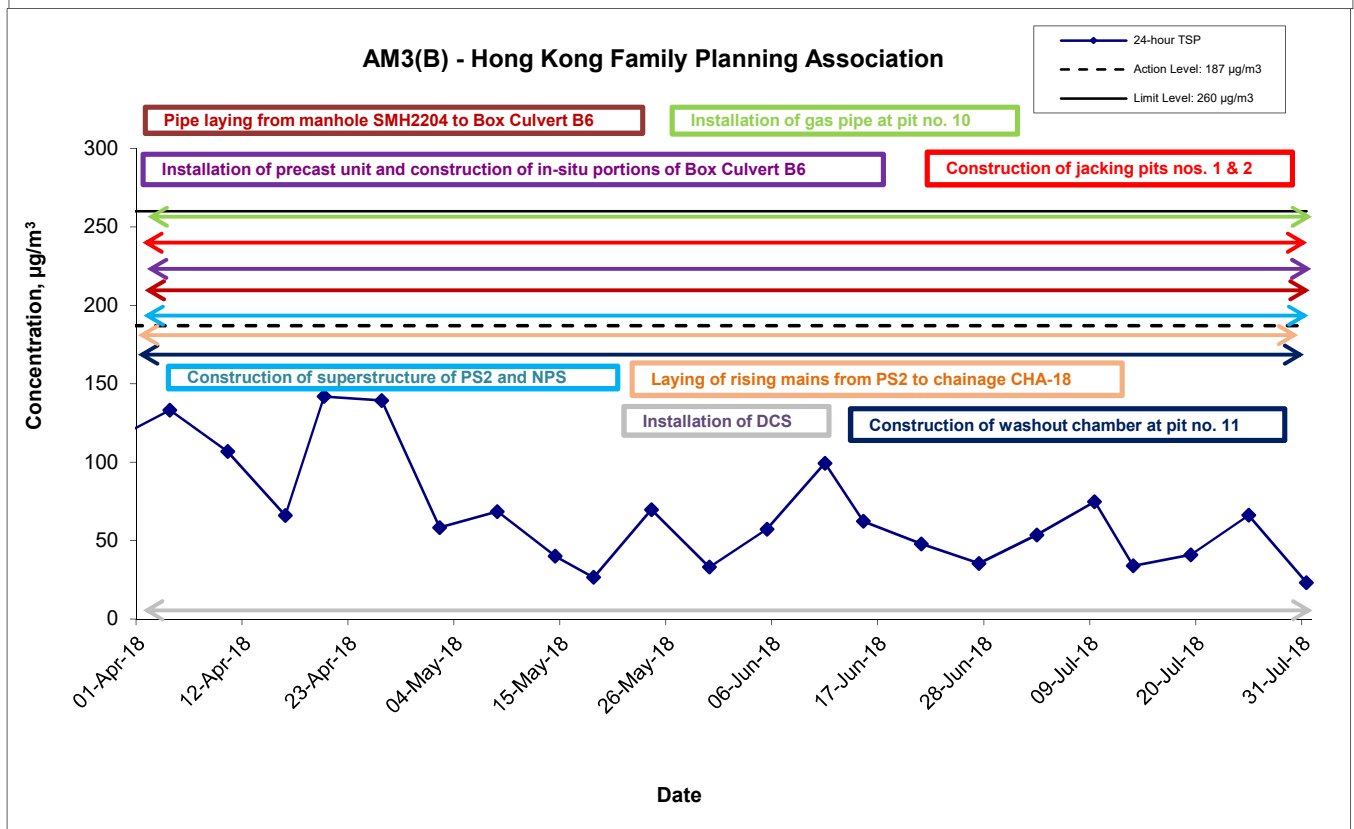
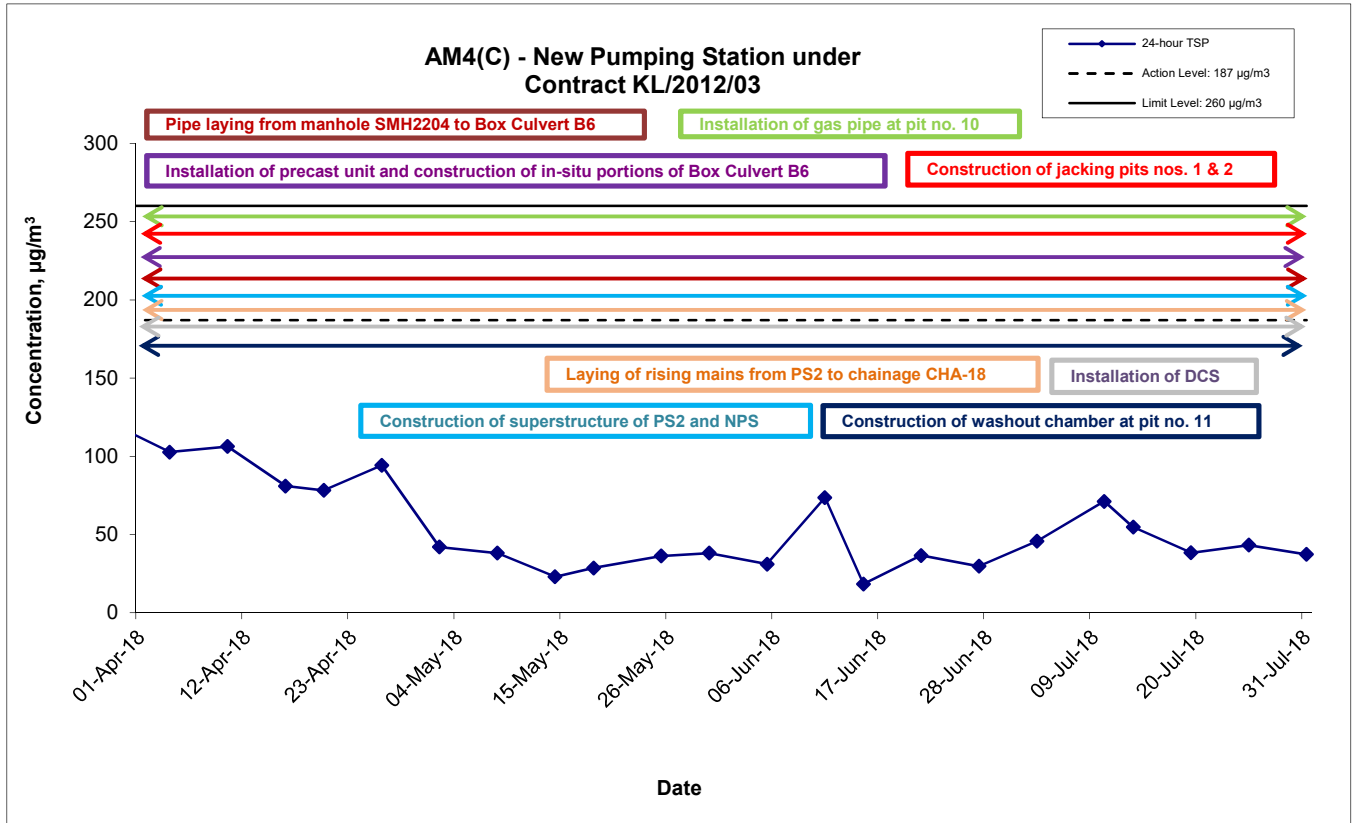
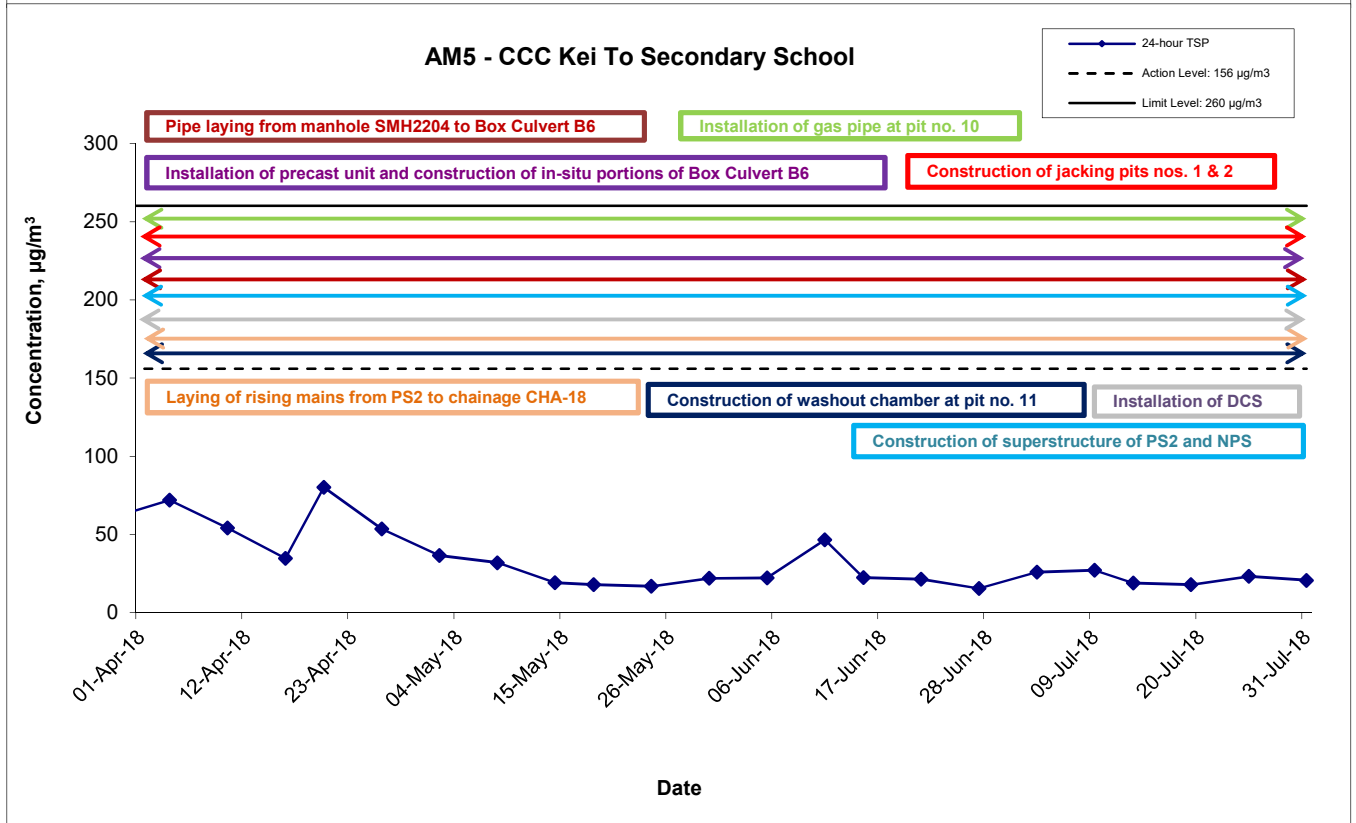
24-hr TSP Concentration Levels

Title Contract No. KL/2012/03 Kai Tak Development –Stage 4 Infrastructure at Former North Apron Area Graphical Presentation of 24-hour TSP Monitoring Results	Scale N.T.S	Project No. MA13056	CINOTECH
	Date Jul 18	Appendix F

Title Contract No. KL/2012/03 Kai Tak Development –Stage 4 Infrastructure at Former North Apron Area Graphical Presentation of 24-hour TSP Monitoring Results	Scale	Project	
	N.T.S	No. MA13056	
	Date Jul 18	Appendix F

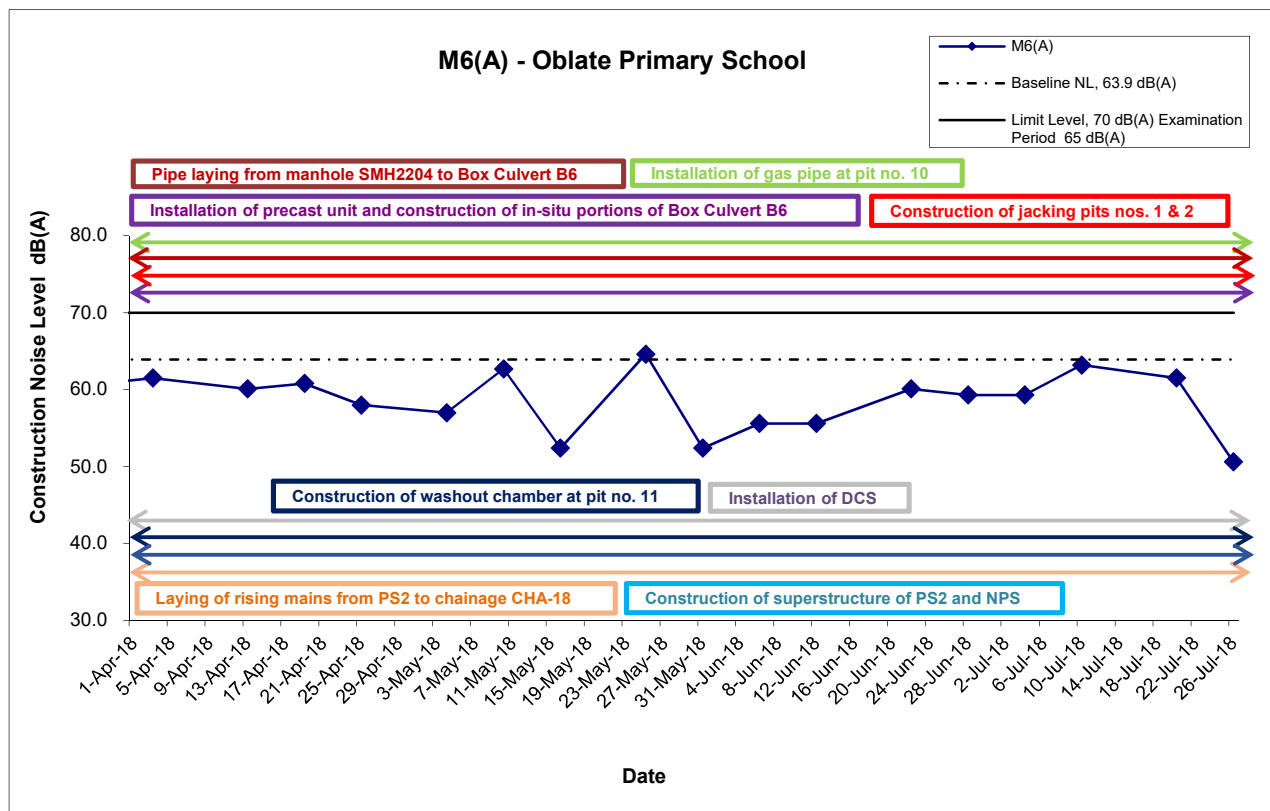
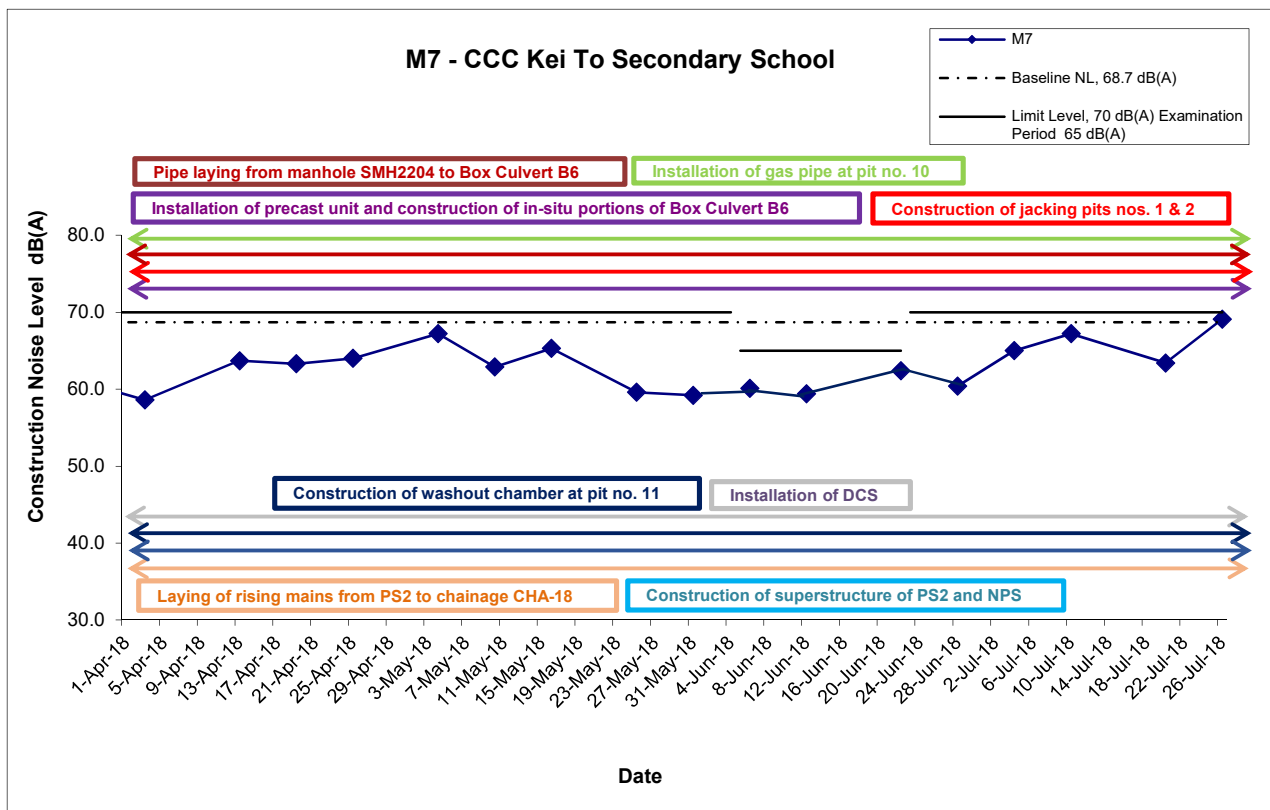
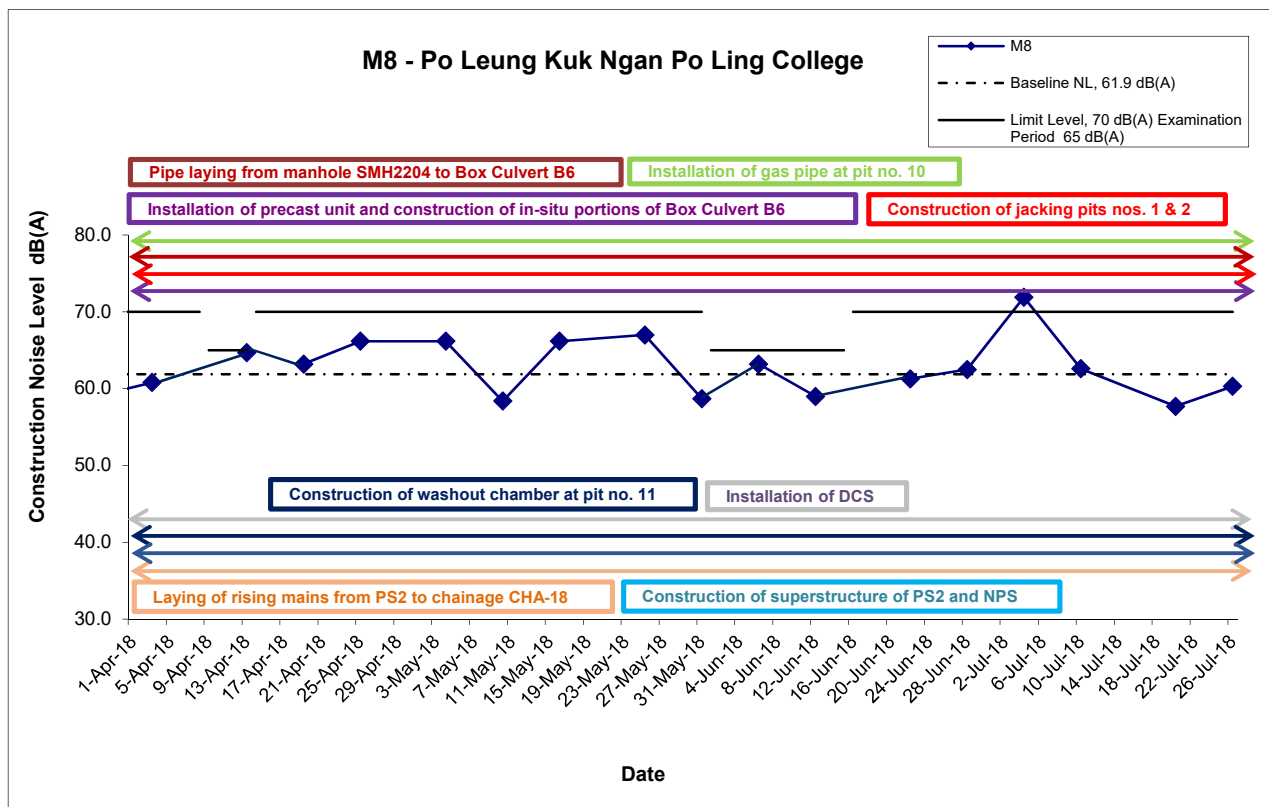
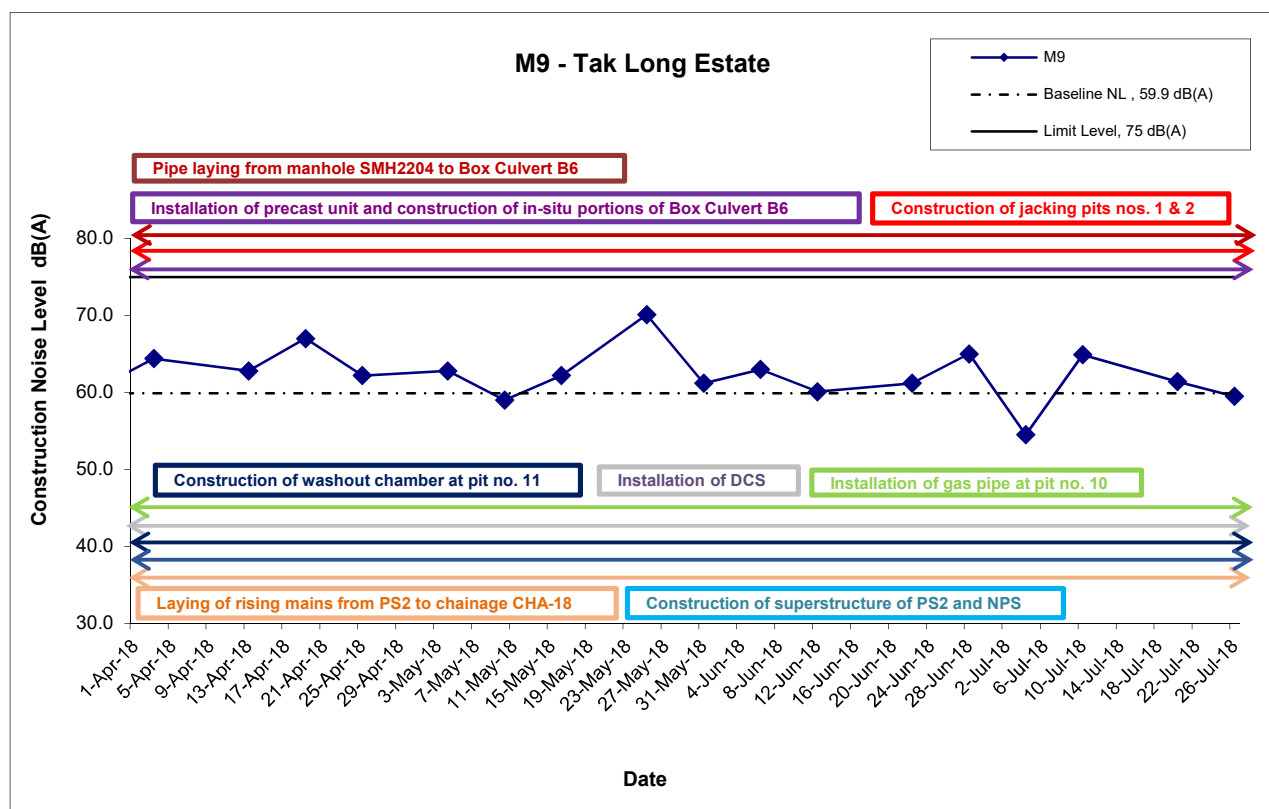
Noise Levels

Remarks: The construction noise levels in the Tables in Appendix G were adopted for plotting the graphs

Title Contract No. KL/2012/03 Kai Tak Development –Stage 4 Infrastructure at Former North Apron Area Graphical Presentation of Construction Noise Monitoring Results	Scale N.T.S	Project No. MA13056	CINOTECH
	Date Jul 18	Appendix G

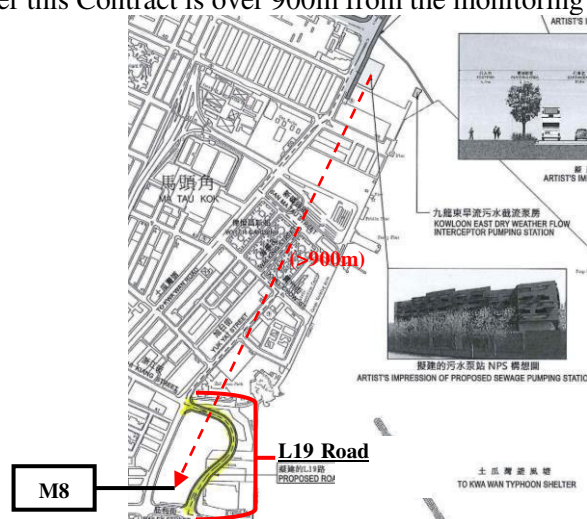
- According to field staffs' observation during the noise monitoring, the major noise source came from the Operation of excavator and dump truck and traffic activities.
- The work at Road L19 is completed on 7th September 2017 and handed over to Highways Department (see the enclosed document), the nearest construction works area (Sewage Pumping Station NPS) under this Contract is over 900m from the monitoring station M8.

Figure 1 – The distance between Noise Monitoring Station (M8) and Sewage Pumping Station NPS

- As the nearest noise source from Contractor is over 900m from the monitoring station (M8), no noise impact would be anticipated from the Contractor's construction area, the Limit Level exceedance was considered to be non- related to this Contract.
