#### CONTRACT NO: HK/2015/01

# WANCHAI DEVELOPMENT PHASE II AND CENTRAL WANCHAI BYPASS SAMPLING, FIELD MEASUREMENT AND TESTING WORK (STAGE 3)

#### QUARTERLY ENVIRONMENTAL MONITORING AND AUDIT REPORT

- MARCH 2016 TO MAY 2016 -

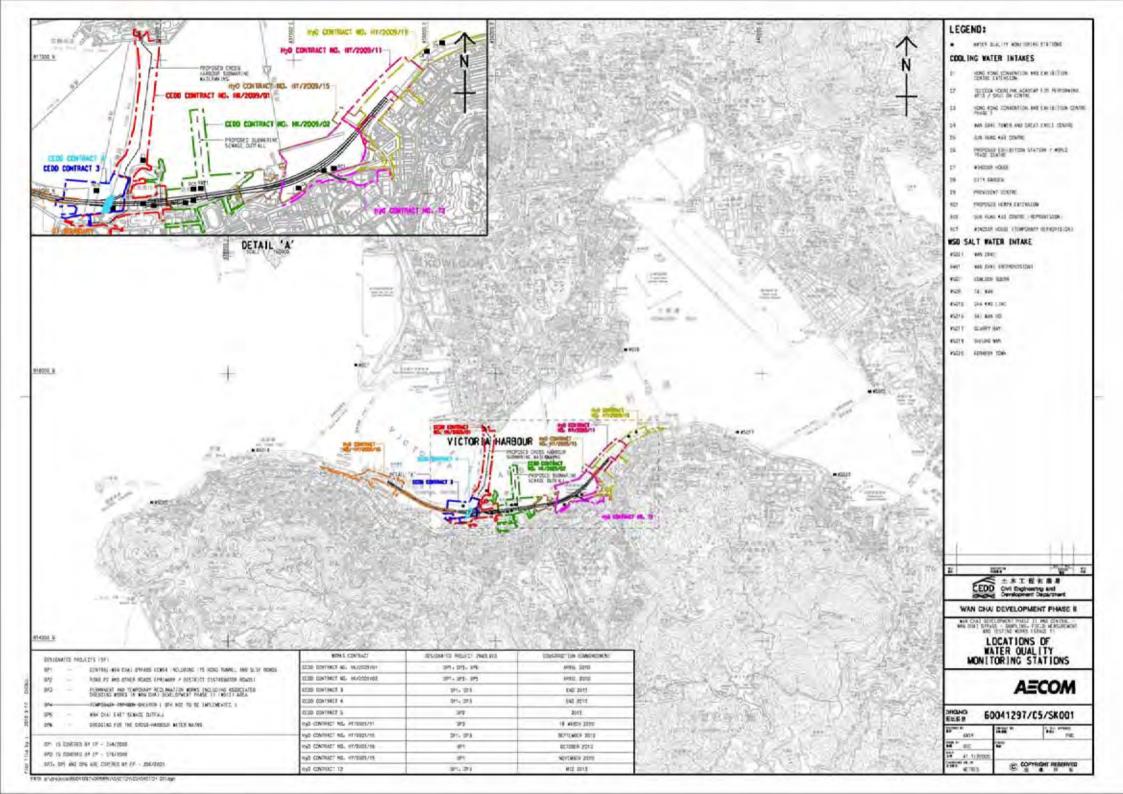
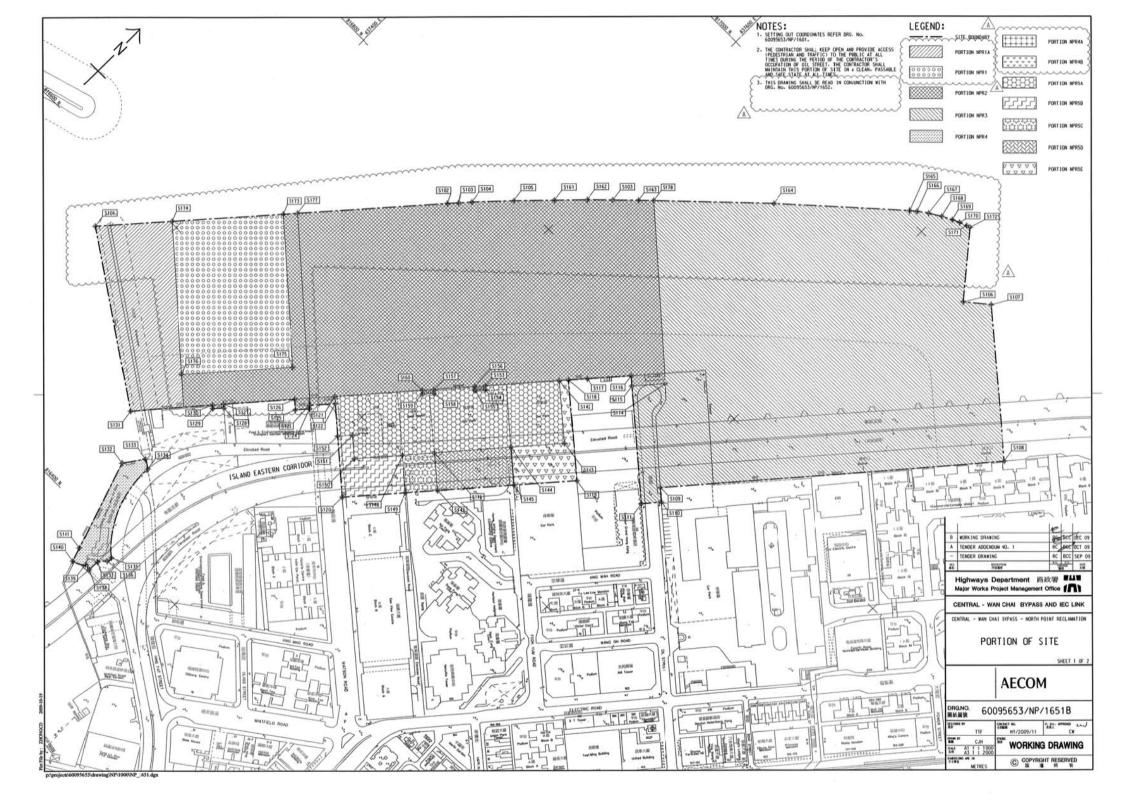
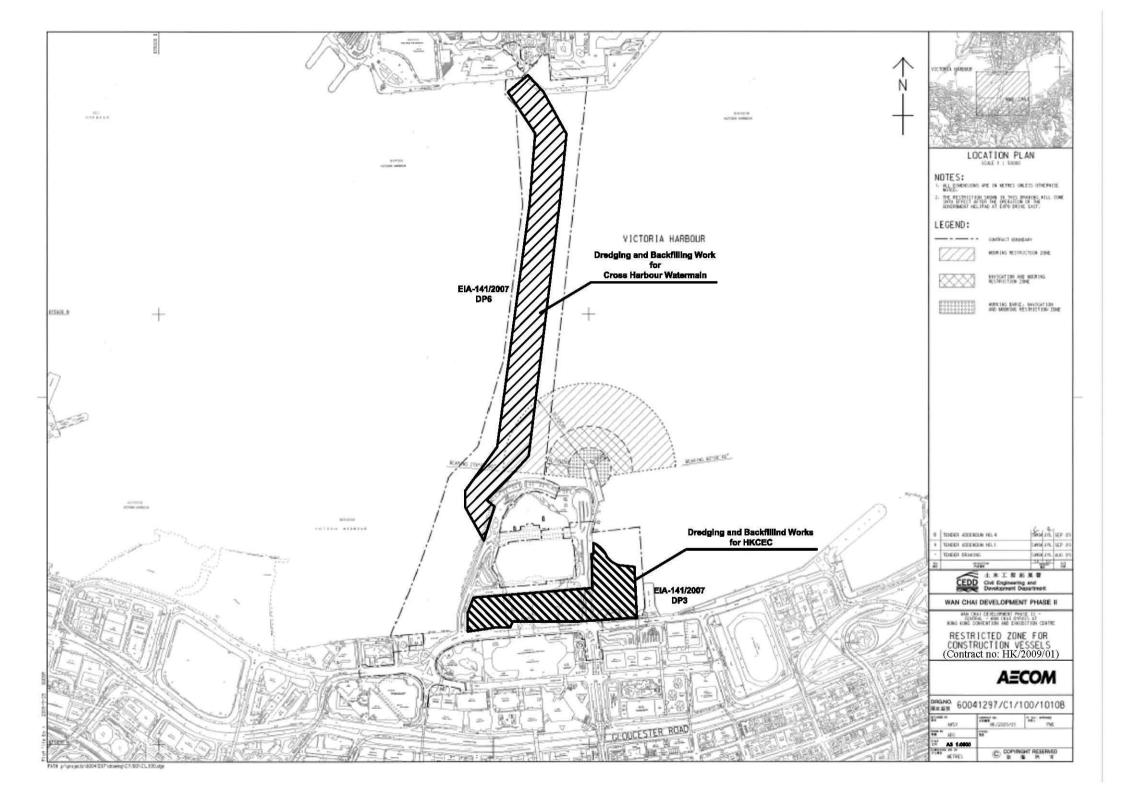
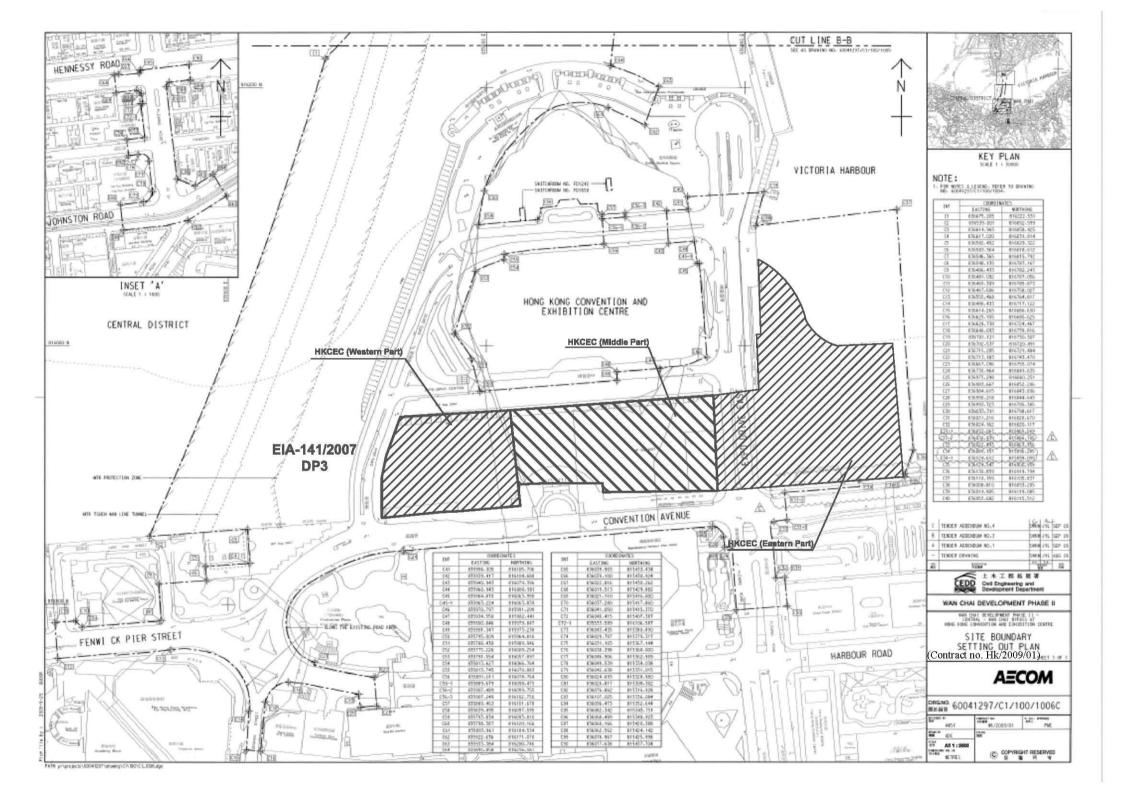
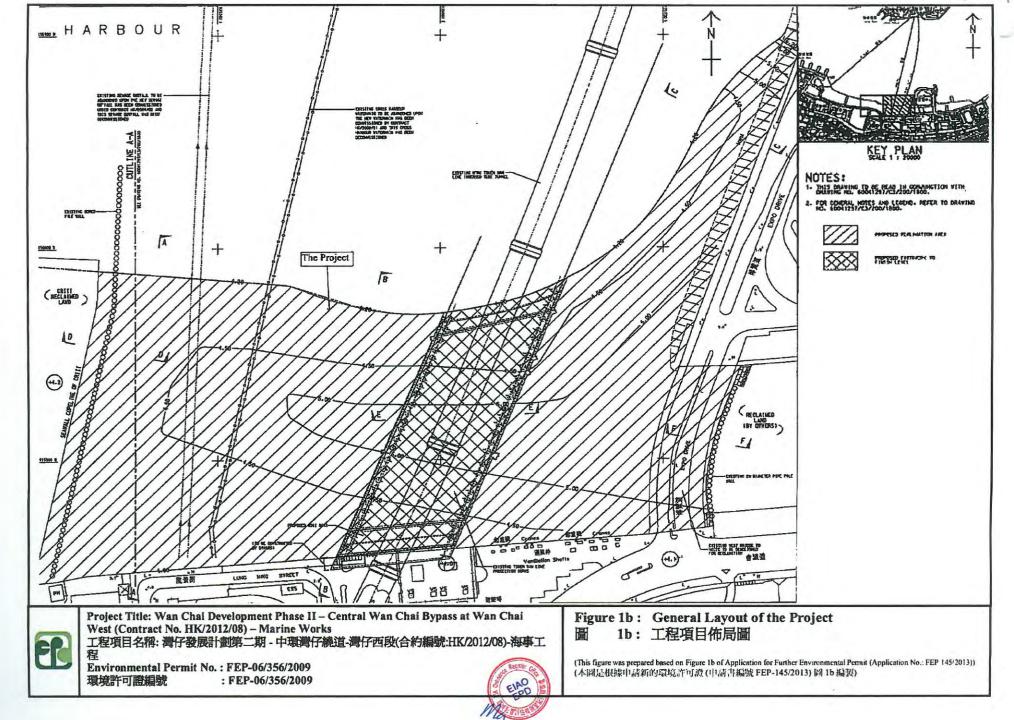
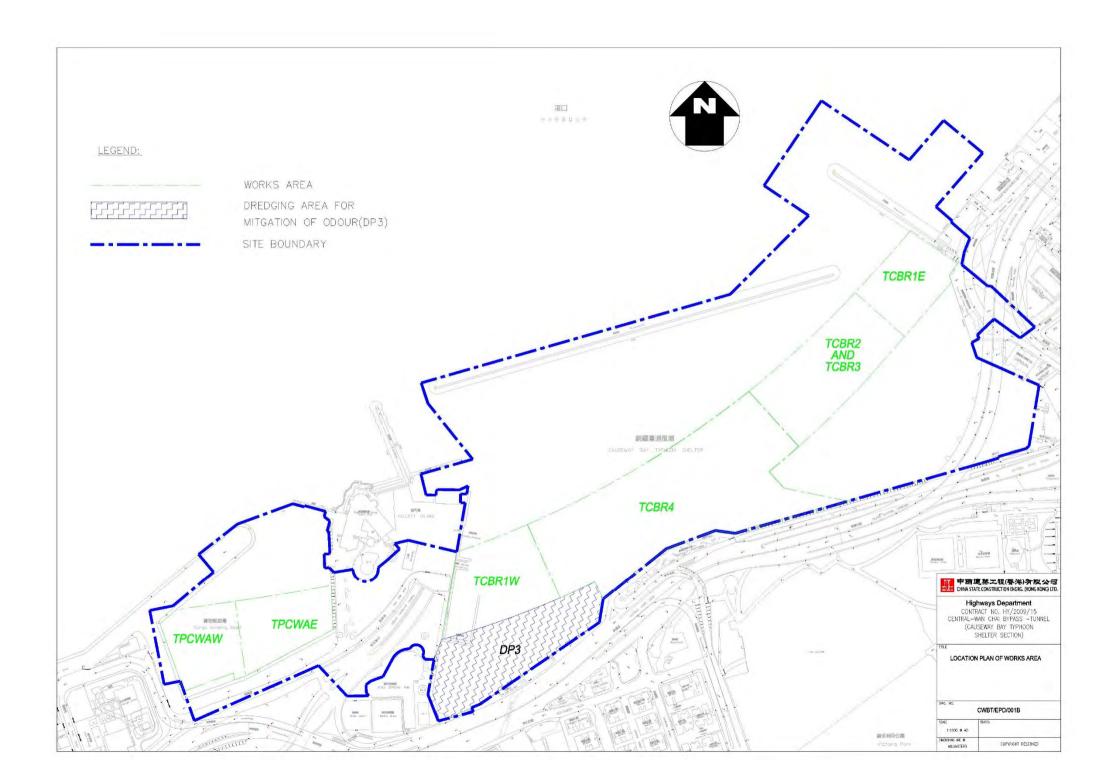
Figure 2.1

Project Layout

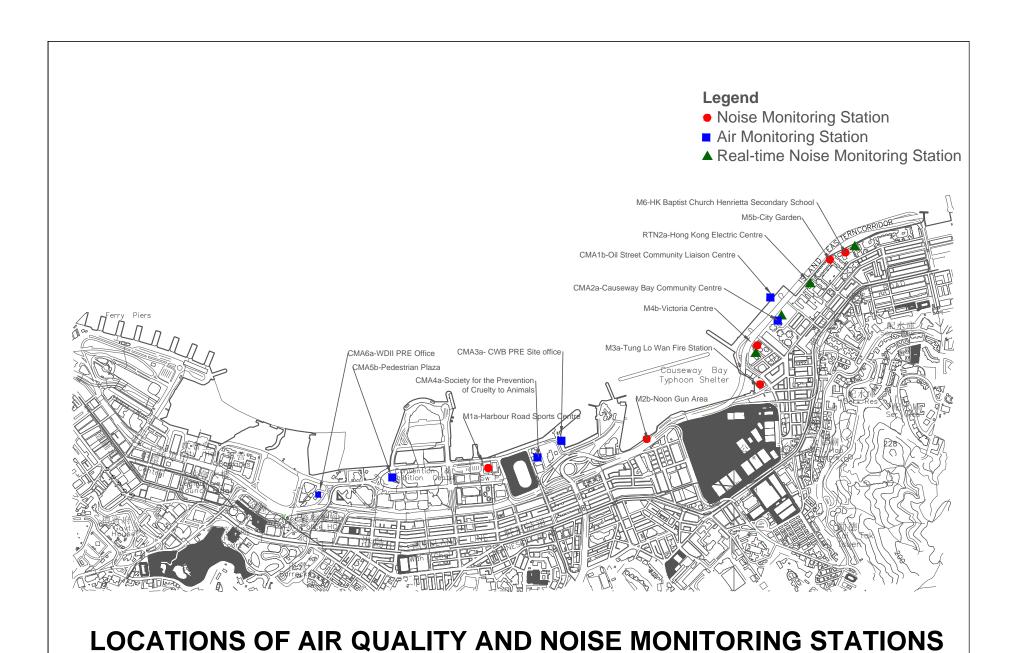
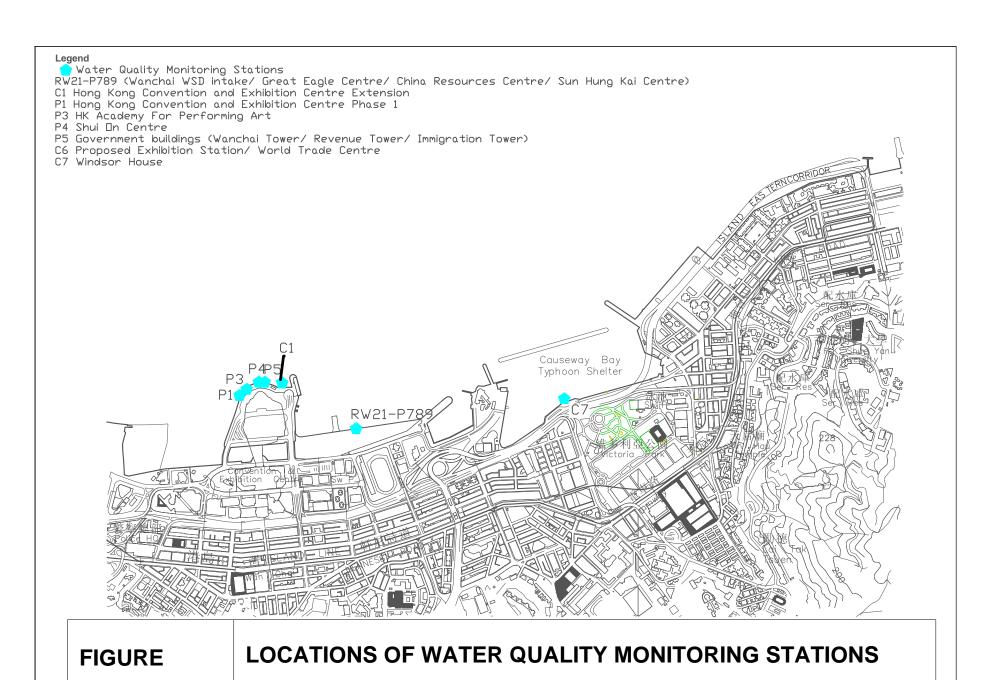
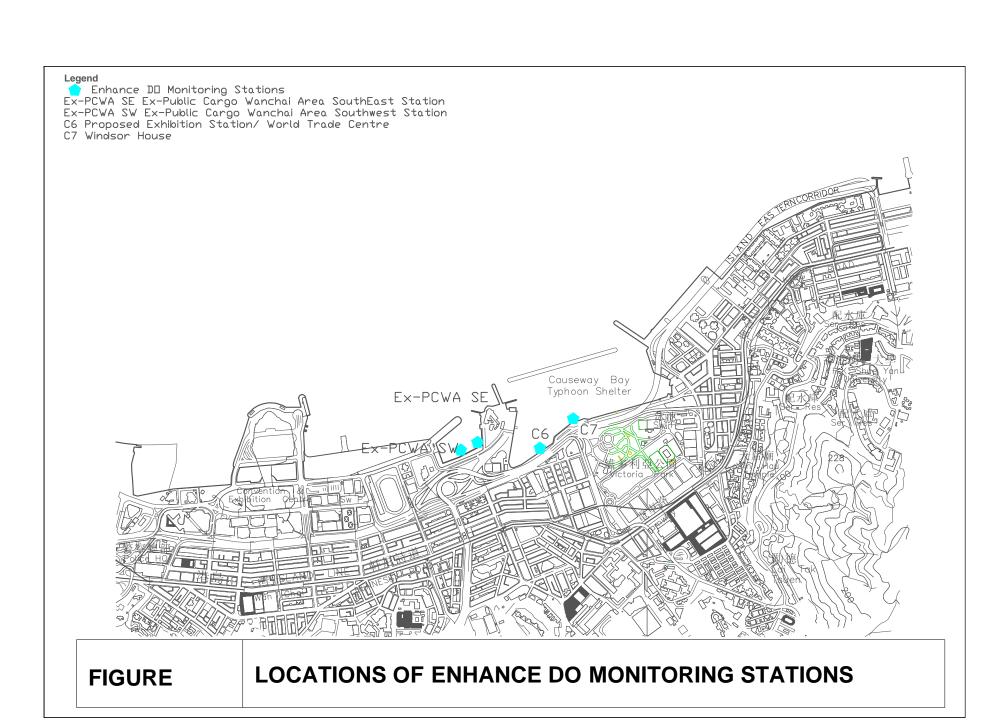
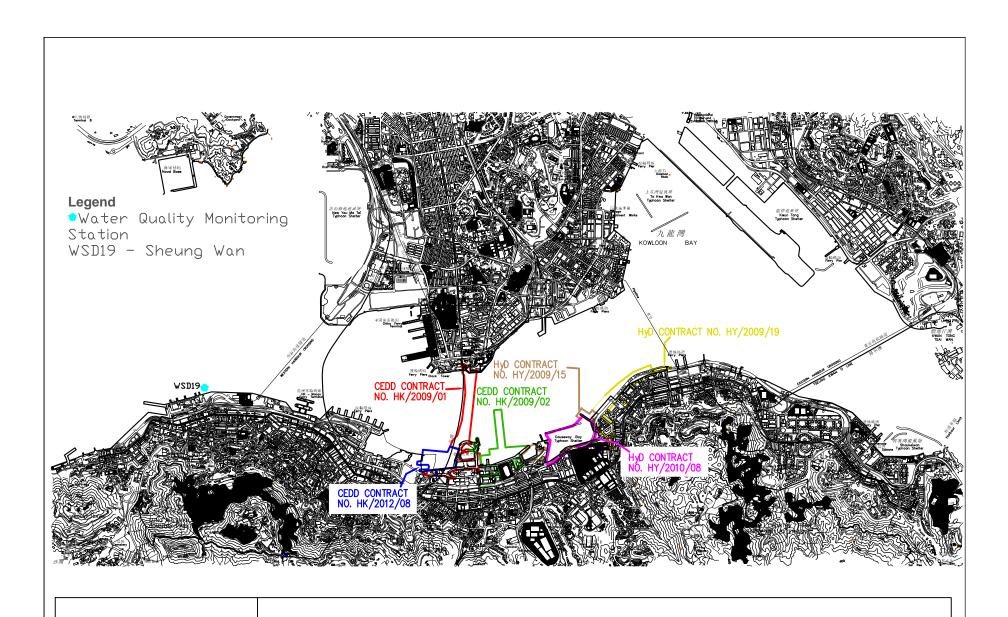
# Figure 3.1

**Locations of Monitoring Stations**

- 3.3.20 The enhanced water quality monitoring and audit programme is to avoid aggravation of odour nuisance from seawater arising from temporary reclamation in the ex-Wan Chai Public Cargo Working Area and the Causeway Bay Typhoon Shelter.
- 3.3.21 Dissolved oxygen monitoring at the intakes C6 and C7 in Causeway Bay Typhoon Shelter when there is temporary reclamation in Causeway Bay Typhoon Shelter and at the southwestern and south-eastern corners of the ex-Wan Chai Public Cargo Working Area. The proposed water quality monitoring stations of the Project are shown in *Table 3.5* and *Figure* 3.1.

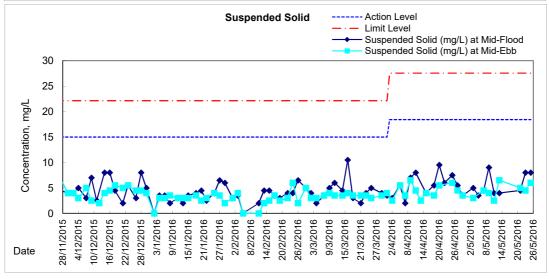
## Graphic Presentation of Water Quality Result of C1 - HKCEC

- 4.4.5. There were 2 action and 1 limit level turbidity exceedances recorded at C1 on 5, 7 and 9 May 2016 in May reporting month.
- 4.4.6. Despite silt screen removal works was conducted on 5 May 2016, removal works including silt screen's frame cutting and lifting works were observed conducted orderly and contractor clarified the cooling intake water supplies was temporary suspended during removal works. Low SS level was recorded during the monitoring period. In view of the above, the turbidity exceedance was considered not related to project works.

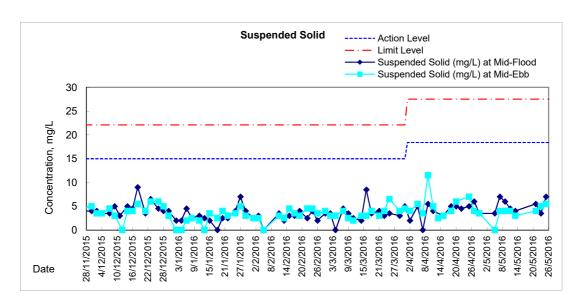
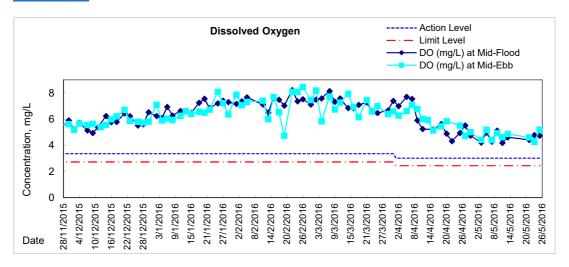
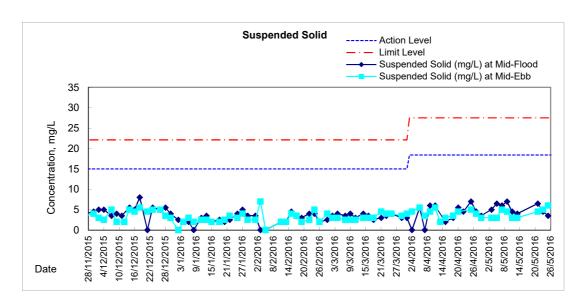
## Graphic Presentation of Water Quality Result of P1 - HKCEC Phase I

- 4.4.27. There was 1 action level turbidity exceedance at P1 recorded on 9 May 2016 in May reporting month.
- 4.4.28. No marine activity was conducted on 9 May 2016. The location of the construction area was downstream of P1 monitoring station during the monitoring period. Territory wide water quality variation was observed across Wan Chai East to Sheung Wan at both upstream and downstream locations of works area potential in related to seasonal tide changes. In view of the above and no exceedance was recorded on the subsequent monitoring, the exceedance was considered not related to Project works.

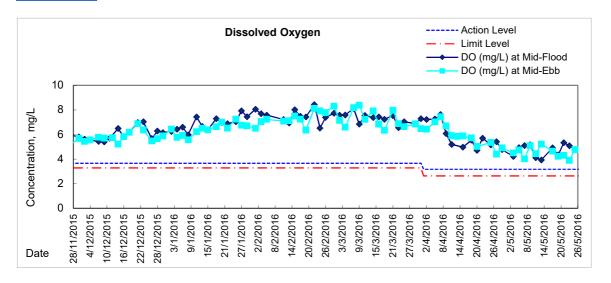
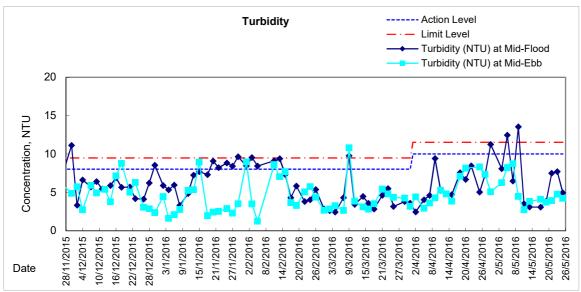
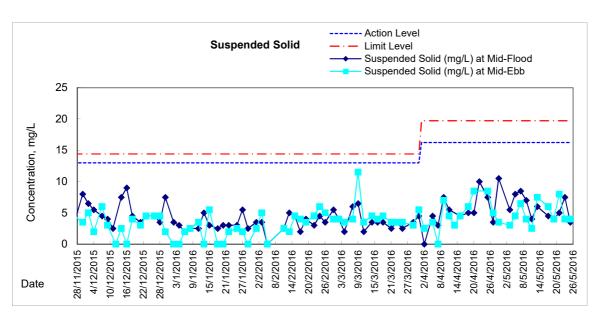
### Graphic Presentation of Water Quality Result of RW21-P789 - GEC/CRC/SHK

- 4.4.10. There were 2 limit level turbidity exceedances recorded at RW21-P789 on 9 March 2016 in the reporting month.
- 4.4.11. Despite no marine construction activities was conducted under Contract HK/2009/02 during the monitoring period on 9 March 2016, overflow of contaminated surface runoff into nearby waters at WCR2 site area was observed during monitoring and affecting the water quality within and outside the silt screen enclosed waterbody at RW21-P789 WQM station. As such, it was concluded that the exceedance was project related and the Contractor of HK/2009/02 was immediately advised to take immediate action to rectify the defects observed. Relevant mitigation measures including provision of water pump to direct the contaminated surface runoff to the nearby collection point and reinforcement of concrete bunding at the concerned location to prevent further surface runoff were implemented by the Contractor of HK/2009/02 on 9 March 2016. Additional monitoring was conducted on 10 March 2016 and the water quality at the concerned location has returned to normal level during the additional monitoring on 10 March 2016. Nevertheless, the contractor was reminded to maintain regular checking of the installed silt screen at WQM station RW21-P789.

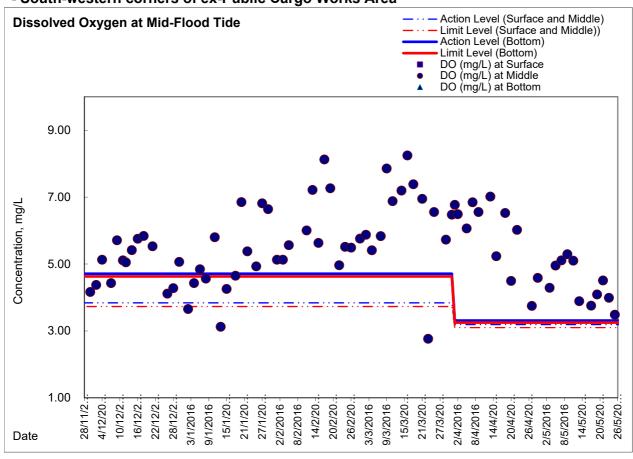
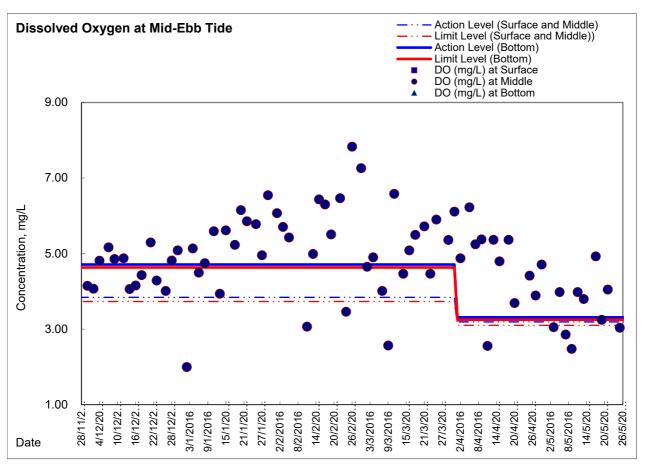
## Graphic Presentation of Enhanced Water Monitoring Results (DO) at Ex-WPCWA SW

- South-western corners of ex-Public Cargo Works Area

- 4.4.39. There were 2 limit level DO exceedances recorded at Ex-WPCWA SW on 9 and 11 March 2016 in March reporting month.
- 4.4.40. After checking with contractor, no marine activity was conducted at TPCWAE on 9 and 11 March 2016, while upstream discharge from nearby culvert was noted. In view of no marine activity was conducted and no exceedance was recorded on the subsequent monitoring, the exceedances were considered not related to Project works.

- 4.4.41. There was 1 limit level DO exceedances recorded at Ex-WPCWA SW on 11 April 2016 in April reporting month.
- 4.4.42. After checking with contractor, despite backfilling works was conducted at TPCWAW on 11 April 2016, contractor mitigation measures include the use of tarpaulin sheet between barge and land and provision of bunding for site runoff control was generally in place. Meanwhile, upstream discharge from nearby culvert was noted. In view of the above and no exceedance was recorded on the subsequent monitoring, the exceedance was considered not related to the Project works.

- 4.4.43. There were 4 limit level DO exceedances recorded at Ex-WPCWA SW on 3, 7, 9 and 25 May 2016 in May reporting month.
- 4.4.44. After checking with contractor, despite backfilling works was conducted at TPCWAW on 3 and 9 May 2016, contractor mitigation measures include the use of tarpaulin sheet between barge and land and provision of bunding for site runoff control was generally in place. Meanwhile, upstream discharge from nearby culvert was noted. In view of the above and no exceedance was recorded on the subsequent monitoring, the exceedance was considered not related to the Project works.
