CONTRACT NO: HK/2015/01

WANCHAI DEVELOPMENT PHASE II AND CENTRAL
WANCHAI BYPASS
SAMPLING, FIELD MEASUREMENT AND TESTING WORKS
(STAGE 3)

MONTHLY ENVIRONMENTAL MONITORING & AUDIT REPORT

- MAY 2016 -

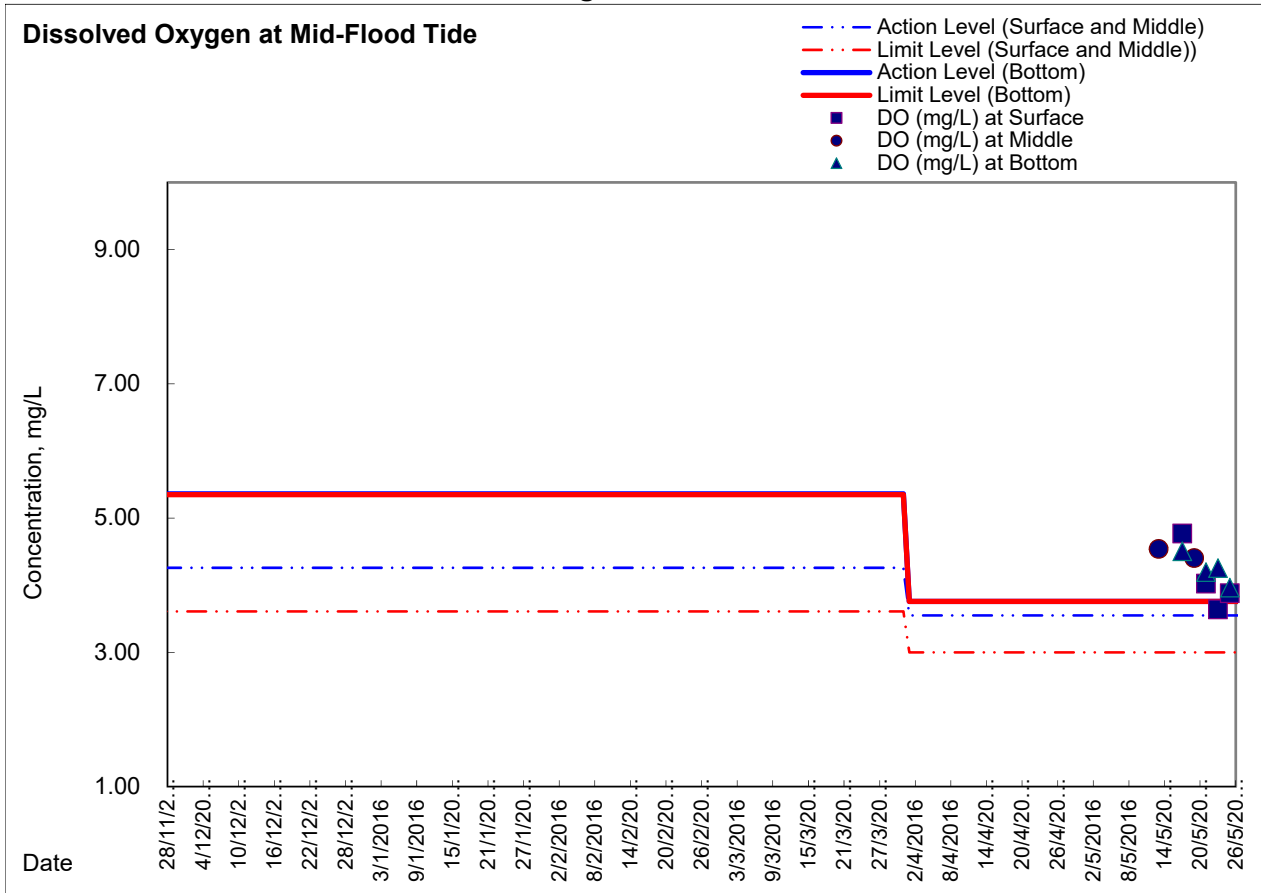
Graphic Presentation of Enhanced Water Monitoring Results (DO) at Ex-WPCWA SE - South-eastern corners of ex-Public Cargo Works Area
