CONTRACT NO: HK/2015/01

**WANCHAI DEVELOPMENT PHASE II AND CENTRAL
WANCHAI BYPASS
SAMPLING, FIELD MEASUREMENT AND TESTING WORKS
(STAGE 3)**

MONTHLY ENVIRONMENTAL MONITORING & AUDIT REPORT

- JUNE 2017 -

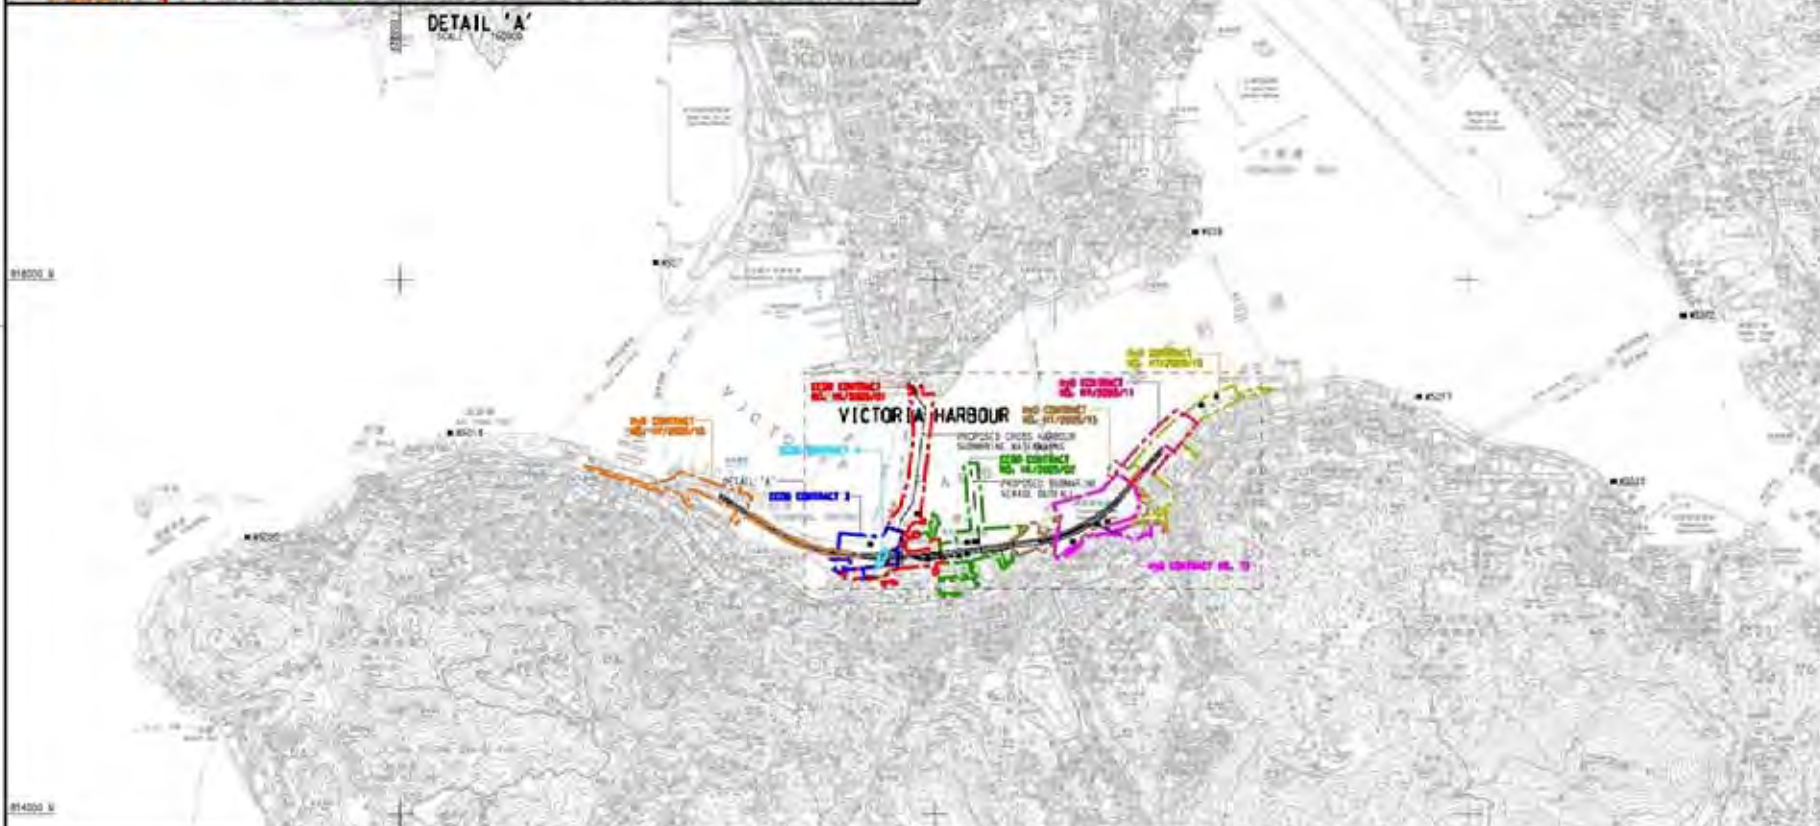
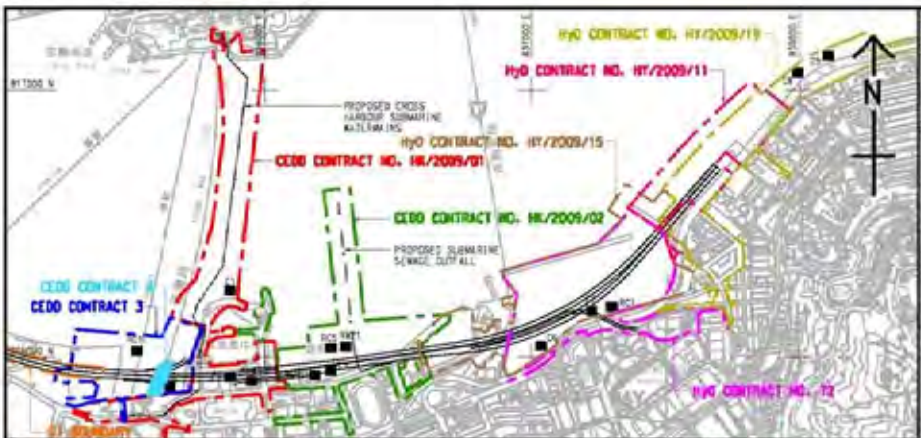
Figure 2.1

Project Layout

- 2.2.1. The Project is located mainly in Wan Chai North, Causeway Bay and North Point, and is demarcated by Gloucester Road and Victoria Park Road to the south, Fenwick Pier Street to the west and Tong Shui Road Interchange to the east, as shown in **Figure 2.1**.

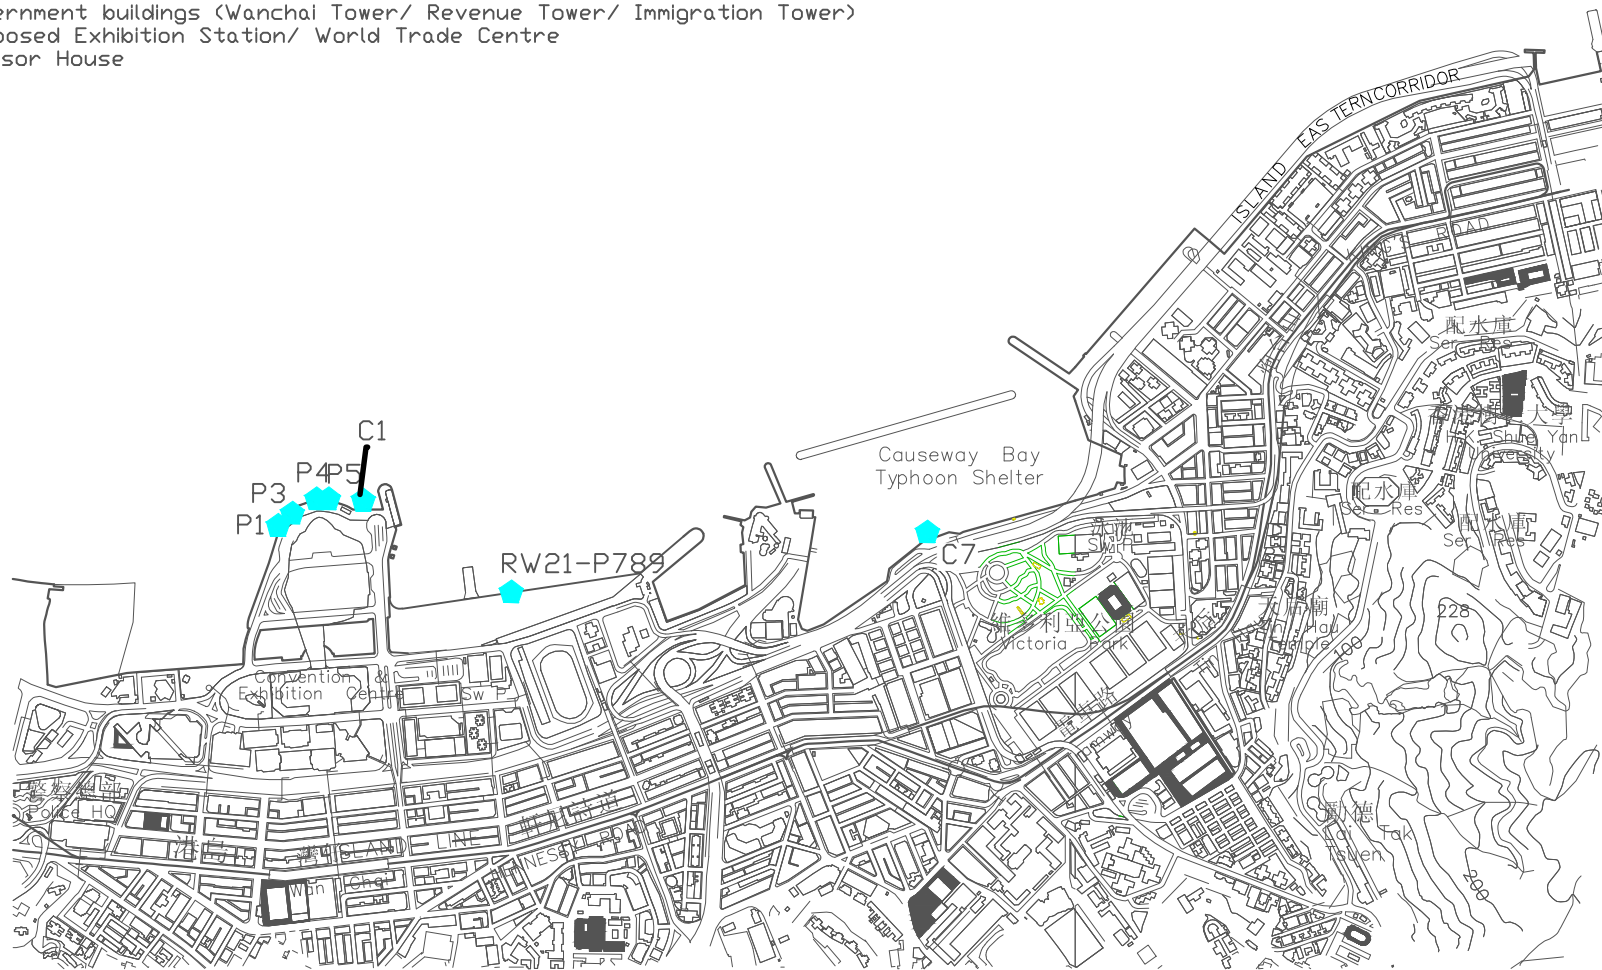
Figure 4.1

LOCATIONS OF WATER QUALITY MONITORING STATIONS

- 4.3.21. The enhanced water quality monitoring and audit programme is to avoid aggravation of odour nuisance from seawater arising from temporary reclamation in the ex-Wan Chai Public Cargo Working Area and the Causeway Bay Typhoon Shelter.
- 4.3.22. Dissolved oxygen monitoring at the intakes C6 and C7 in Causeway Bay Typhoon Shelter when there is temporary reclamation in Causeway Bay Typhoon Shelter and at the south-western and south-eastern corners of the ex-Wan Chai Public Cargo Working Area. The proposed water quality monitoring stations of the Project are shown in **Table 4.5** and [Figure 4.1](#).

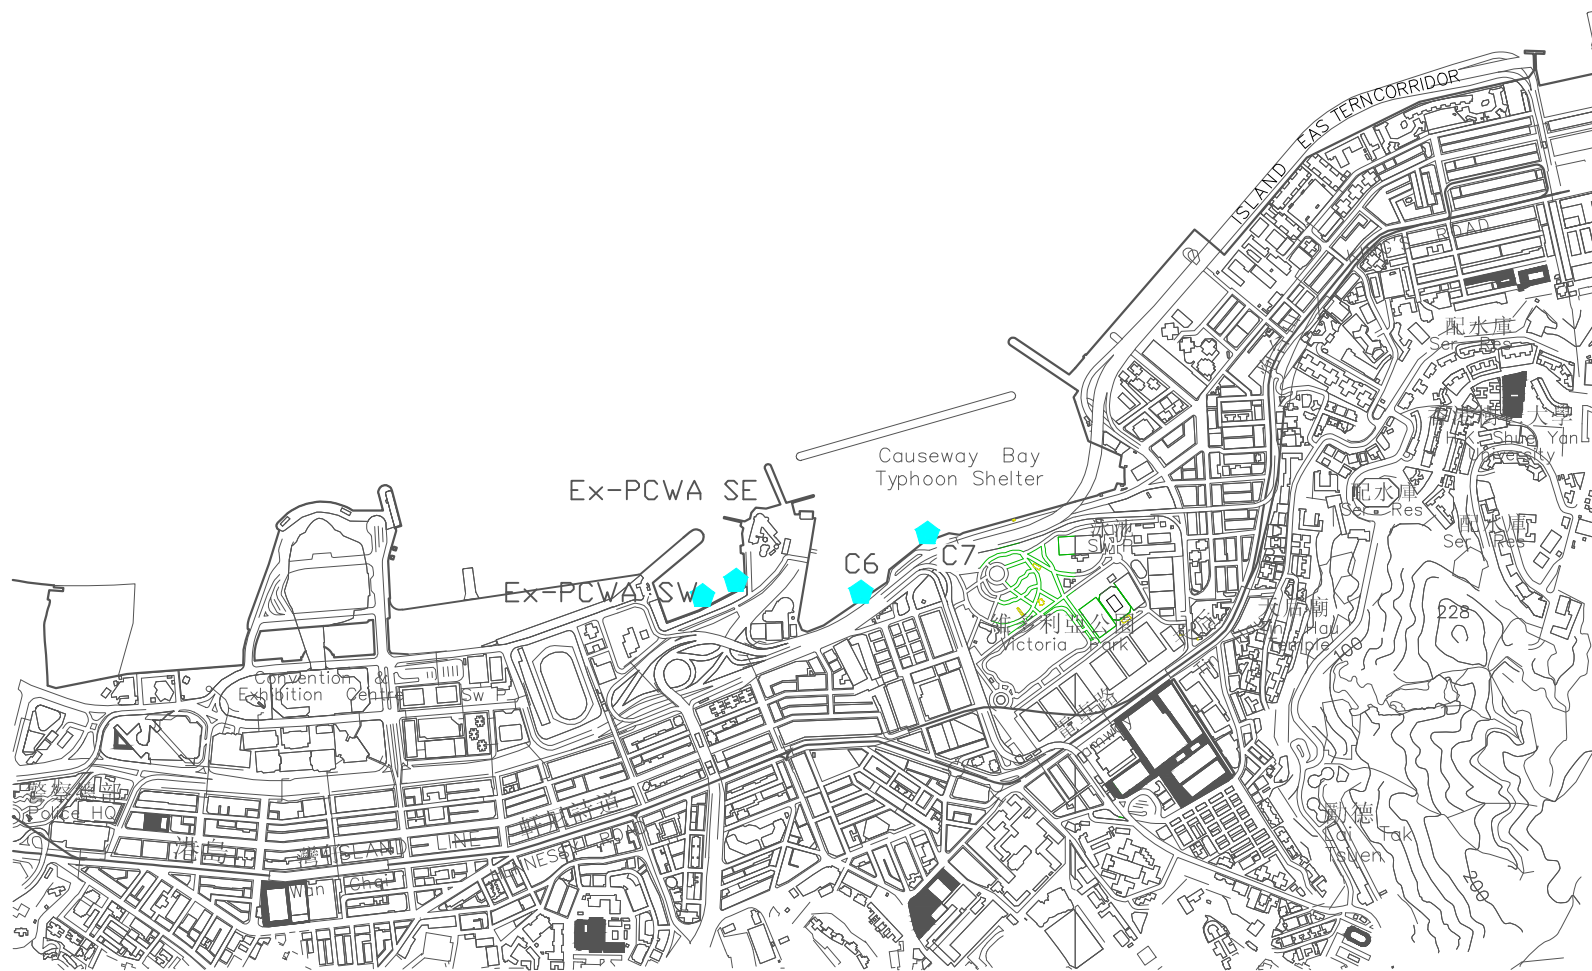
LOCATIONS OF ENHANCE DO MONITORING STATIONS

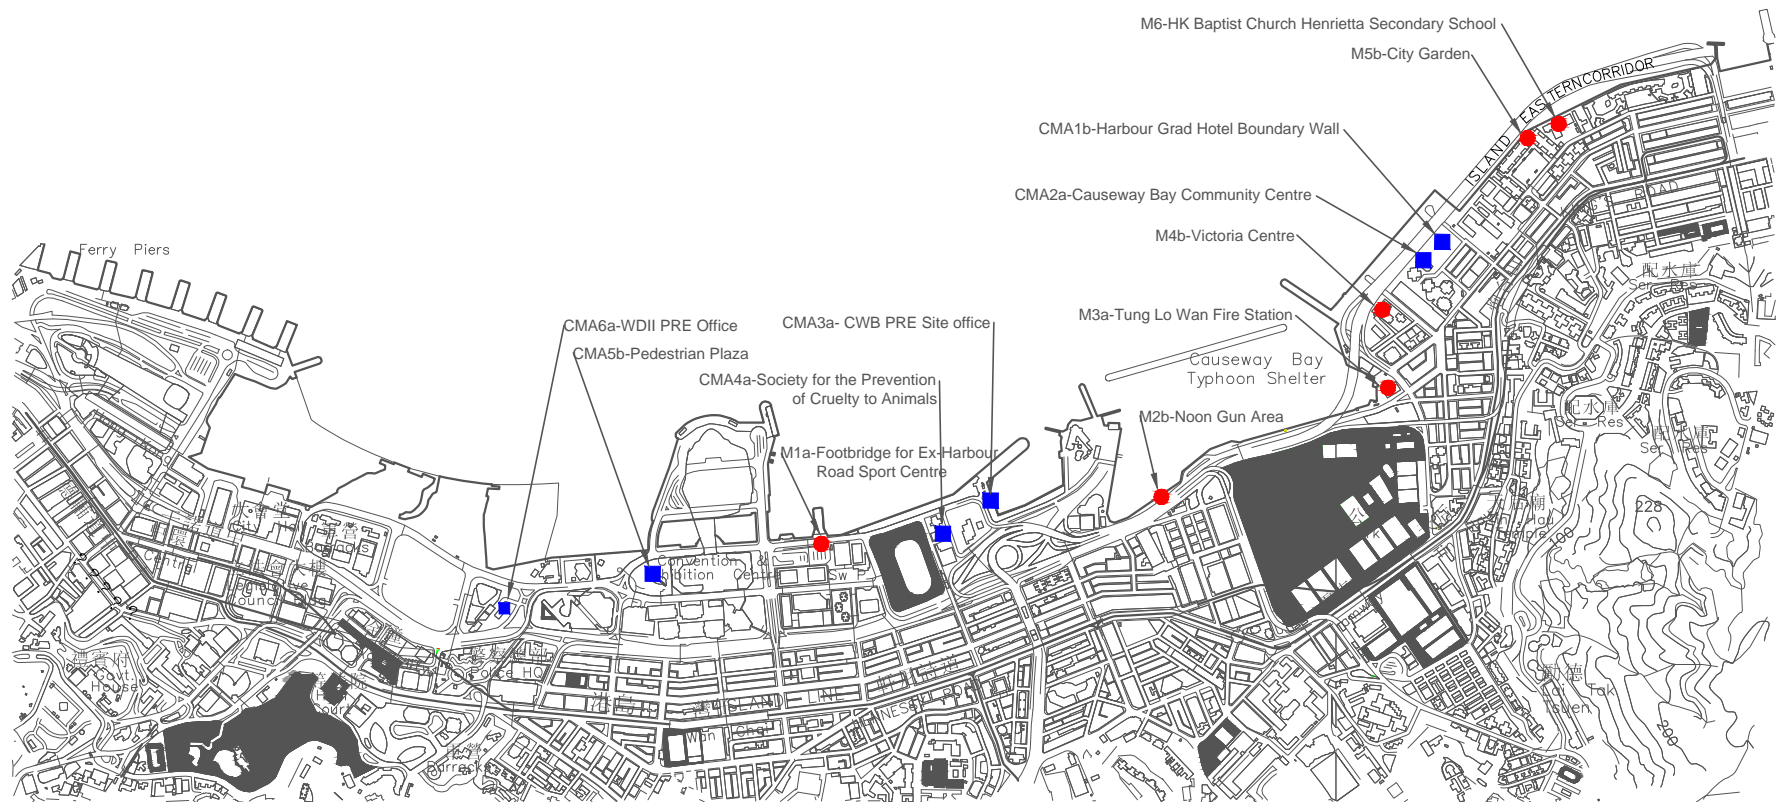
LOCATIONS OF AIR QUALITY AND NOISE MONITORING STATIONS

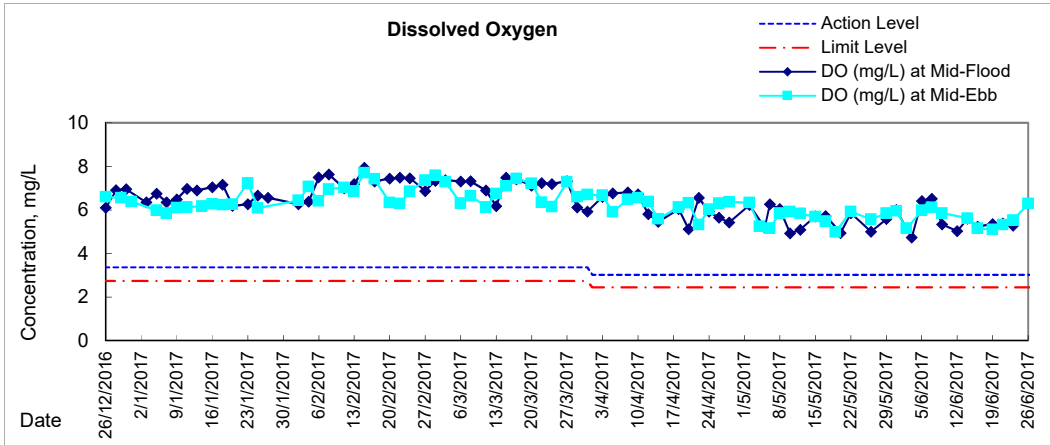
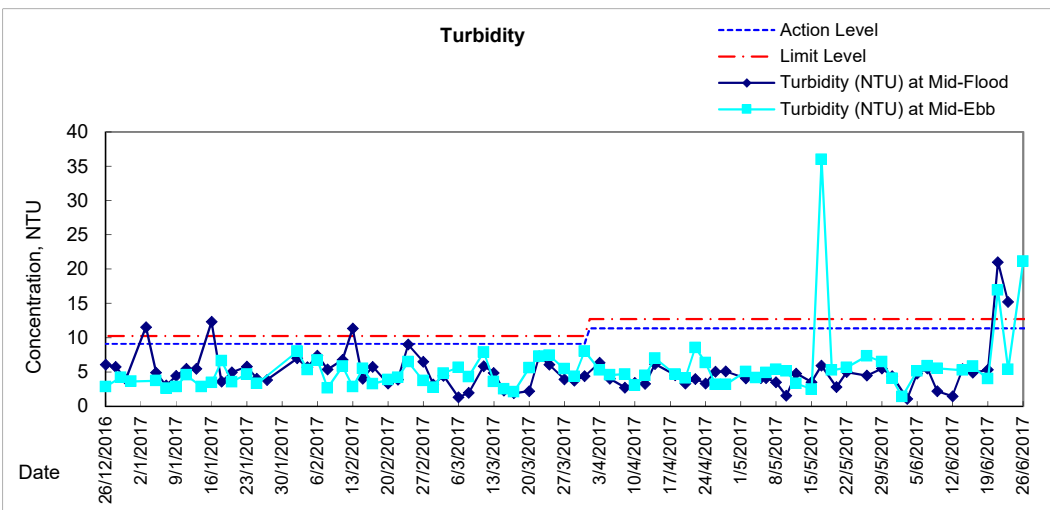
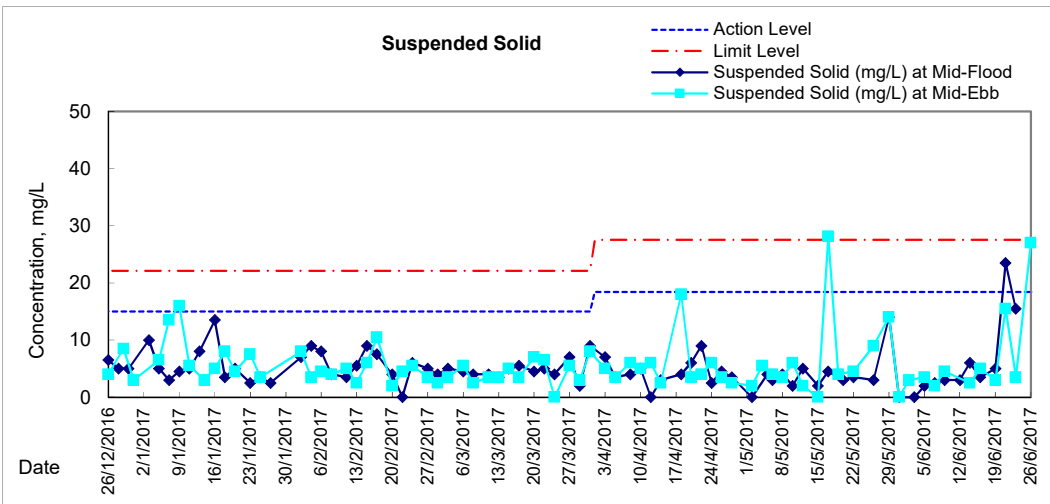
Graphic Presentation of Water Quality Result of C7 - Windsor House

- xxxi. There were four limit level of turbidity exceedances and two action level of suspended solid exceedance were recorded in this reporting month.
- xxxii. Investigation found that 1 limit level of turbidity exceedance recorded at monitoring station C7 on 23 June 2017 was not related to Project works.

- xxxiii. Investigation found that 3 limit level of turbidity exceedances and 2 action level of suspended solid exceedances recorded at monitoring station C7 on 21 and 26 June 2017 were concluded as related to Project works.

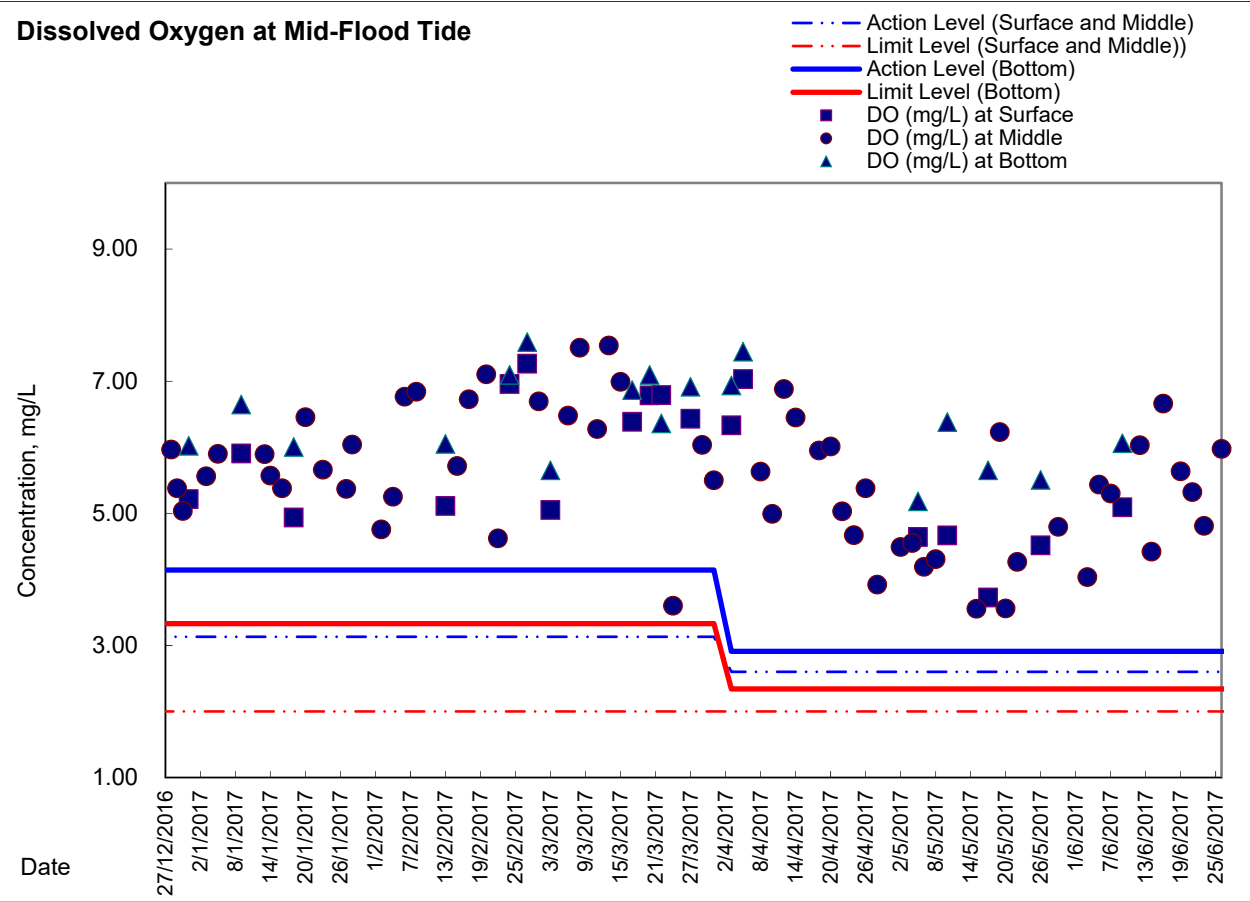
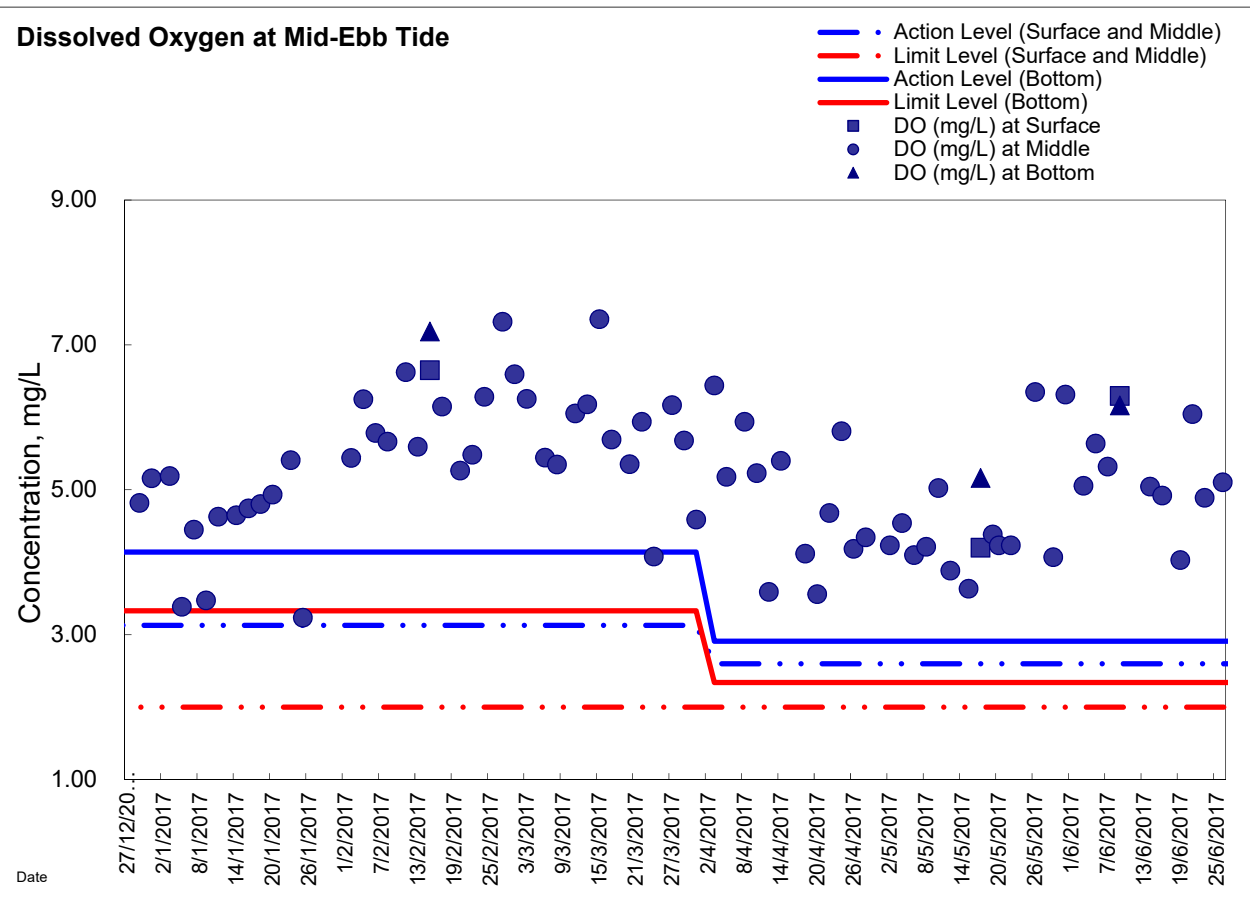
Graphic Presentation of Enhanced Water Monitoring Results (DO) at C6 - Excelsior Hotel
