CONTRACT NO: HK/2015/01

**WANCHAI DEVELOPMENT PHASE II AND CENTRAL
WANCHAI BYPASS
SAMPLING, FIELD MEASUREMENT AND TESTING WORKS
(STAGE 3)**

MONTHLY ENVIRONMENTAL MONITORING & AUDIT REPORT

- MAY 2018 -

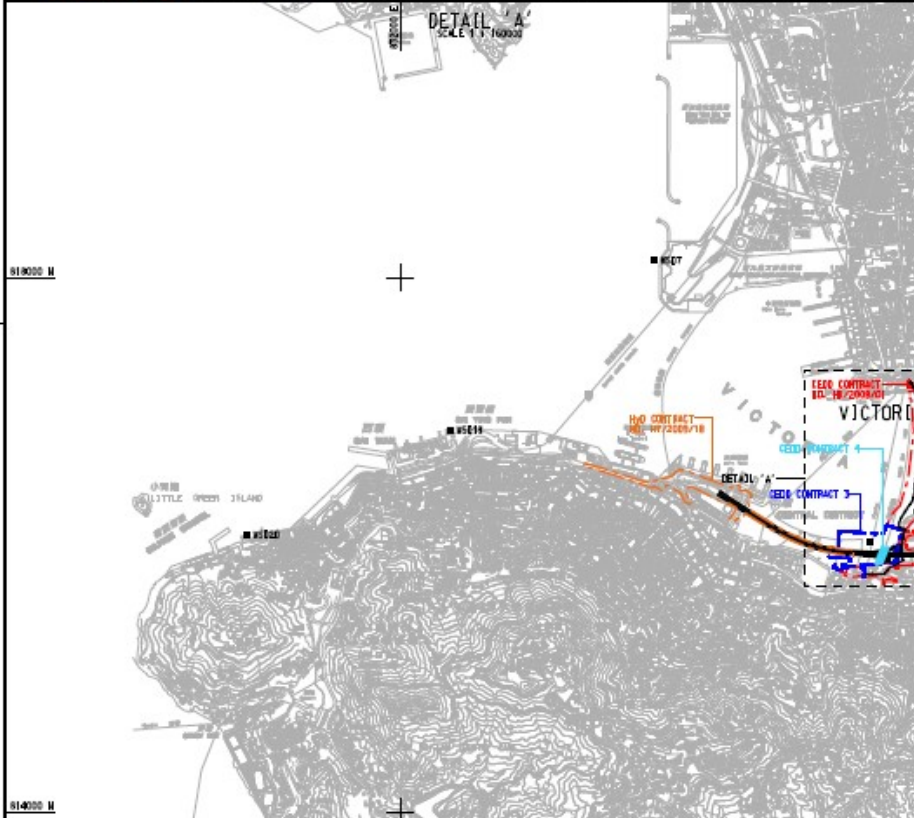
Figure 2.1

- 2.2.1. The Project is located mainly in Wan Chai North, Causeway Bay and North Point, and is demarcated by Gloucester Road and Victoria Park Road to the south, Fenwick Pier Street to the west and Tong Shui Road Interchange to the east, as shown in **Figure 2.1**.

Project Layout
