CONTRACT NO: HK/2015/01

**WANCHAI DEVELOPMENT PHASE II AND CENTRAL
WANCHAI BYPASS
SAMPLING, FIELD MEASUREMENT AND TESTING WORKS
(STAGE 3)**

MONTHLY ENVIRONMENTAL MONITORING & AUDIT REPORT

- JANUARY 2019 -

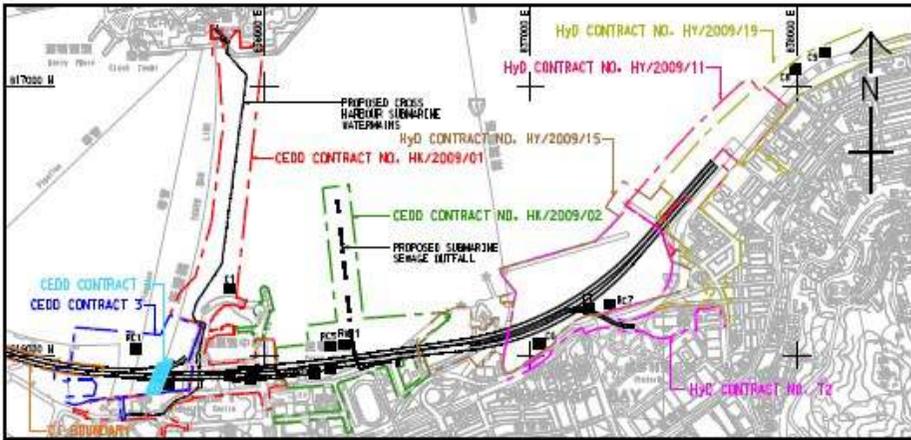
Figure 2.1

- 2.2.1. The Project is located mainly in Wan Chai North, Causeway Bay and North Point, and is demarcated by Gloucester Road and Victoria Park Road to the south, Fenwick Pier Street to the west and Tong Shui Road Interchange to the east, as shown in **Figure 2.1**.

Project Layout

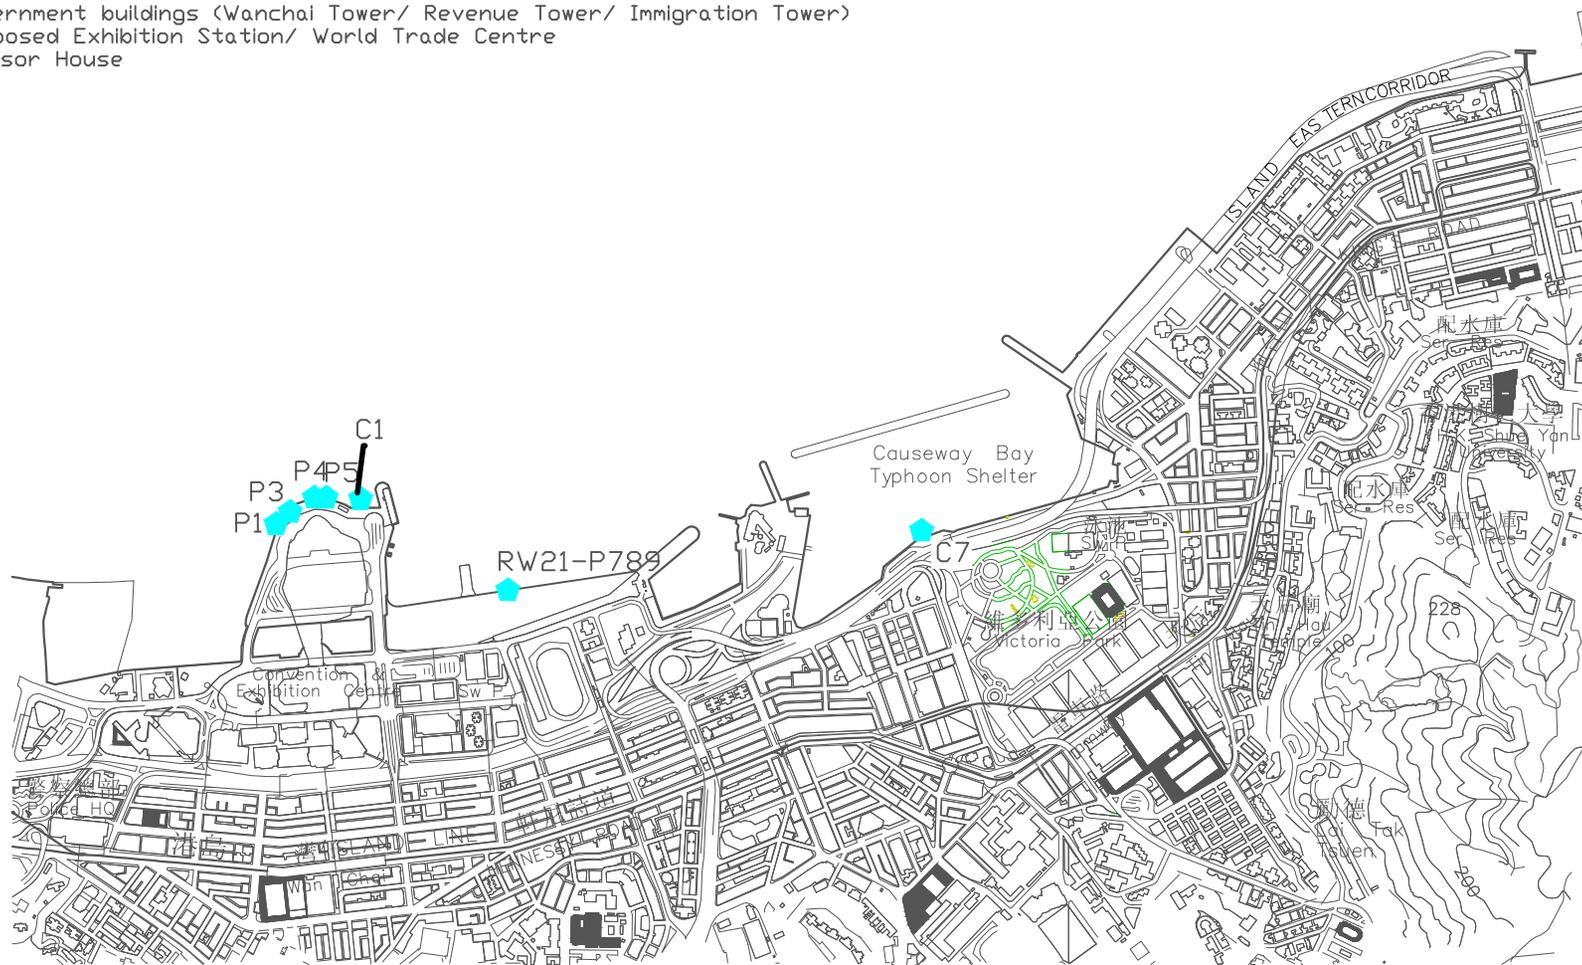
Figure 4.1

- 4.3.21. The enhanced water quality monitoring and audit programme is to avoid aggravation of odour nuisance from seawater arising from temporary reclamation in the ex-Wan Chai Public Cargo Working Area and the Causeway Bay Typhoon Shelter.
- 4.3.22. Dissolved oxygen monitoring at the intakes C6 and C7 in Causeway Bay Typhoon Shelter when there is temporary reclamation in Causeway Bay Typhoon Shelter and at the south-western and south-eastern corners of the ex-Wan Chai Public Cargo Working Area. The proposed water quality monitoring stations of the Project are shown in [Table 4.5](#) and [Figure 4.1](#).

LOCATIONS OF WATER QUALITY MONITORING STATIONS

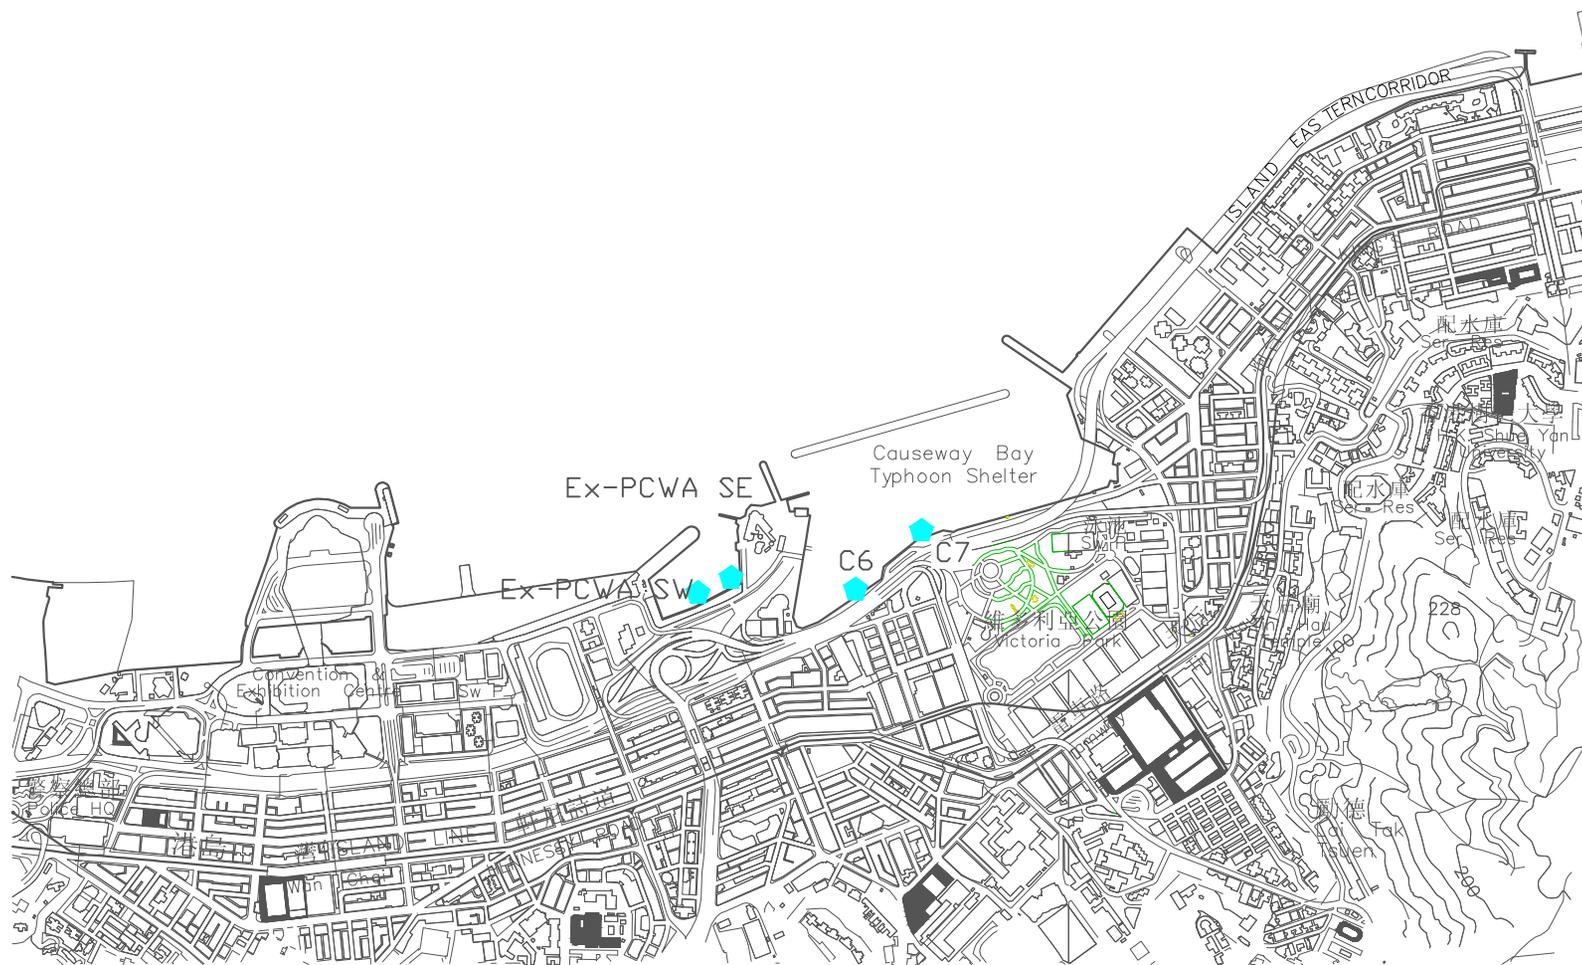
LOCATIONS OF ENHANCE DO MONITORING STATIONS

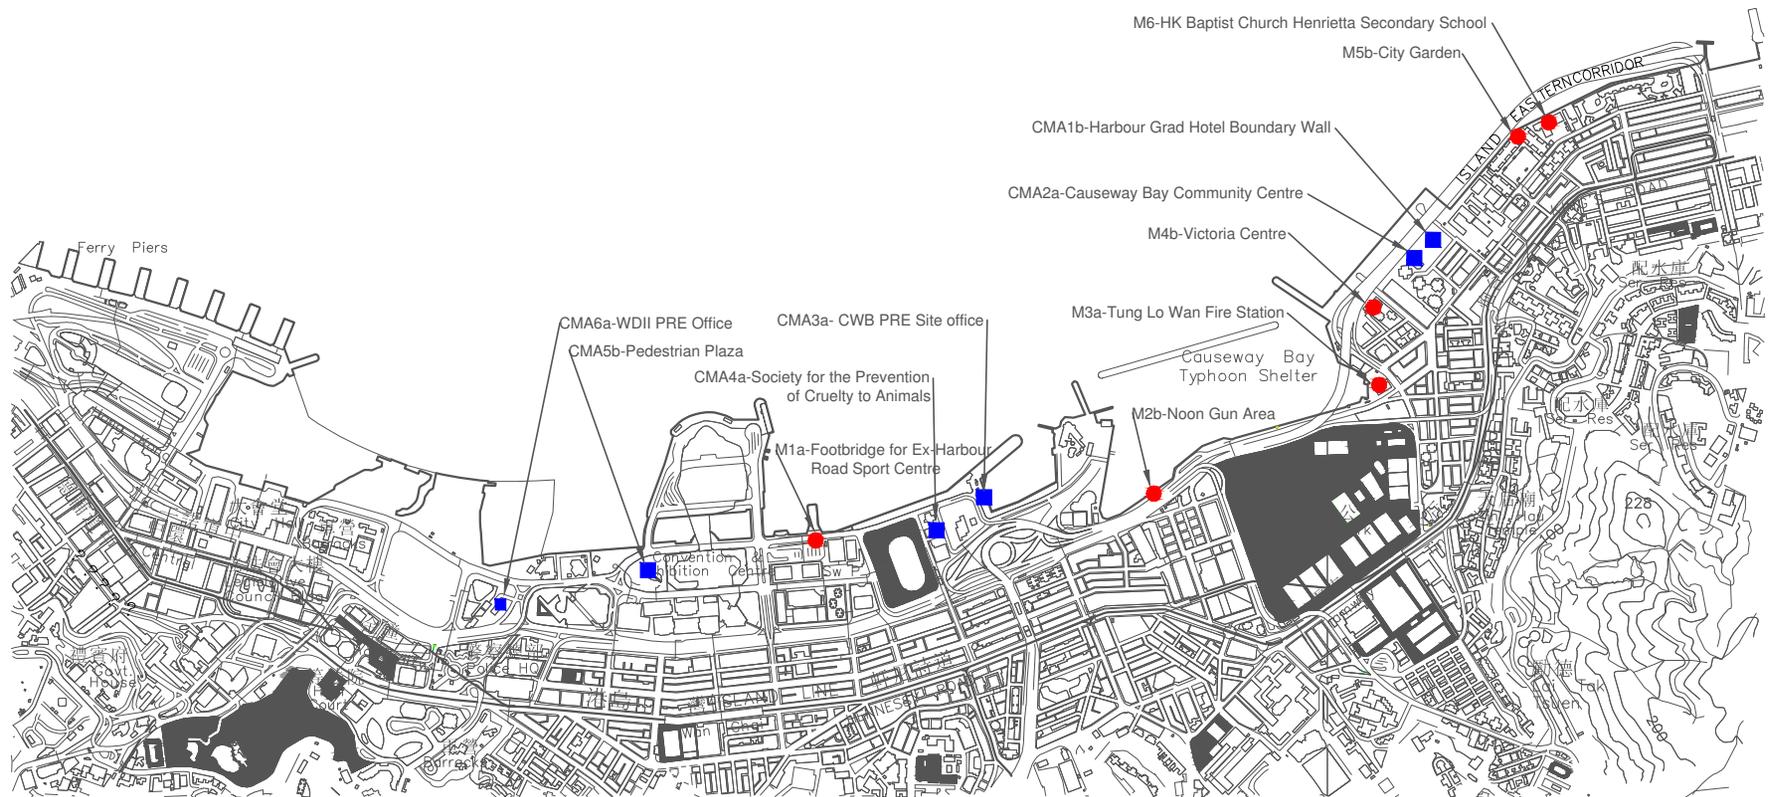
- x. 1-hour and 24-hour Total Suspended Particulates (TSP) monitoring were conducted at CMA1b – Oil Street Site Office; CMA2a – Causeway Bay Community Center; CMA3a – CWB PRE Site Office Area; CMA4a – Society for the Prevention of Cruelty to Animals; CMA5b – Pedestrian Plaza; CMA6a – WDII PRE Site Office in the reporting month.

LOCATIONS OF AIR QUALITY AND NOISE MONITORING STATIONS

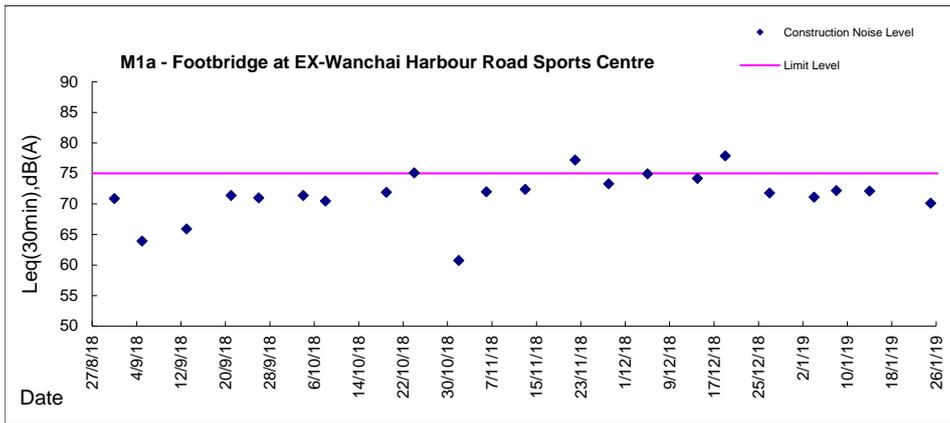
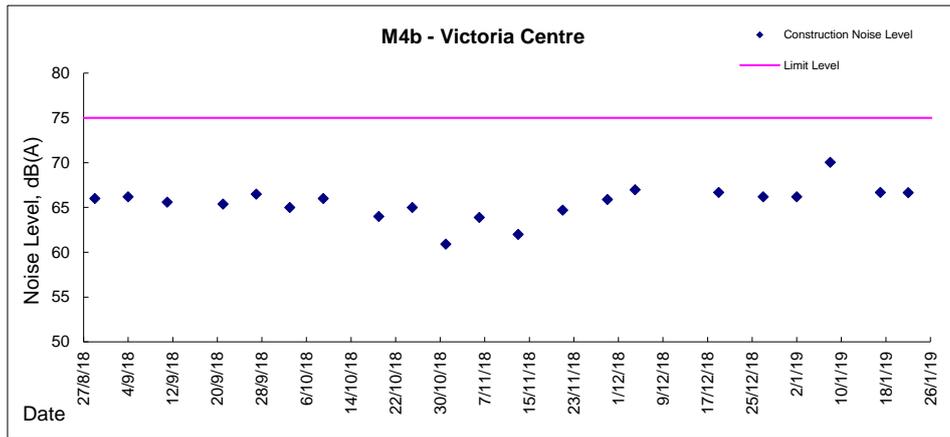
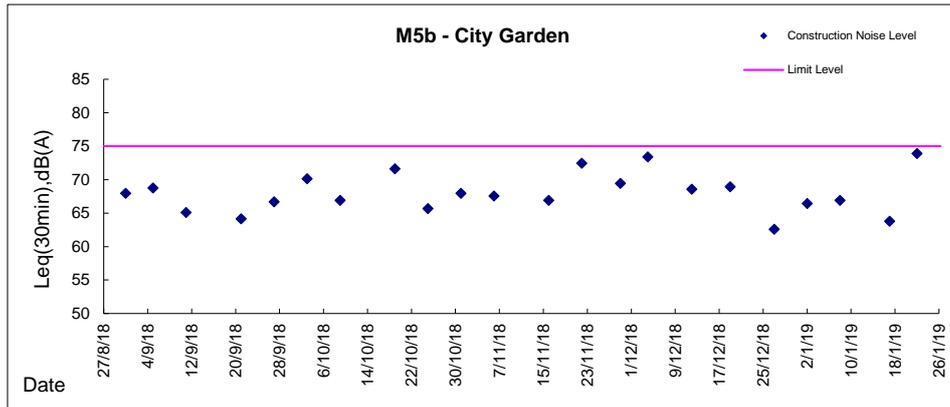
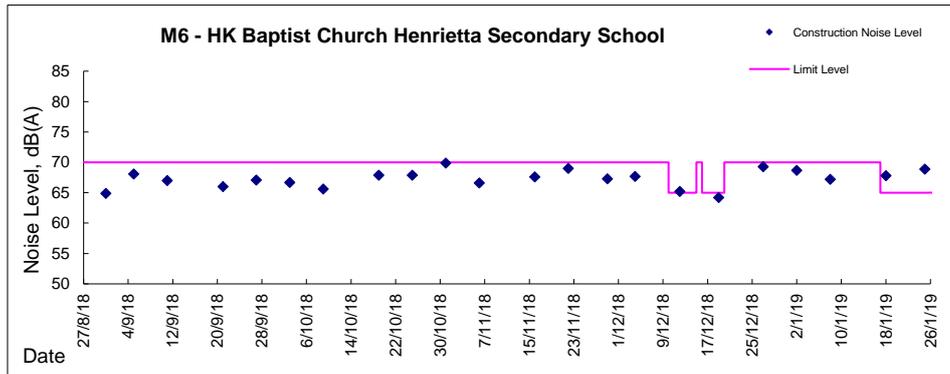
- 5.1.5. Two limit level exceedance was recorded at M6 – Hong Kong Baptist Church Henrietta Secondary School on 18 and 25 January 2019 in the reporting period.
- 5.1.6. No construction works was conducted on 18 January 2019 under HY/2009/19 around the monitoring location and nearby traffic noise was observed as major noise source during monitoring. As such, the exceedance was considered as non-Project related.
- 5.1.7. No construction works was conducted on 25 January 2019 under HY/2009/19 around the monitoring location and nearby traffic noise was observed as major noise source during monitoring. As such, the exceedance was considered as non-Project related.
- 5.1.8. Noise monitoring results measured in this reporting period are reviewed and summarized. Details of noise monitoring results and graphical presentation can be referred in **Appendix 5.2.**

Graphic Presentation of Noise Monitoring Result
Day Time (0700 - 1900hrs on normal weekdays)

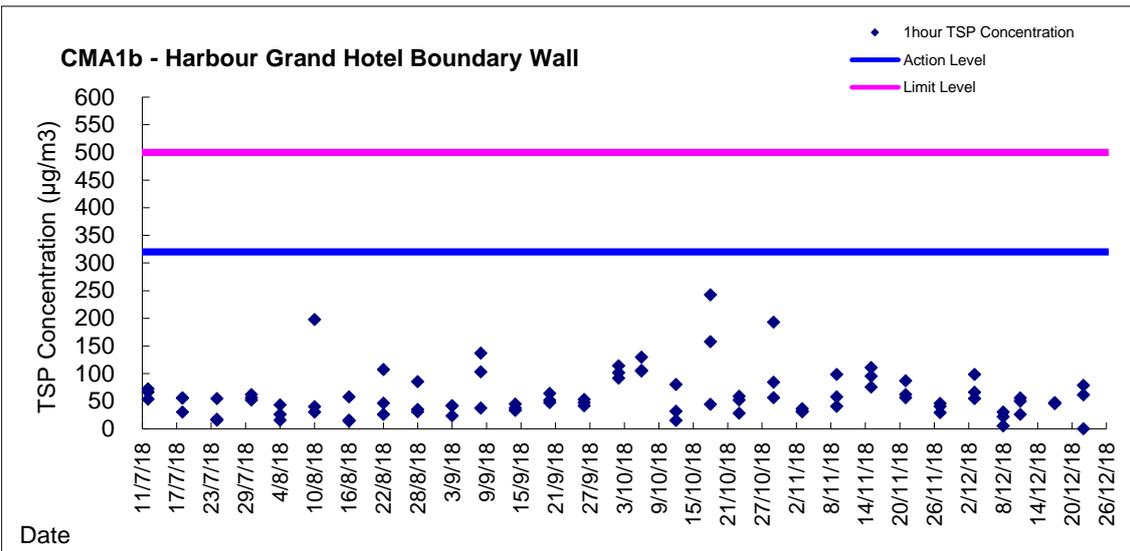
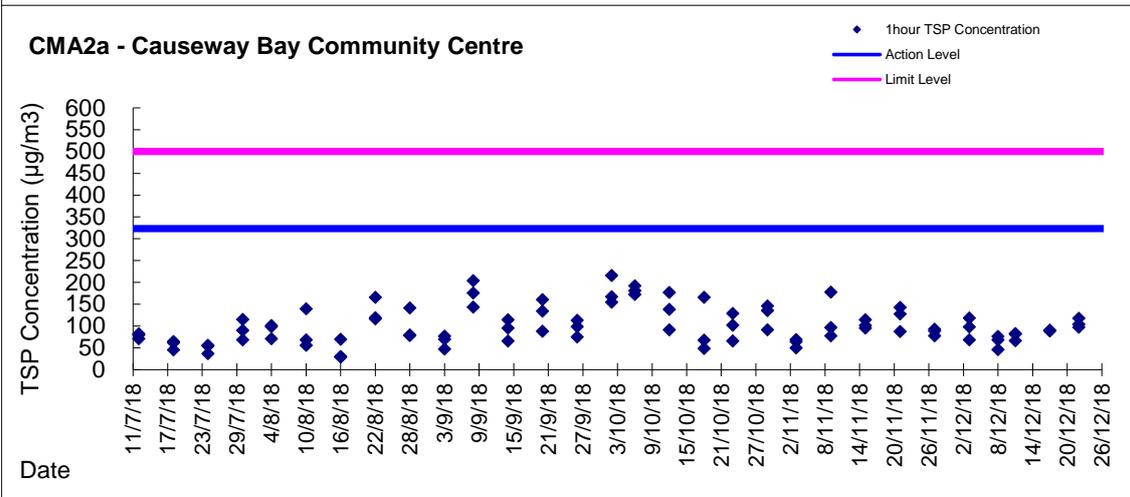
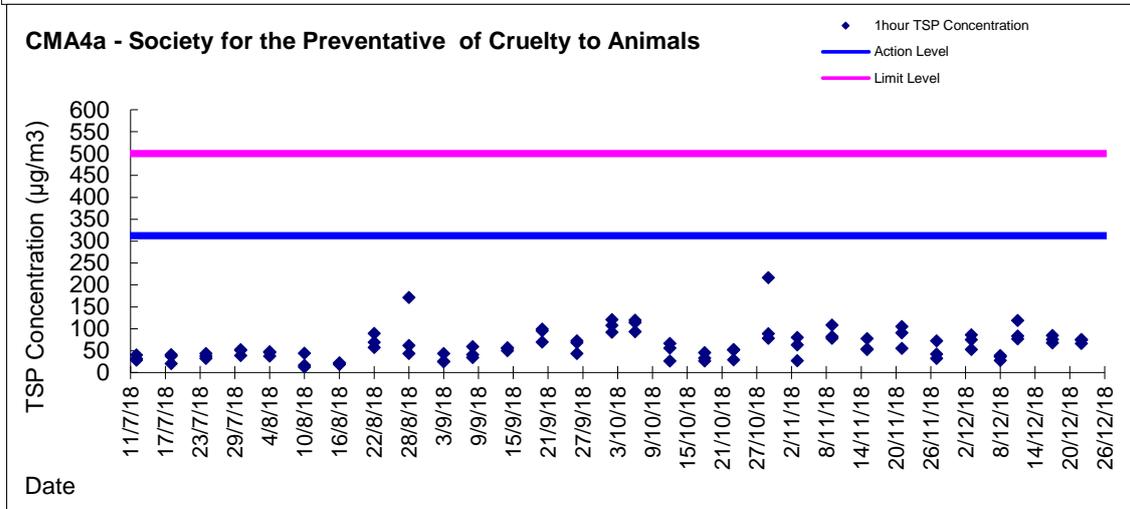
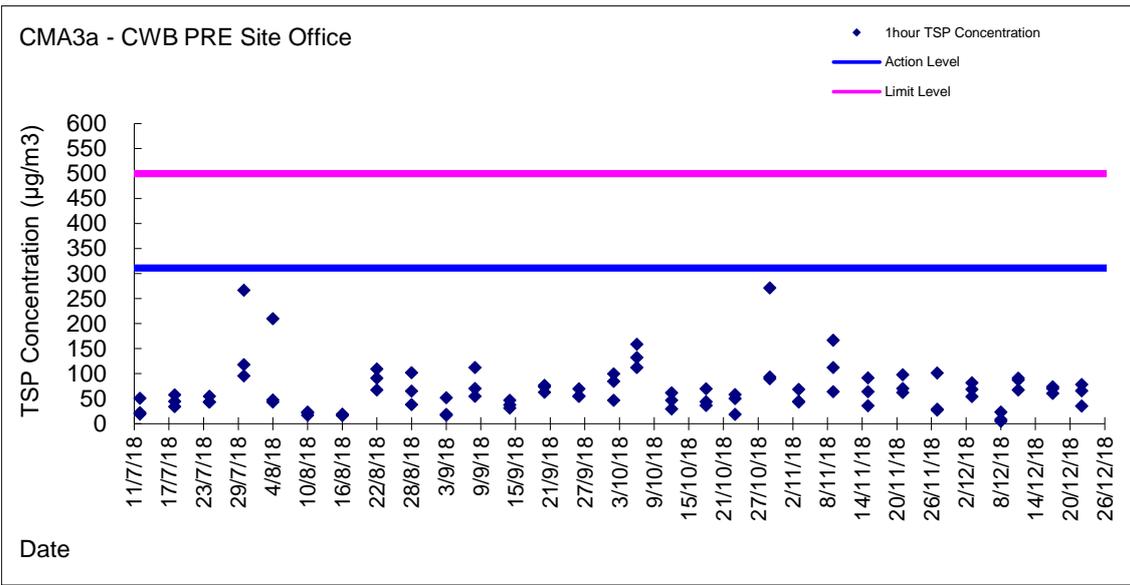
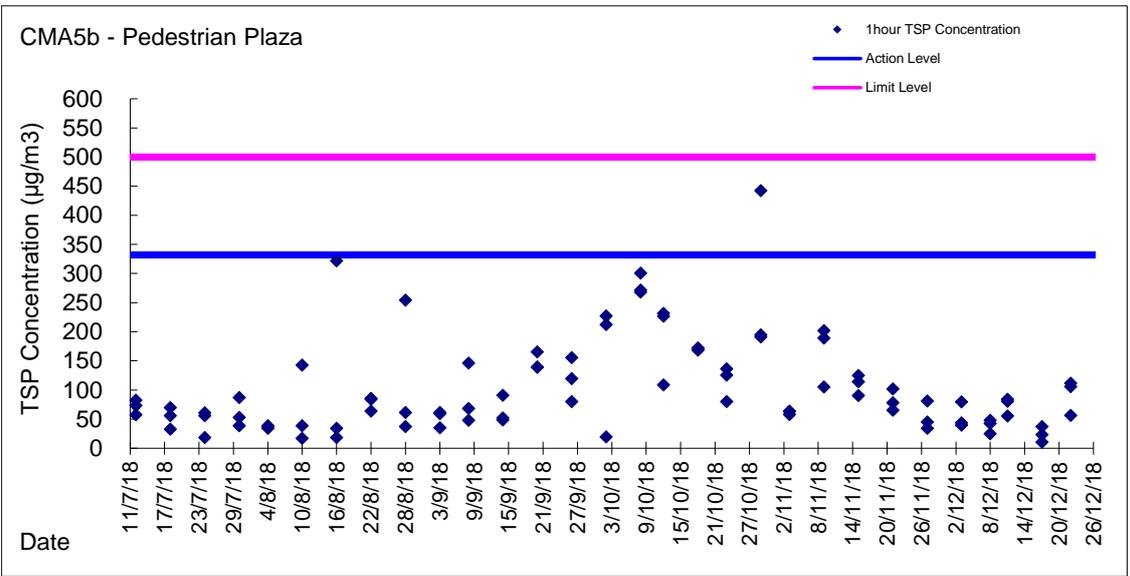
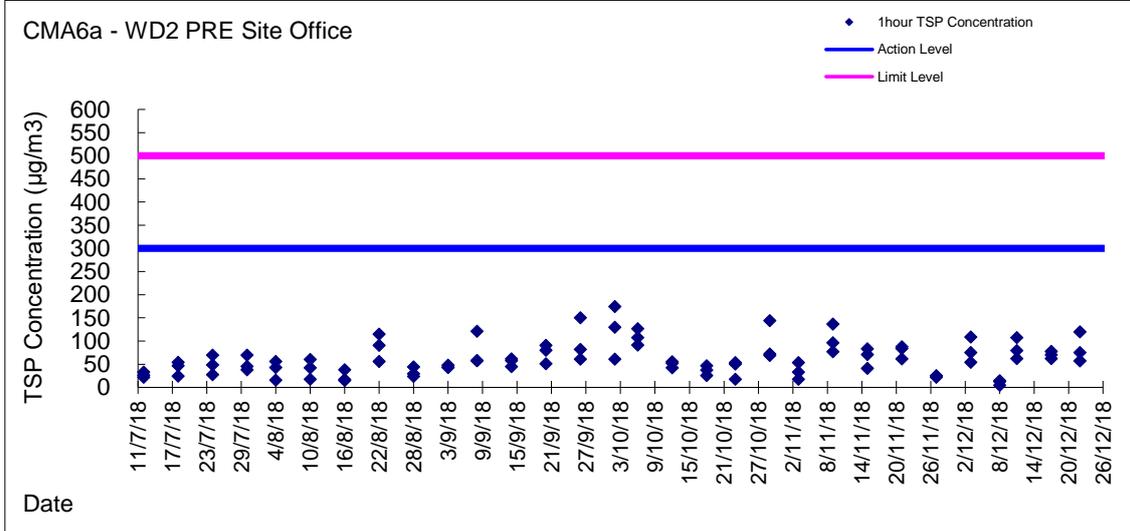
Graphic Presentation of 1 hour TSP Result

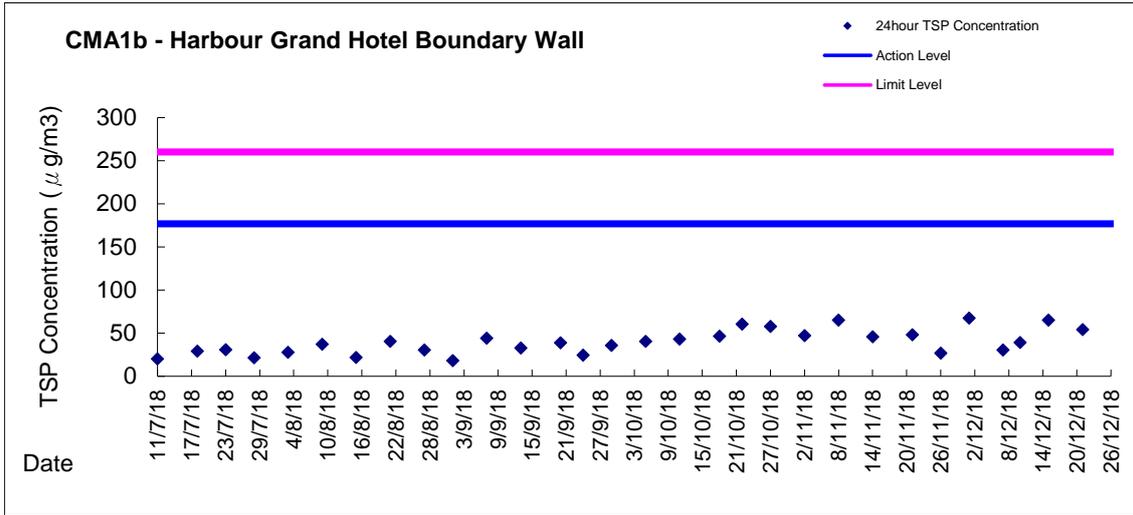
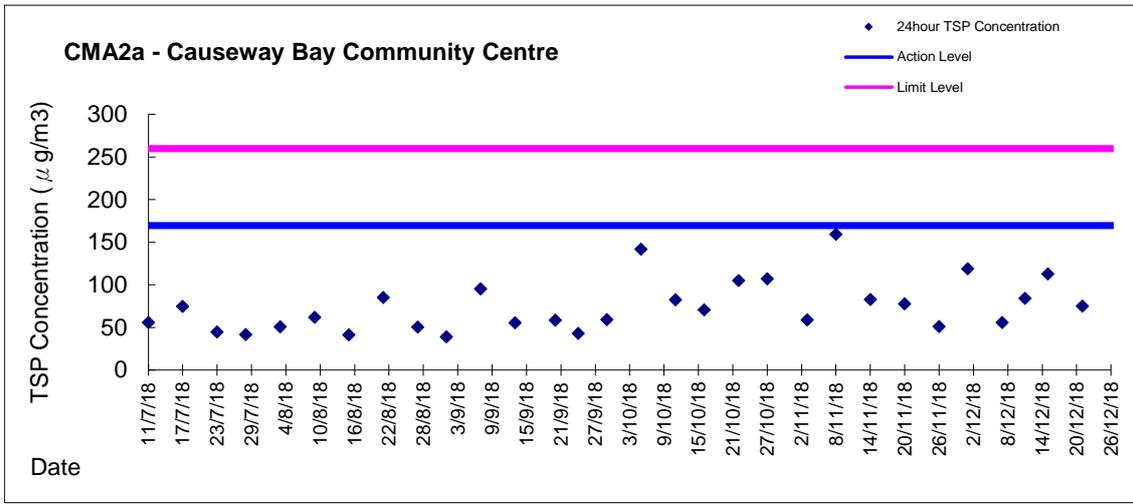
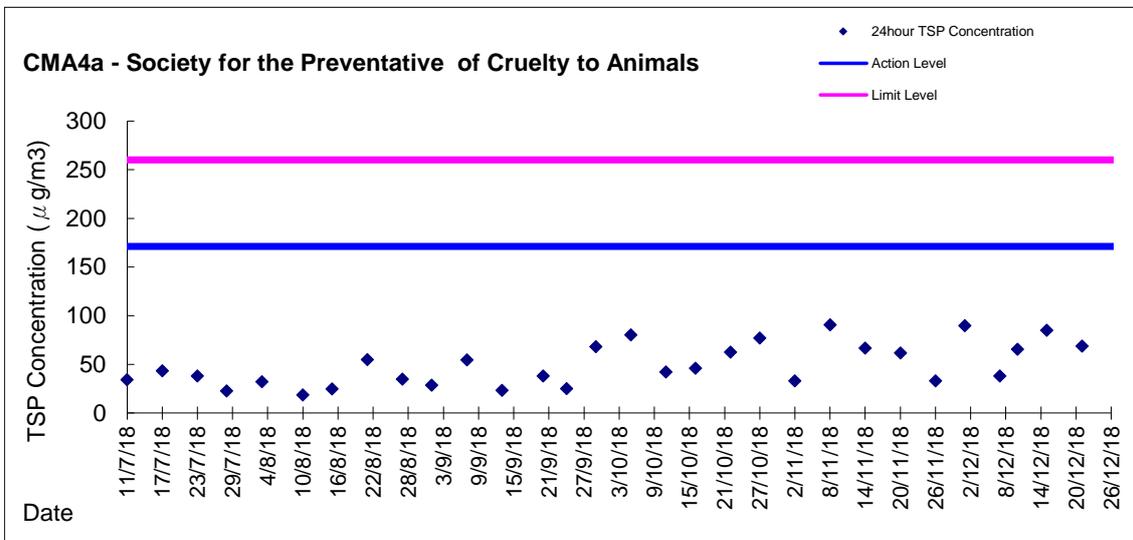
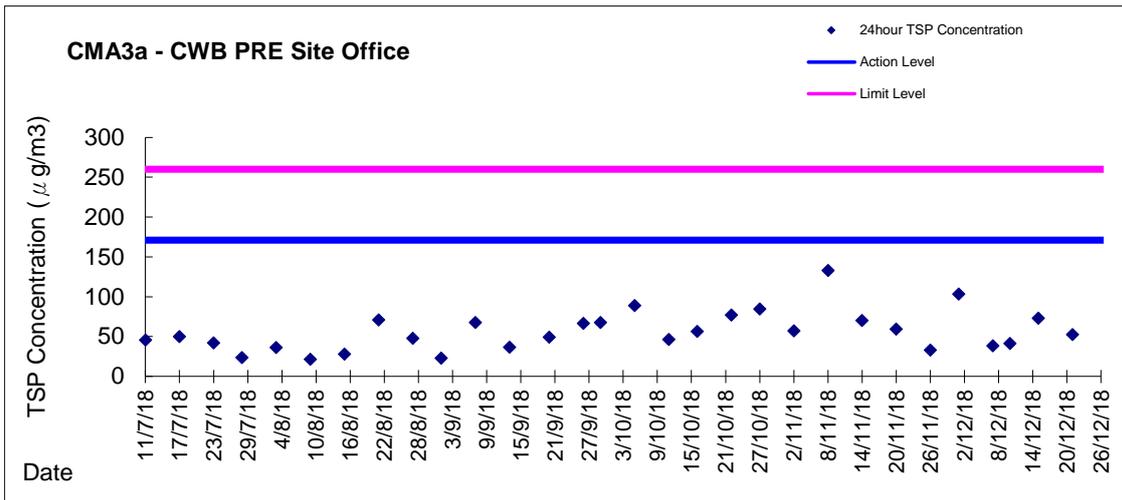
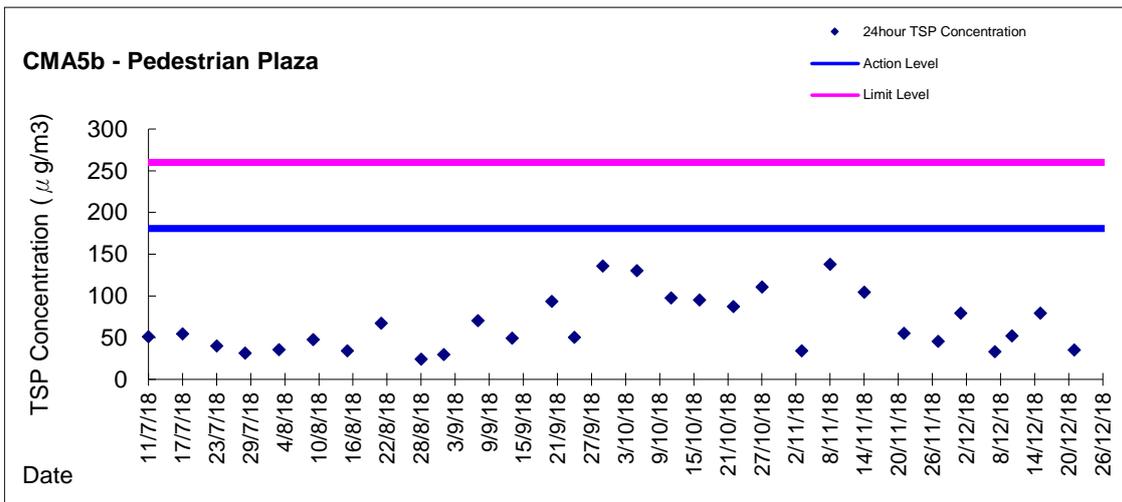
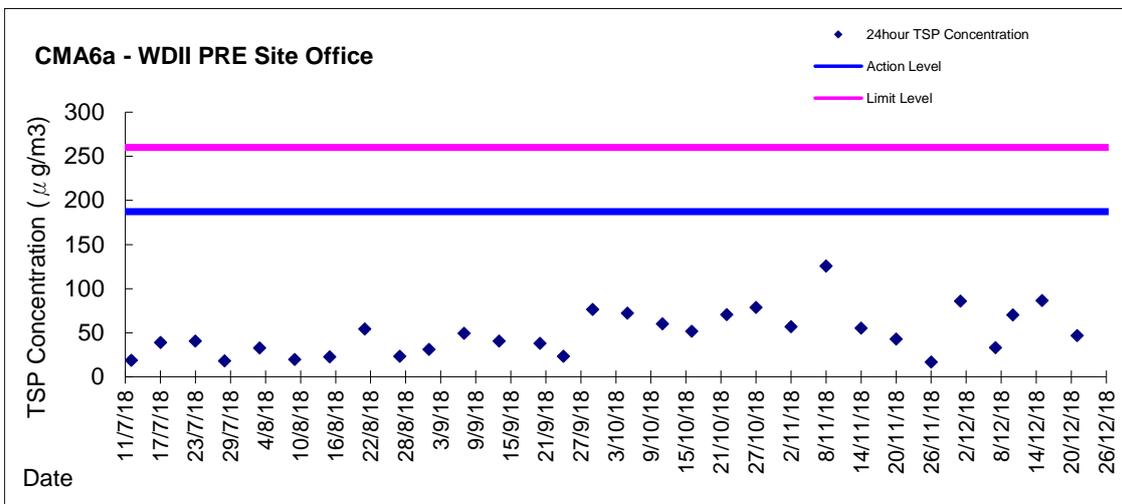
Graphic Presentation of 24 hour TSP Result
