CONTRACT NO: HK/2015/01

**WANCHAI DEVELOPMENT PHASE II AND CENTRAL
WANCHAI BYPASS
SAMPLING, FIELD MEASUREMENT AND TESTING WORKS
(STAGE 3)**

MONTHLY ENVIRONMENTAL MONITORING & AUDIT REPORT

- MARCH 2019 -

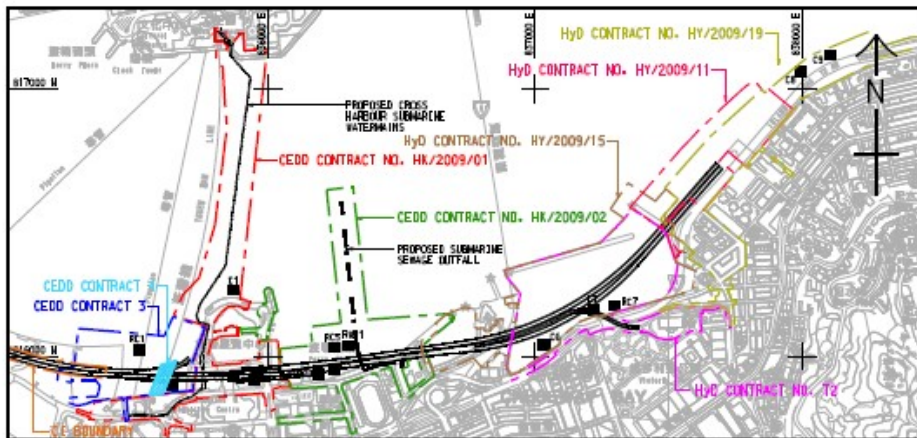
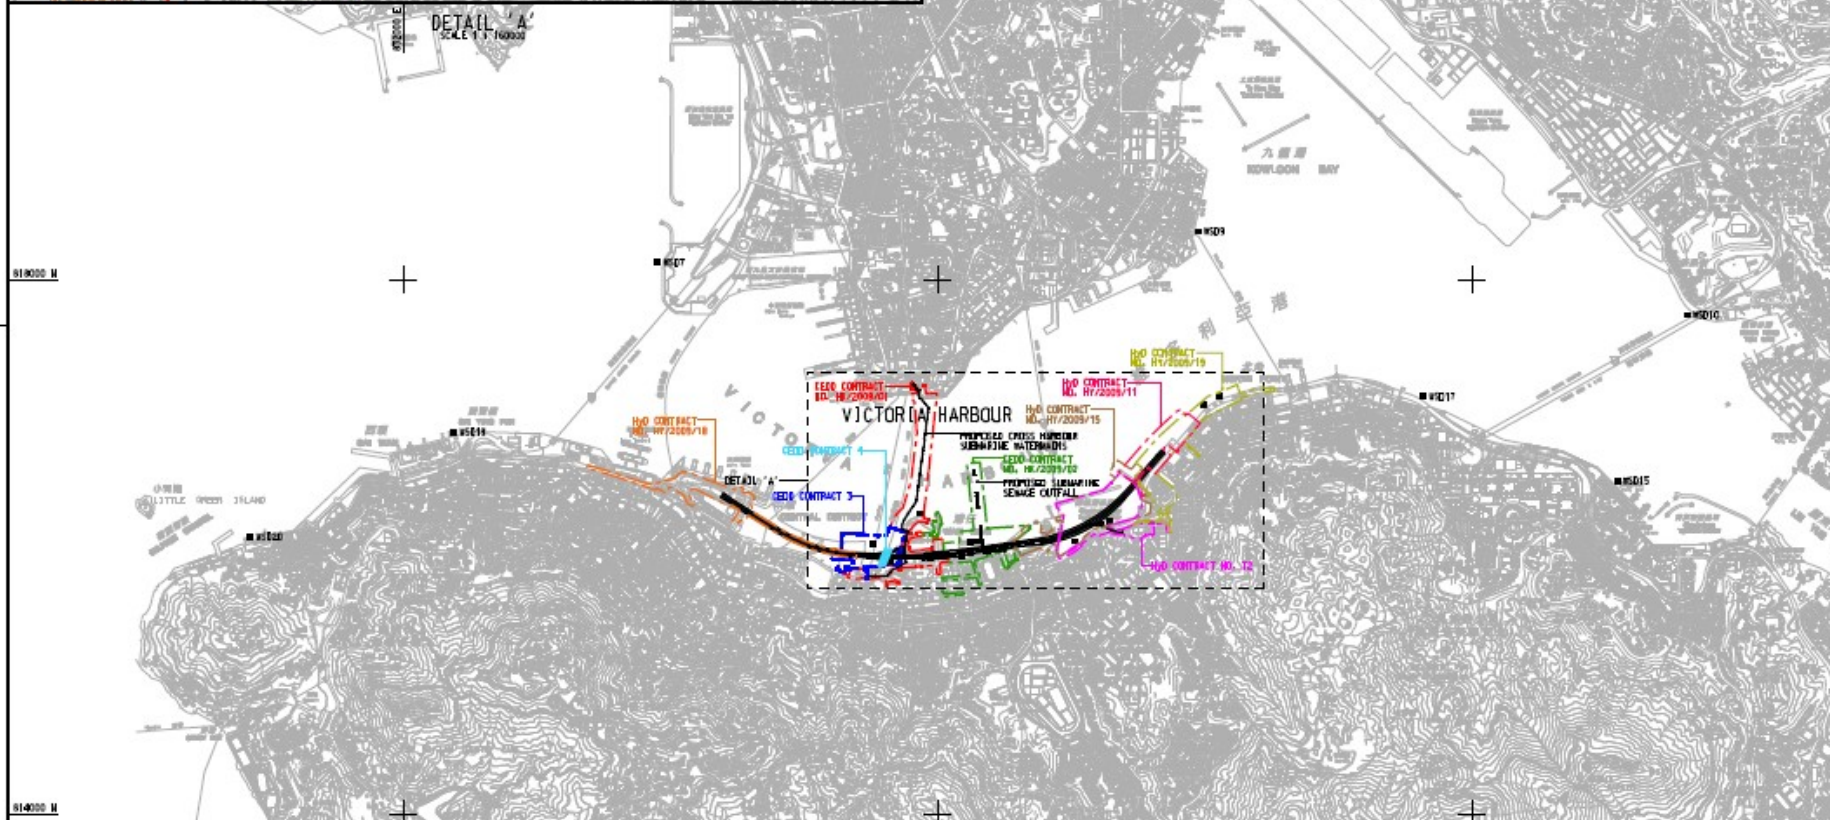
Figure 2.1

- 2.2.1. The Project is located mainly in Wan Chai North, Causeway Bay and North Point, and is demarcated by Gloucester Road and Victoria Park Road to the south, Fenwick Pier Street to the west and Tong Shui Road Interchange to the east, as shown in ***Figure 2.1***.

Project Layout

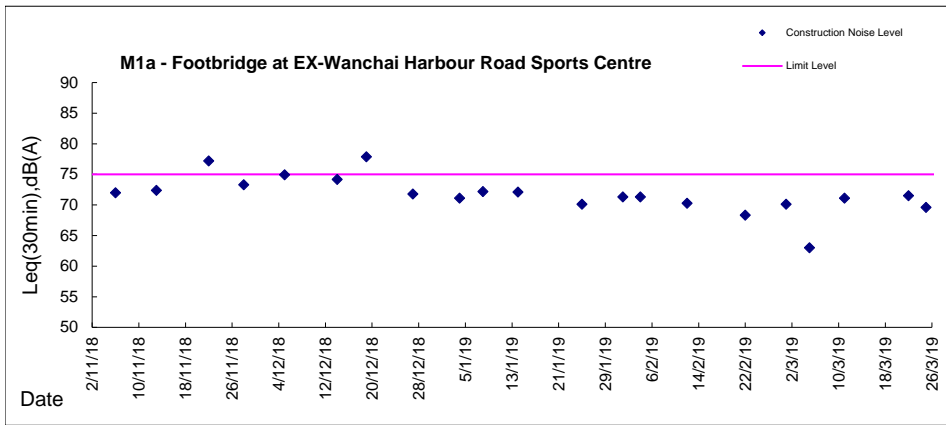
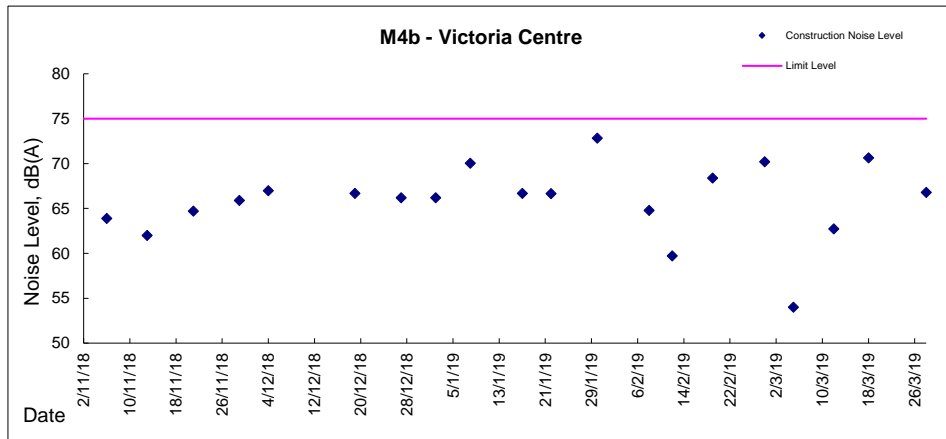
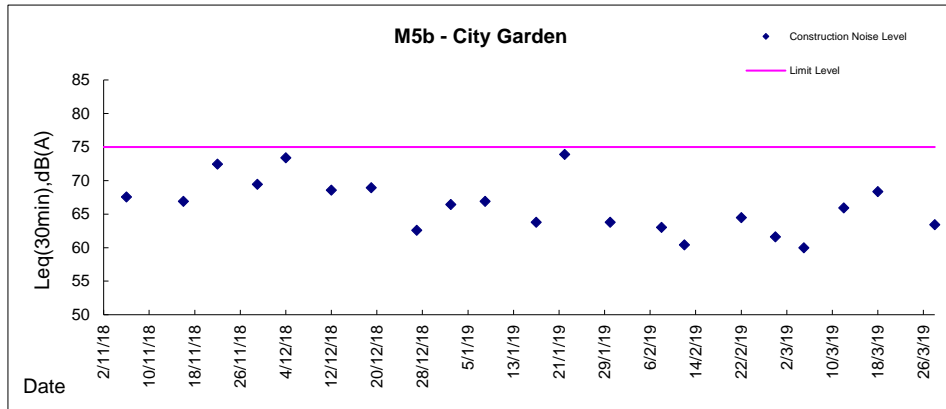
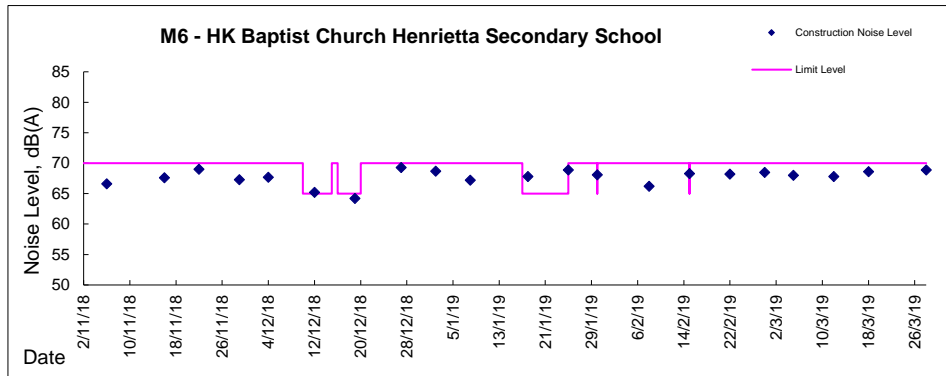
Graphic Presentation of Noise Monitoring Result
Day Time (0700 - 1900hrs on normal weekdays)

Date	Time	Weather	Measurement Noise Level			Baseline Level	Construction Noise Level	Limit Level
			Leq	L10	L90	Leq	Leq	Leq
Unit: dB(A), (30-min)								
5/3/19	15:05	Fine	67.8	69.0	65.5	71	68	70
12/3/19	11:10	Fine	67.8	68.5	65.7	71	68	70
18/3/19	11:28	Fine	68.6	69.5	67.0	71	69	70
28/3/19	10:25	Fine	68.9	70.0	67.5	71	69	70

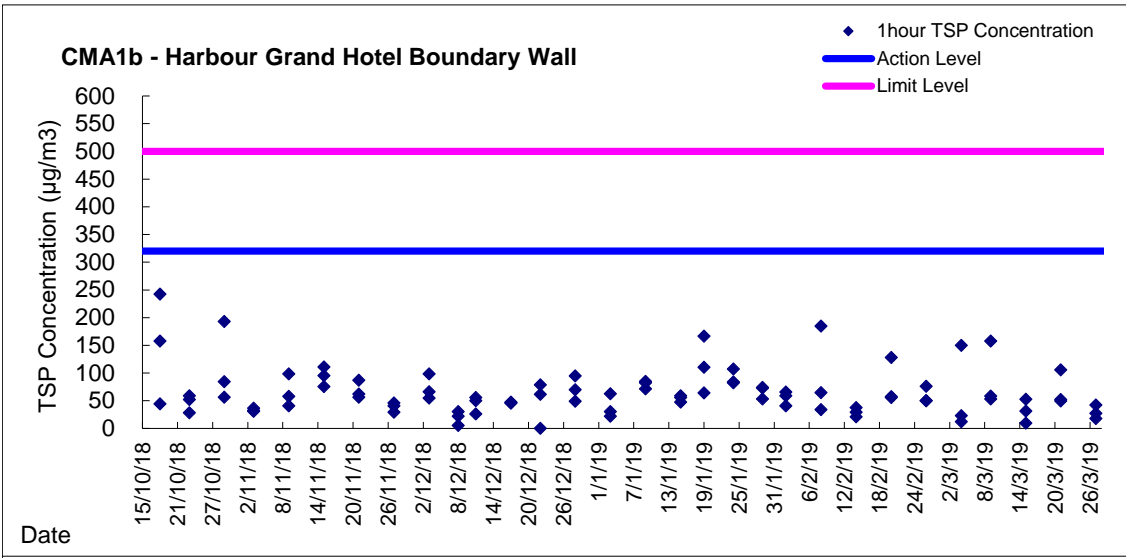
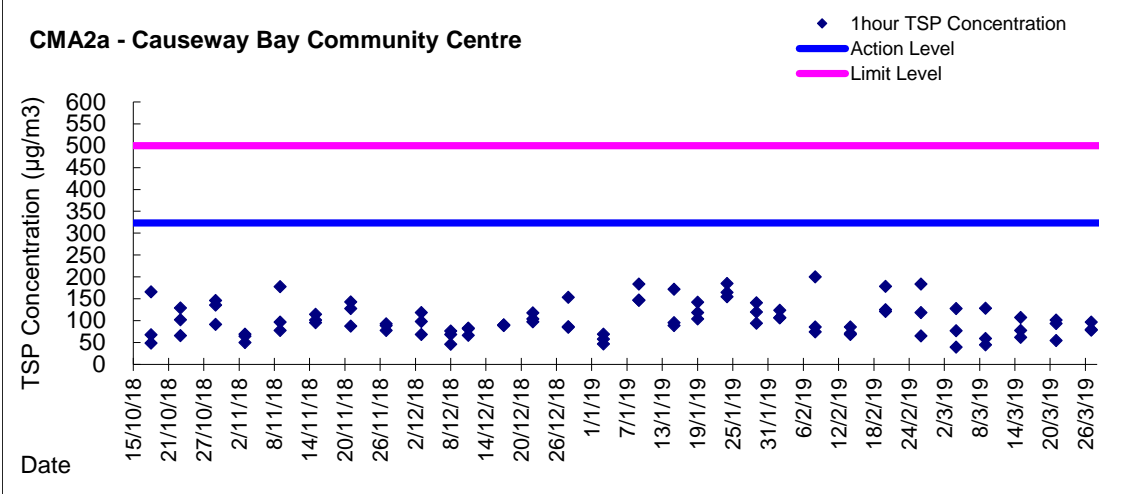
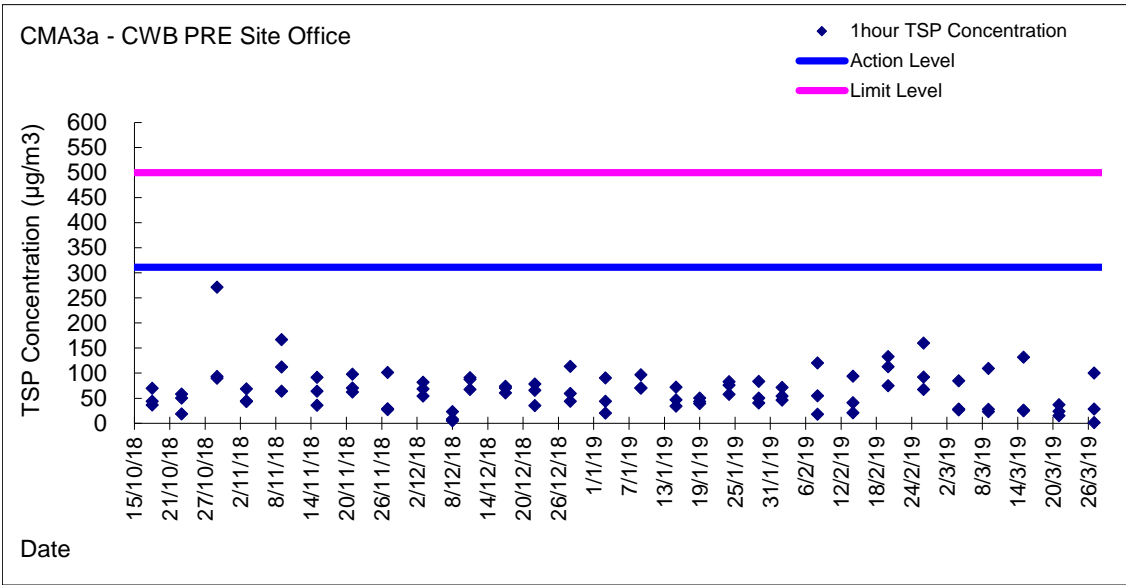
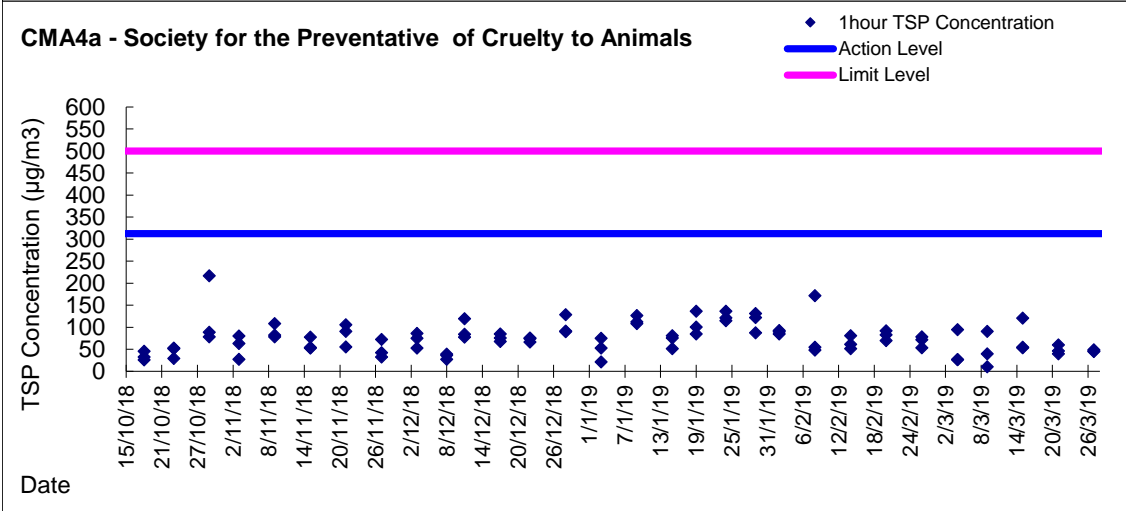
Graphic Presentation of 1 hour TSP Result

15-Mar-19	13:00	Cloudy	CMA4a_1hr_2_140725	2.6605	2.6647	27152.29	27153.29	1.00	1.27	1.27	1.27	76	55.0
15-Mar-19	14:15	Cloudy	CMA4a_1hr_3_140805	2.6593	2.6685	27153.29	27154.29	1.00	1.27	1.27	1.27	76	120.4
21-Mar-19	8:03	Cloudy	CMA4a_1hr_1_140852	2.6442	2.6472	27178.29	27179.29	1.00	1.26	1.26	1.26	75	39.8
21-Mar-19	9:40	Cloudy	CMA4a_1hr_2_140856	2.6455	2.6490	27179.29	27180.29	1.00	1.26	1.26	1.26	75	46.4
21-Mar-19	11:00	Cloudy	CMA4a_1hr_3_140864	2.6507	2.6552	27180.29	27181.29	1.00	1.26	1.26	1.26	75	59.6
27-Mar-19	8:26	Cloudy	CMA4a_1hr_1_140874	2.6489	2.6523	27205.29	27206.29	1.00	1.26	1.26	1.26	76	44.9
27-Mar-19	9:50	Cloudy	CMA4a_1hr_2_140887	2.6271	2.6306	27206.29	27207.29	1.00	1.26	1.26	1.26	76	46.2
27-Mar-19	13:00	Cloudy	CMA4a_1hr_3_140831	2.6660	2.6697	27207.29	27208.29	1.00	1.26	1.26	1.26	76	48.8
