CONTRACT NO: HK/2011/07

WANCHAI DEVELOPMENT PHASE II AND CENTRAL
WANCHAI BYPASS
SAMPLING, FIELD MEASUREMENT AND TESTING WORK
(STAGE 2)

QUARTERLY ENVIRONMENTAL MONITORING
AND AUDIT REPORT

- DECEMBER 2012 TO FEBRUARY 2013 -

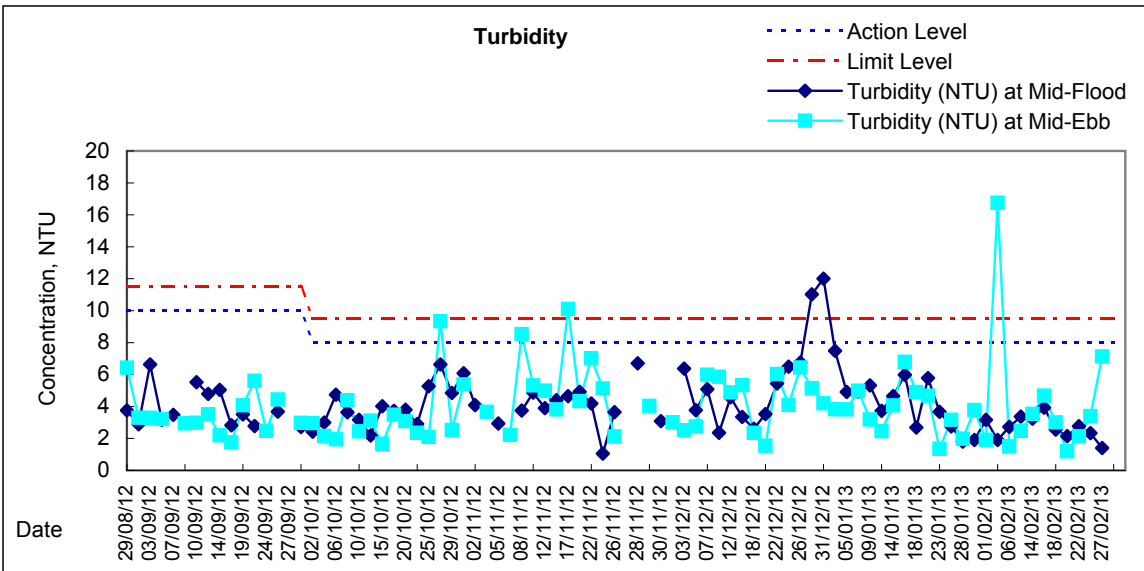
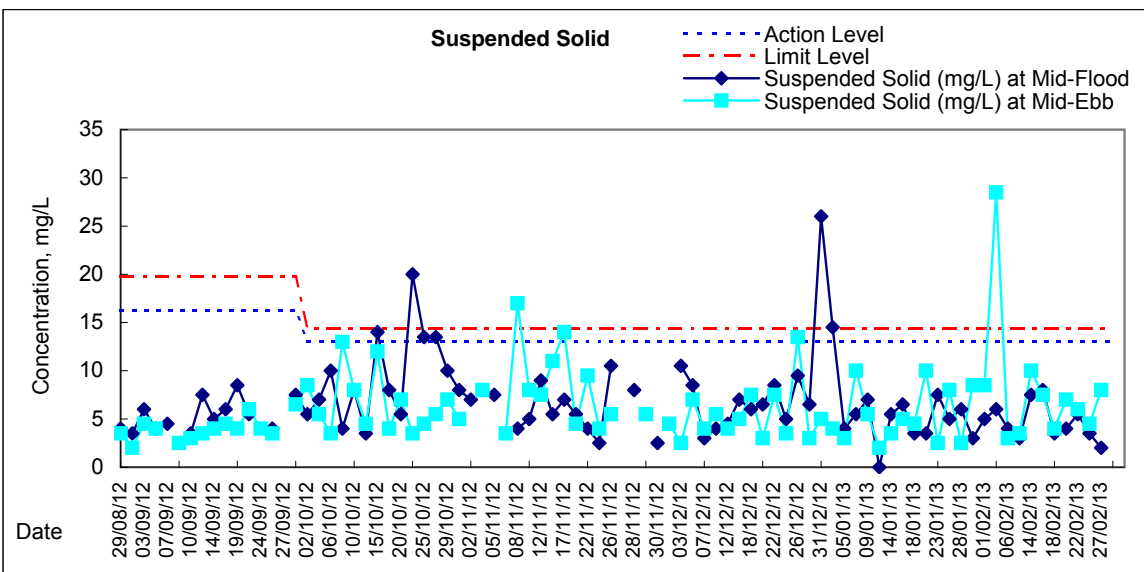
Graphic Presentation of Water Quality Result of WSD21 - Wan Chai

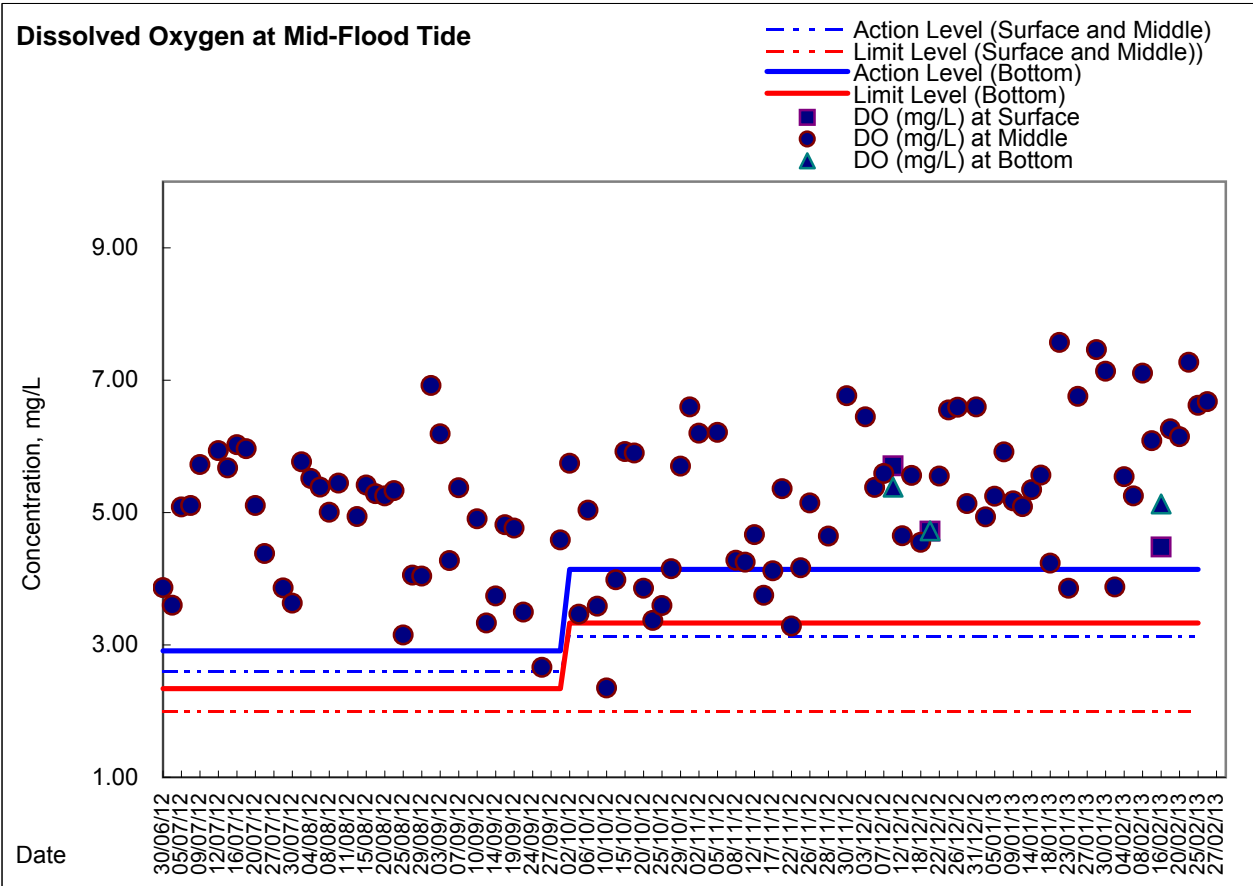
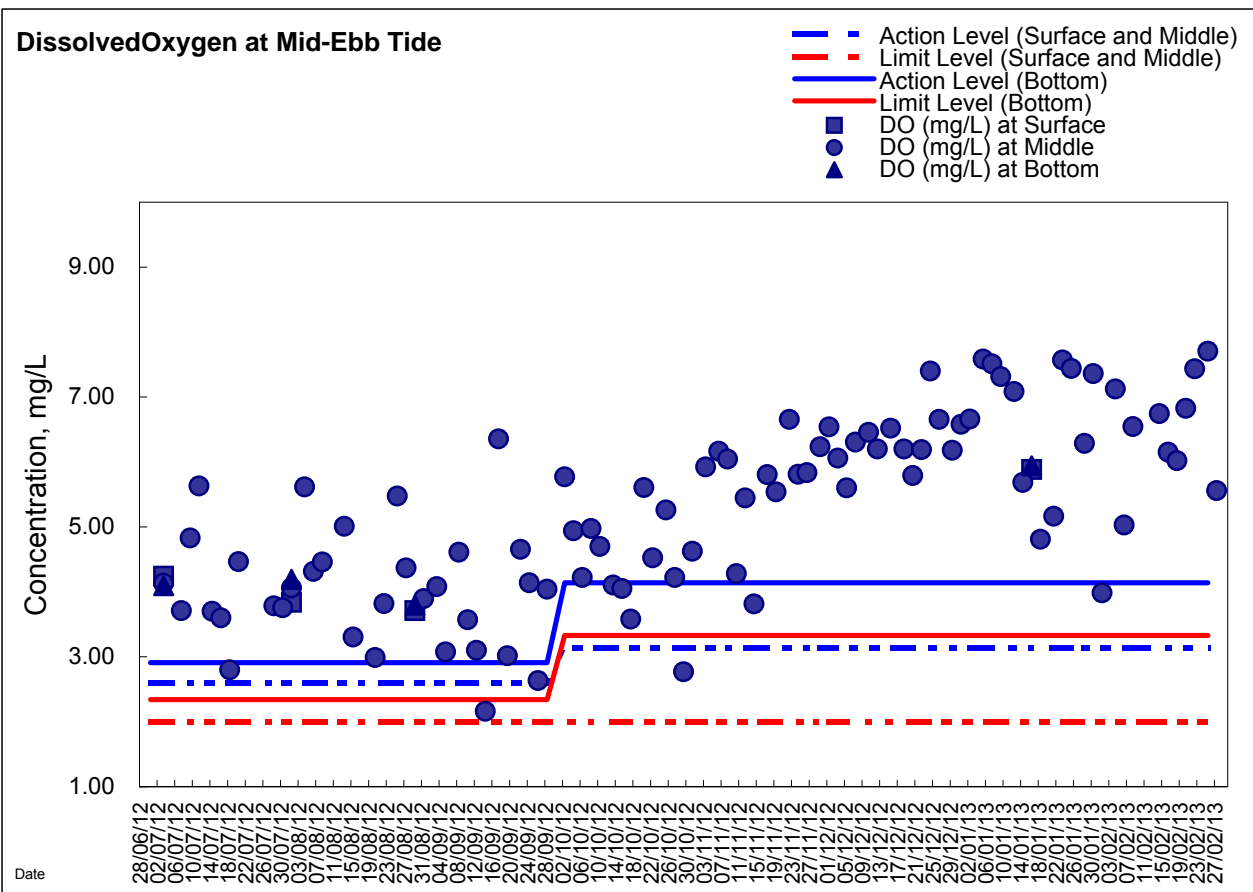
Graphic Presentation of Enhanced Water Monitoring Results (DO) at C6 - Excelsior Hotel

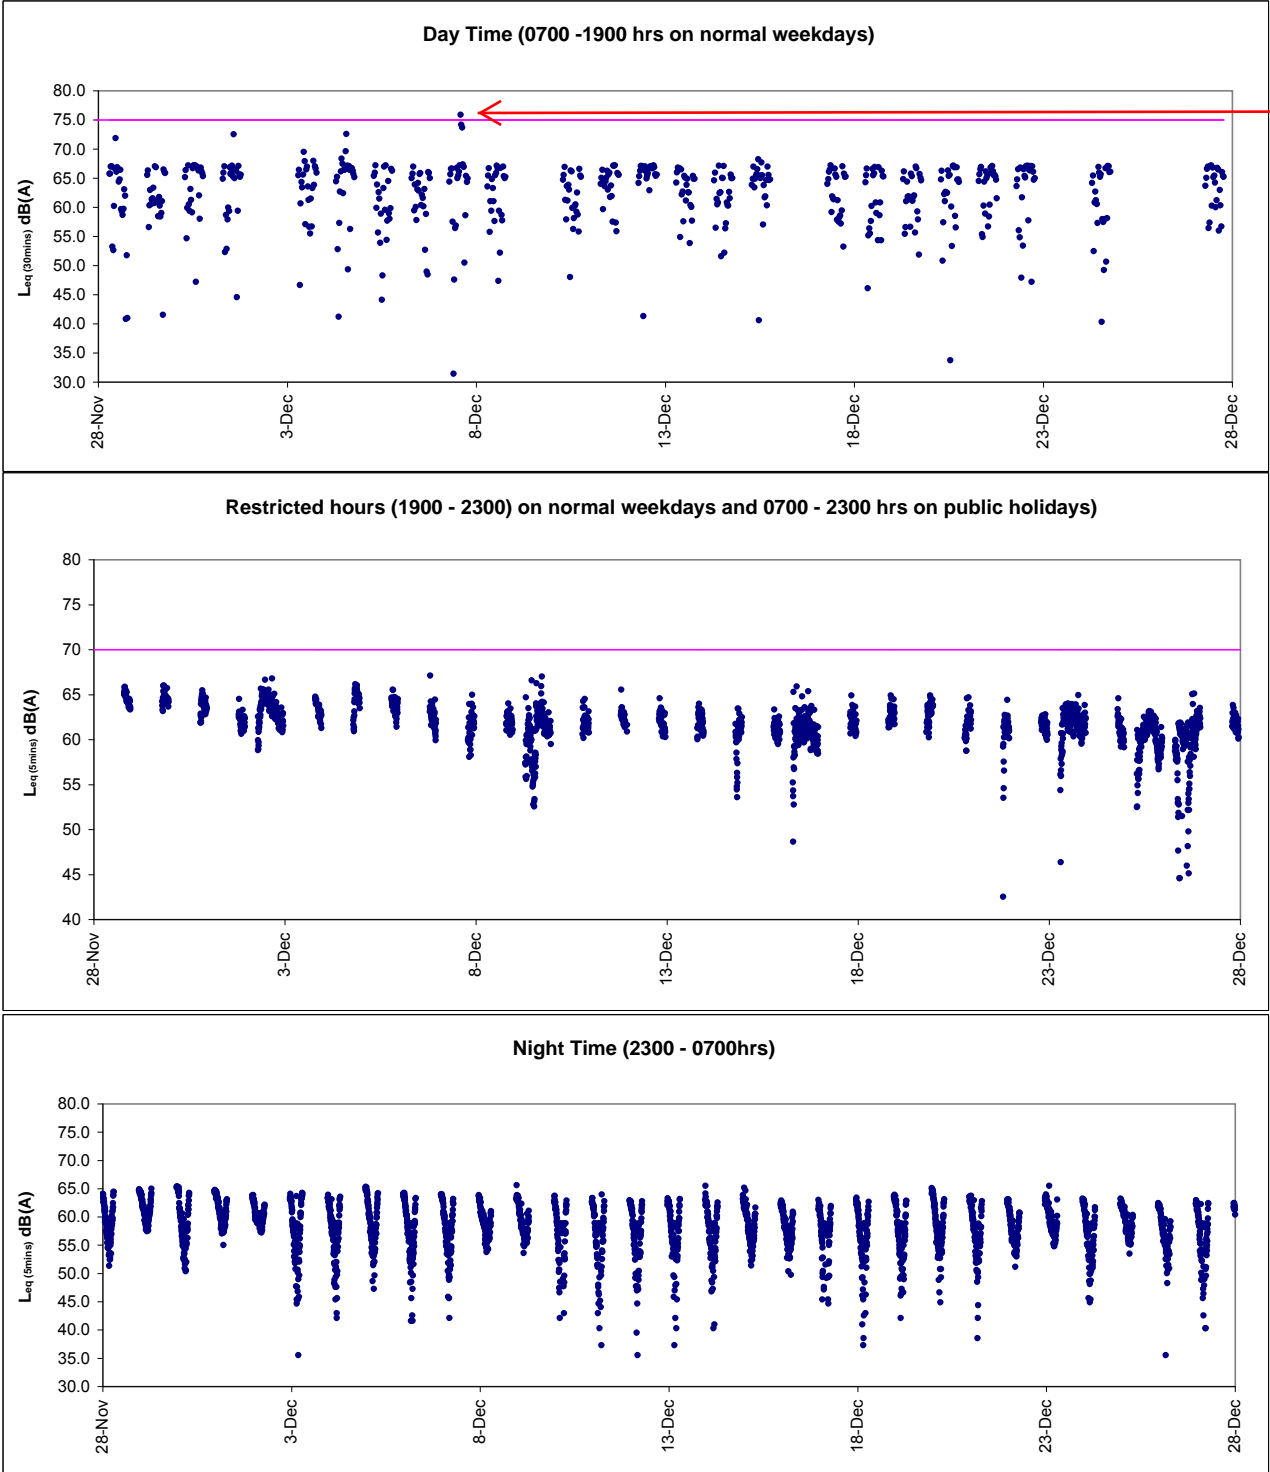
Graphic Presentation of Real Time Noise Monitoring Result (RTN2a- Hong Kong Electric Centre)

After checking with contractor HY/2009 19, no noisy construction activities were conducted during monitoring. Exceedance was considered to be contributed by the non CWB construction activities at the construction site next to Hong Kong Electric Centre

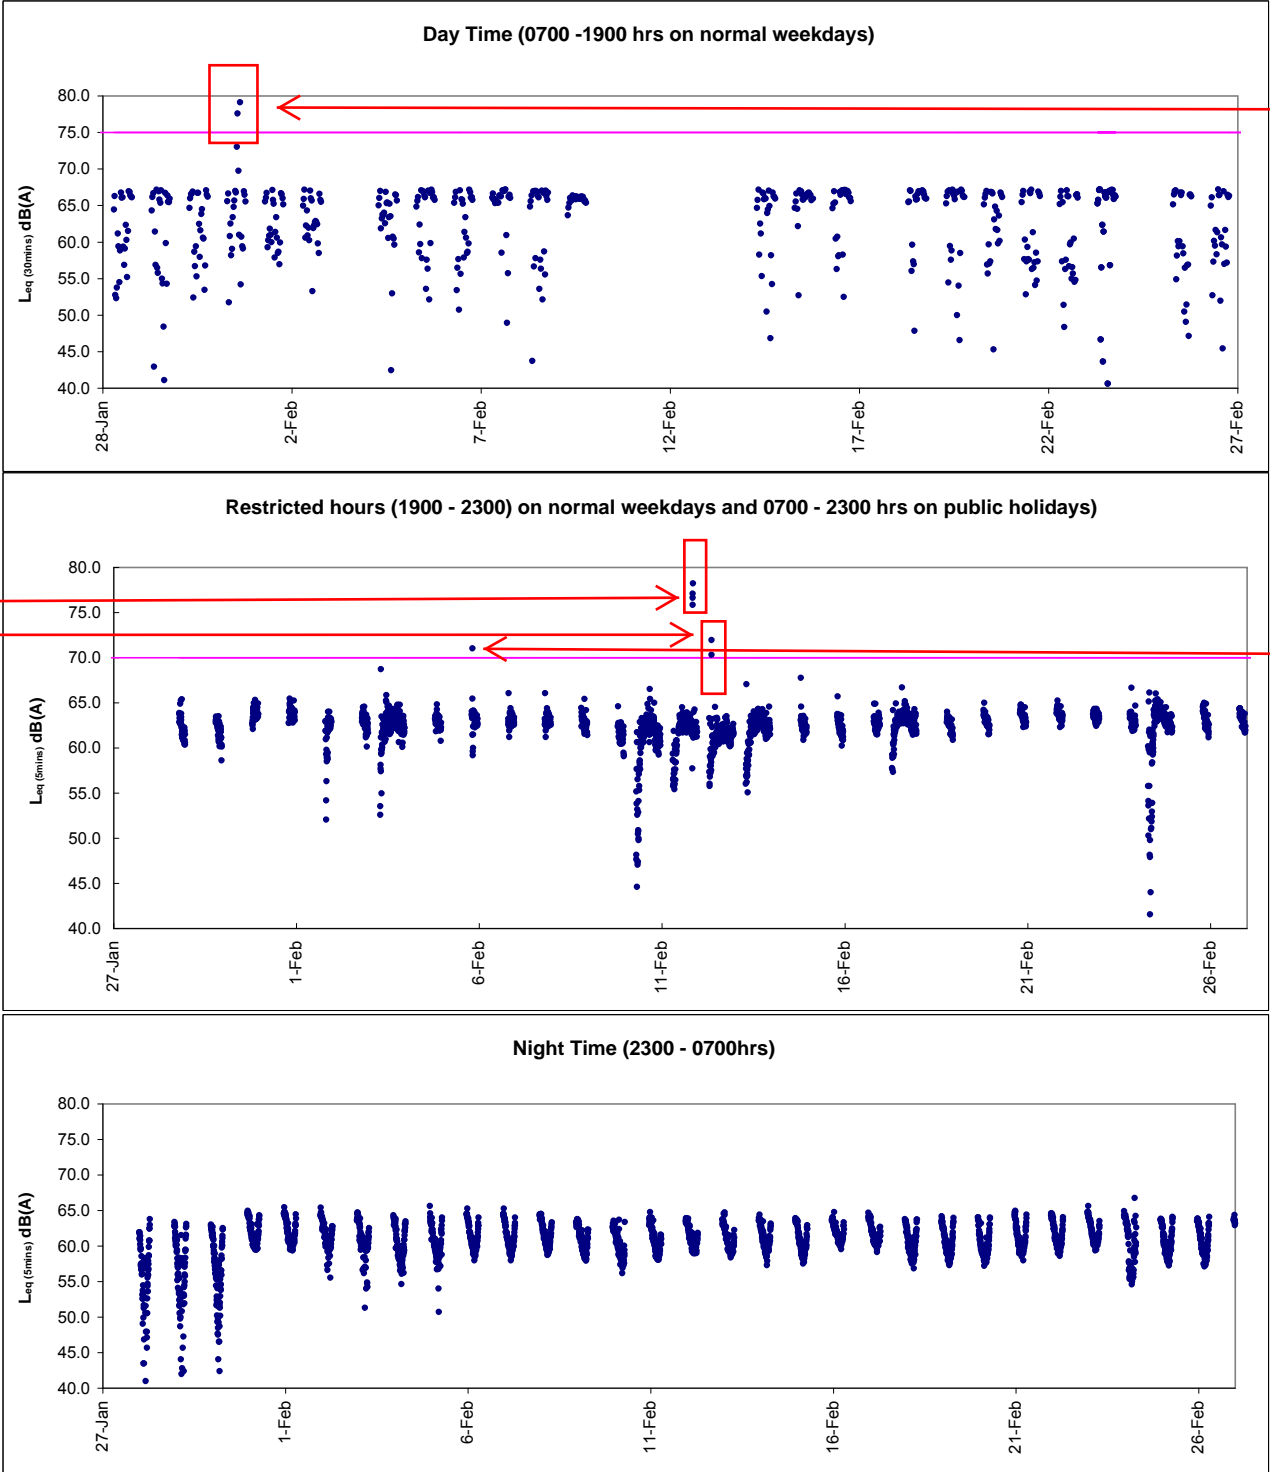
Graphic Presentation of Real Time Noise Monitoring Result (RTN2a- Hong Kong Electric Centre)

After checking with contractor HY/2009/19. No construction activities were conducted during the recorded period. Exceedances were contributed by Chinese New year pyrotechnic display.

After checking with contractor HY/2009/19, no noisy construction activities were conducted during the recorded period and the exceedance was non-continuous. Exceedances were considered to be contributed by nearby IEC traffic
