Contract No. HK/2011/07
Wanchai Development Phase II and Central Wanchai Bypass
Sampling, Field Measurement and testing Works (Stage 2)
Quarterly EM&A Report (Mar 2014-May 2014)

**WANCHAI DEVELOPMENT PHASE II AND CENTRAL
WANCHAI BYPASS
SAMPLING, FIELD MEASUREMENT AND TESTING WORK
(STAGE 2)**

**QUARTERLY ENVIRONMENTAL MONITORING
AND AUDIT REPORT**

- MARCH 2014 TO MAY 2014 -

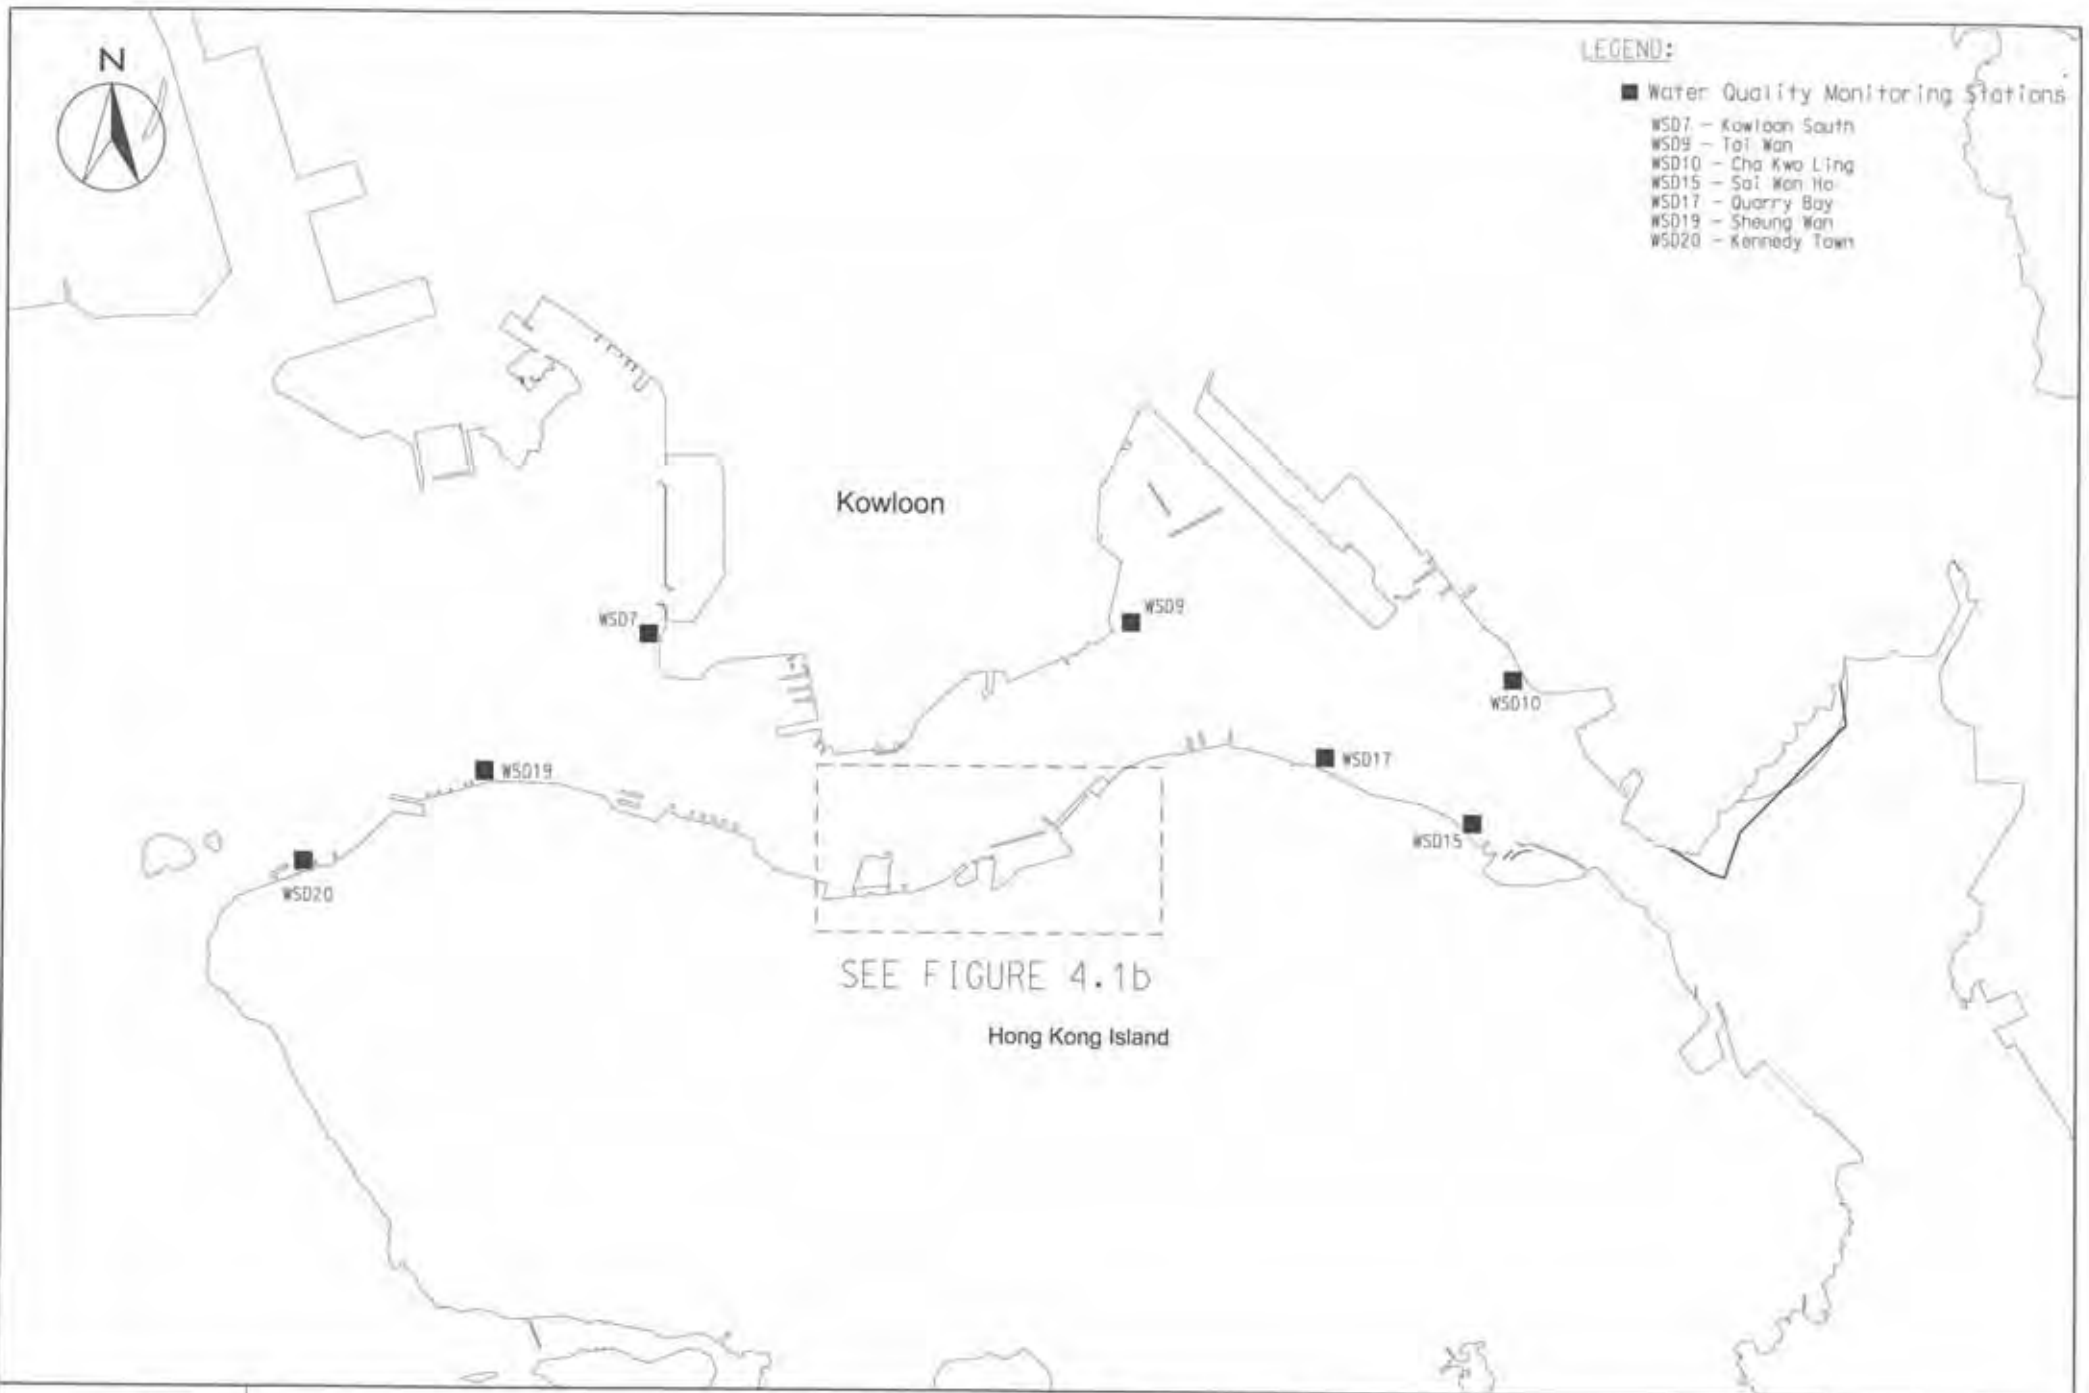
Figure 3.1

Locations of Monitoring Stations

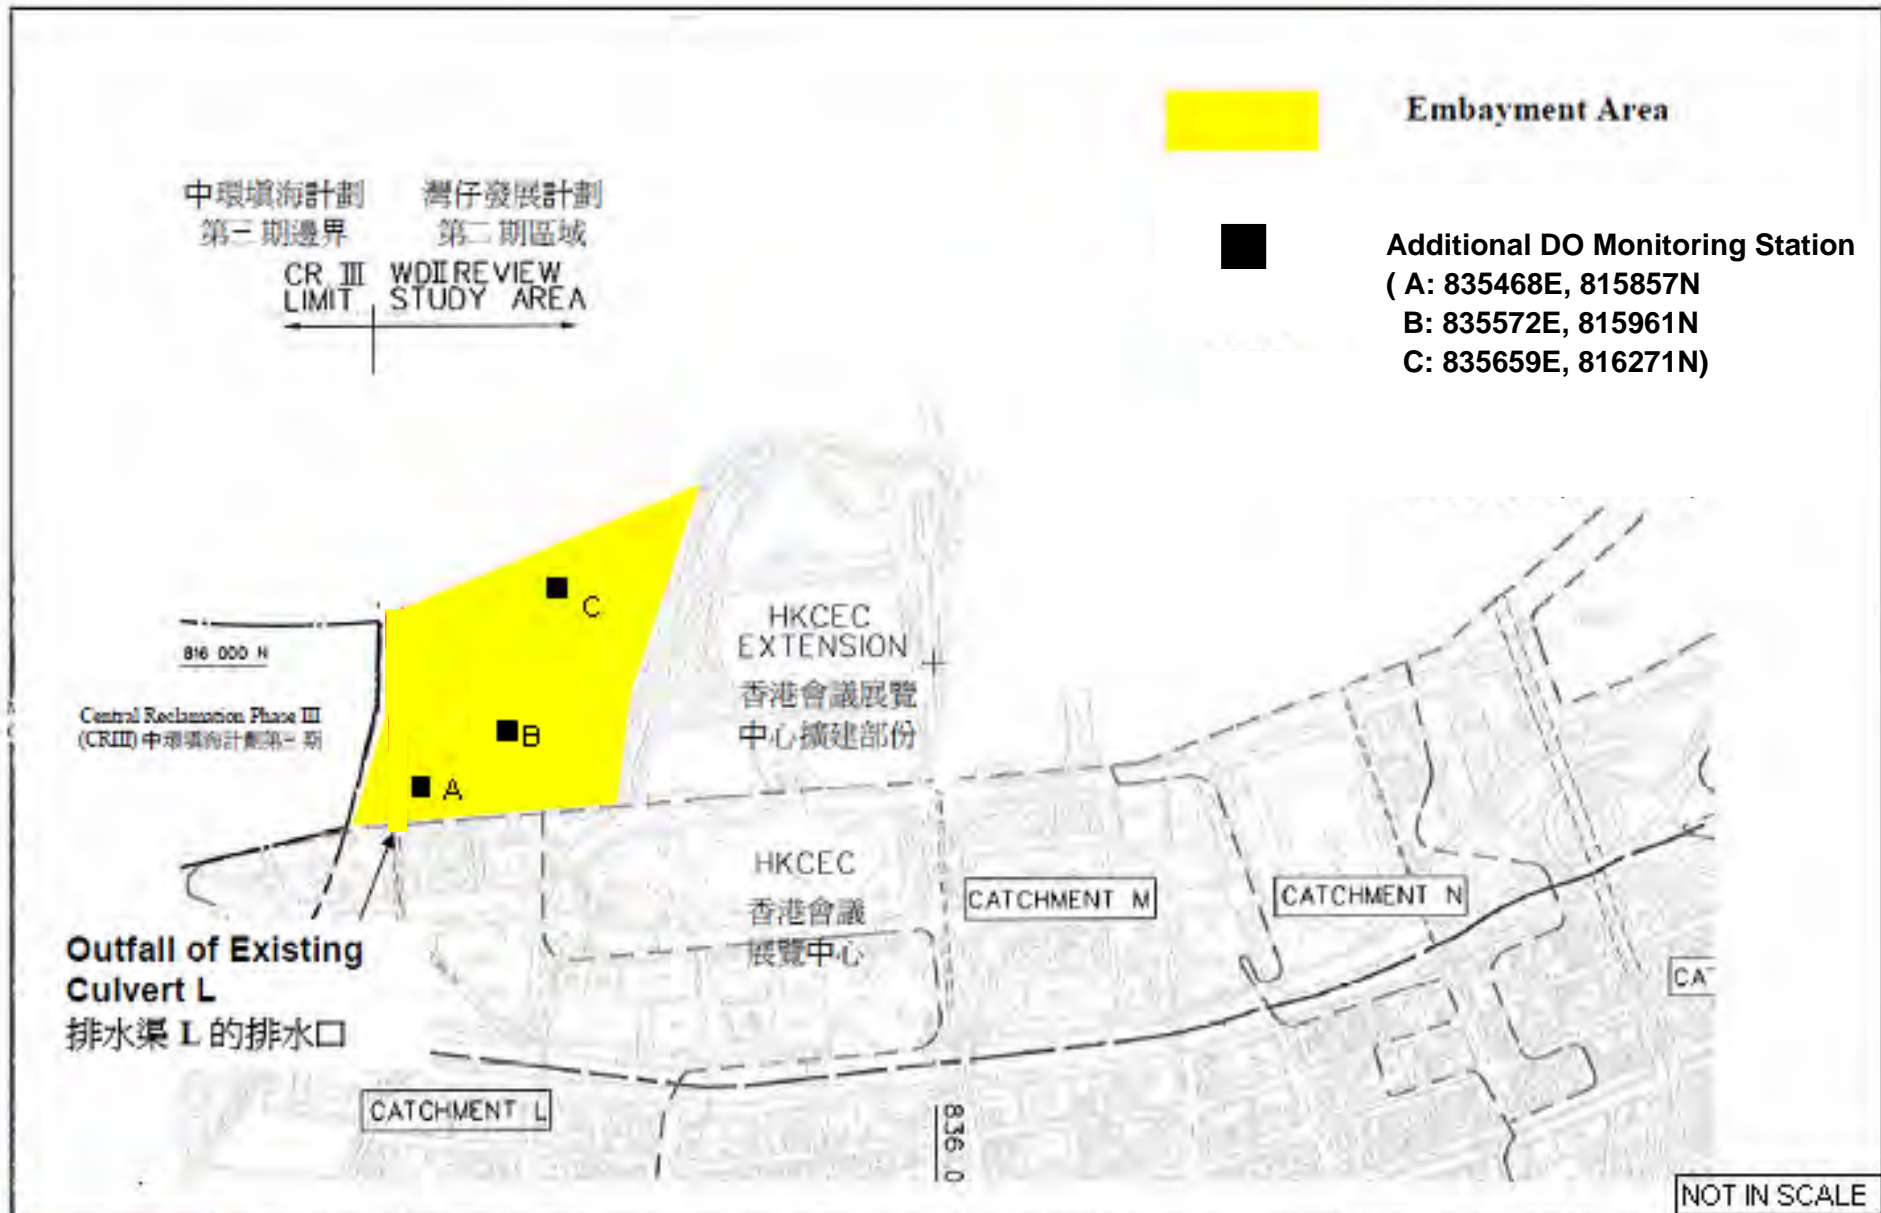
Location Plan of Additional Dissolved Oxygen Monitoring Stations for Culvert L Water Discharge Flow

- xxxiii. In response to the Condition 2.18 of the Environmental Permit no. EP-356/2009 requiring that a silt curtain / impermeable barrier system be installed to channel water discharge flow from Culvert L to locations outside the embayment area, a proposed replacement of the requirement with additional dissolved oxygen monitoring has been conducted at three monitoring stations, namely A, B and C between the eastern seawall of Central Reclamation Phase III and the HKCEC Extension since November 2011 under EP-356/2009 so that DO level between the eastern seawall of Central Reclamation Phase II and the HKCEC extension could be continuously monitored.

- 3.3.25 In response to the Condition 2.18 of the Environmental Permit no. EP-356/2009 requiring that a silt curtain / impermeable barrier system be installed to channel water discharge flow from Culvert L to locations outside the embayment area, a proposed replacement of the requirement with additional dissolved oxygen monitoring has been conducted at three monitoring stations, namely A, B and C between the eastern seawall of Central Reclamation Phase III and the HKCEC Extension since November 2011 under EP-356/2009 so that DO level between the eastern seawall of Central Reclamation Phase II and the HKCEC extension could be continuously monitored.

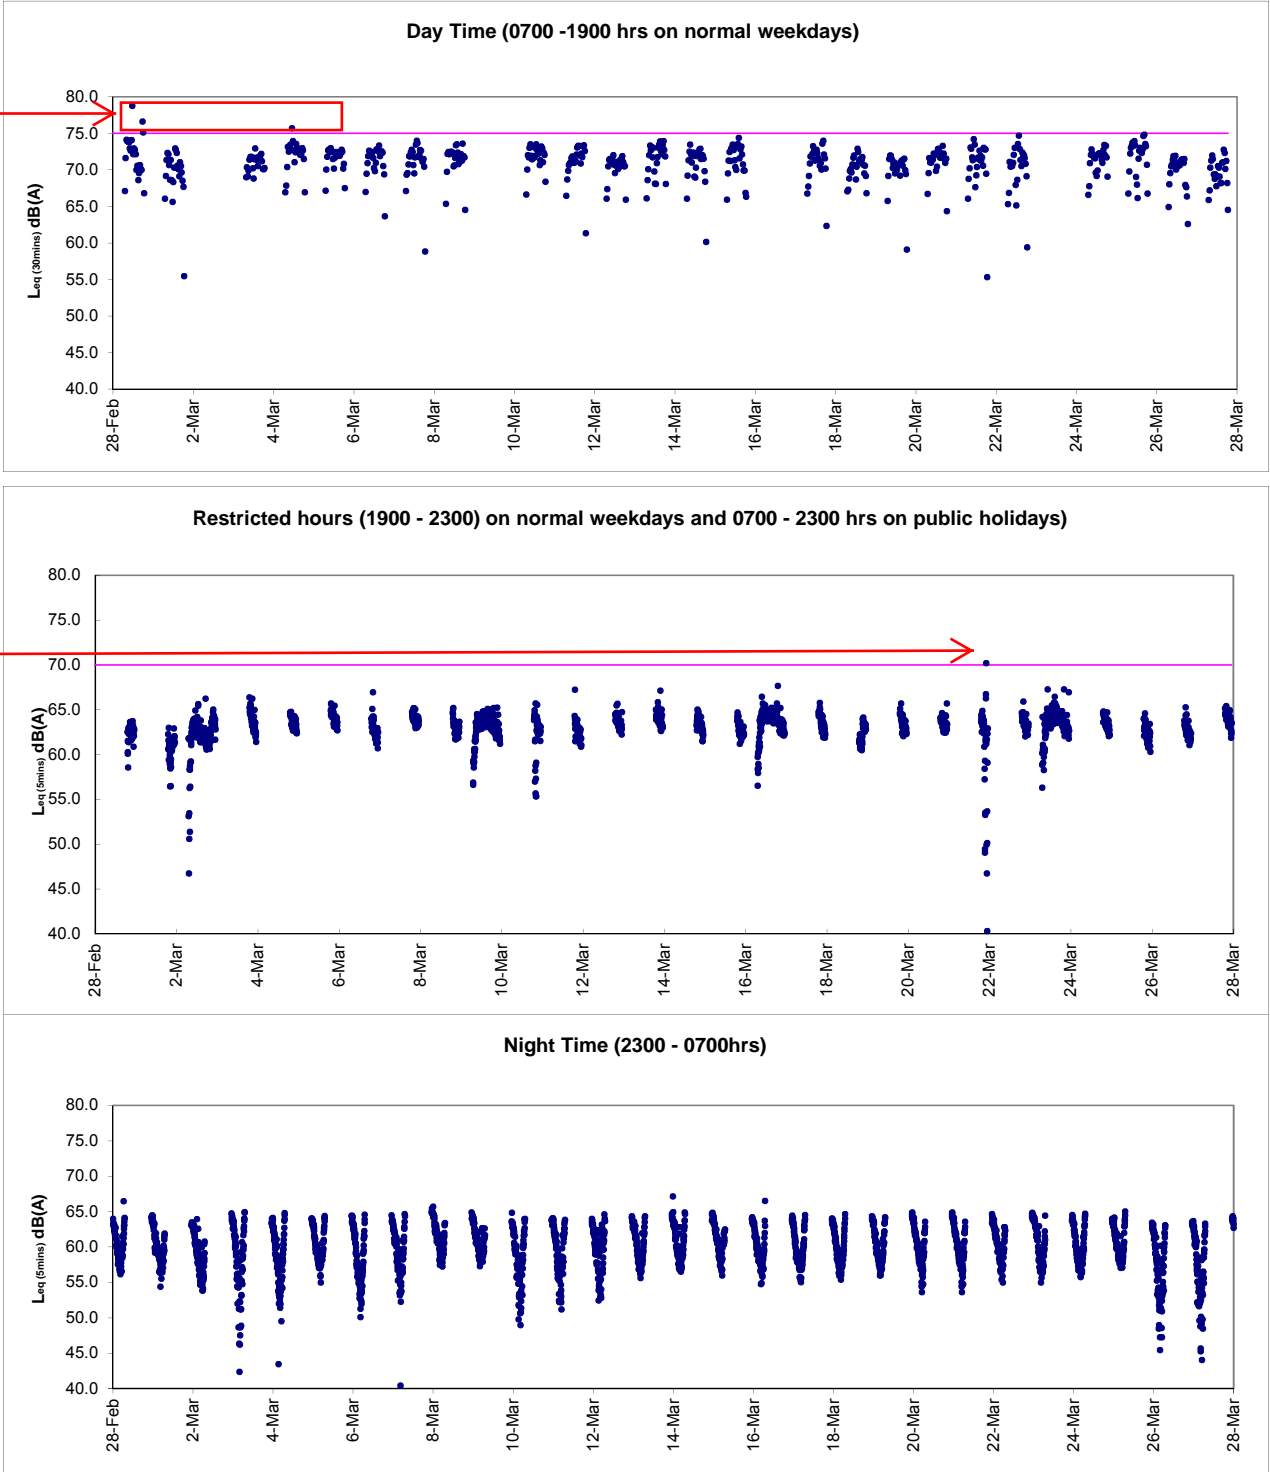
Graphic Presentation of Real Time Noise Monitoring Result (RTN2a- Hong Kong Electric Centre)

After checking with contractor HY/2009/19, no construction works were conducted at the concerned location during the recorded period. As such, the exceedances were considered to be contributed by nearby IEC traffic and nearby non- CWB Projects.

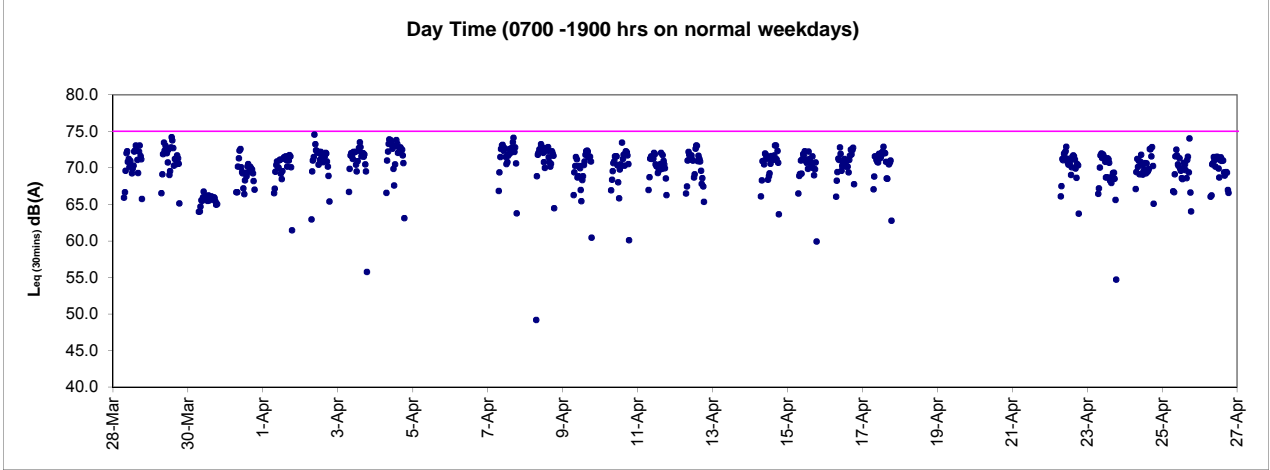
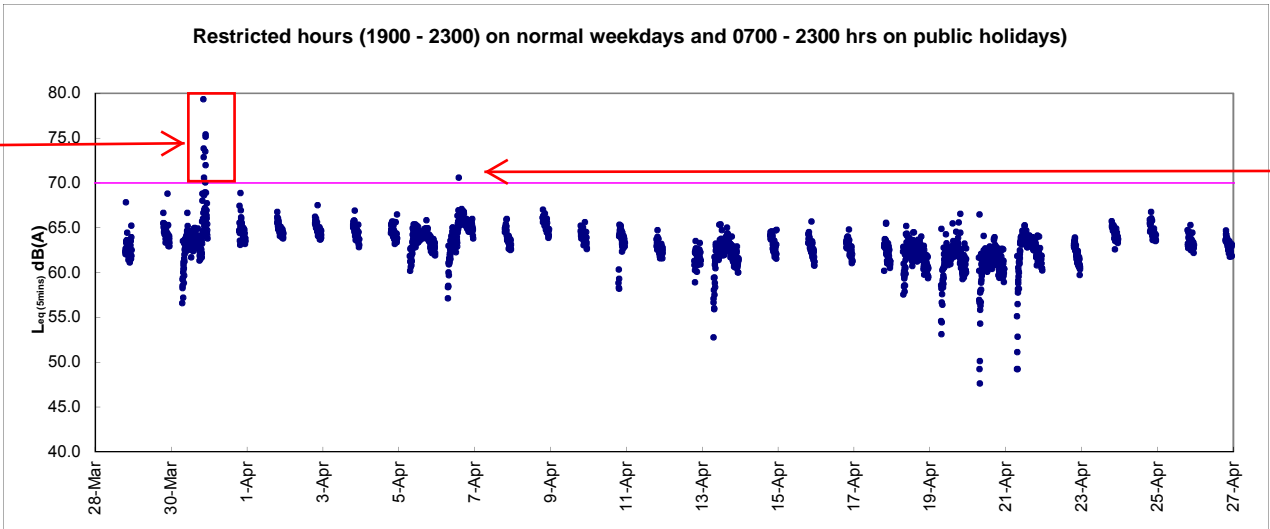
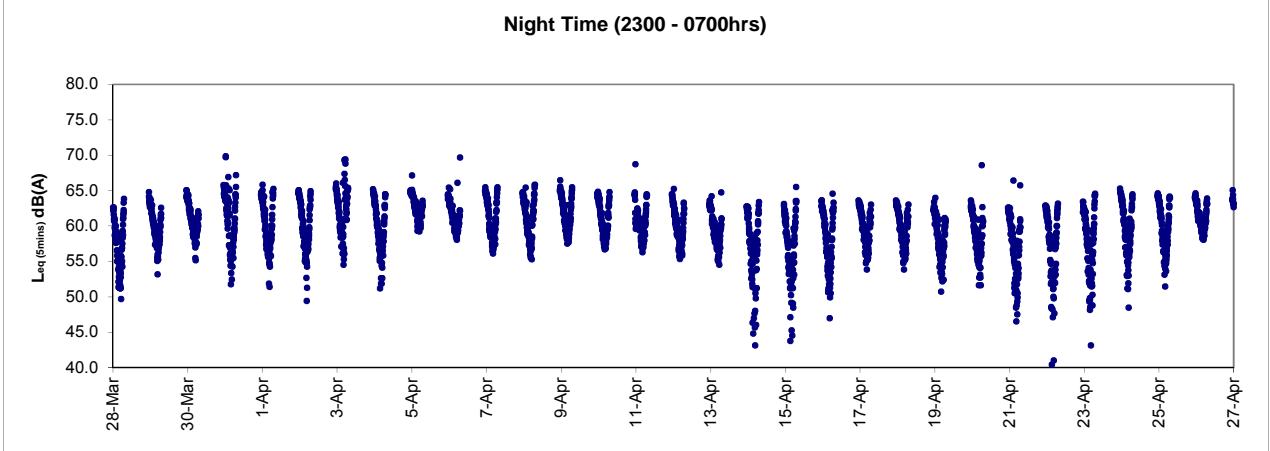
Graphic Presentation of Real Time Noise Monitoring Result (RTN2a- Hong Kong Electric Centre)

After checking with contractor HY/2009/19, no construction works were conducted at the concerned location during the recorded period and the major contribution was considered to be contributed by the adverse weather condition during the hoisting period of Black Rainstorm Warning Signal and not related to Projects

After checking with contractor HY/2009/19, no construction works were conducted at the concerned location during the recorded period and the exceedances were non-continuous and contributed by nearby IEC and slip road traffic.

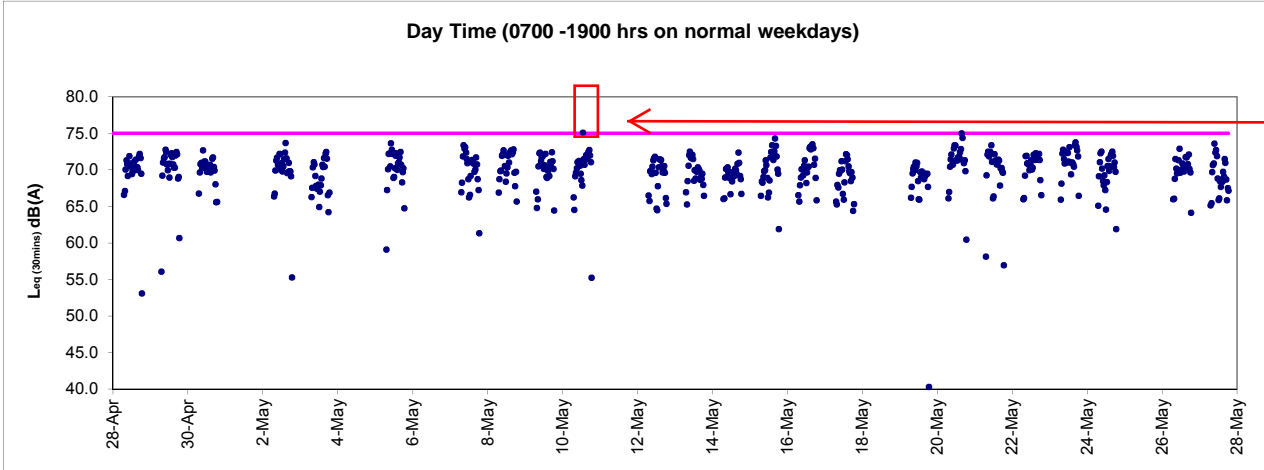
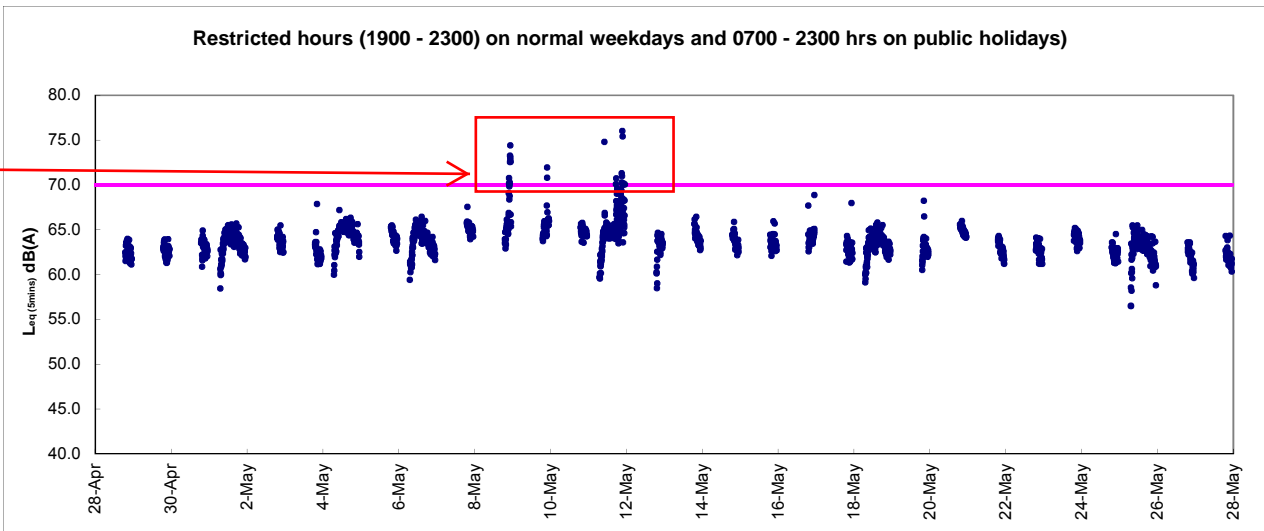
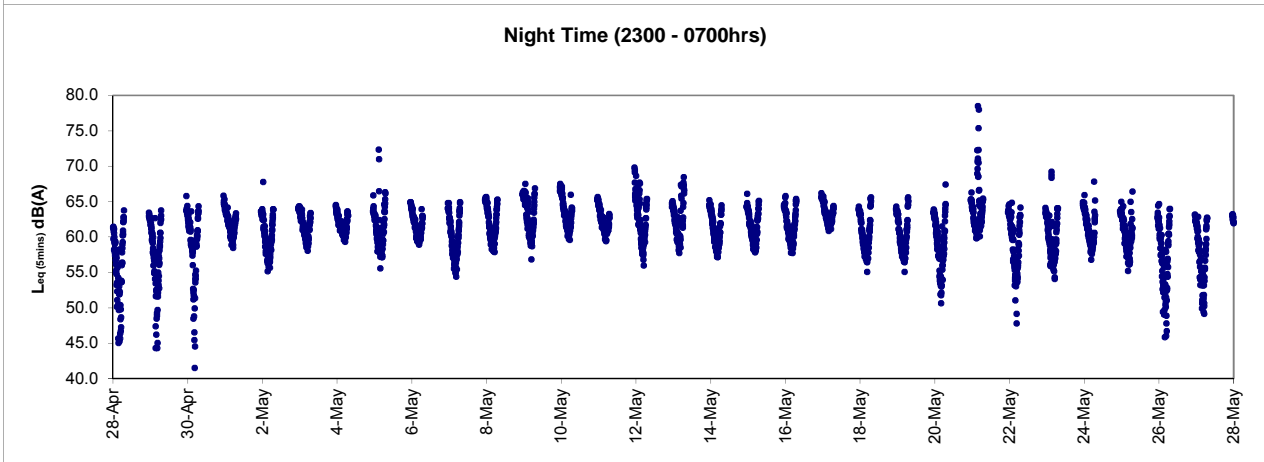
Graphic Presentation of Real Time Noise Monitoring Result (RTN2a- Hong Kong Electric Centre)

After checking with contractor HY/2009/19, no major noisy construction works were conducted at the concerned location during the recorded period and the major contribution was considered to be contributed by the adverse weather condition during the hoisting period of Rainstorm Warning Signal and not related to Projects

After checking with contractor HY/2009/19, socket piling works were conducted at the concerned location on the monitoring day. Contractor mitigation measures including erection of temporary noise barrier was in place and piling works at adjacent non-CWB project was observed. In view of the exceedances are non-continuous, the exceedances are considered not related to Projects works
