Contract No. HK/2011/07  
Wanchai Development Phase II and Central Wanchai Bypass  
(Shatin to Central Link (SCL) Protection  
Works at Causeway Bay Typhoon Shelter)

SHATIN TO CENTRAL LINK (SCL) PROTECTION WORKS AT  
CAUSEWAY BAY TYPHOON SHELTER (CBTS)

MONTHLY ENVIRONMENTAL MONITORING & AUDIT REPORT

- SEPTEMBER 2013 -

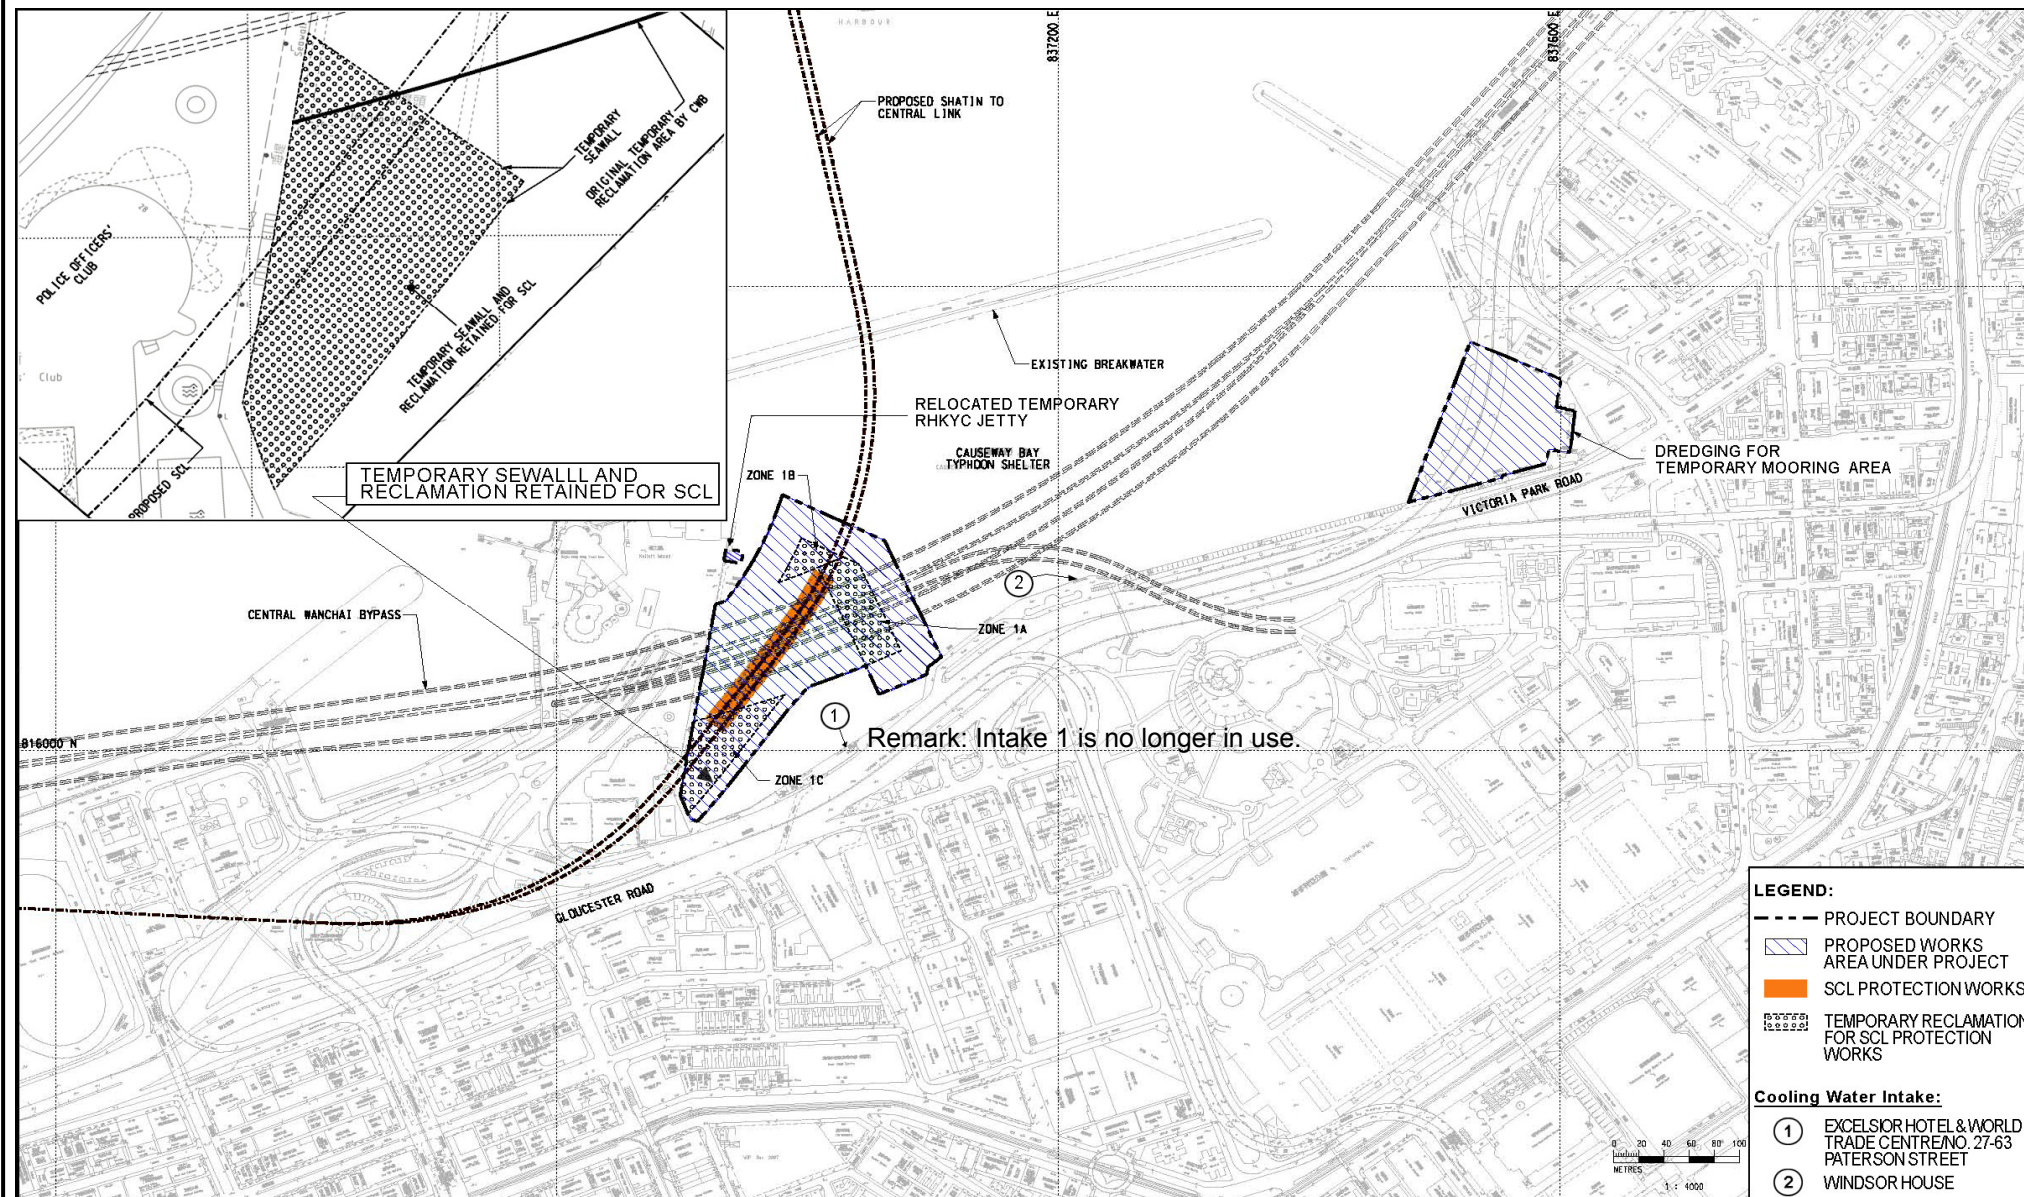
***Figure 2.1***

***Project Layout***

- 2.2.1. The study area encompasses existing developments in Causeway Bay Typhoon Shelter as shown in **Figure 2.1**. The scope of the Project includes:
- Temporary reclamation, which occupies about 0.7ha of Government foreshore and sea-bed (of which 0.3ha is already authorized under CWB project, i.e. additional reclamation of 0.4ha is required).
  - Dredging works at the southeast corner of the CBTS to provide space for temporary relocation of anchorage area due to the additional temporary reclamation for the Project.
  - Construction of a section of the twin track railway tunnel structure (approximately 160m long) above the proposed CWB located entirely offshore within the CBTS.
  - Relocation of the temporary Royal Hong Kong Yacht Club (RHKYC) jetty within the CWB temporary reclamation to a new location.

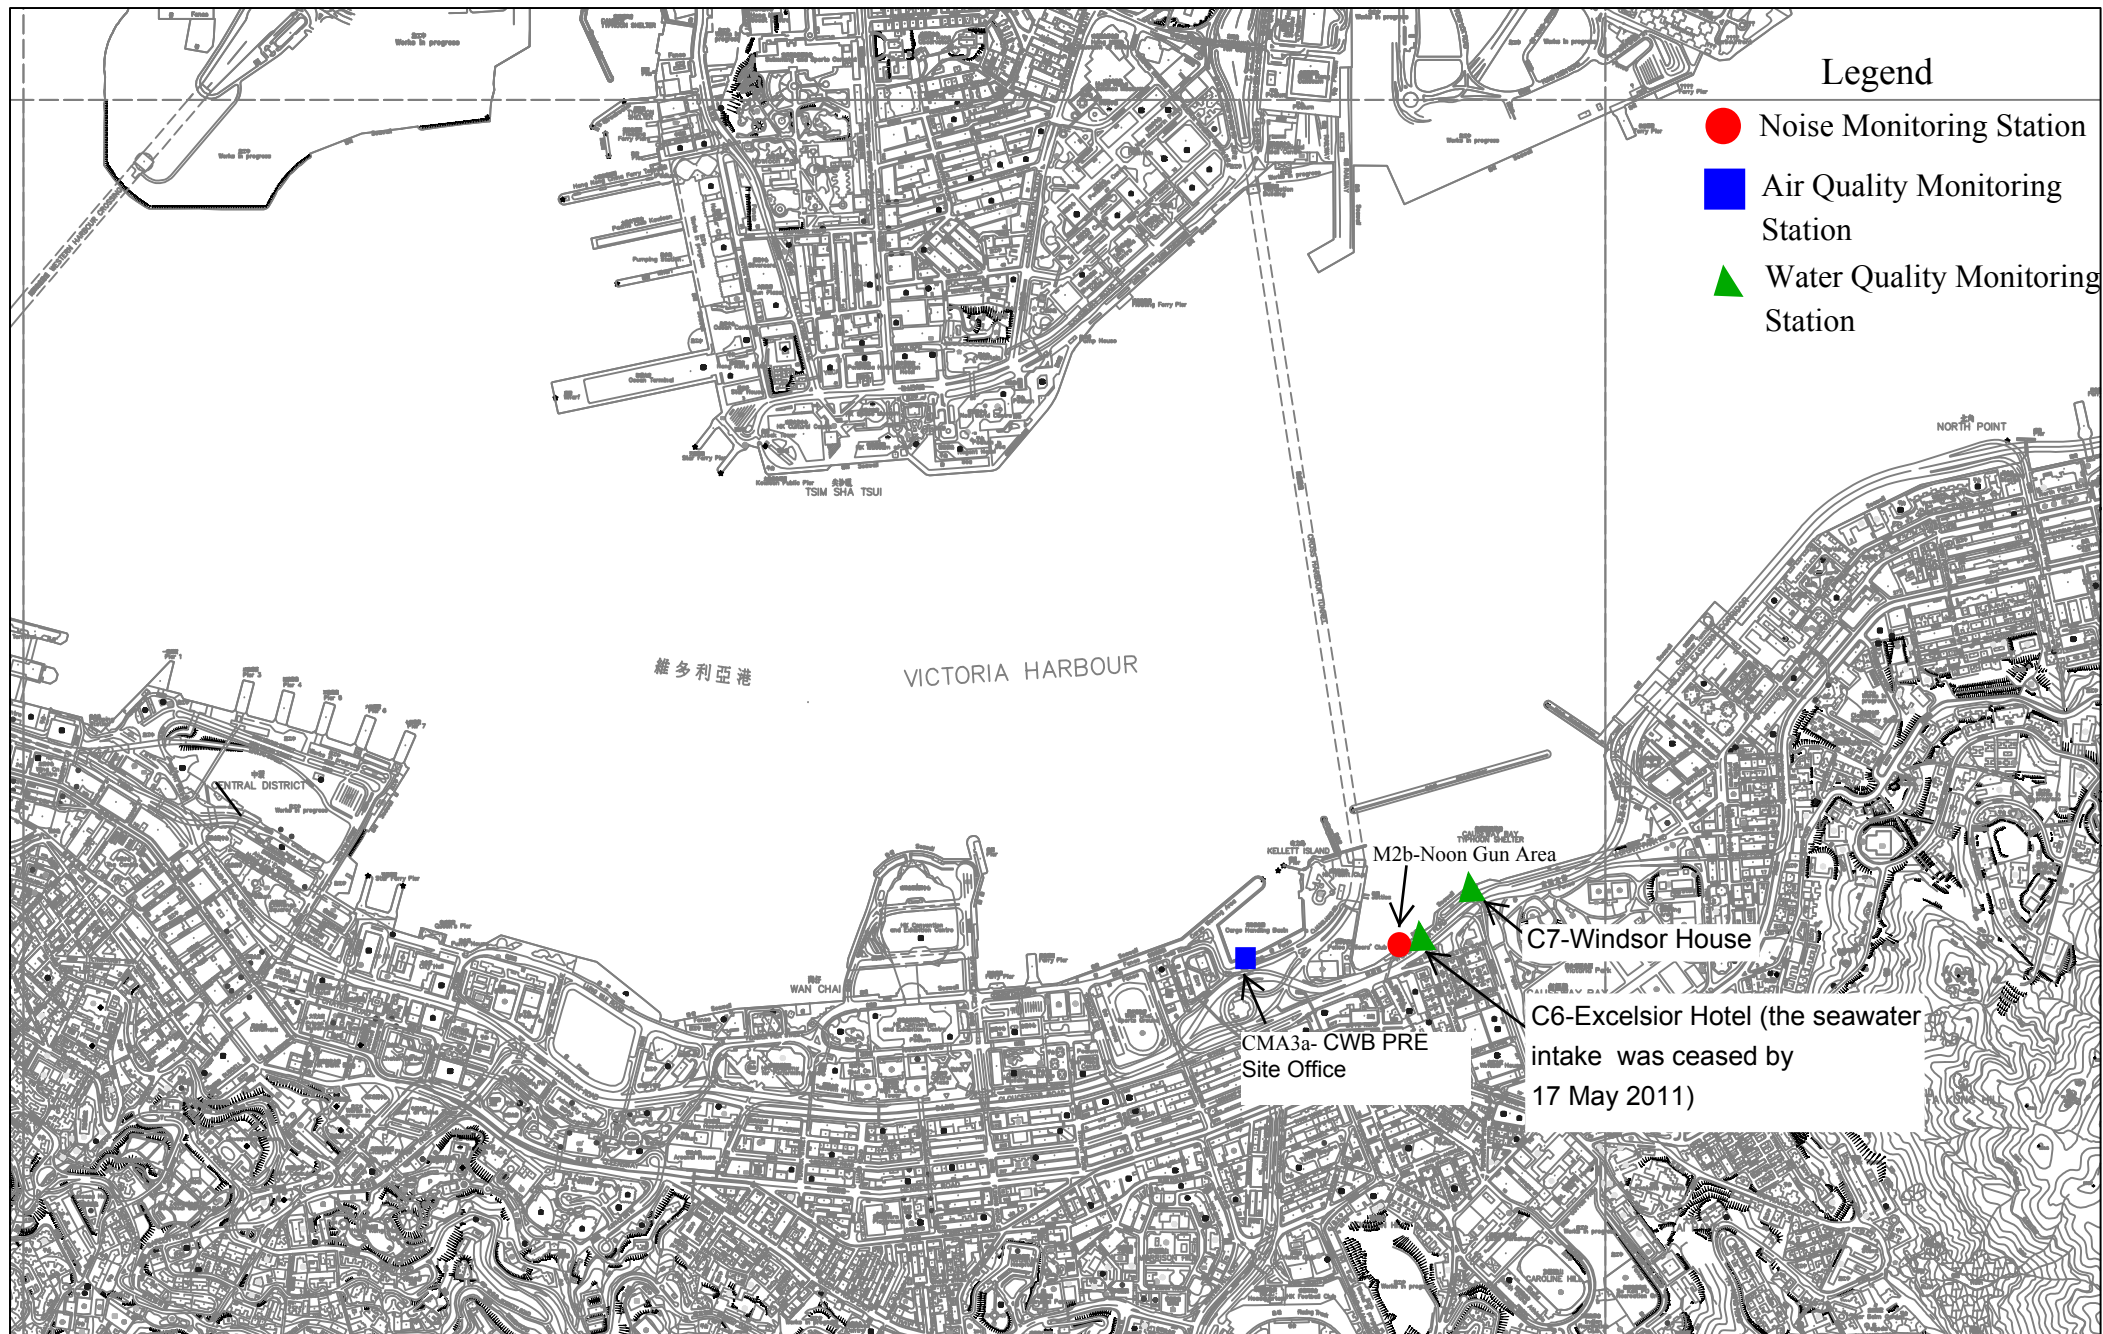
***Figure 2.3***

***Locations of Monitoring Stations***

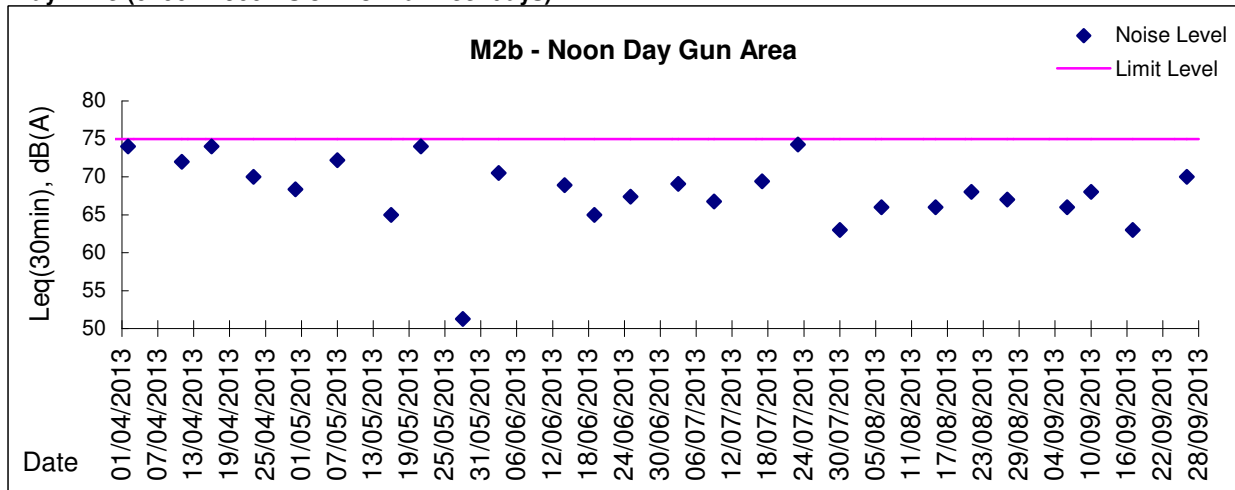
**Graphic Presentation of Noise Monitoring Result**

**Day Time (0700 - 1900hrs on normal weekdays)**

\*Due to adverse weather condition, noise monitoring was rescheduled from 03 Sep 2013 to 06 Sep 2013

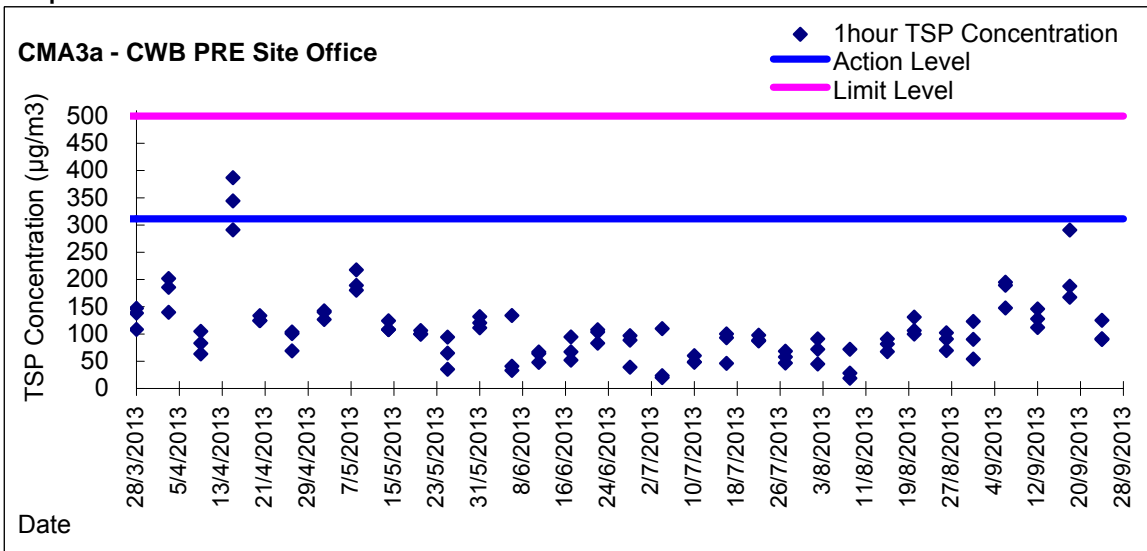
### Graphic Presentation of 1 hour TSP Result

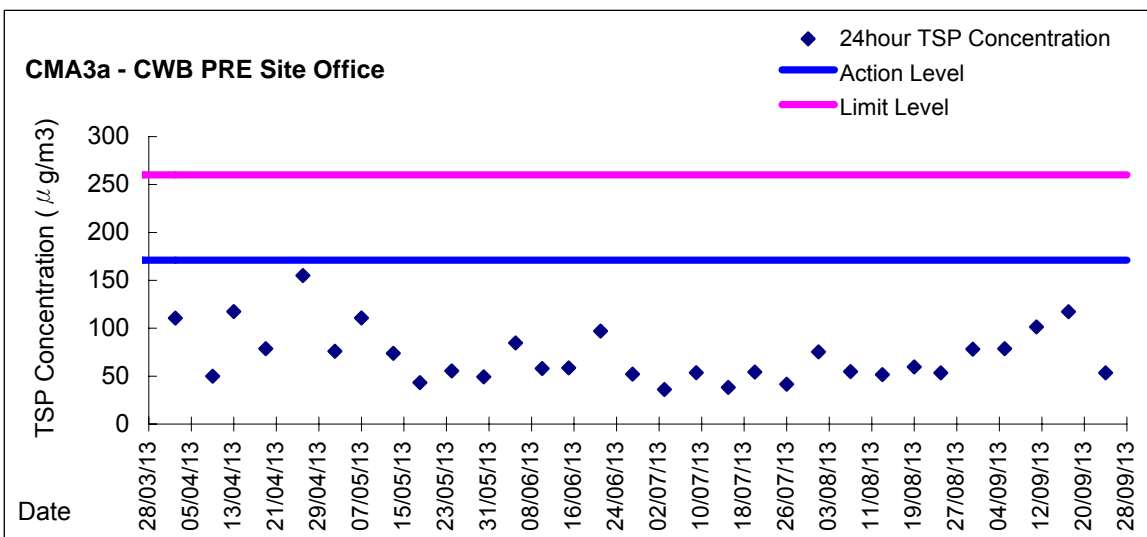
### Graphic Presentation of 24 hour TSP Result

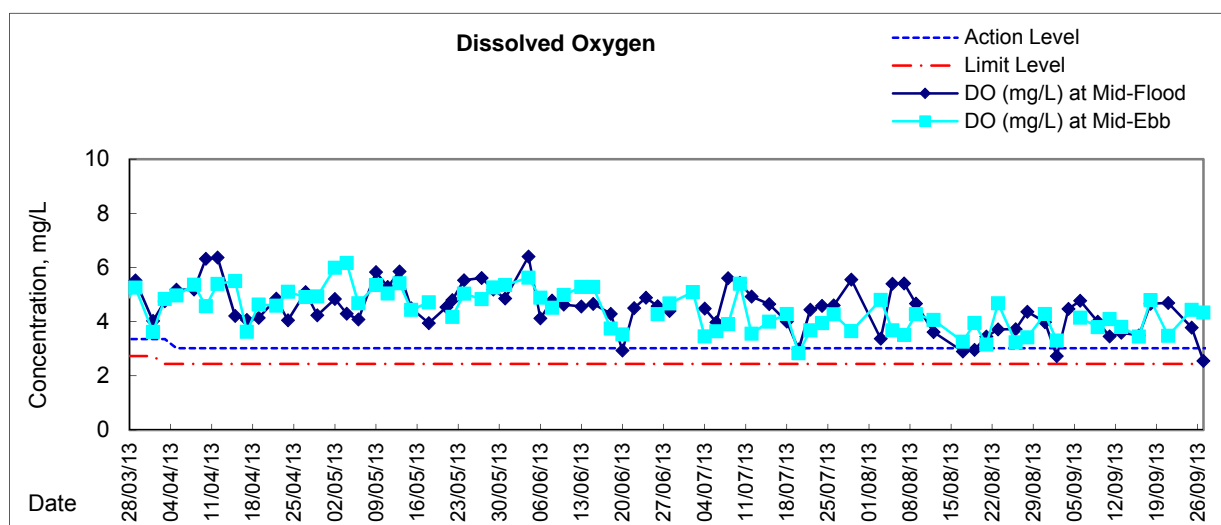
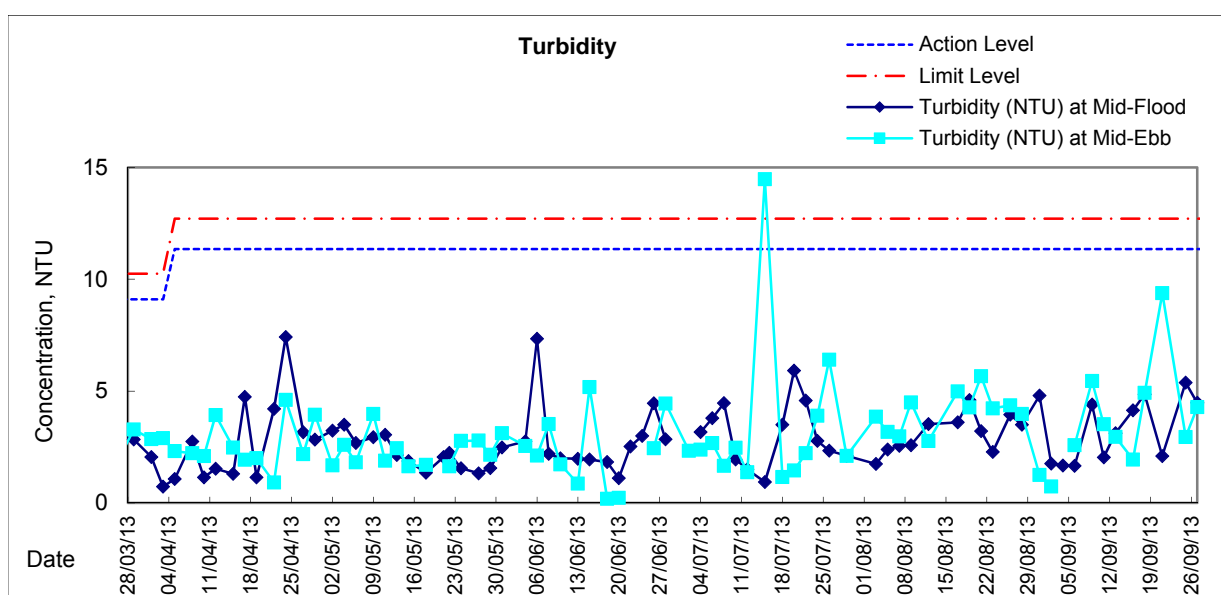
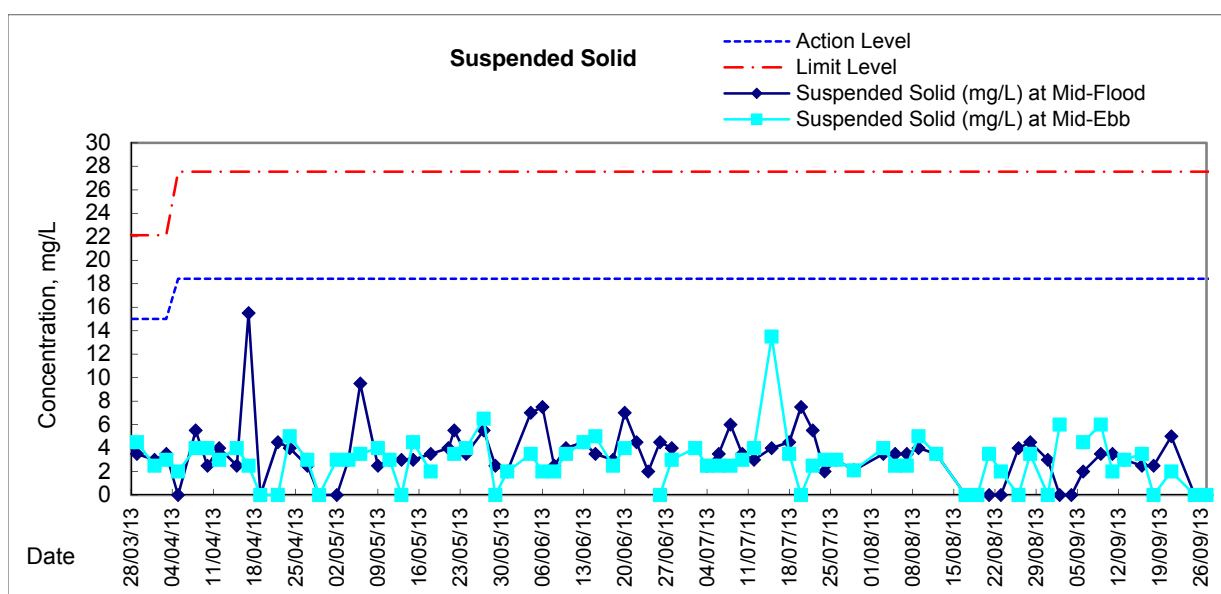
# Graphic Presentation of Water Quality Result of C7 - Windsor House

\*Due to the enforcement of Amber Rainstorm Warning on 4 Sep 2013, water quality monitoring at ebb tide was cancelled.

\*\*Due to the enforcement of Gale Signal No. 8 on 23 Sep 2013, water quality monitoring at flood tide was cancelled.

X_10C581	27-Sep-13	Mid-flood	C7	DO(mg/L)	2.55	3.02	2.44	Possible reason:	Natural variation or changes of water quality in the vicinity of the water quality monitoring station
				Turbidity	1.76	11.35	12.71	Action taken / to be taken:	Immediate repeated in-situ measurements had conducted to confirm the exceedances. Checking with contractor's works on 27 September 2013, no marine works in the vicinity of the monitoring location was conducted on that day. Checking with contractor's inspection record, the silt screen and silt curtain were in proper condition on that day.
				SS	<2	18.42	27.54	Remarks / Other Obs:	No further exceedance was recorded in the next consecutive monitoring. In view that the silt screen and silt curtain were in proper condition, the exceedance was considered not project related.
