**Shatin to Central Link –
Tai Wai to Hung Hom Section and
Mong Kok East to Hung Hom Section**

Monthly EM&A Report No. 10

[Period from 1 to 30 June 2013]

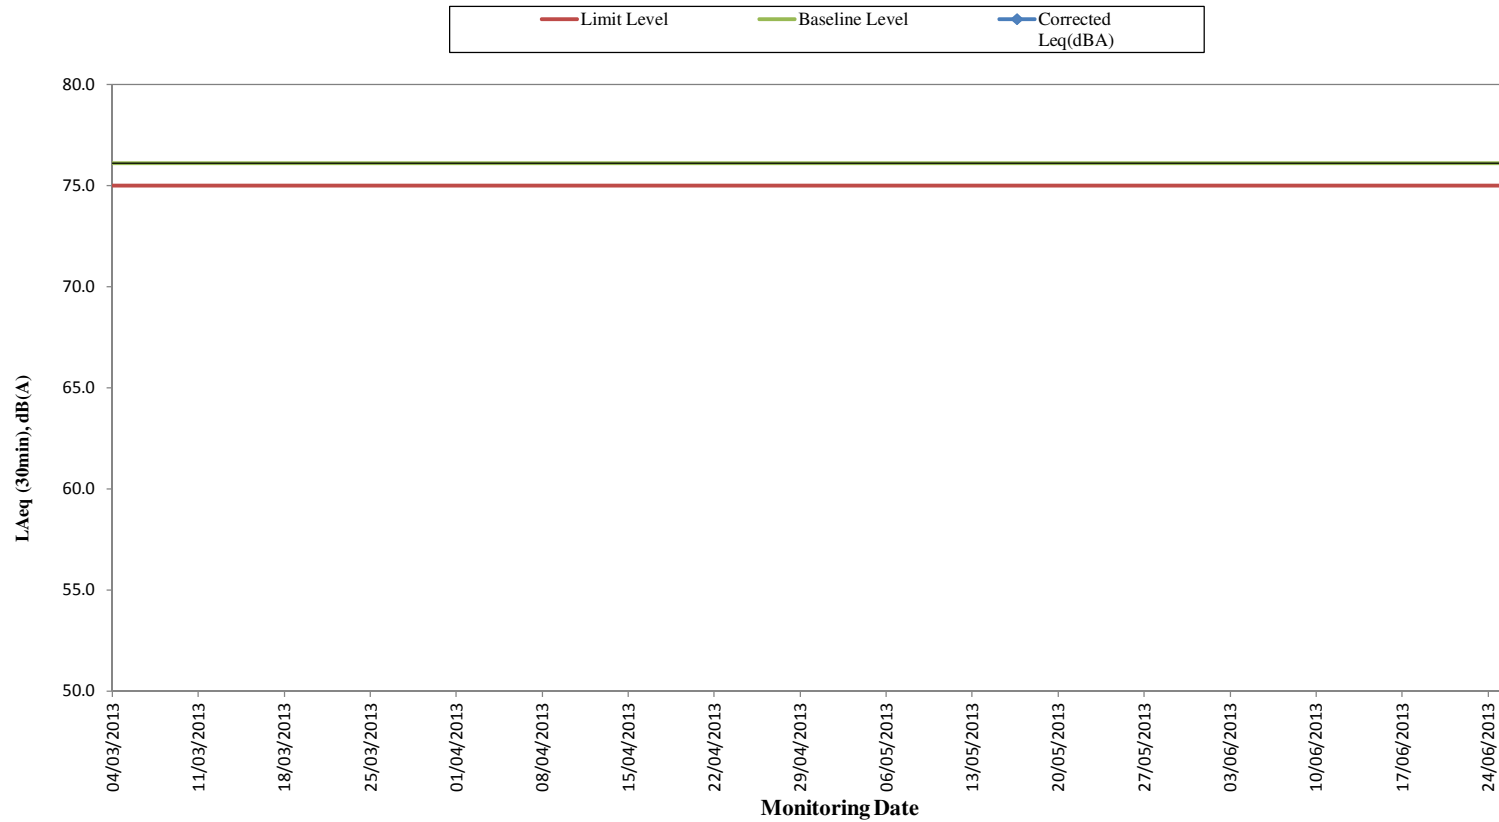
Regular Noise Monitoring Results at NMS-CA-6 (No. 16-23 Nam Kok Road) (LAeq, 30min) for the Past 4 Months

- For those corrected noise levels that are not shown in this graph, the measured noise levels are below baseline level.

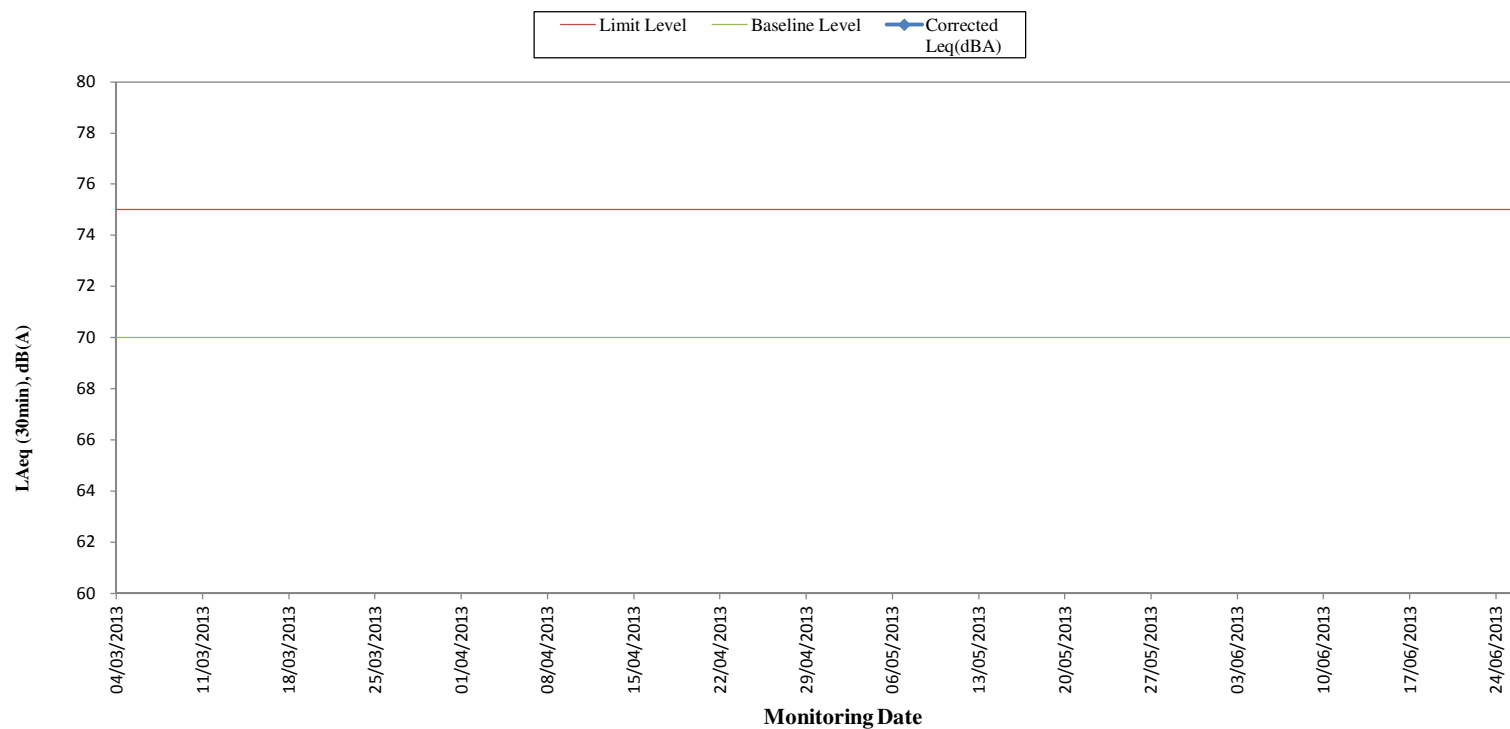
Regular Noise Monitoring Results at NMS-CA-7 (Skytower Tower 2) (LAeq, 30min) for the Past 4 Months

- For those corrected noise levels that are not shown in this graph, the measured noise levels are below baseline level.

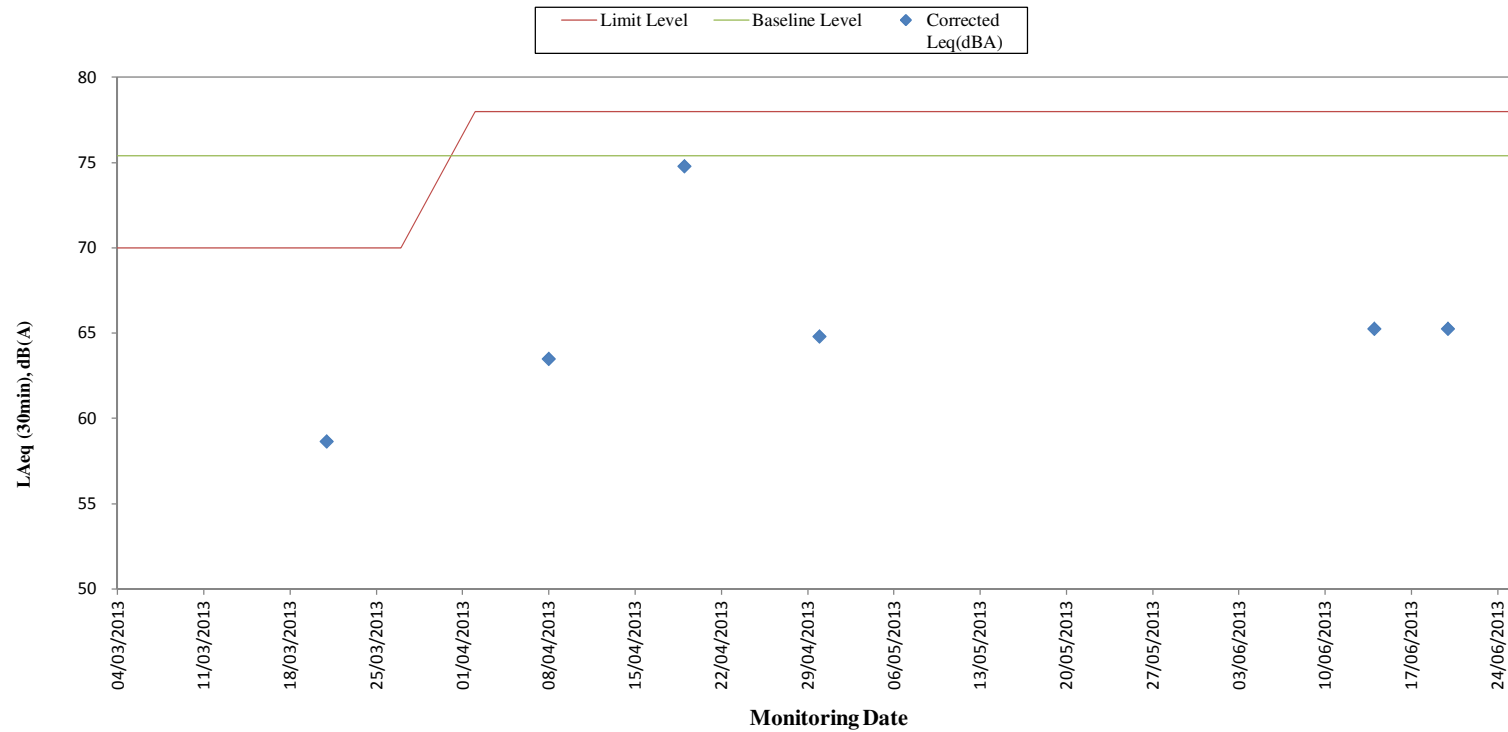
Regular Noise Monitoring Results at NMS-CA- 8 (SKH Good Shepherd Primary School) (LAeq, 30min) for the Past 4 Months

- For those corrected noise levels that are not shown in this graph, the measured noise levels are below baseline level.
- The limit level was 78dB(A) in April 2013 as continuous noise monitoring was conducted in this month.

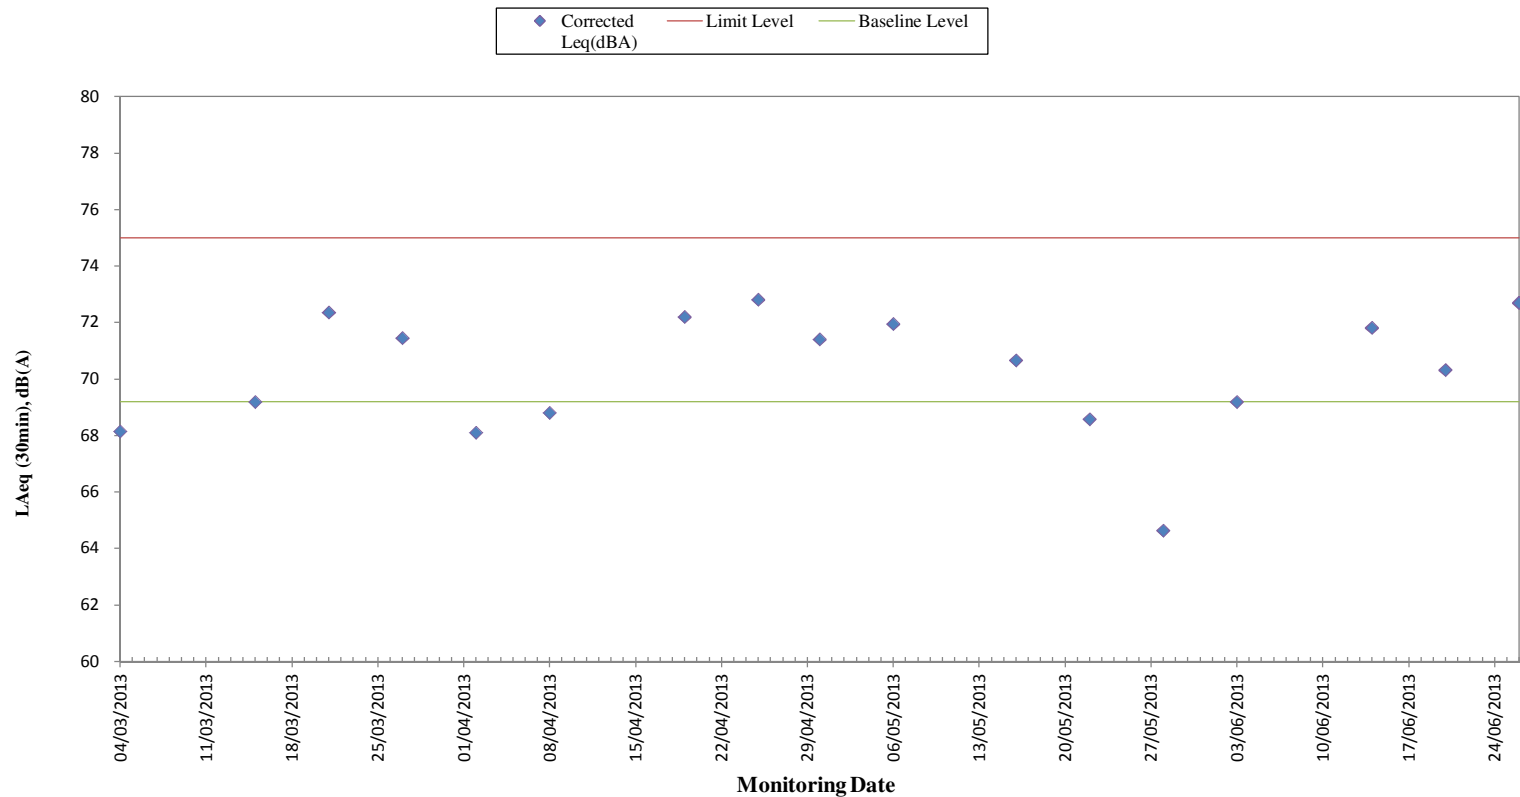
**Regular Noise Monitoring Results at NMS-CA-9 (Kong Yiu Mansion)
(L_{Aeq}, 30min) for the Past 4 Months**

- For those corrected noise levels that are not shown in this graph, the measured noise levels are below baseline level.

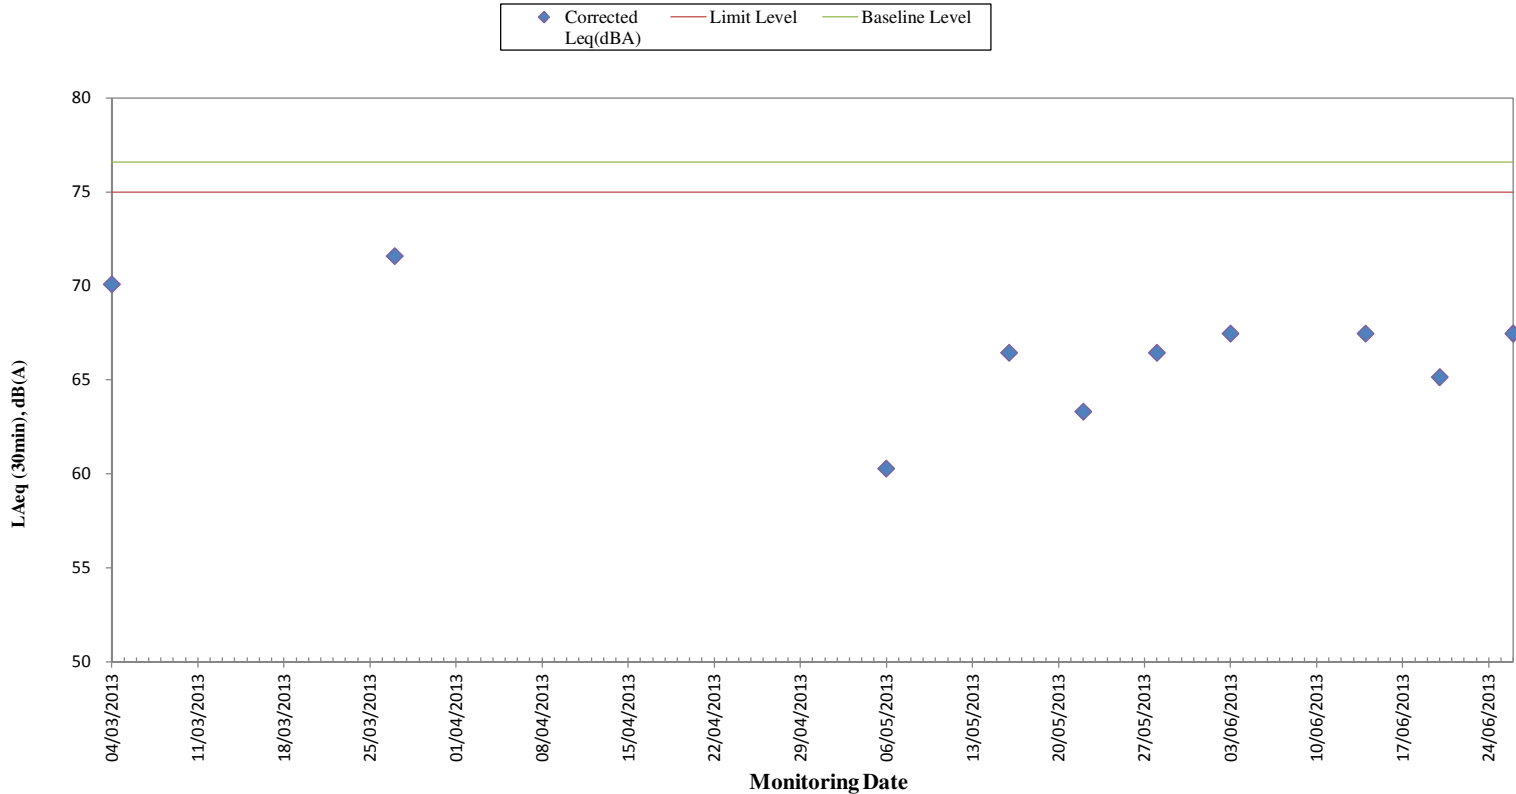
**Regular Noise Monitoring Results at NMS-CA-10 (Chat Ma Mansion) (LAeq, 30min)
for the Past 4 Months**

- For those corrected noise levels that are not shown in this graph, the measured noise levels are below baseline level.

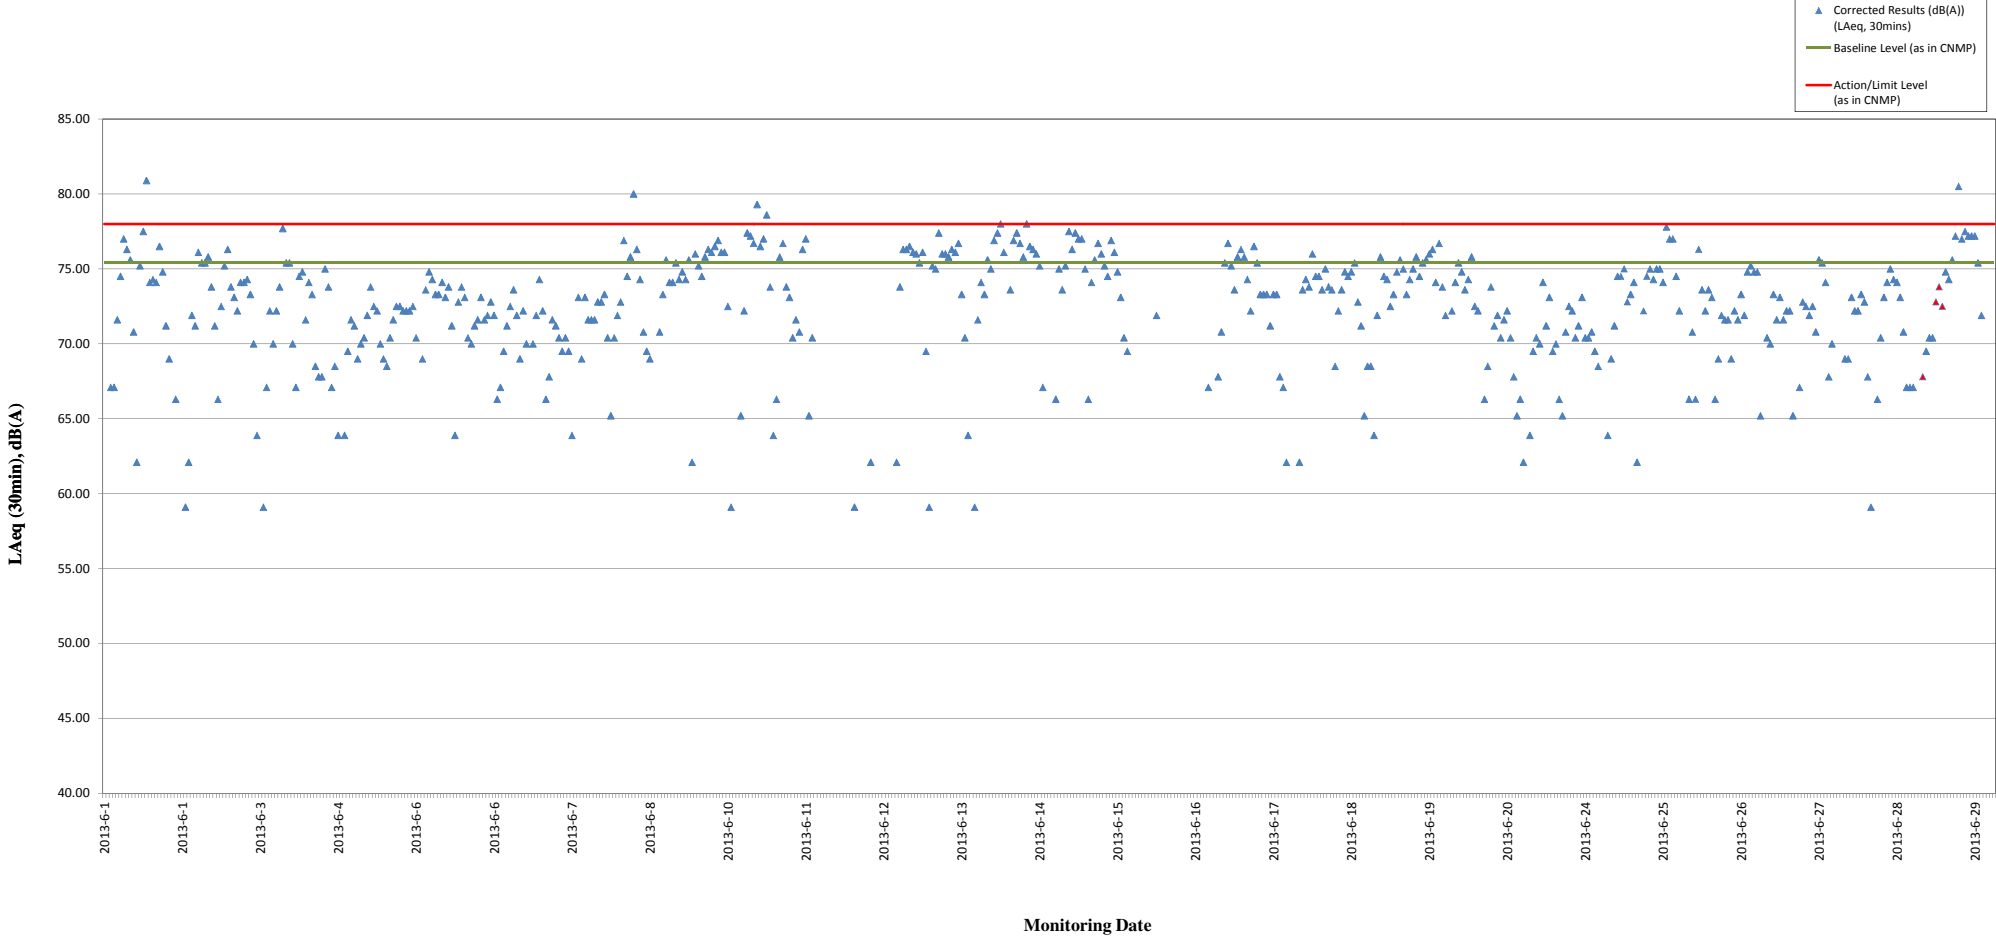
Continuous Noise Monitoring at MTW-16-1 (SKH Good Shepherd Primary School) in June 2013- (LAeq, 30min)

Remarks:
 - For those corrected noise levels that are not shown in this graph, the measured noise levels are below baseline level.

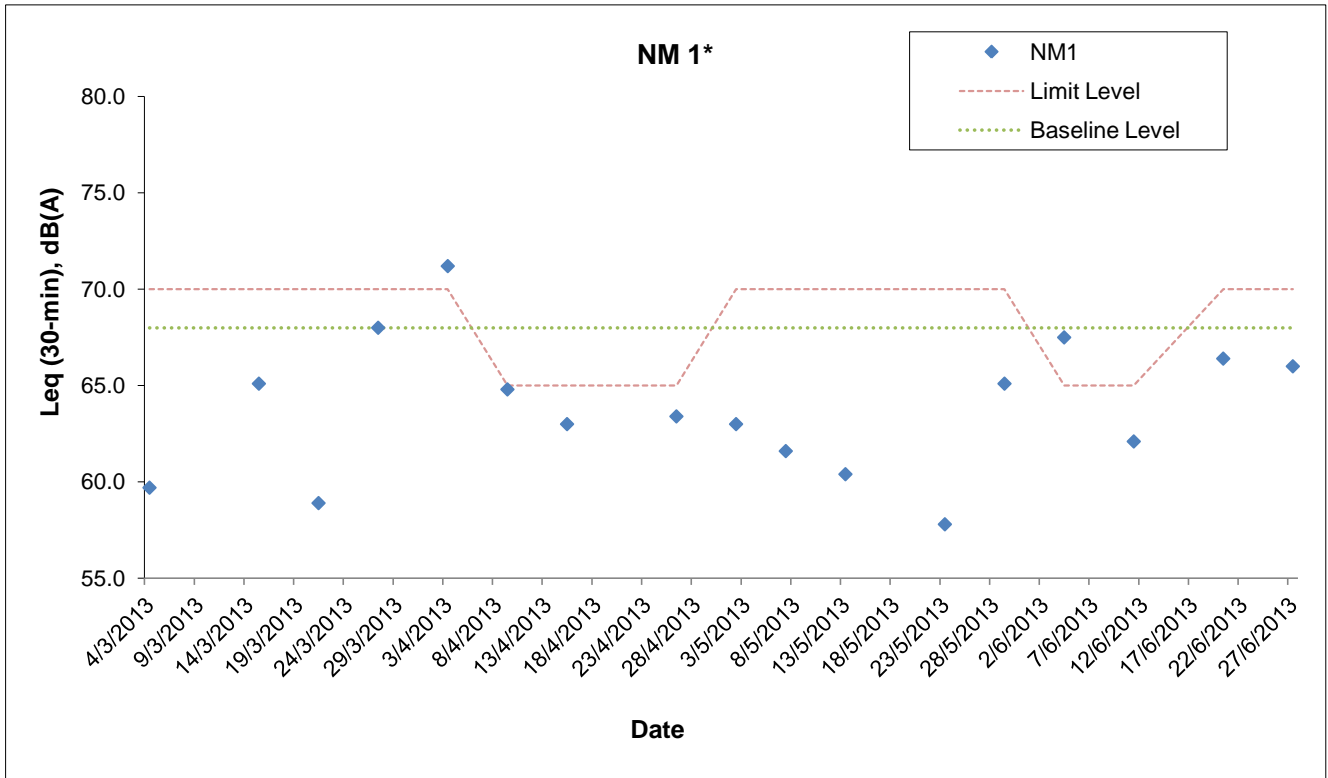
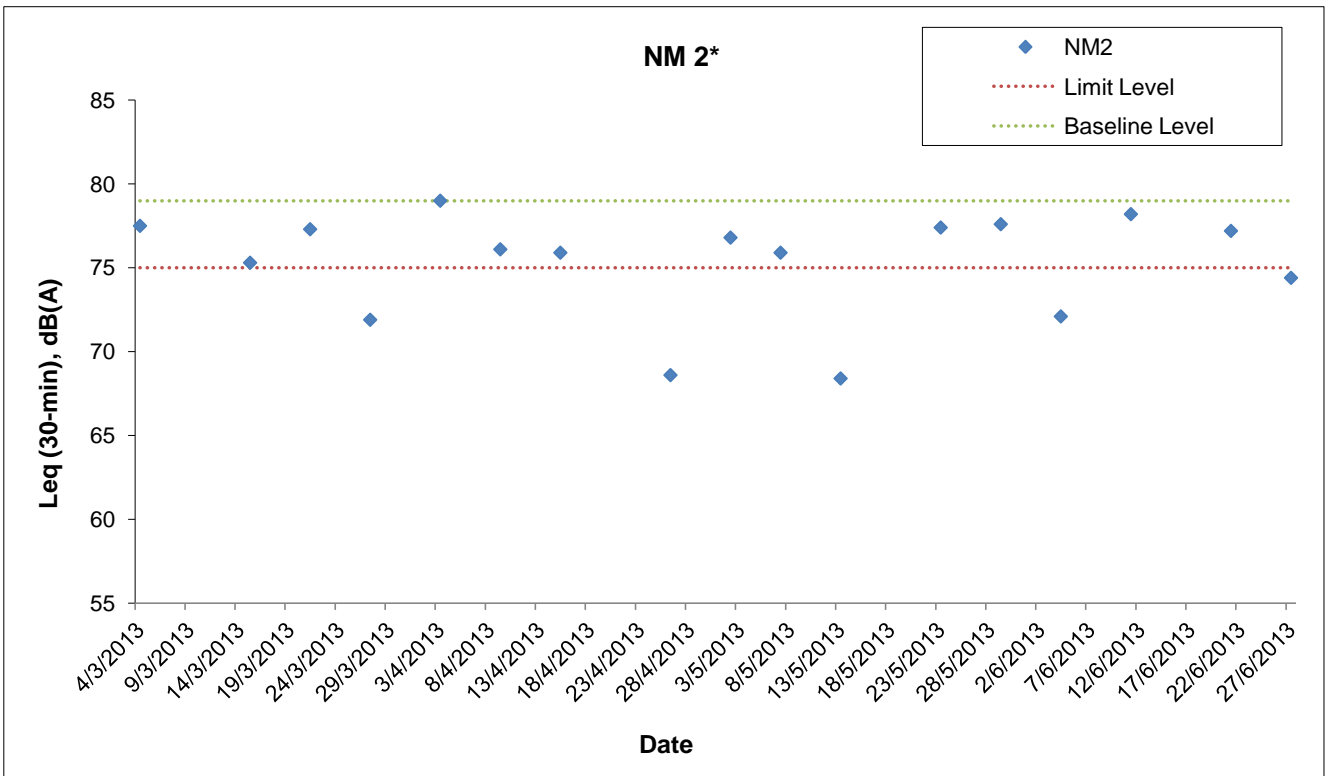
Appendix H Regular Construction Noise Monitoring Results

* - The noise monitoring results of the measurements are higher than the daytime construction noise criterion. However, the results are not considered as exceedance if they are either below the baseline level or below the limit level after deducting the baseline noise level.
