**Shatin to Central Link –  
Tai Wai to Hung Hom Section and  
Mong Kok East to Hung Hom Section**

Monthly EM&A Report No. 12

[Period from 1 to 31 August 2013]

Consultancy Agreements  
No. C11033 & C11033B

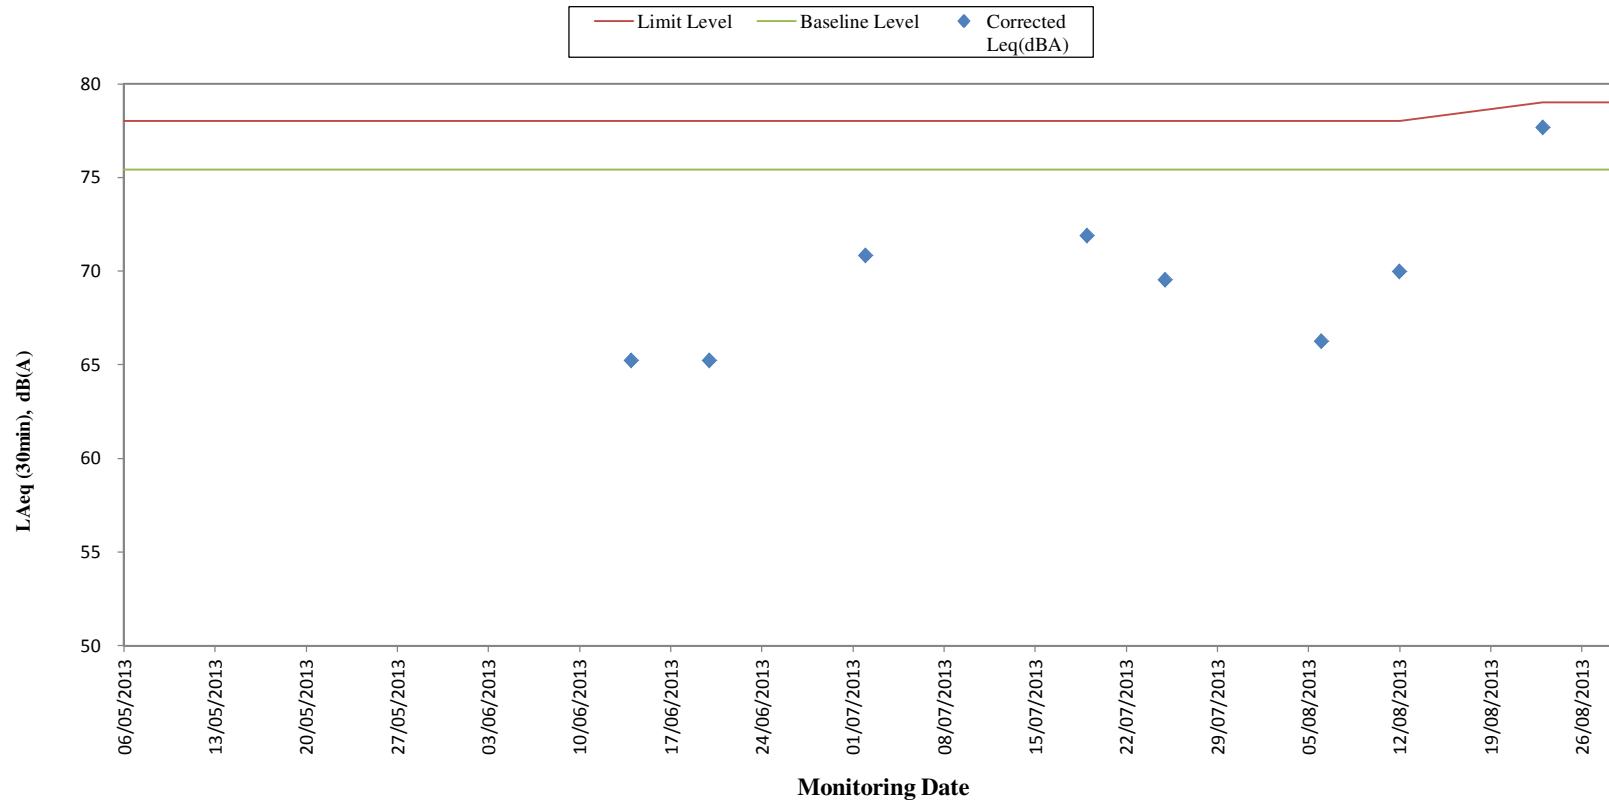
## Regular Noise Monitoring Results at NMS-CA- 8 (SKH Good Shepherd Primary School) (L<sub>Aeq</sub>, 30min) for the Past 4 Months

- For those corrected noise levels that are not shown in this graph, the measured noise levels are below baseline level.
- The limit level was updated from 78dB(A) to 79 dB(A) on 22 Aug 2013 as per the latest CNMP and CNMMP.
