**Shatin to Central Link –
Tai Wai to Hung Hom Section and
Mong Kok East to Hung Hom Section**

Monthly EM&A Report No. 37

[Period from 1 to 30 September 2015]

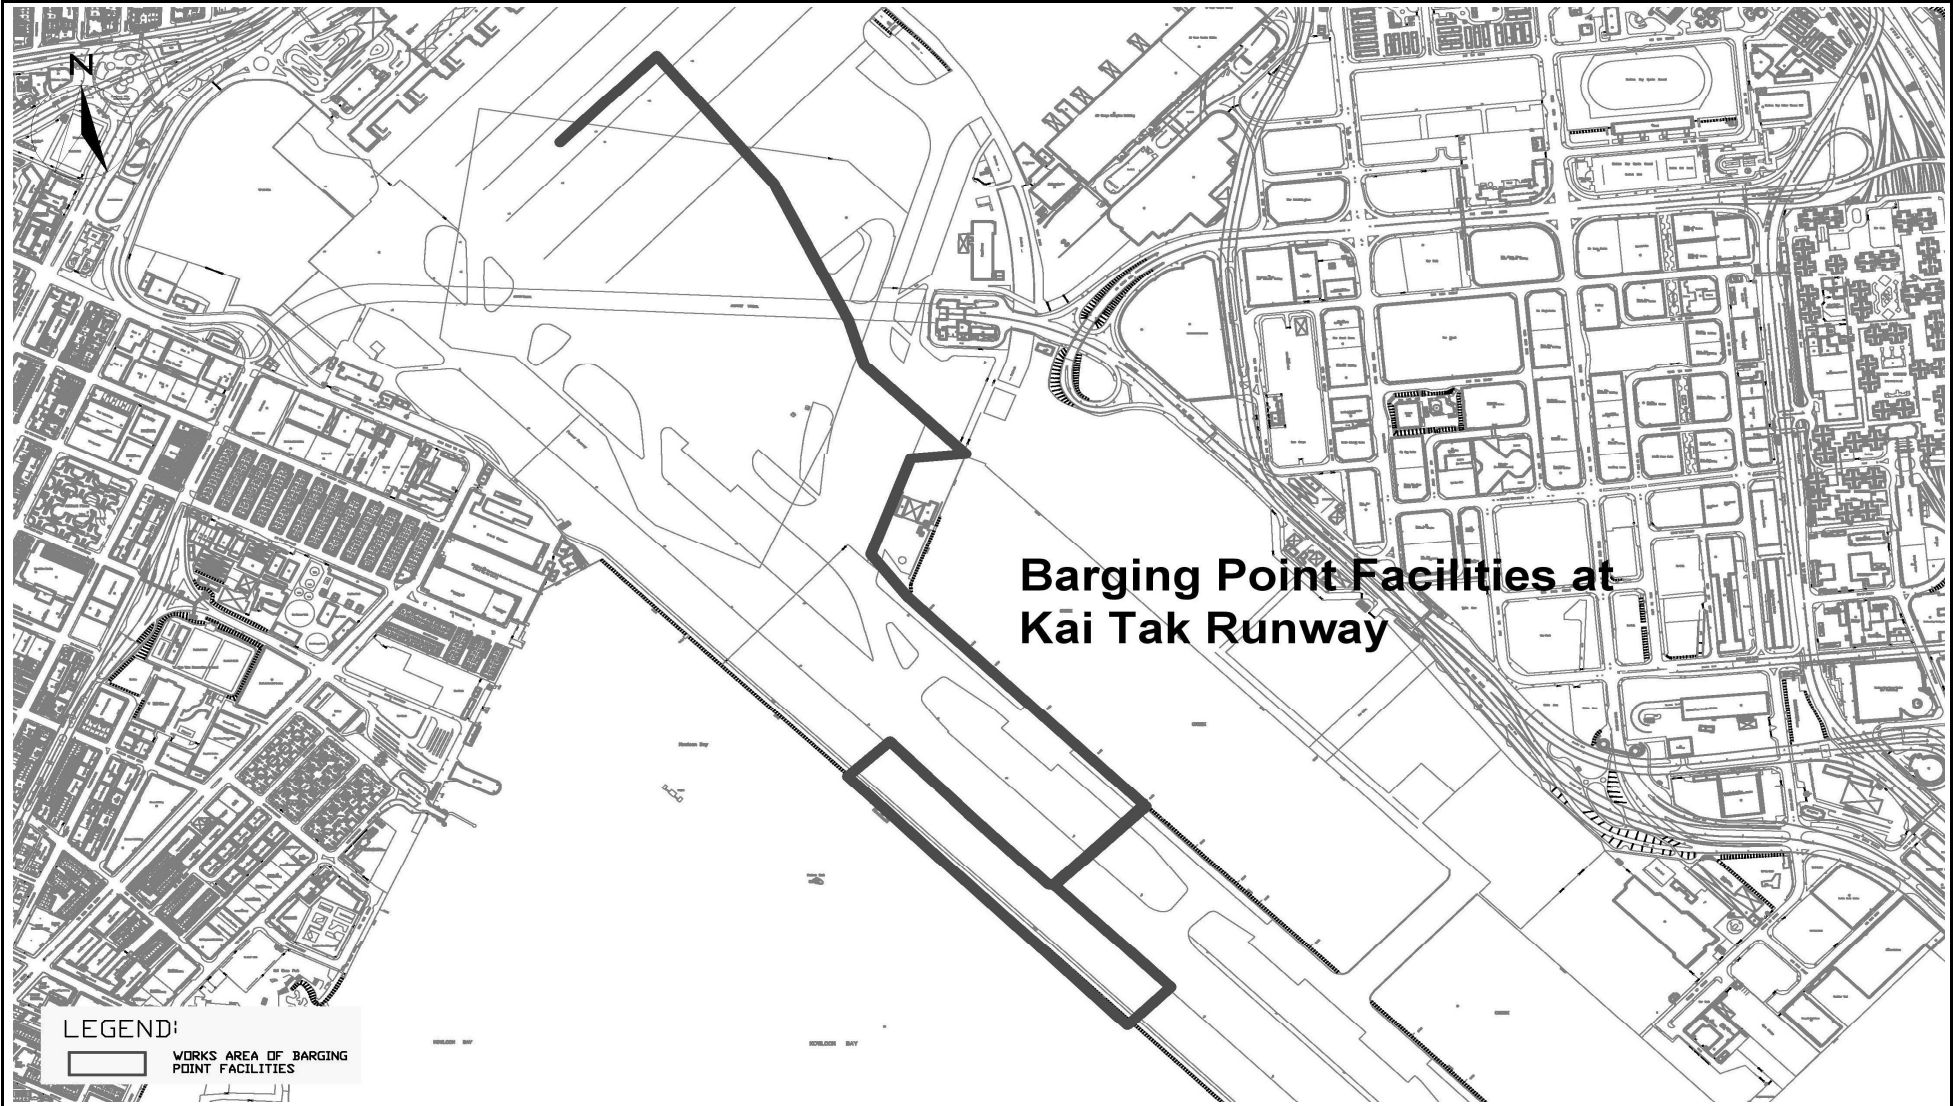
Title <p style="text-align: center;">SCL Contract 1108A The Shatin to Central Link - Kai Tak Barging Point Facilities Site Layout Plan</p>	Scale <p style="text-align: center;">N.T.S</p>	Project No. <p style="text-align: center;">MA12028</p>	
	Date <p style="text-align: center;">Apr-14</p>	Figure <p style="text-align: center;">1</p>

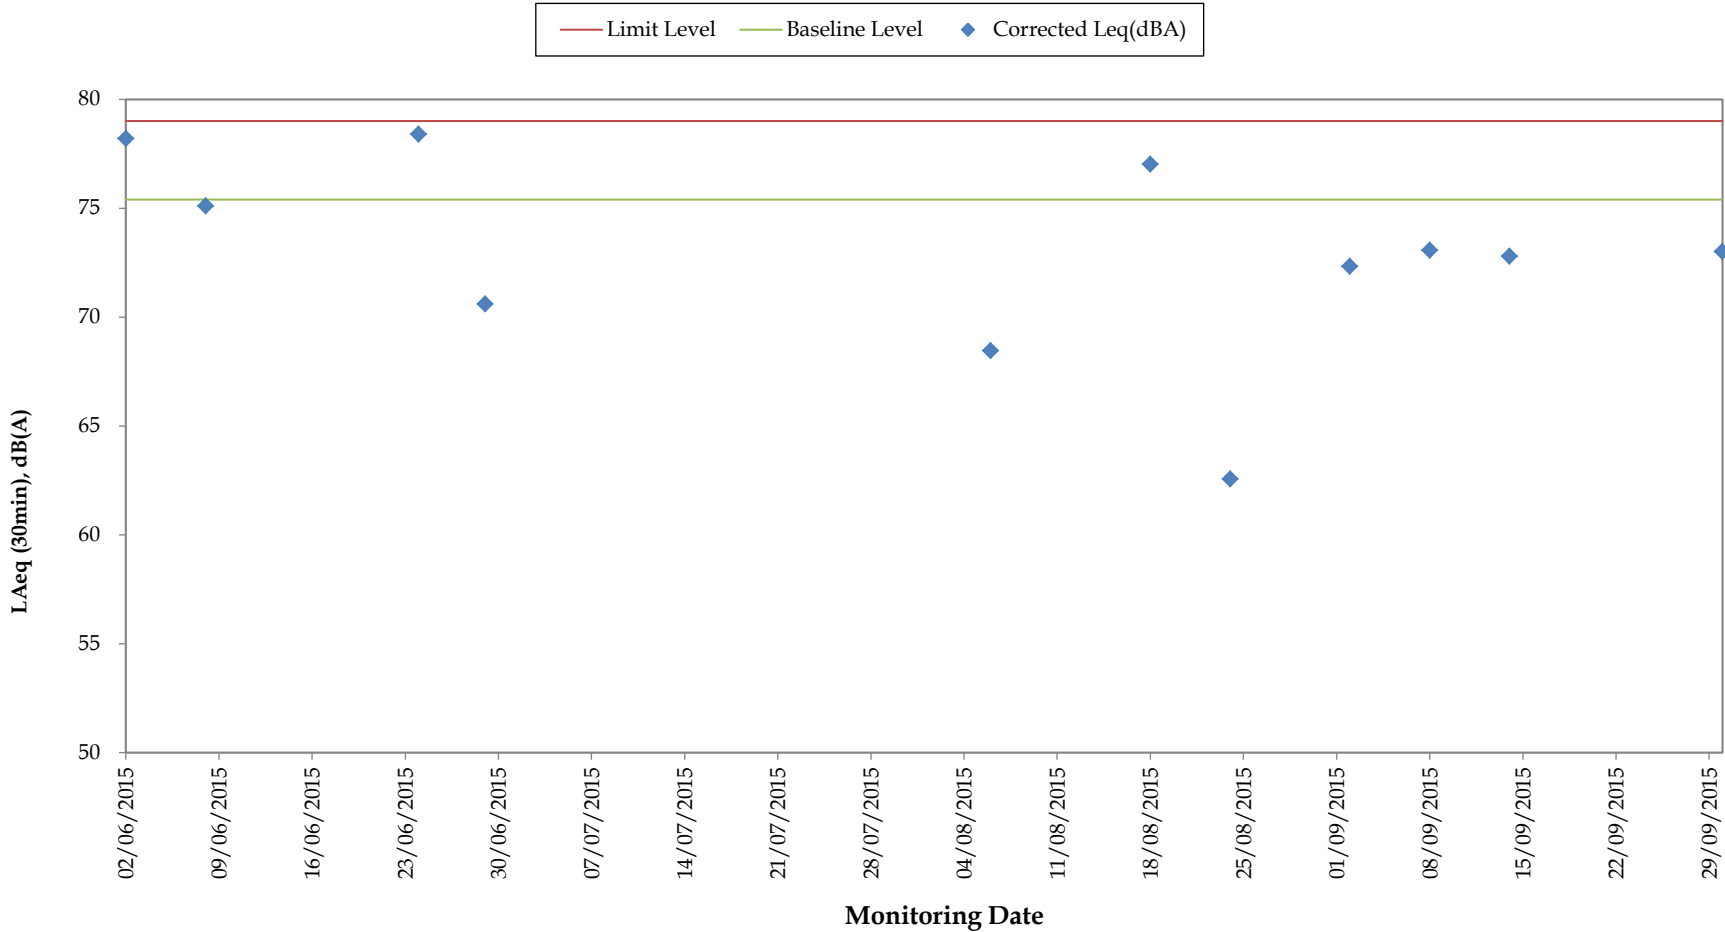
Regular Noise Monitoring Results at NMS-CA- 8 (SKH Good Shepherd Primary School) (LAeq, 30min) for the Past 4 Months

- For those corrected noise levels that are not shown in this graph, the measured noise levels are below baseline level.
- The limit level was updated from 78dB(A) to 79 dB(A) on 22 Aug 2013 as per the latest CNMP and CNMMP.

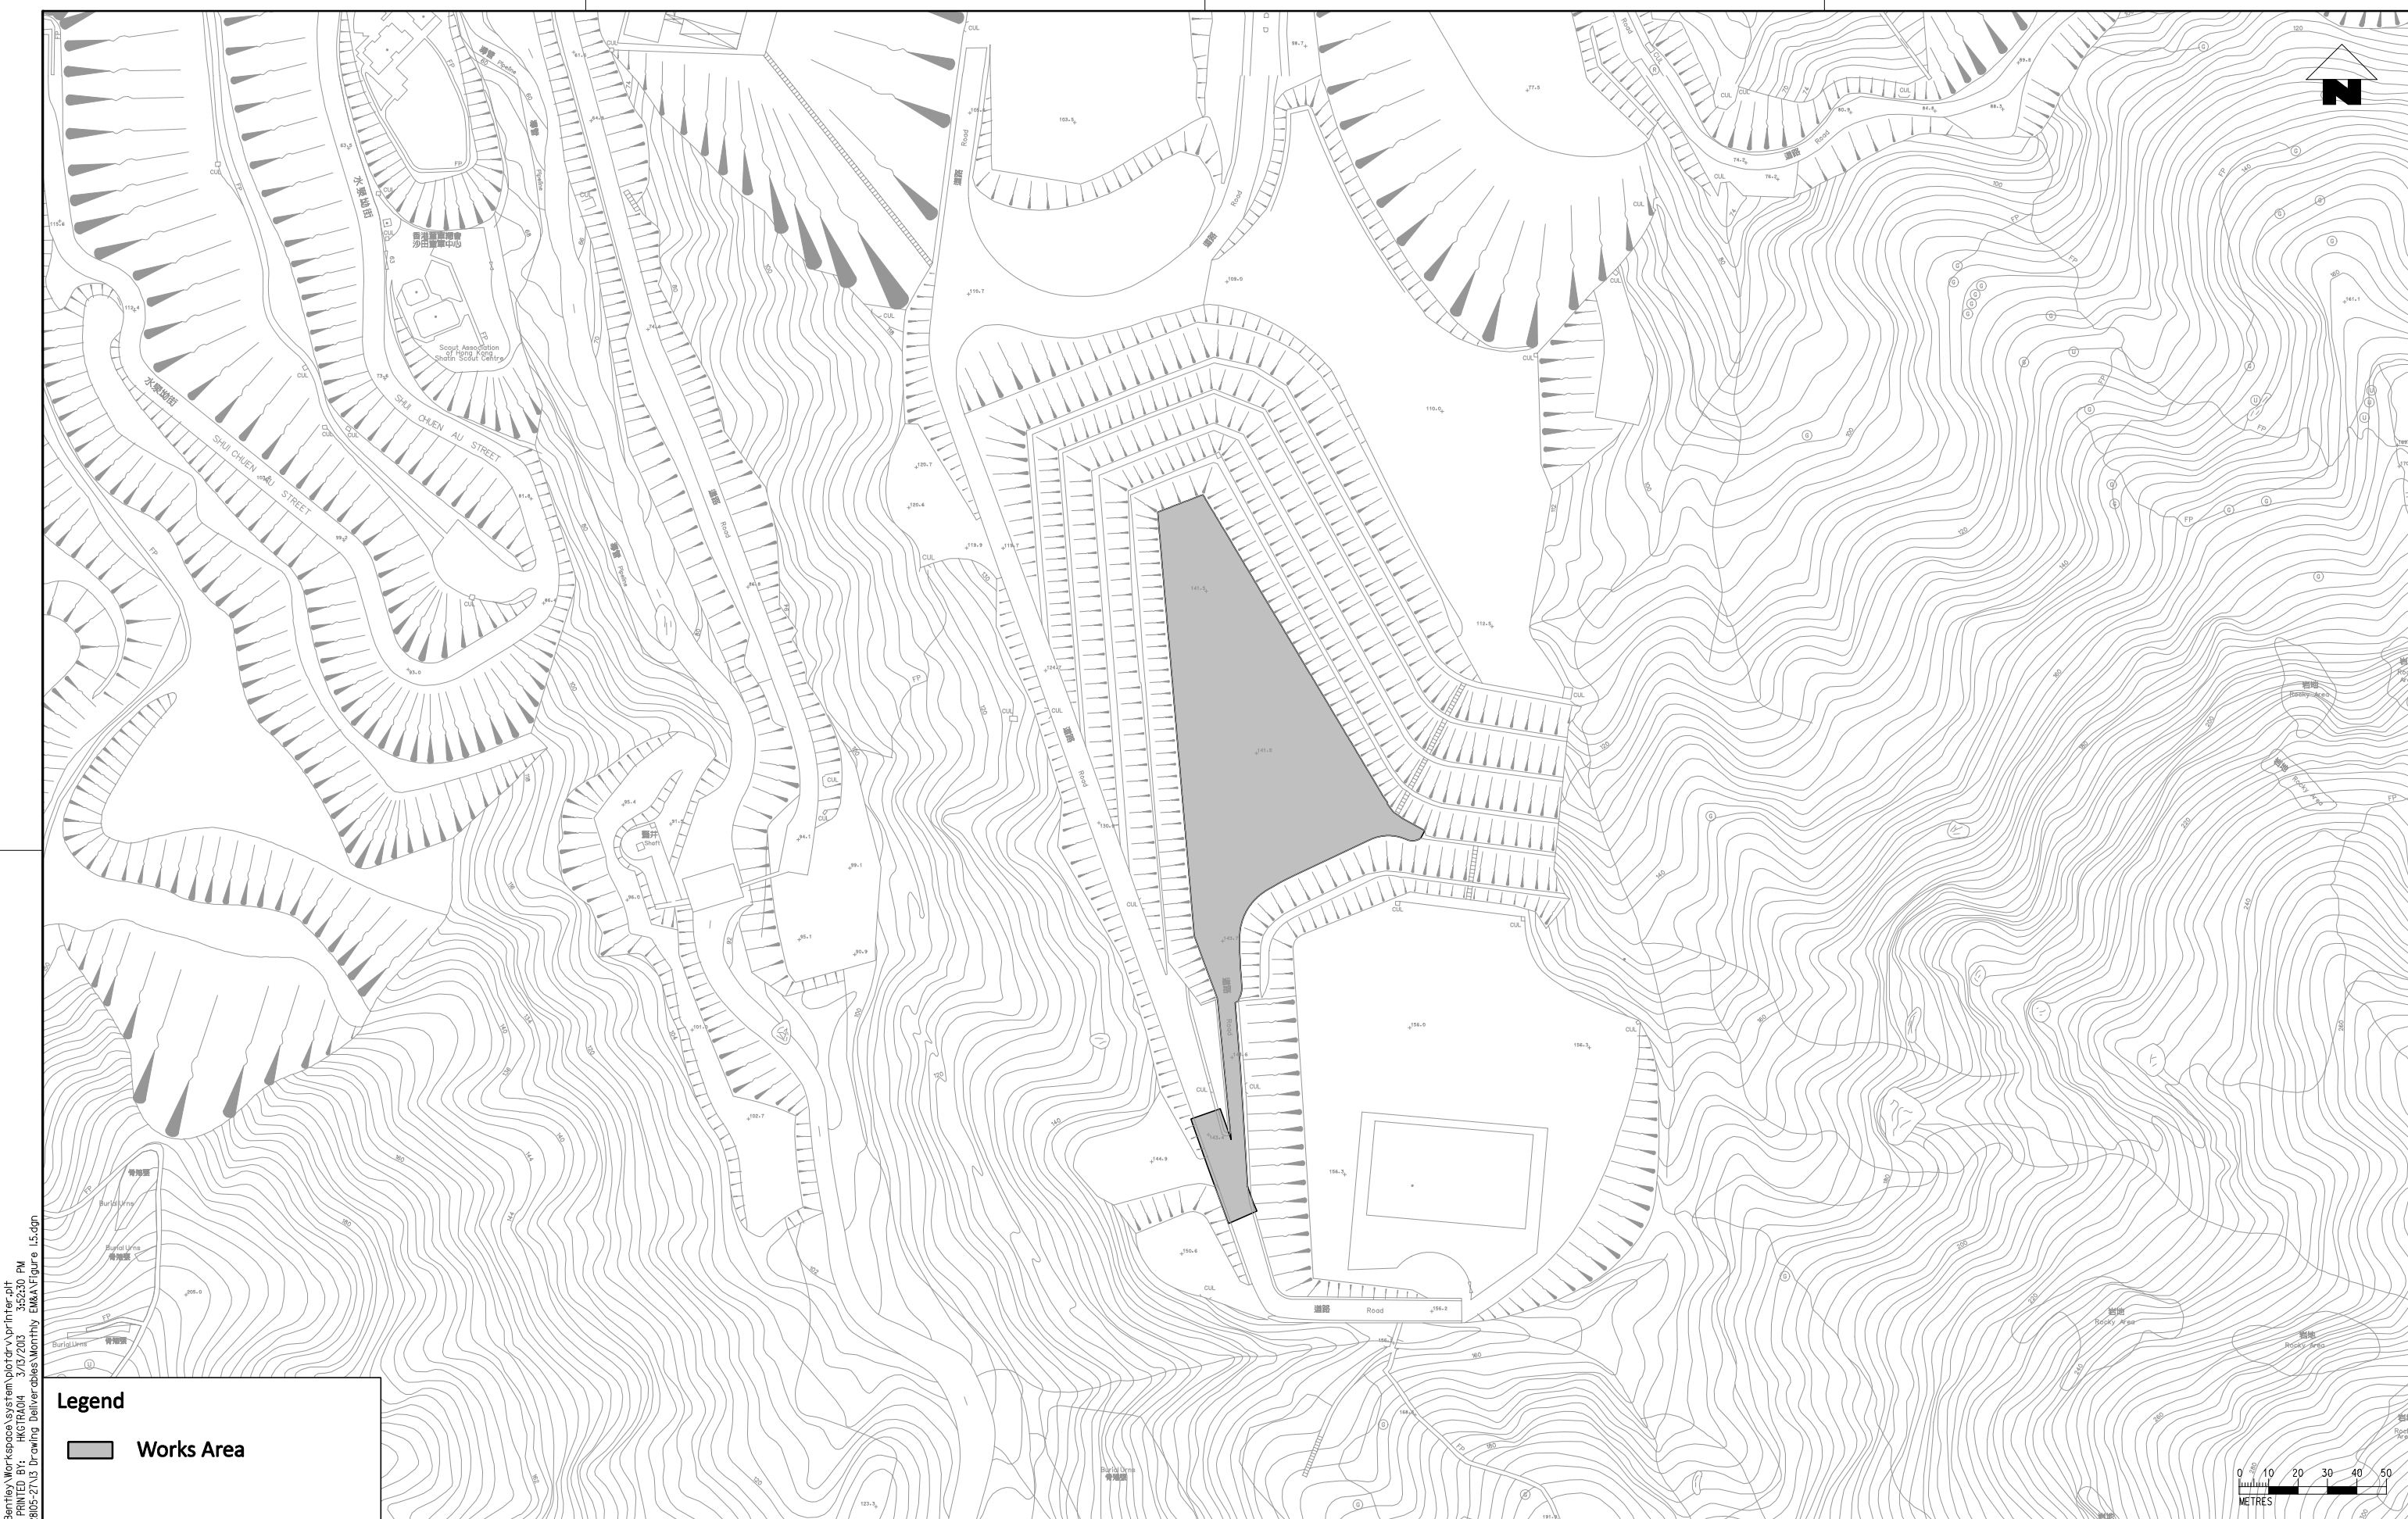
DRAWING NO.
 Figure 1.4

- Figure 1.3: Locations of Project Works Areas – Site layout Plan of Fung Tak EAP/EEP (Sheet 3 of 6)
- Figure 1.4: Locations of Project Works Areas – Site Layout Plan of Ma Chai Hang Shaft (Sheet 4 of 6)
