**Shatin to Central Link –
Tai Wai to Hung Hom Section and
Mong Kok East to Hung Hom Section**

Monthly EM&A Report No. 46

[Period from 1 to 30 June 2016]

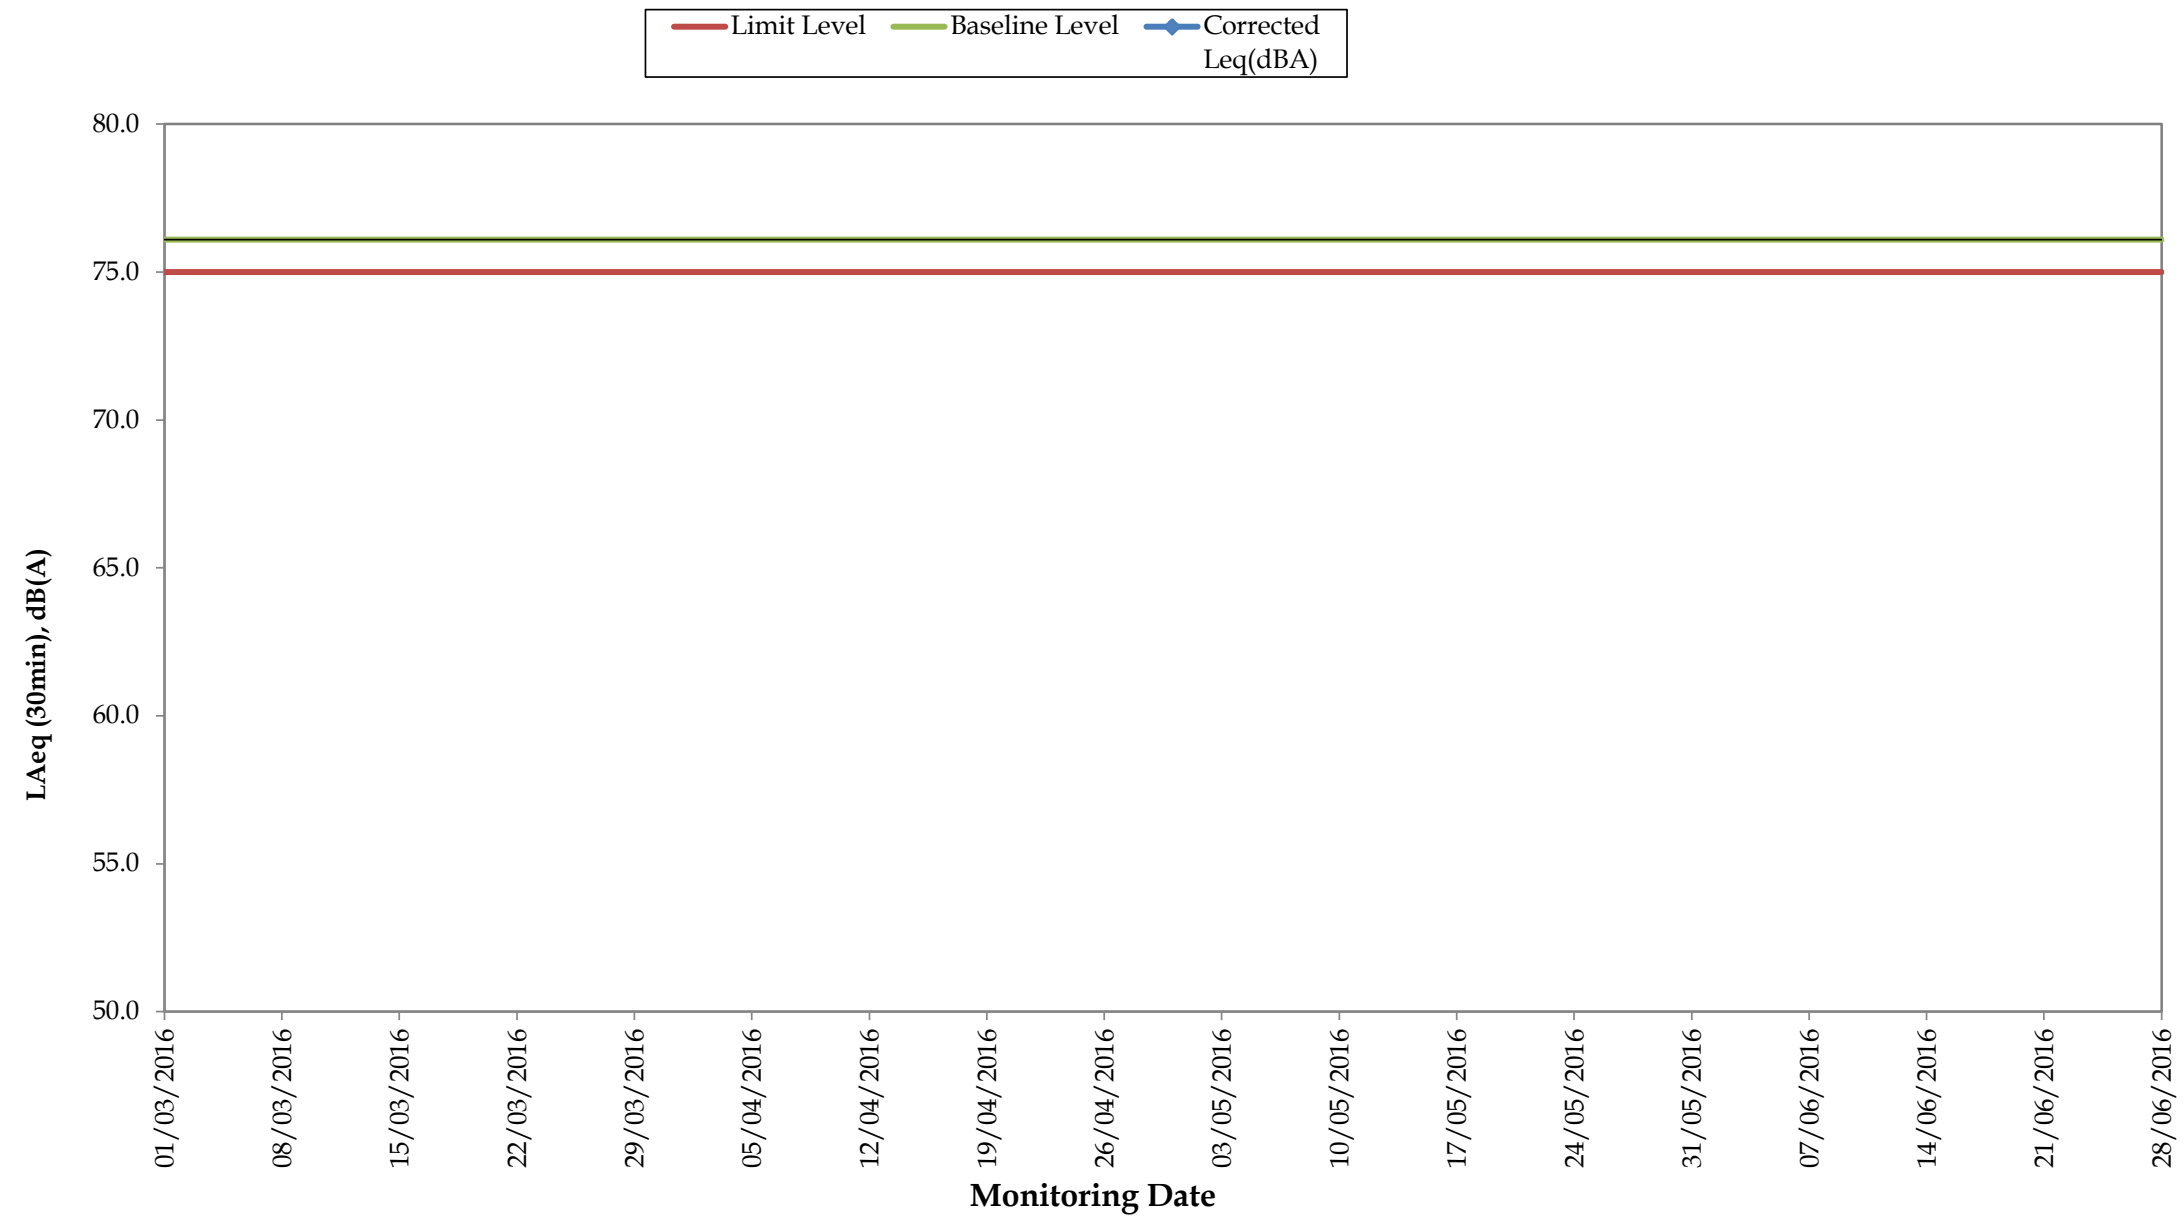
Regular Noise Monitoring Results at NMS-CA-6 (No. 16-23 Nam Kok Road) (LAeq, 30min) for the Past 4 Months

- For those corrected noise levels that are not shown in this graph, the measured noise levels are below baseline level.

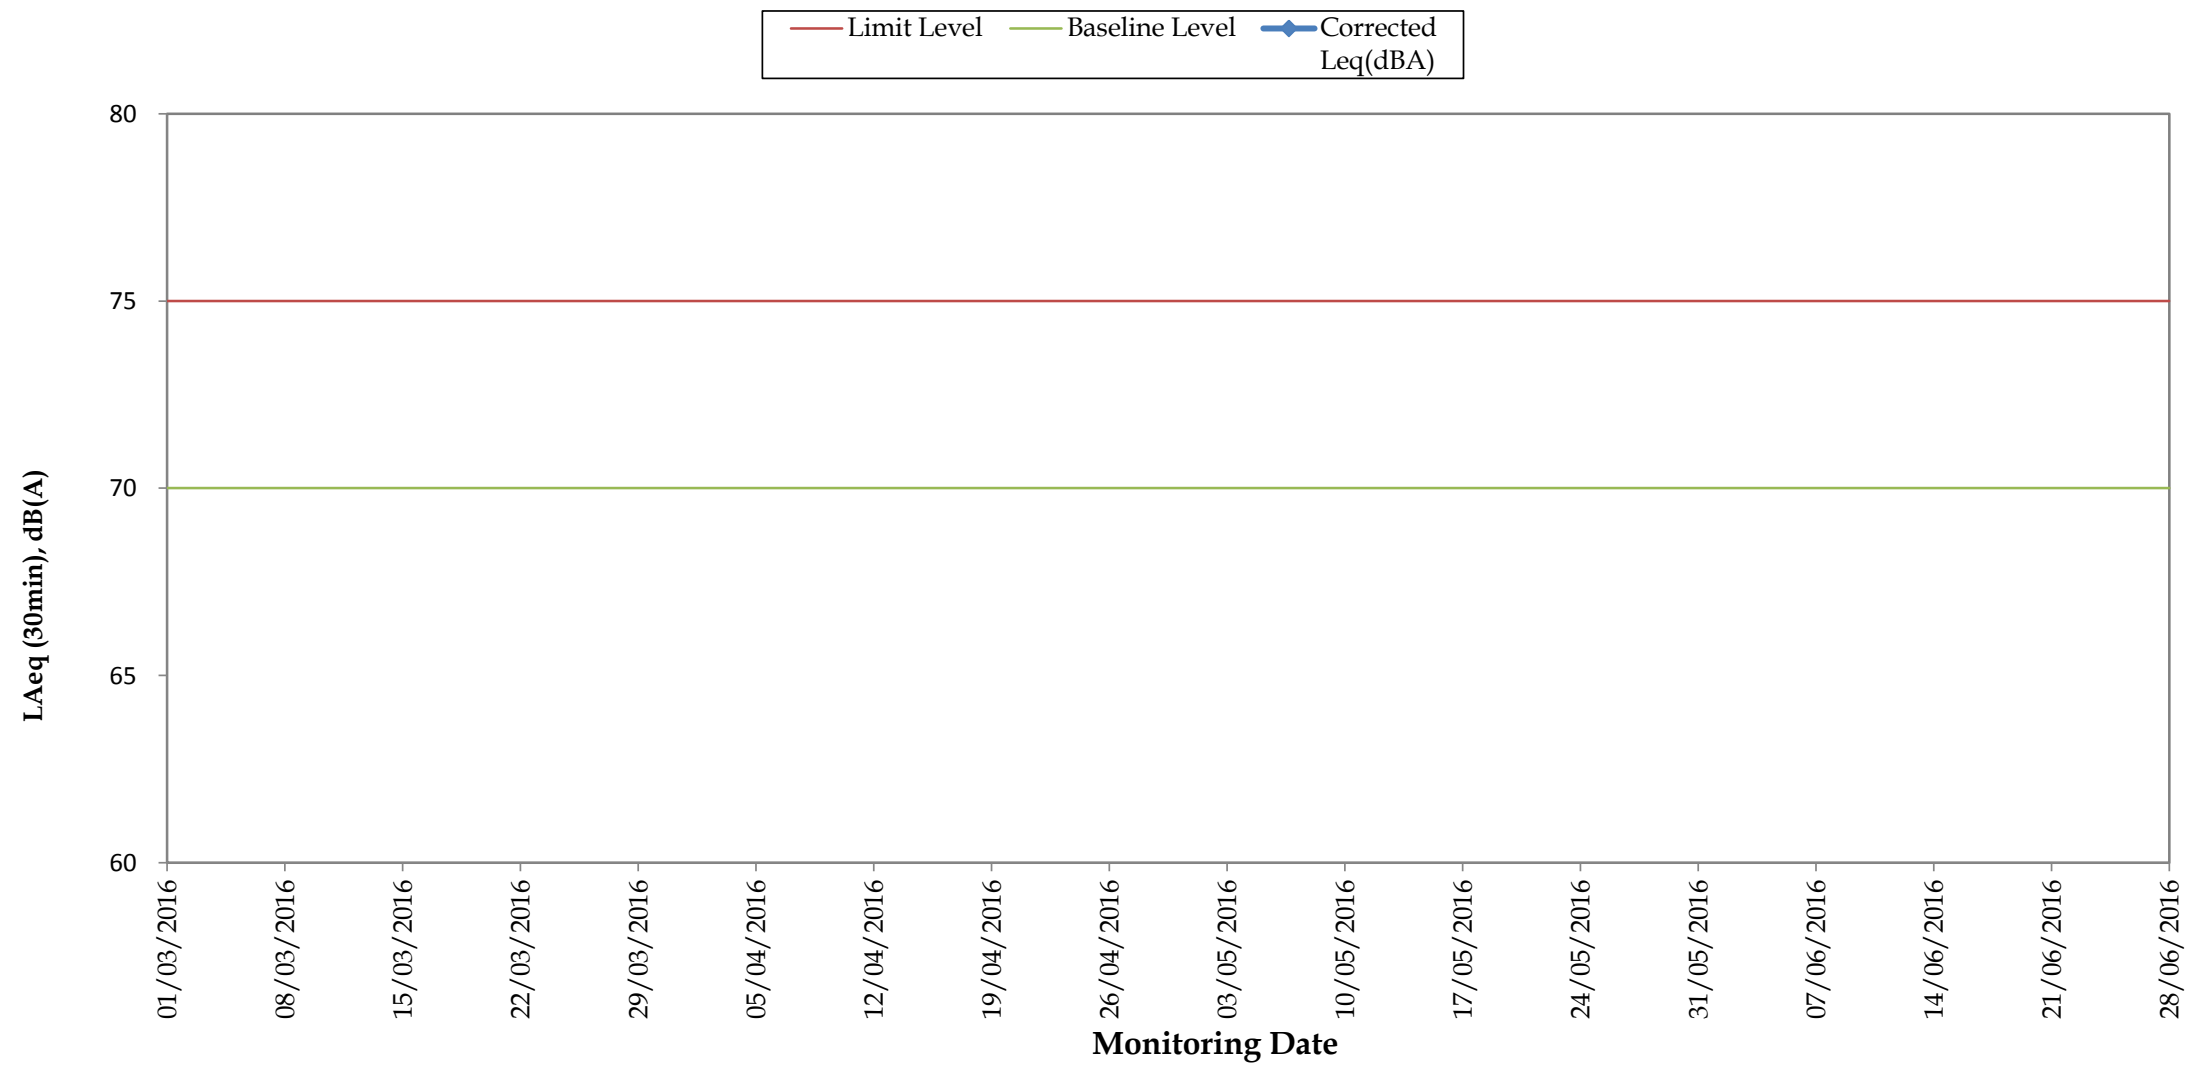
Regular Noise Monitoring Results at NMS-CA-7 (Skytower Tower 2) (LAeq, 30min) for the Past 4 Months

- For those corrected noise levels that are not shown in this graph, the measured noise levels are below baseline level.

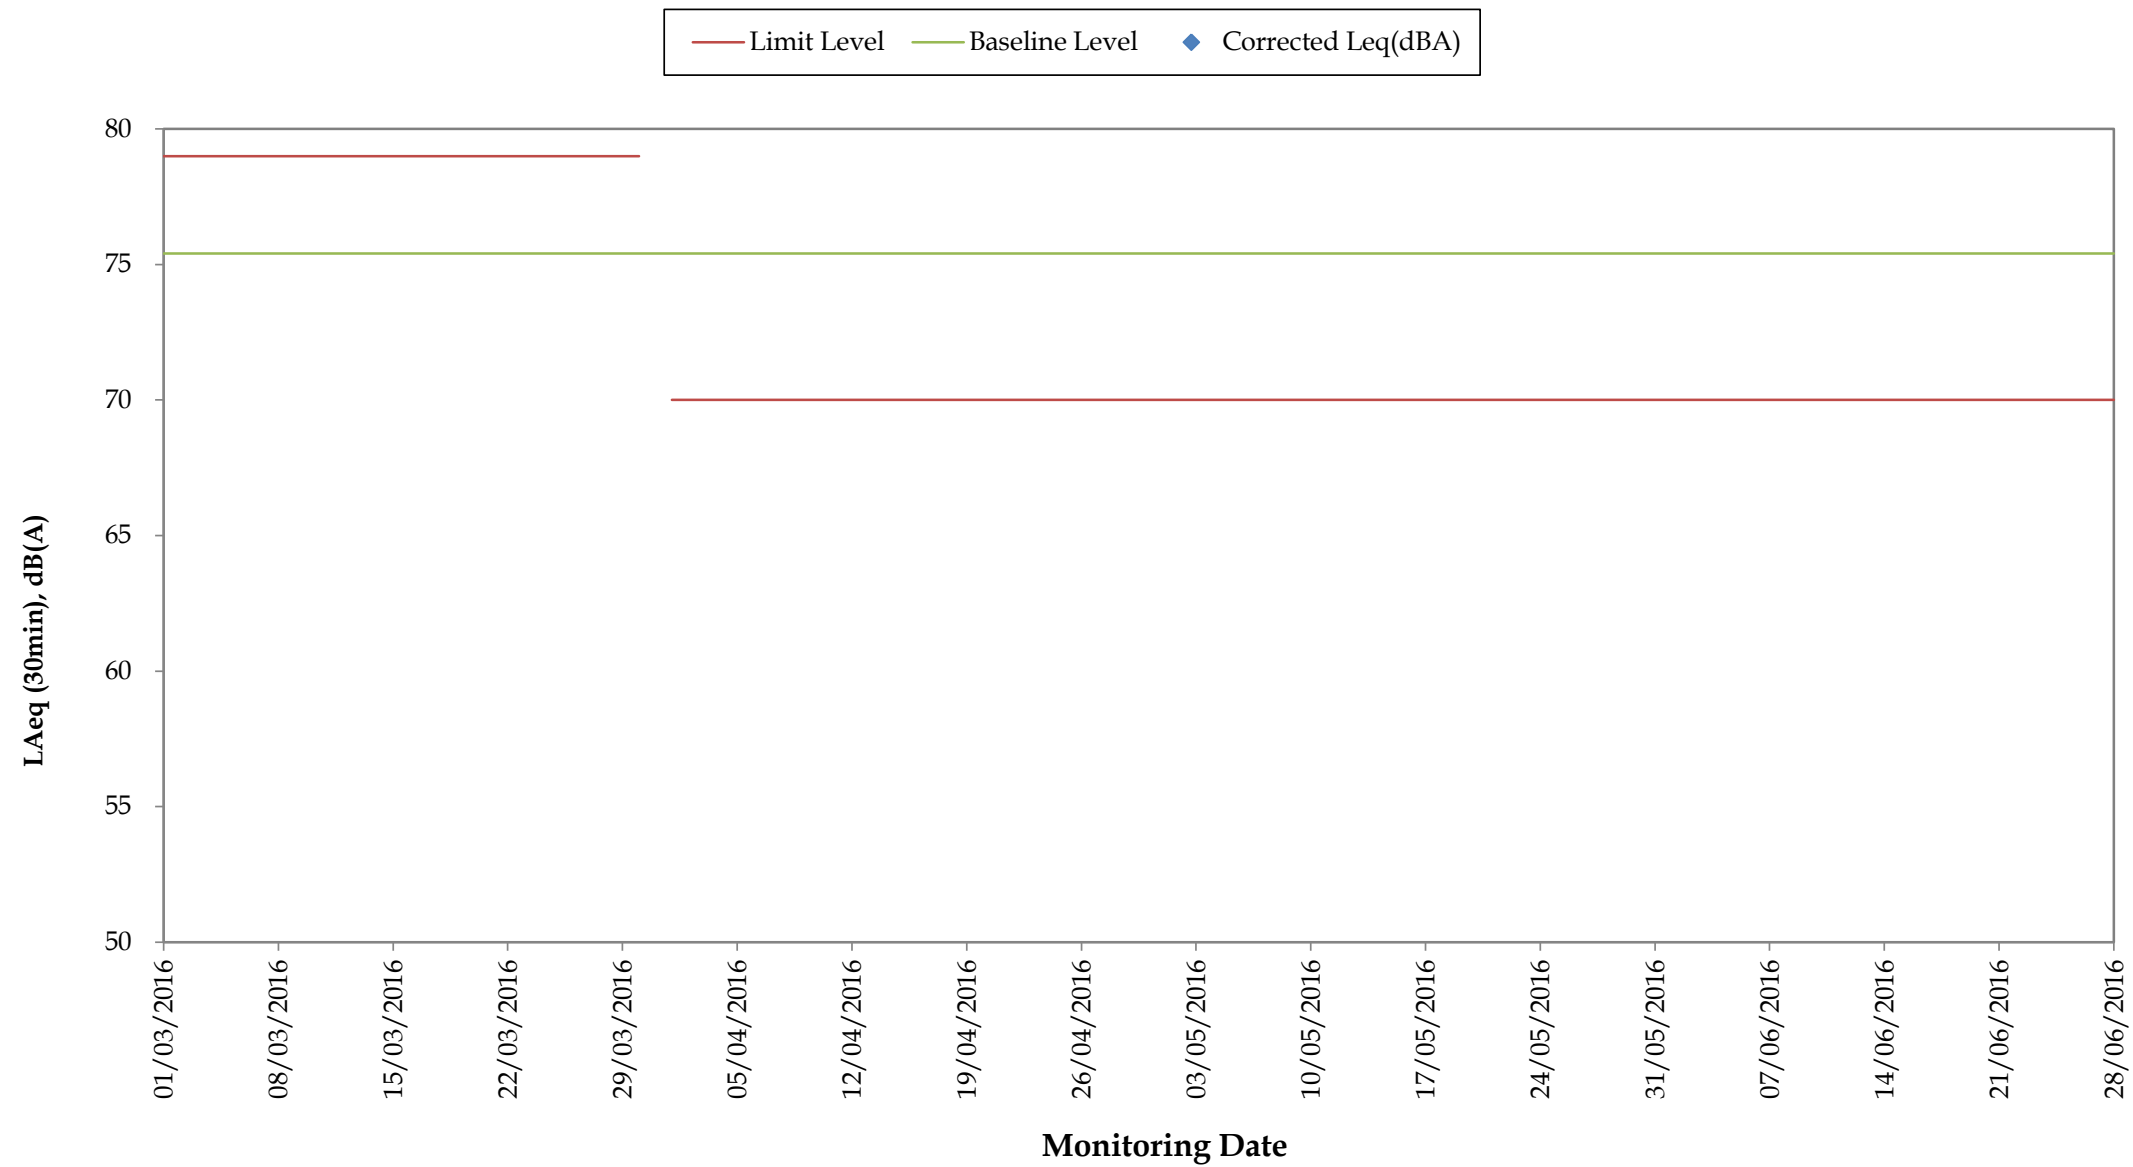
Regular Noise Monitoring Results at NMS-CA- 8 (SKH Good Shepherd Primary School) (LAeq, 30min) for the Past 4 Months

- For those corrected noise levels that are not shown in this graph, the measured noise levels are below baseline level.
- The limit level was updated from 78dB(A) to 79 dB(A) on 22 Aug 2013 as per the latest CNMP and CNMMP.
- The limit level was updated from 79dB(A) to 70dB(A)/65dB(A) (during normal/examination period) from April 2016, as the continuous noise monitoring was completed in March 2016 according to the latest CNMP

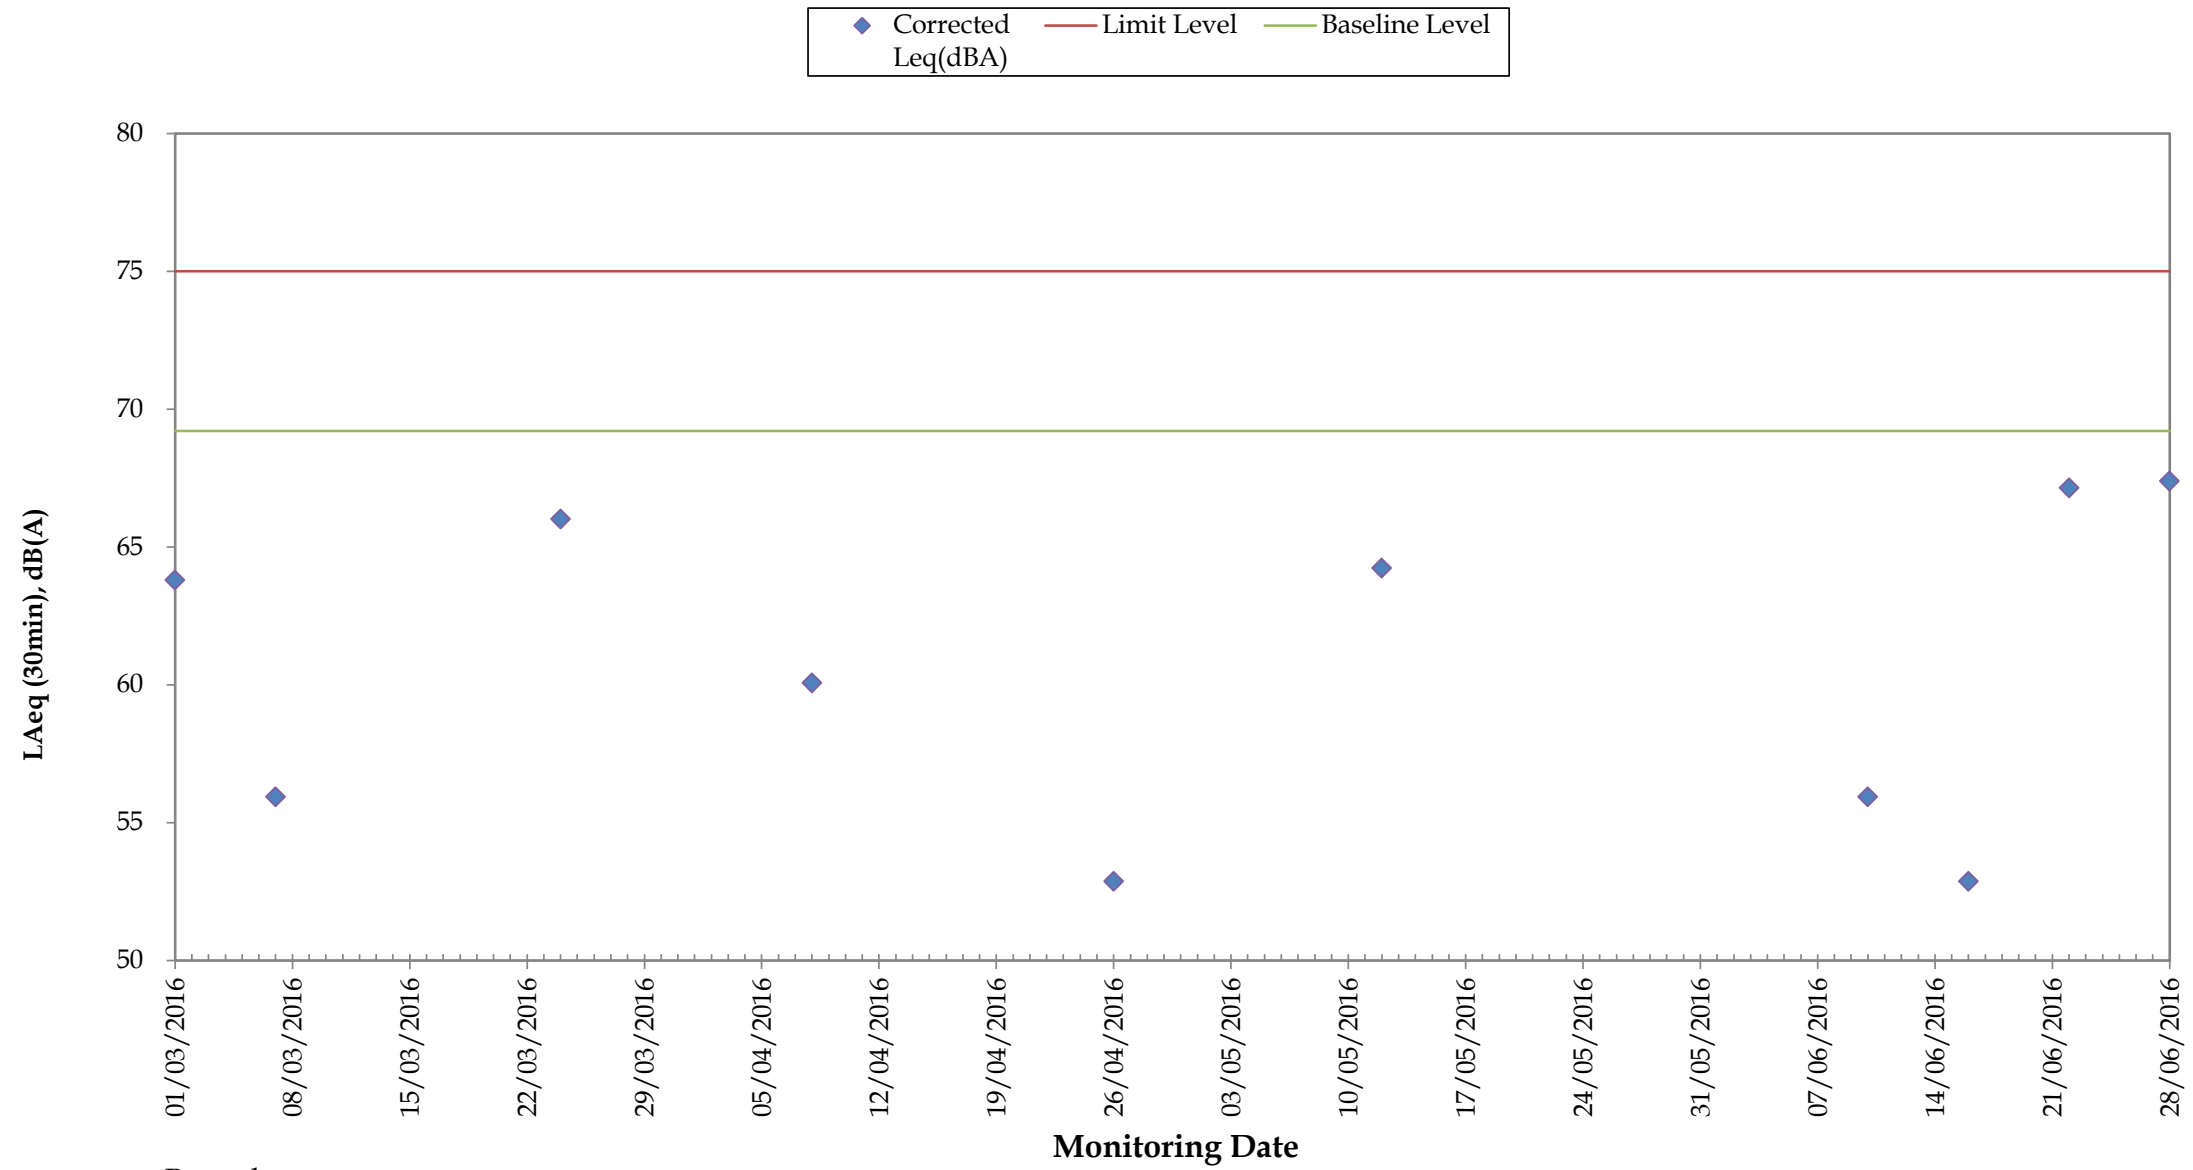
Regular Noise Monitoring Results at NMS-CA-9 (Kong Yiu Mansion) (LAeq, 30min)) for the Past 4 Months

- For those corrected noise levels that are not shown in this graph, the measured noise levels are below baseline level.

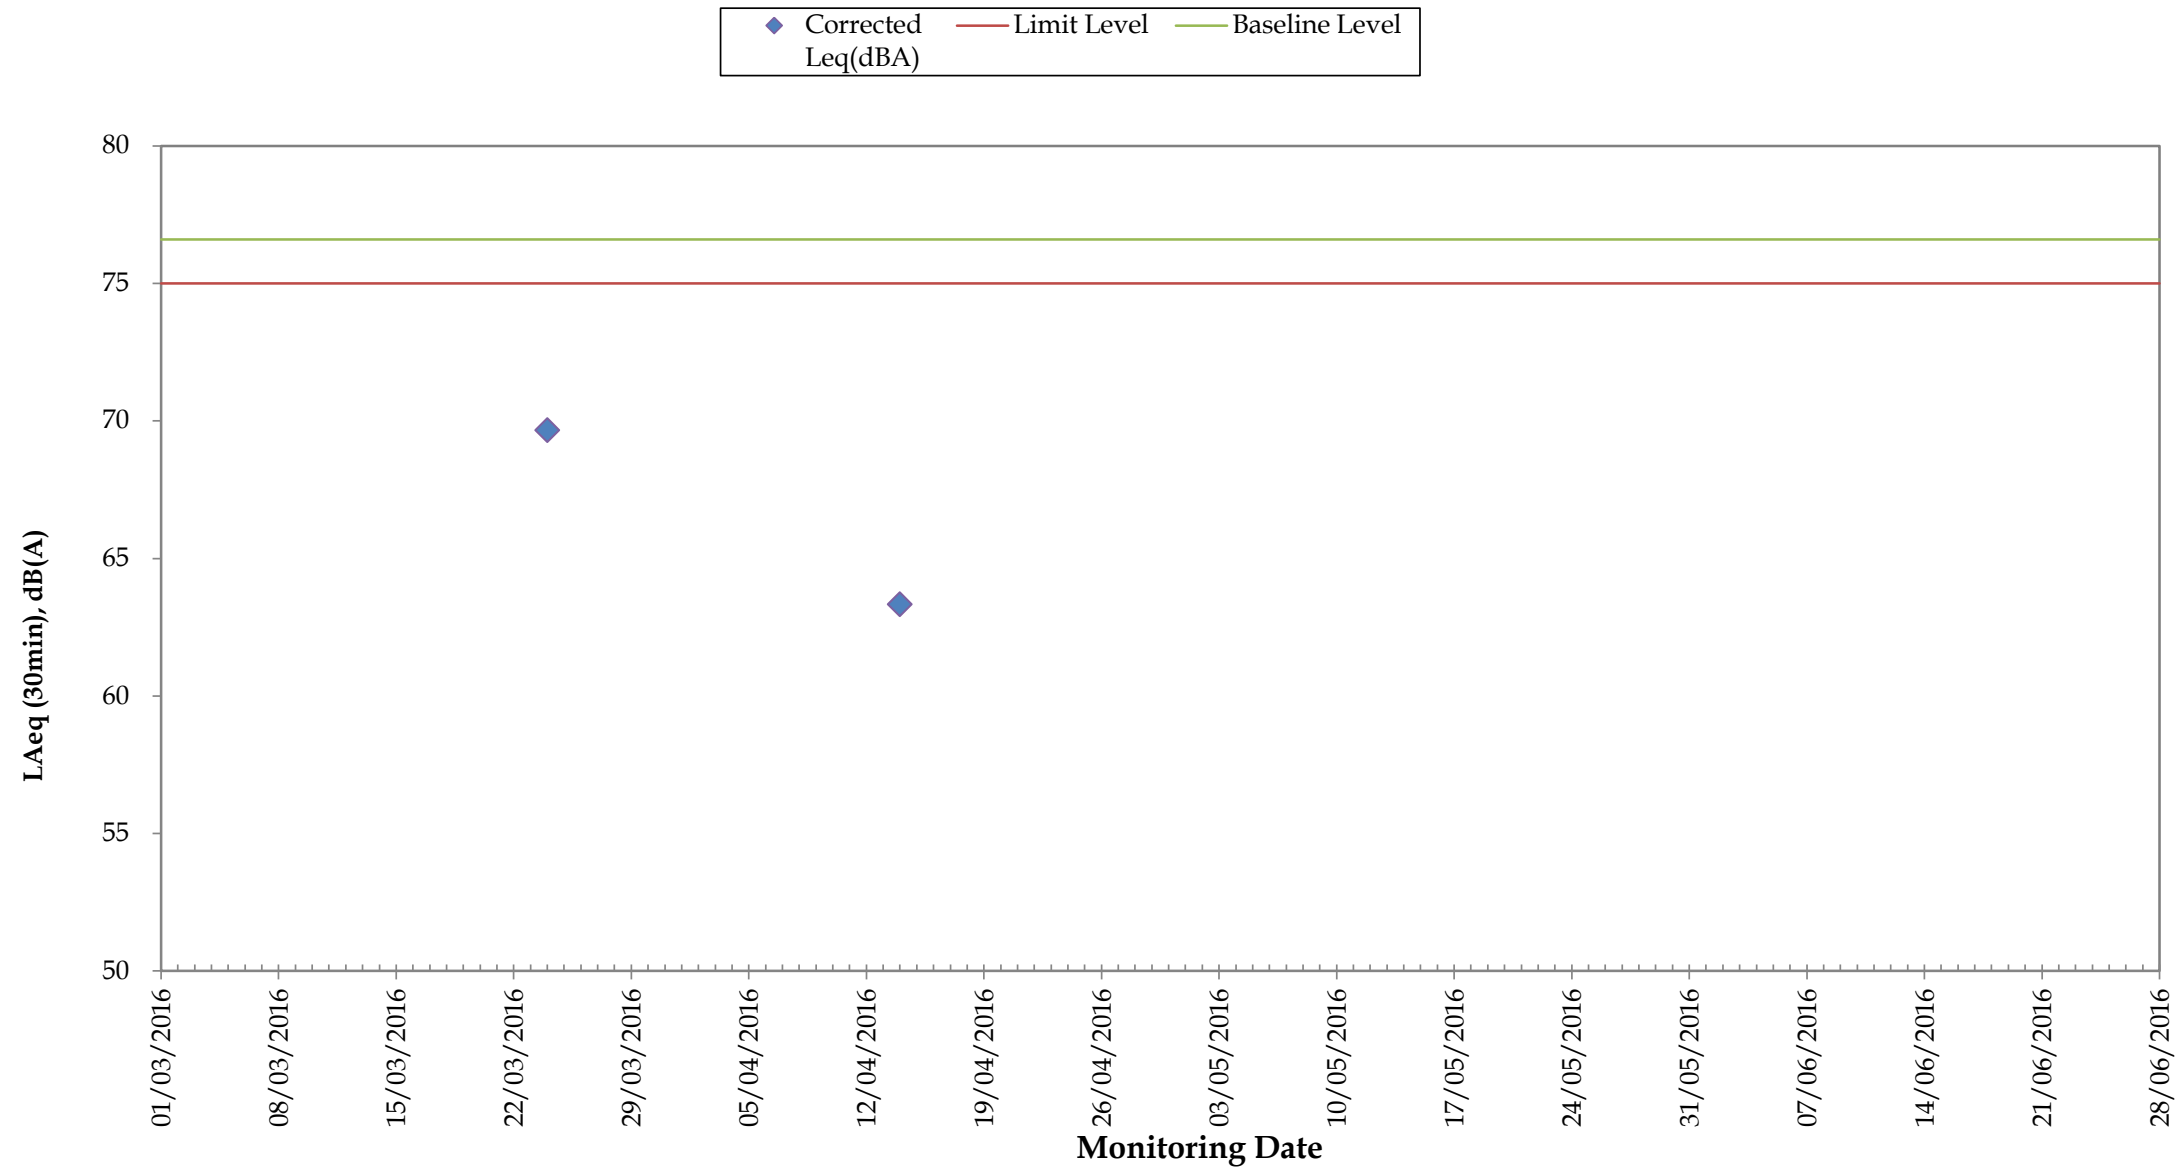
Regular Noise Monitoring Results at NMS-CA-10 (Chat Ma Mansion) (LAeq, 30min) for the Past 4 Months

- For those corrected noise levels that are not shown in this graph, the measured noise levels are below baseline level.
- Noise monitoring at NMS-CA-10 (Chat Ma Mansion) was temporarily suspended due to request from the Management Office.

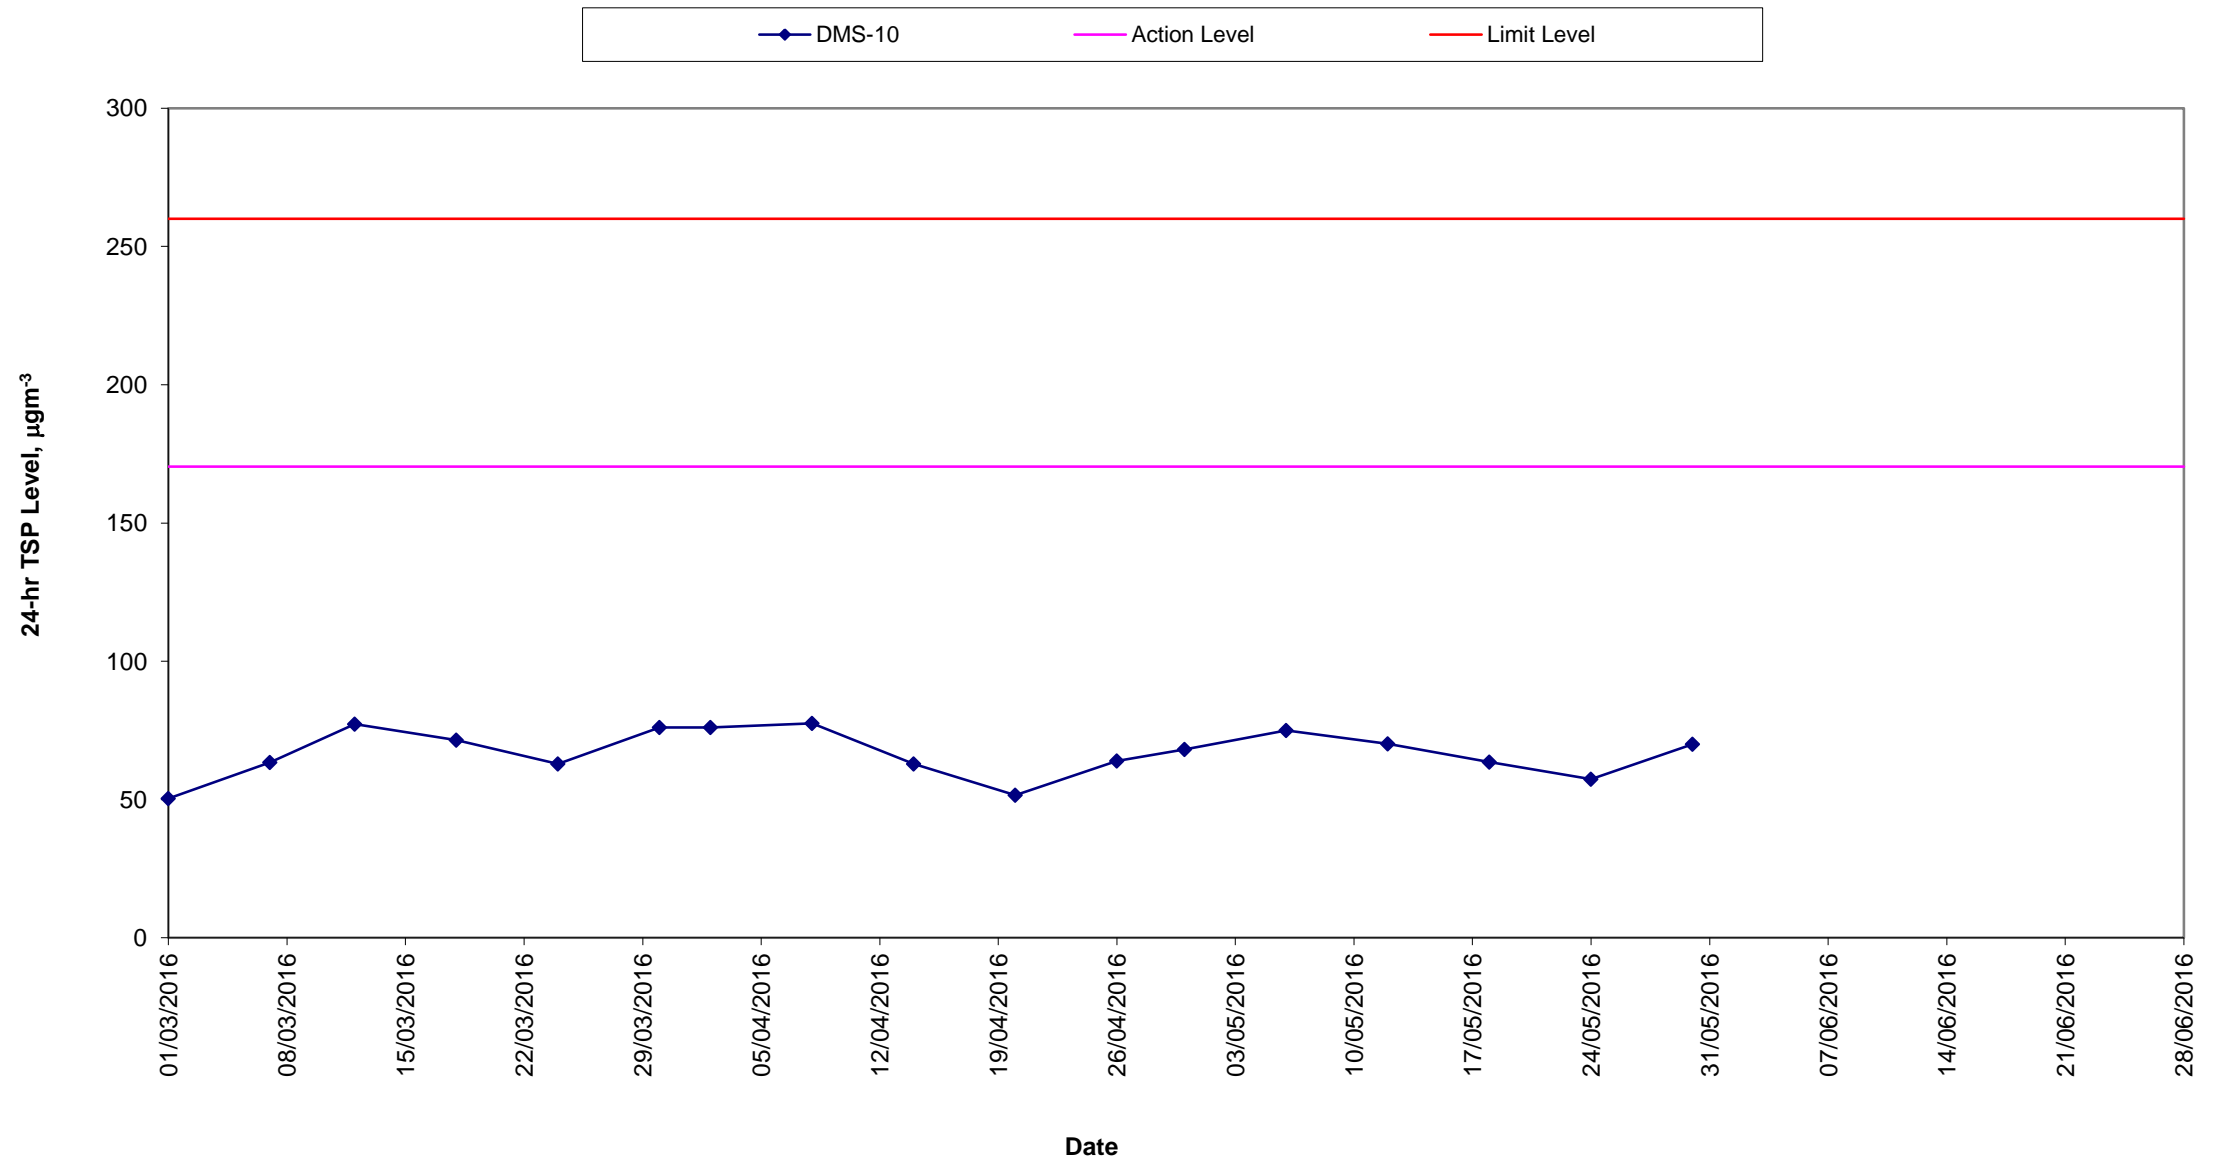
Construction Dust Monitoring Results for the Past 4 Months DMS-10 (Chat Ma Mansion)

- 24-hour averaged dust monitoring at DMS-10 (Chat Ma Mansion) was temporary suspended due to request from the Management Office.

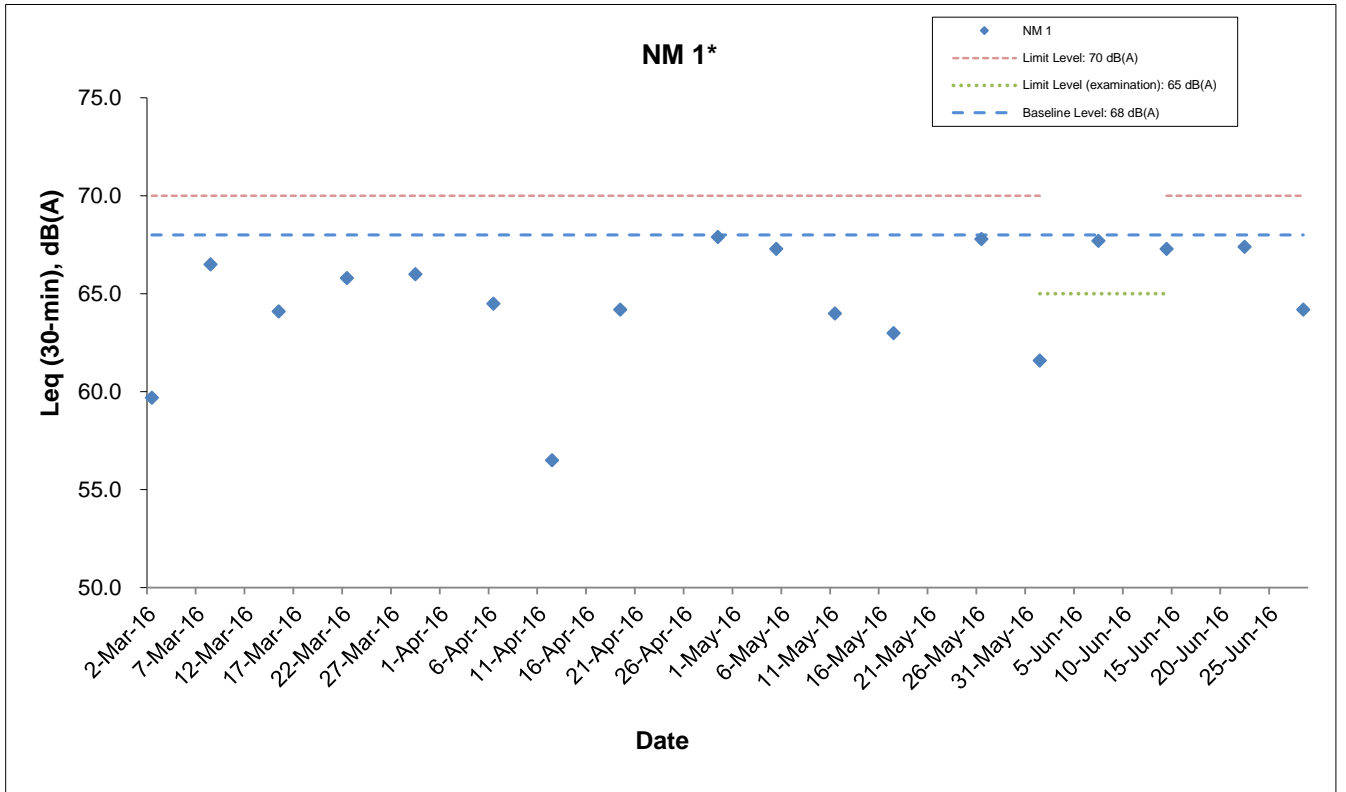
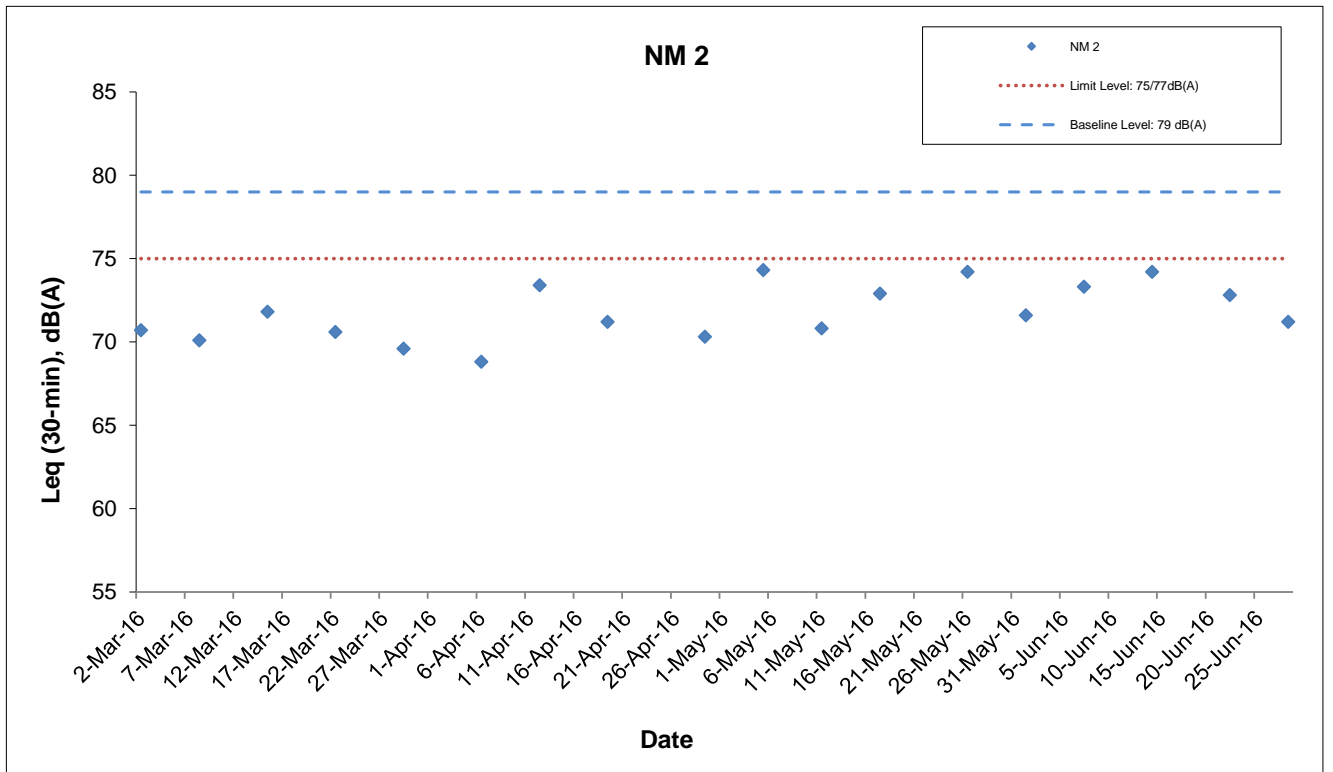
Appendix H Regular Construction Noise Monitoring Results

* - The noise monitoring results of the measurements are higher than the daytime construction noise criterion. However, the results are not considered as exceedance if they are either below the baseline level or below the limit level after deducting the baseline noise level.

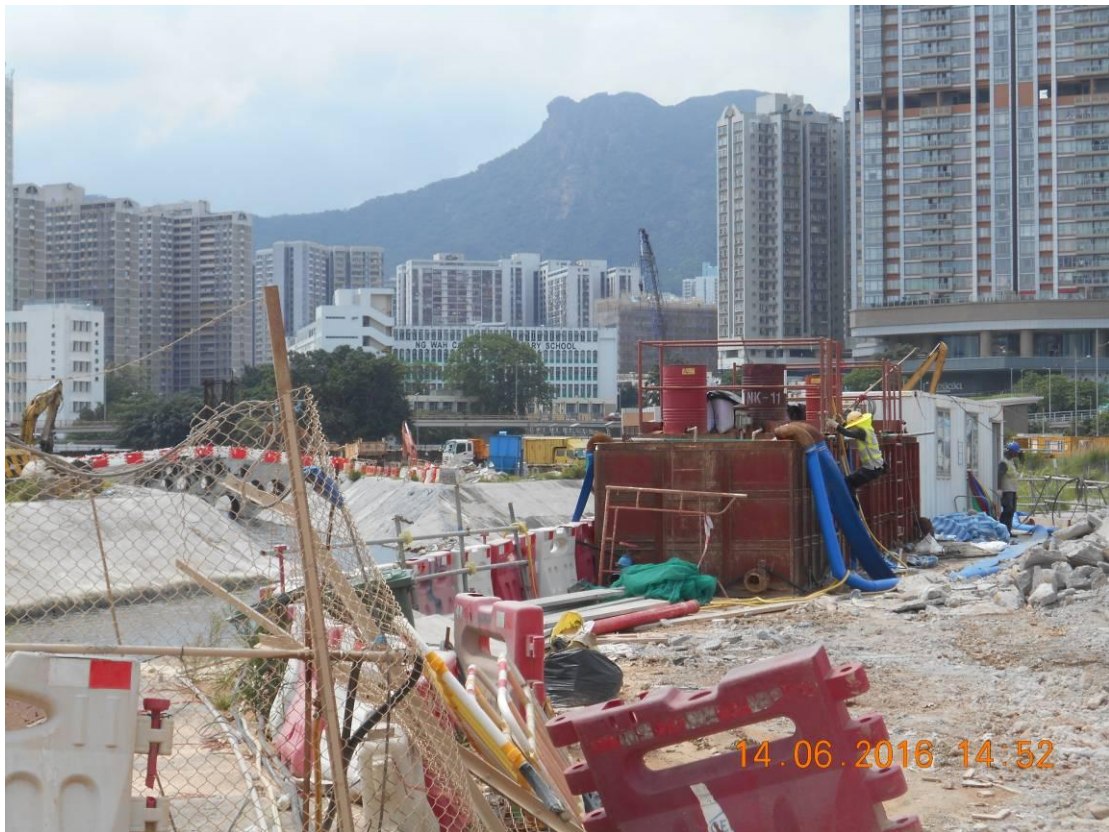
Fig.1 – Sedimentation tank was provided for desilting.

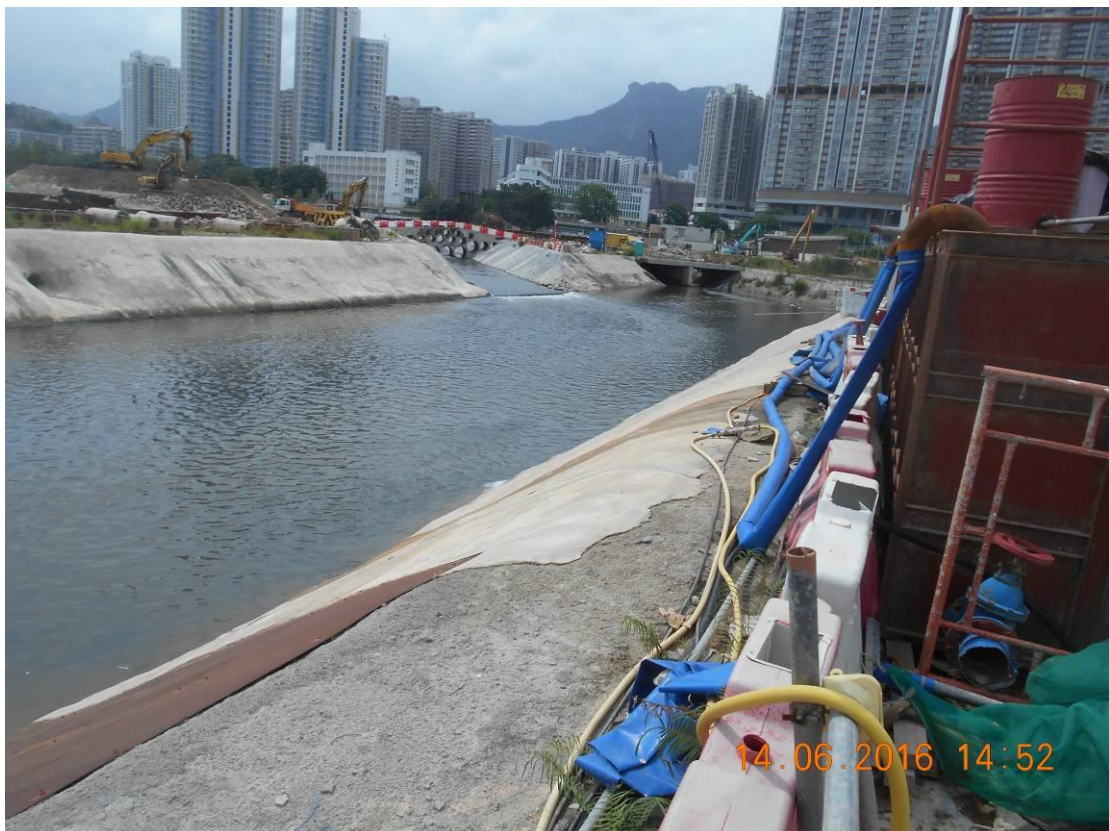
Fig.2 – Sedimentation tank was provided for desilting.

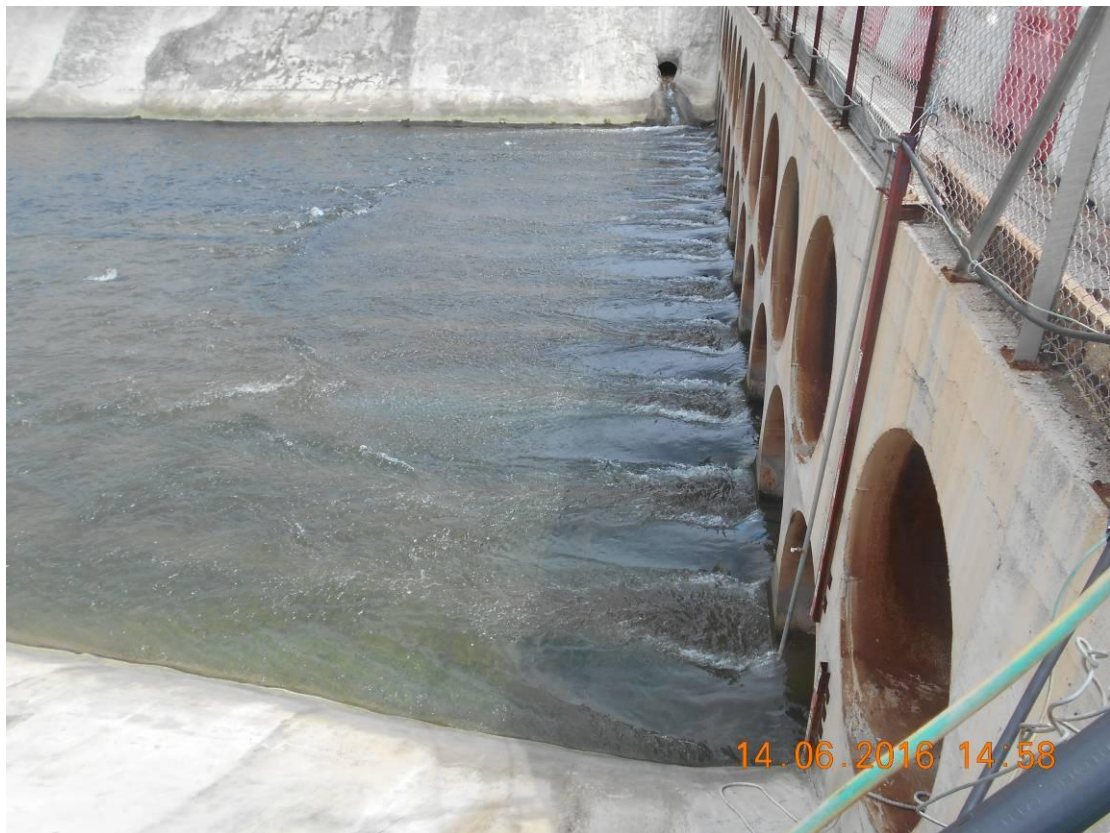
Fig.3–The discharge of site water was treated.
