**Shatin to Central Link –  
Tai Wai to Hung Hom Section and  
Mong Kok East to Hung Hom Section**

Monthly EM&A Report No. 48

[Period from 1 to 31 August 2016]

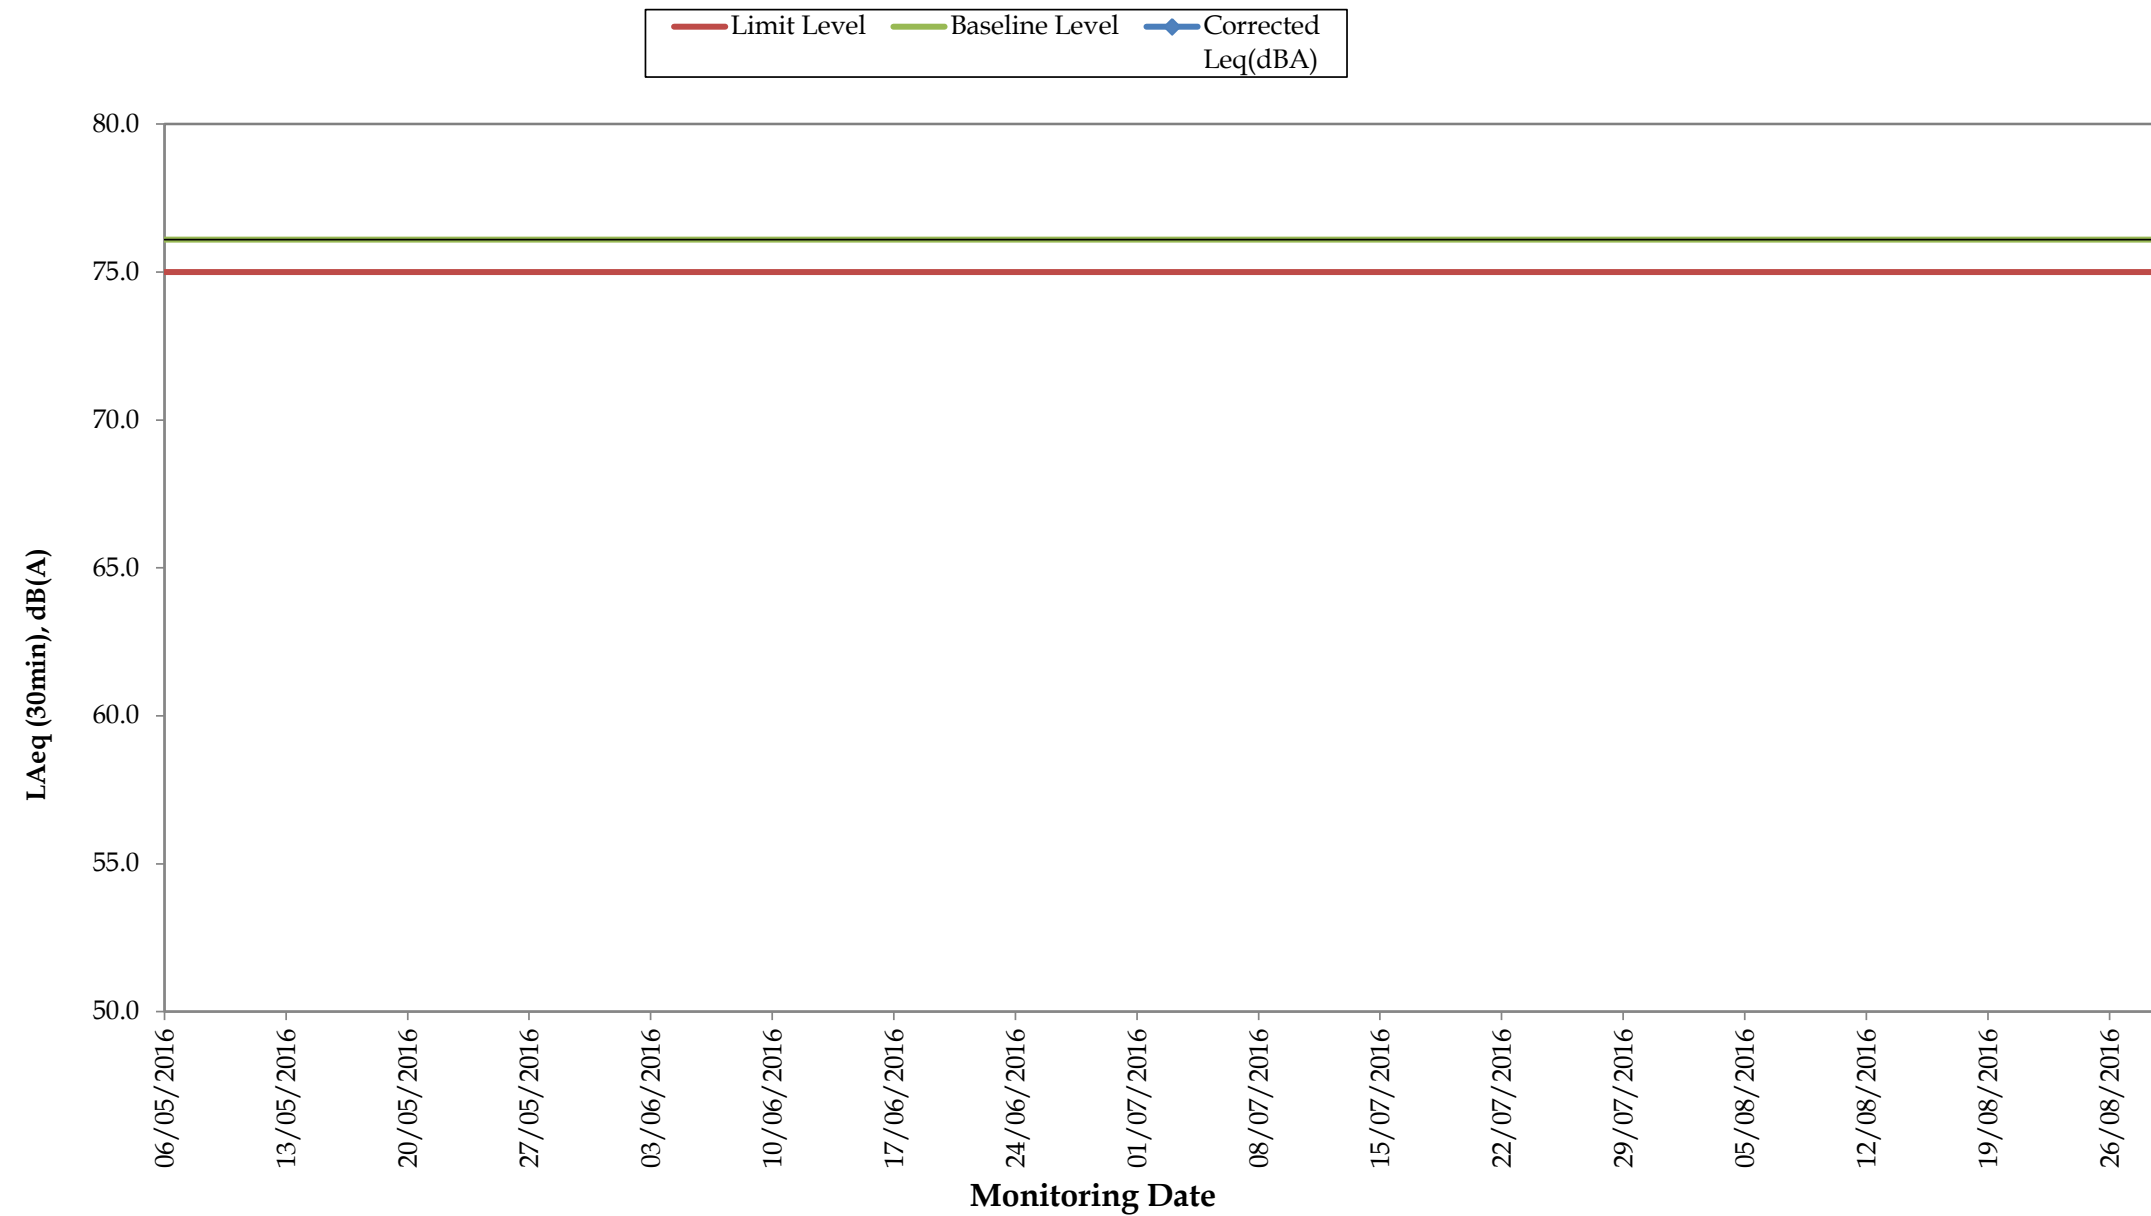
## Regular Noise Monitoring Results at NMS-CA-6 (No. 16-23 Nam Kok Road) (LAeq, 30min) for the Past 4 Months

- For those corrected noise levels that are not shown in this graph, the measured noise levels are below baseline level.

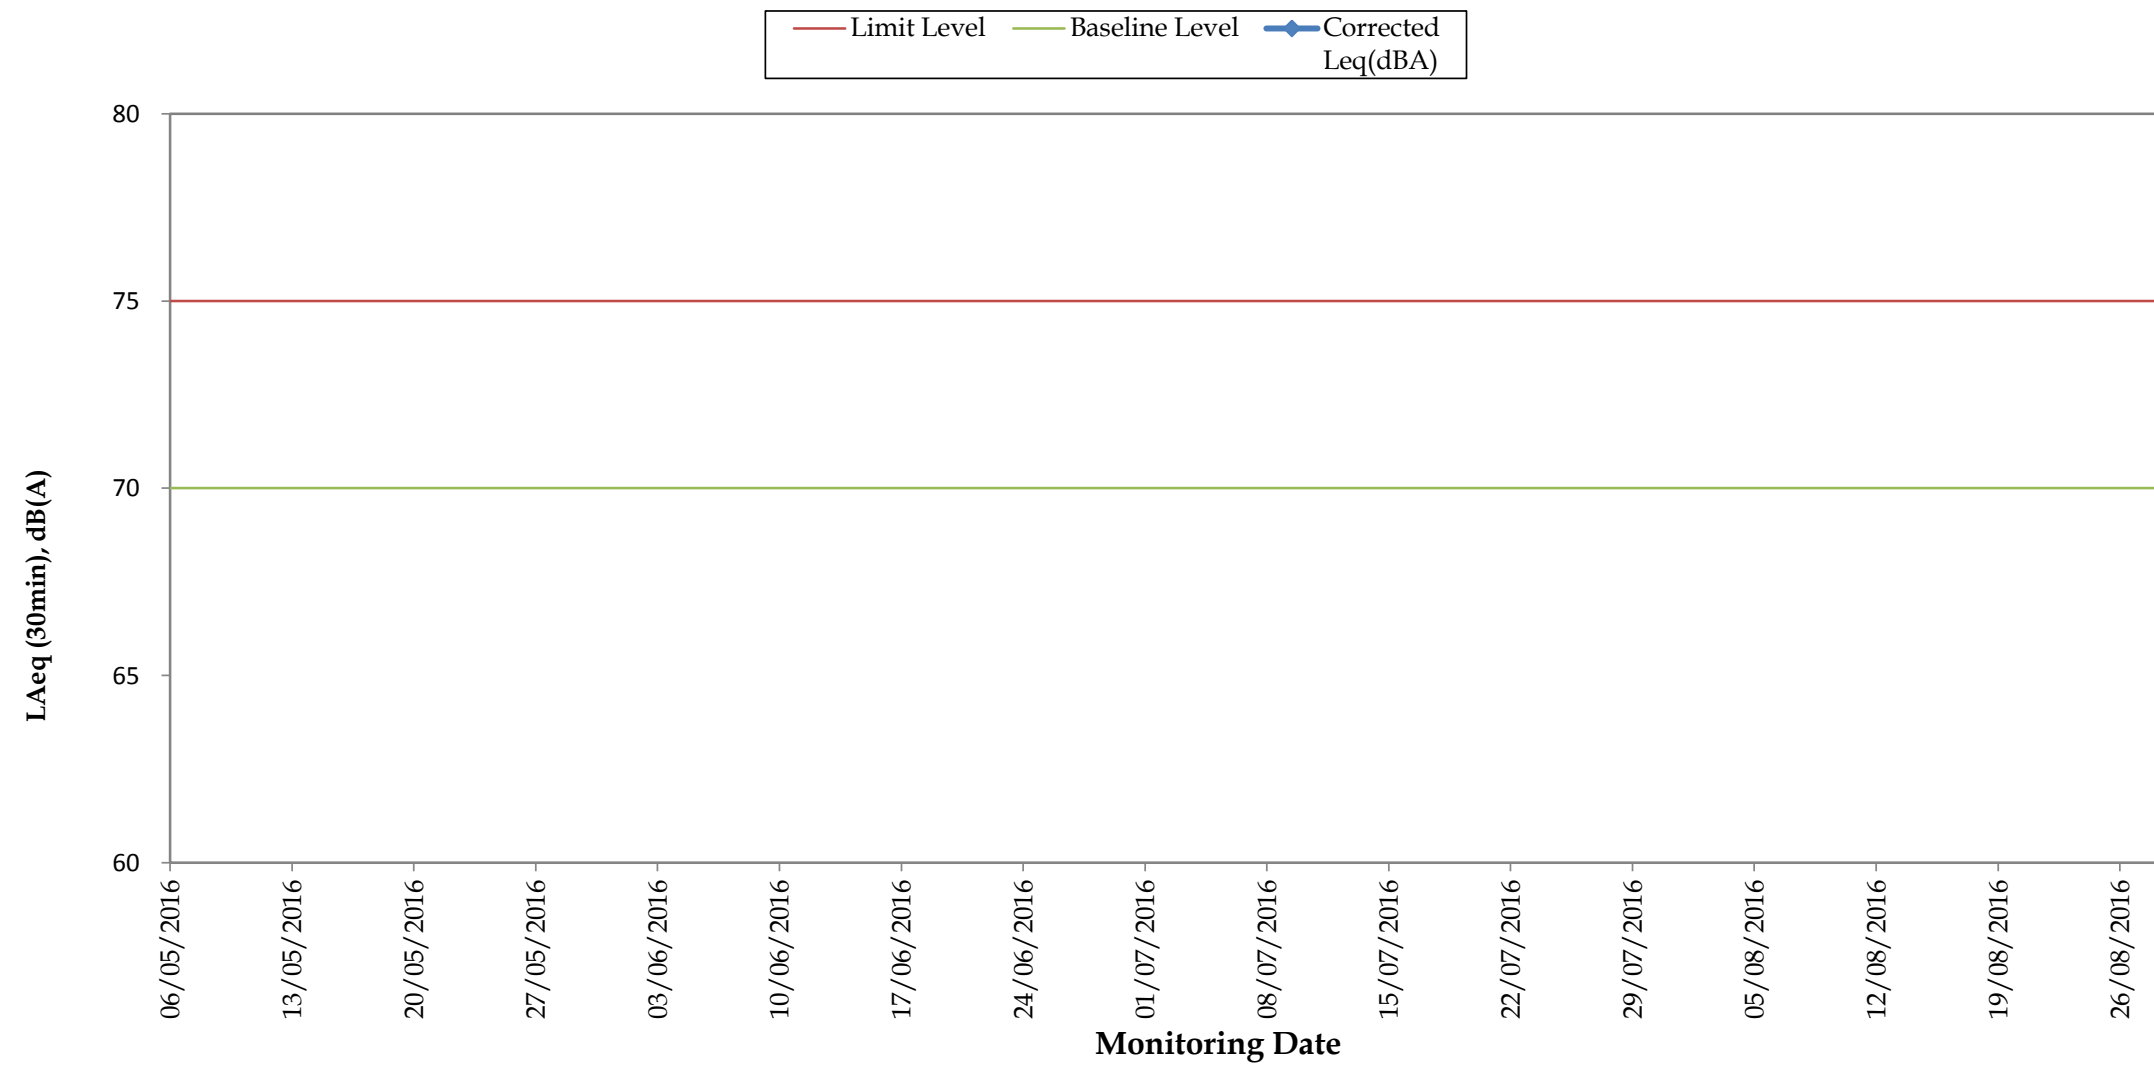
## Regular Noise Monitoring Results at NMS-CA-7 (Skytower Tower 2) (LAeq, 30min) for the Past 4 Months

- For those corrected noise levels that are not shown in this graph, the measured noise levels are below baseline level.

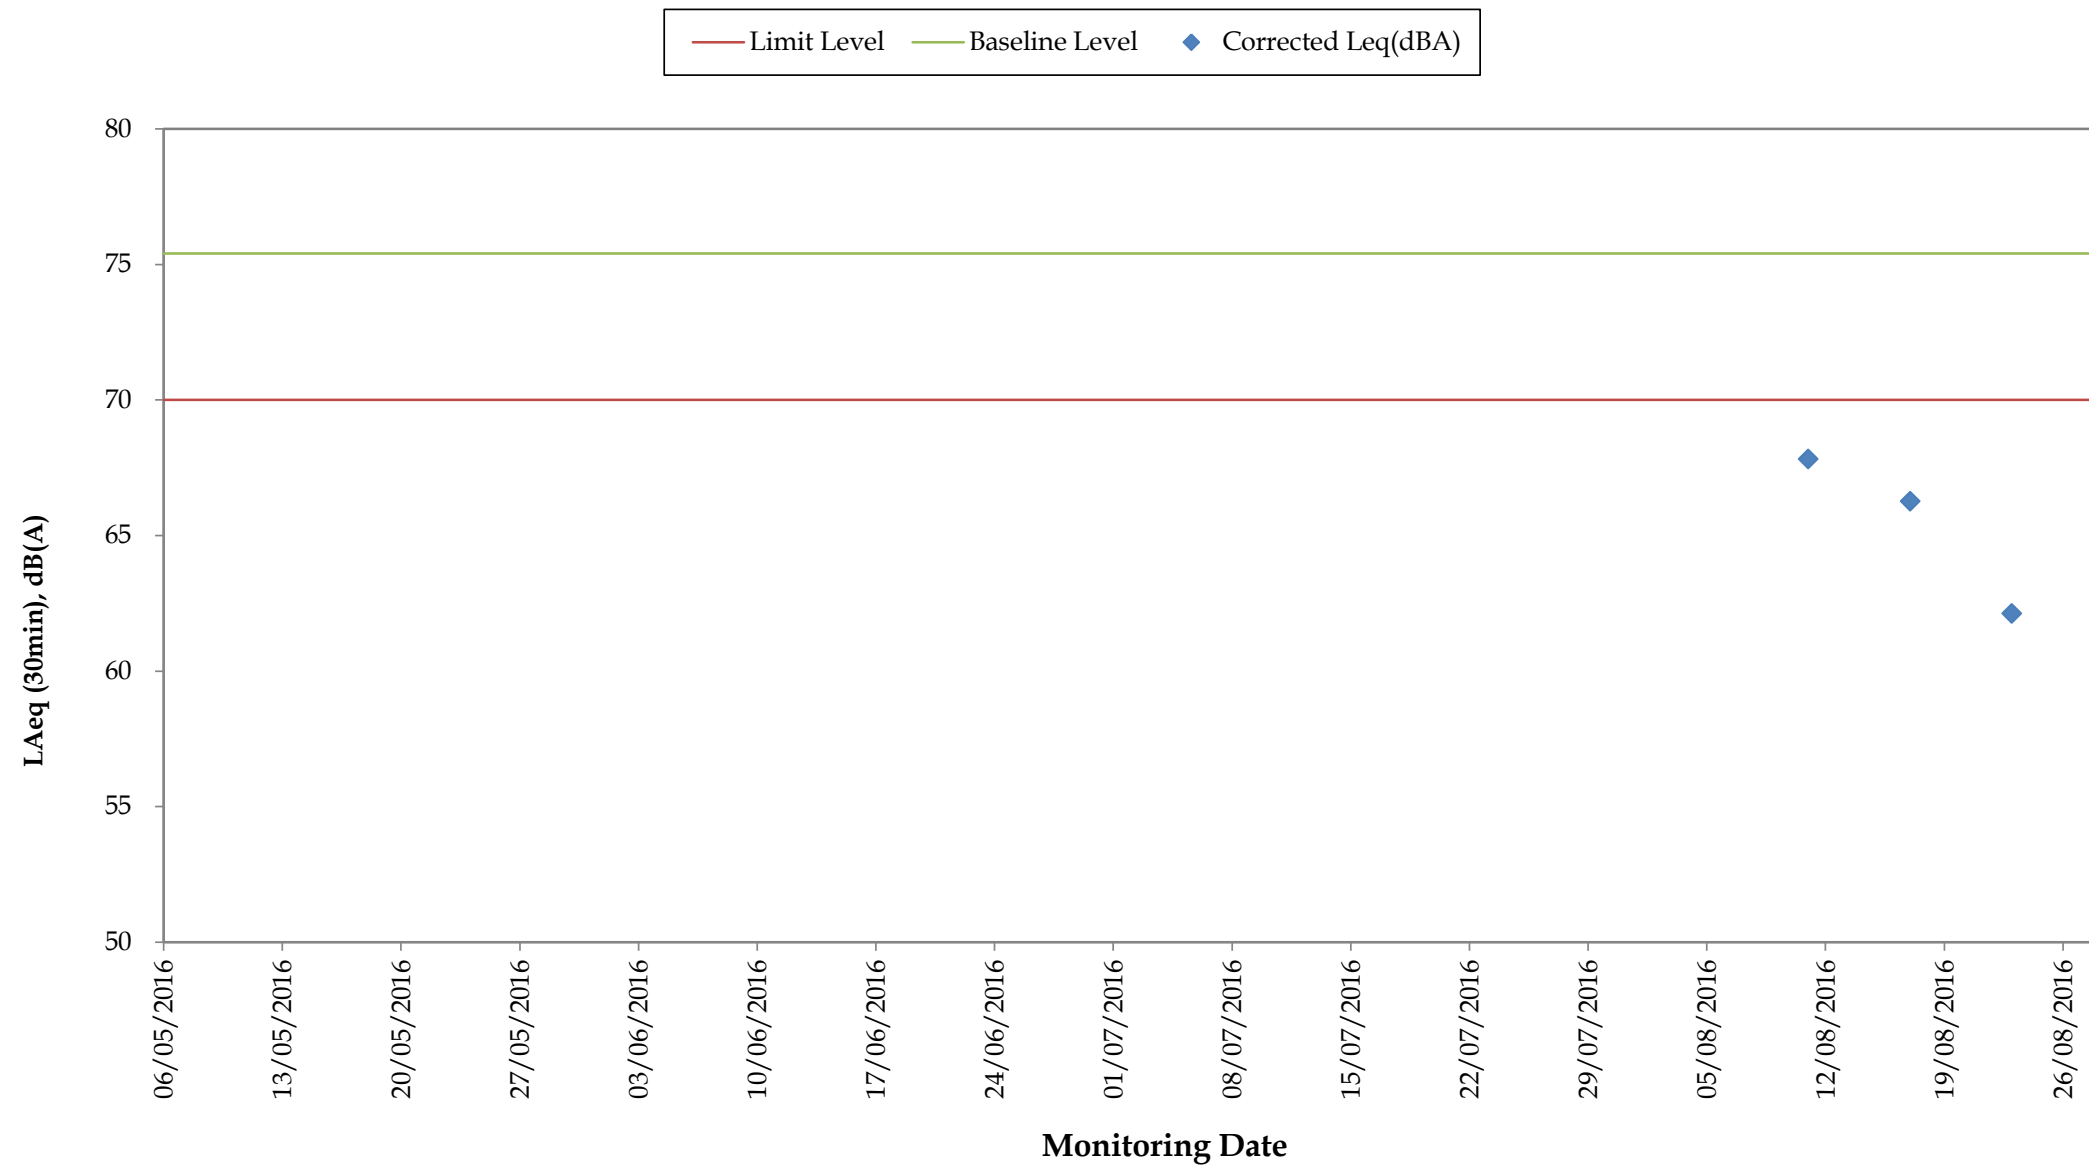
## Regular Noise Monitoring Results at NMS-CA- 8 (SKH Good Shepherd Primary School) (LAeq, 30min) for the Past 4 Months

- For those corrected noise levels that are not shown in this graph, the measured noise levels are below baseline level.
- The limit level was updated from 78dB(A) to 79 dB(A) on 22 Aug 2013 as per the latest CNMP and CNMMP.
- The limit level was updated from 79dB(A) to 70dB(A)/65dB(A) (during normal/examination period) from April 2016, as the continuous noise monitoring was completed in March 2016 according to the latest CNMP

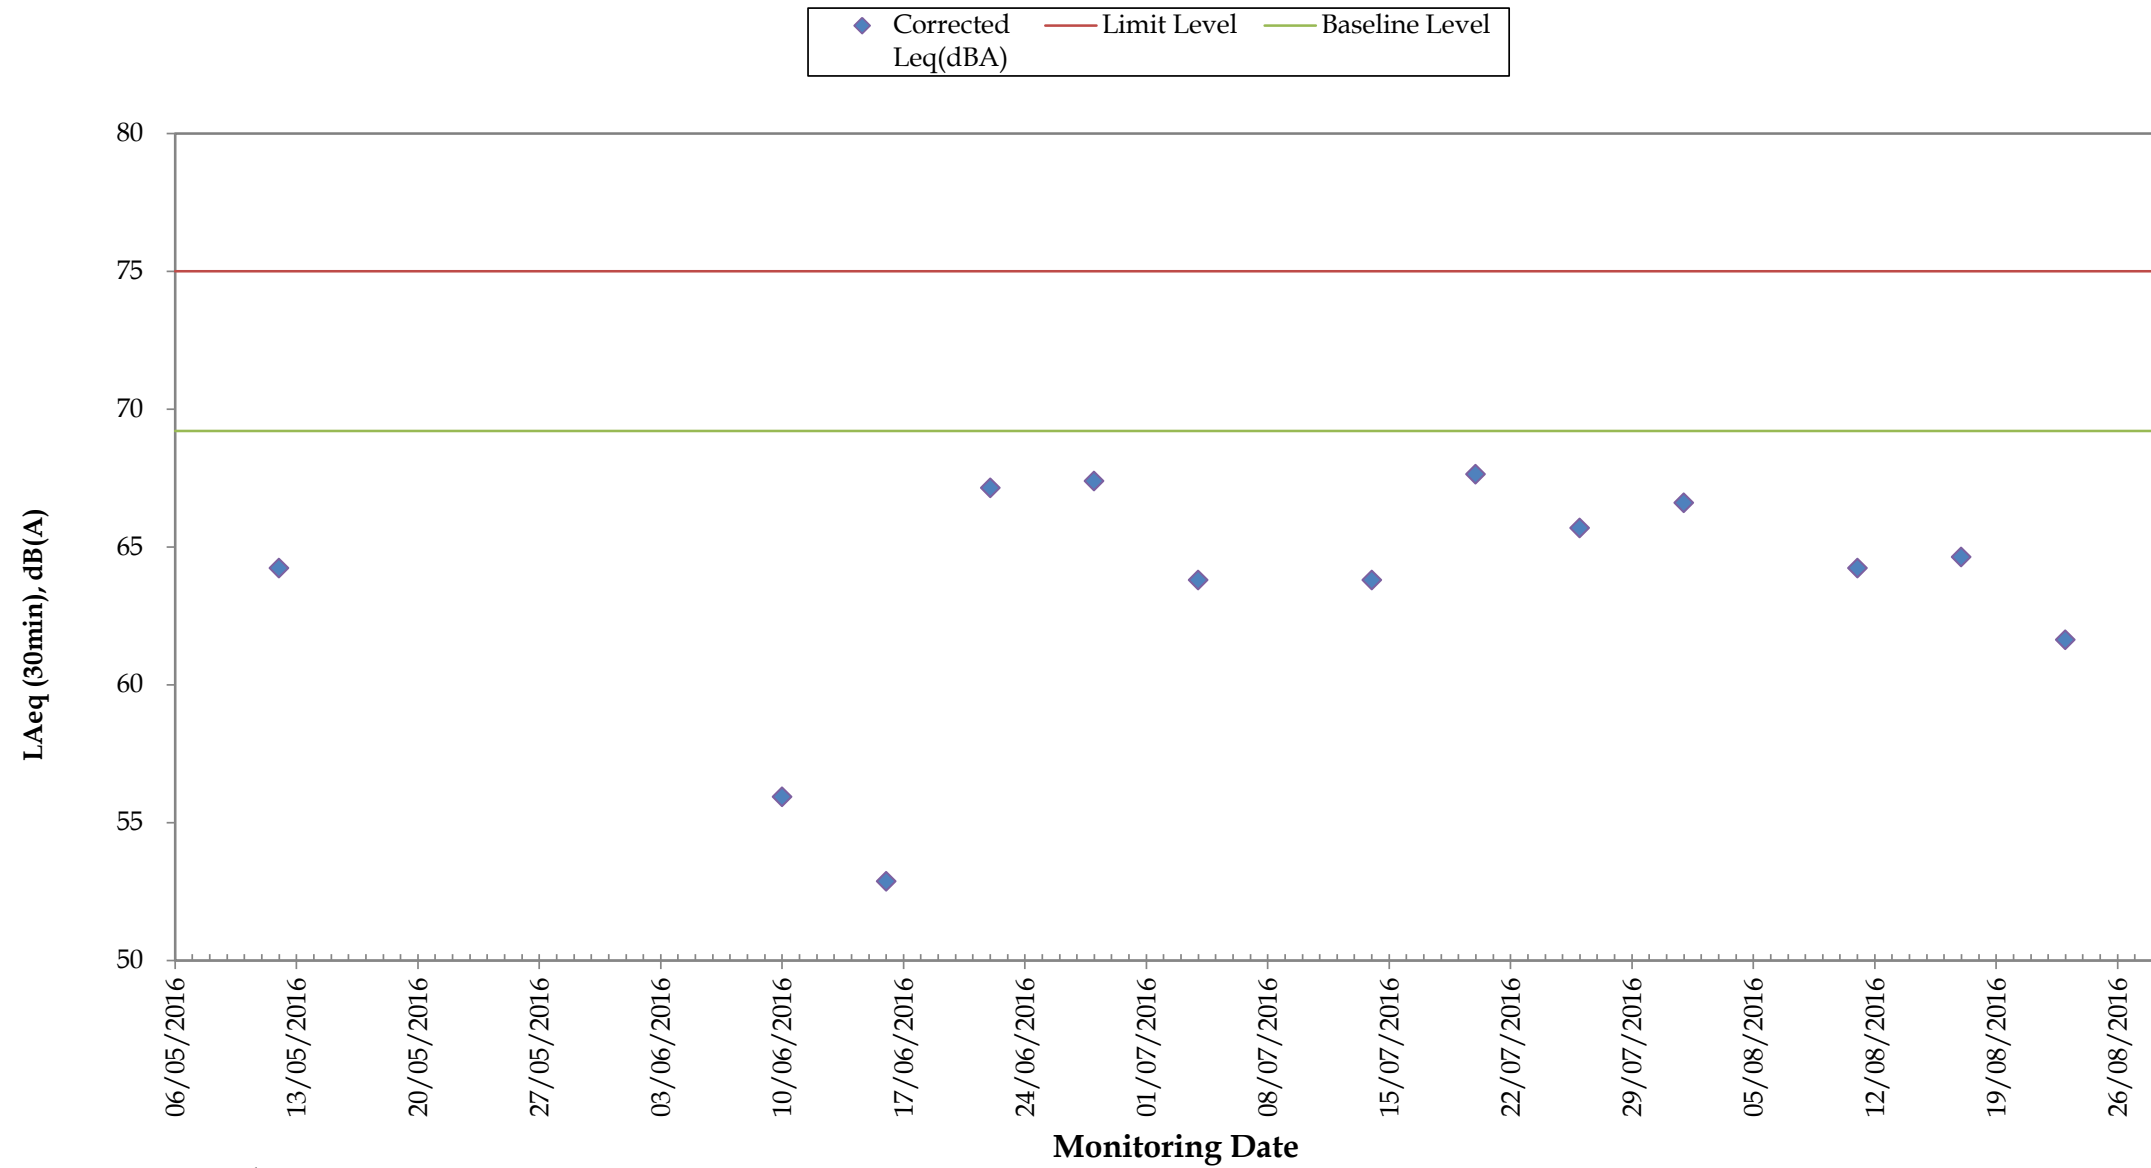
### Regular Noise Monitoring Results at NMS-CA-9 (Kong Yiu Mansion) (LAeq, 30min) ) for the Past 4 Months

- For those corrected noise levels that are not shown in this graph, the measured noise levels are below baseline level.

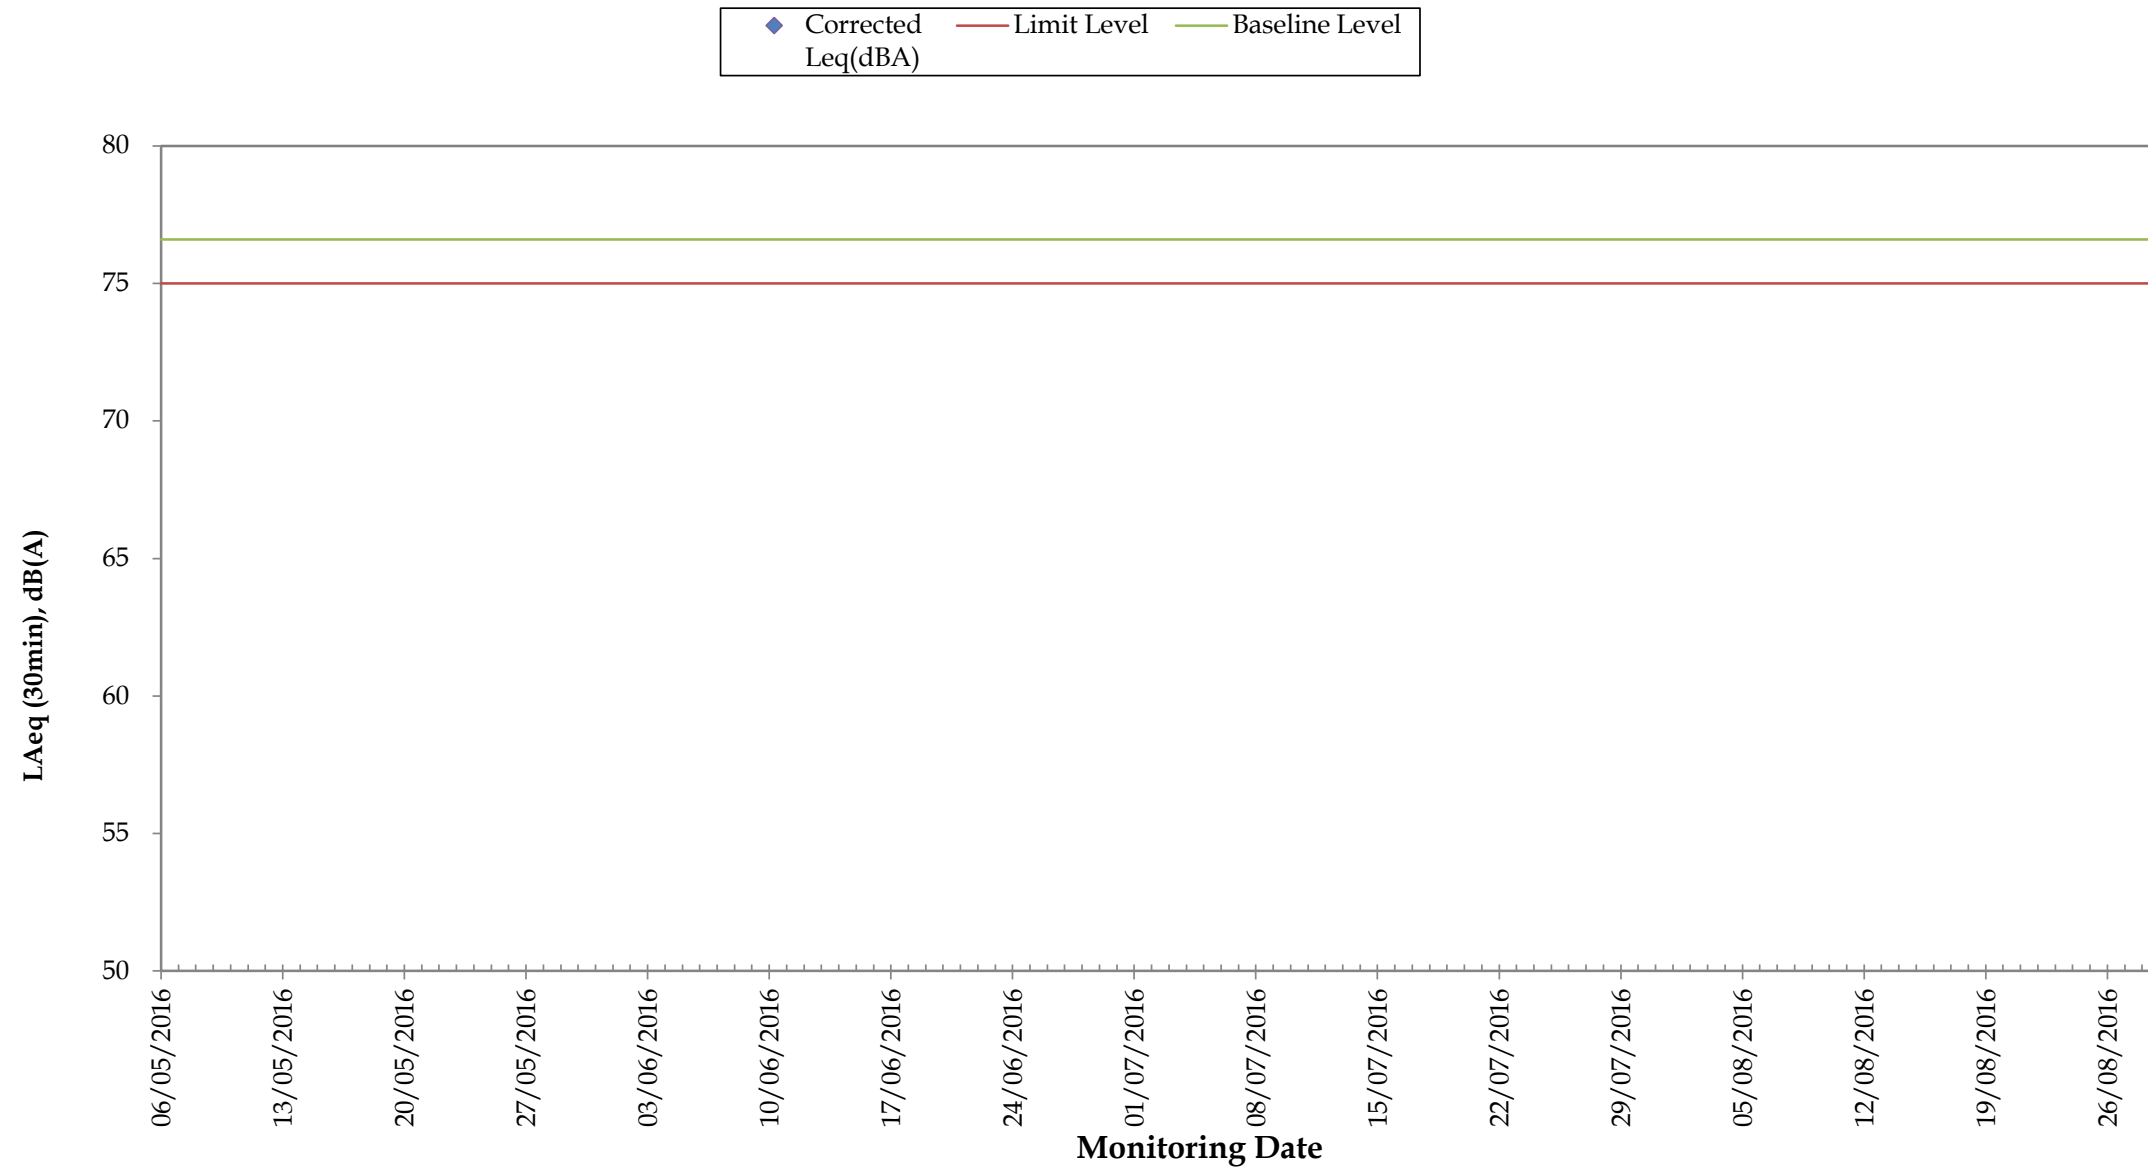
## Regular Noise Monitoring Results at NMS-CA-10 (Chat Ma Mansion) (LAeq, 30min) for the Past 4 Months

- For those corrected noise levels that are not shown in this graph, the measured noise levels are below baseline level.
- Noise monitoring at NMS-CA-10 (Chat Ma Mansion) was temporarily suspended since June 2016 due to request from the Management Office and was resumed on 26 July 2016.

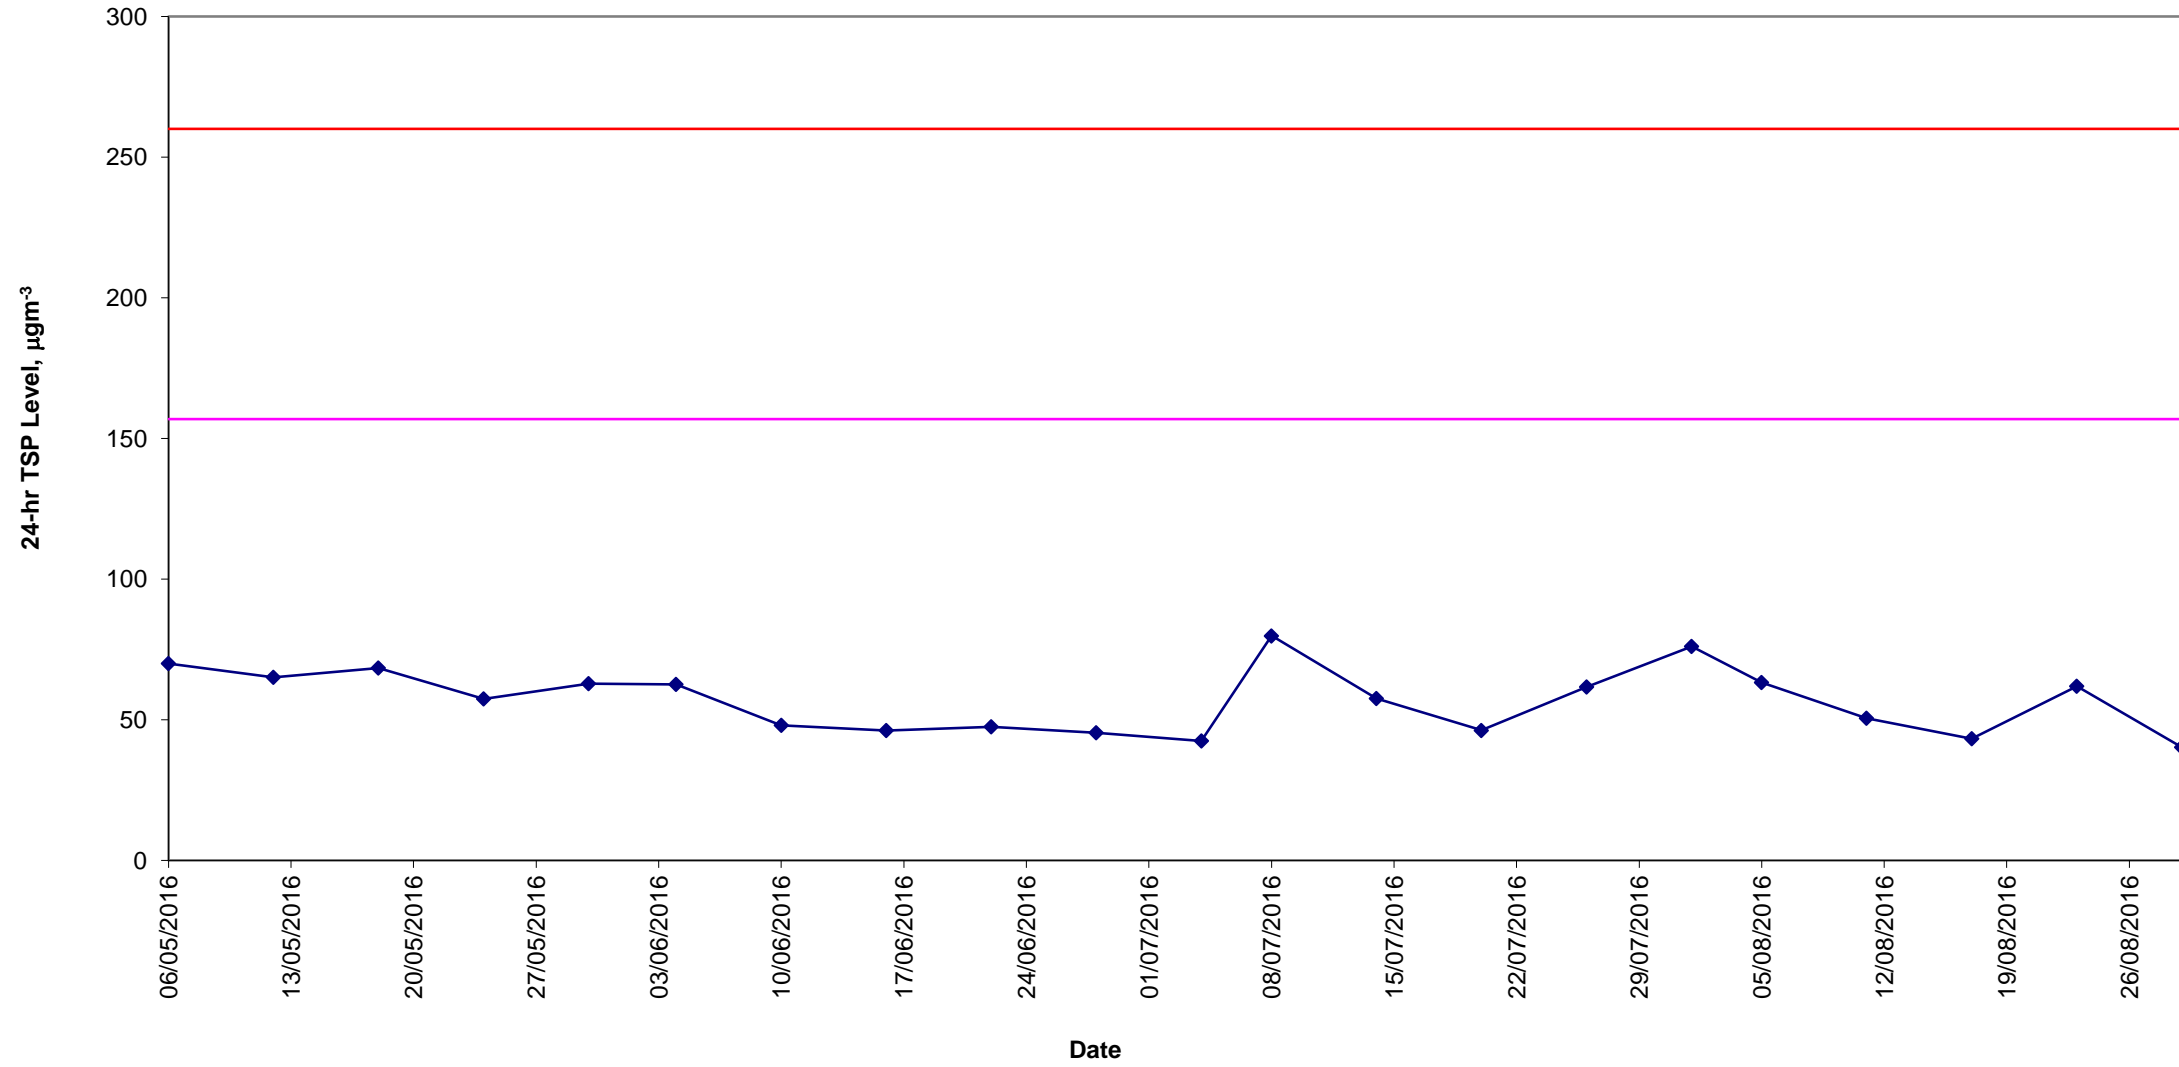
### Construction Dust Monitoring Results for the Past 4 Months DMS-6 (Katherine Building)

◆ DMS-6    ◆ Action Level    ◆ Limit Level

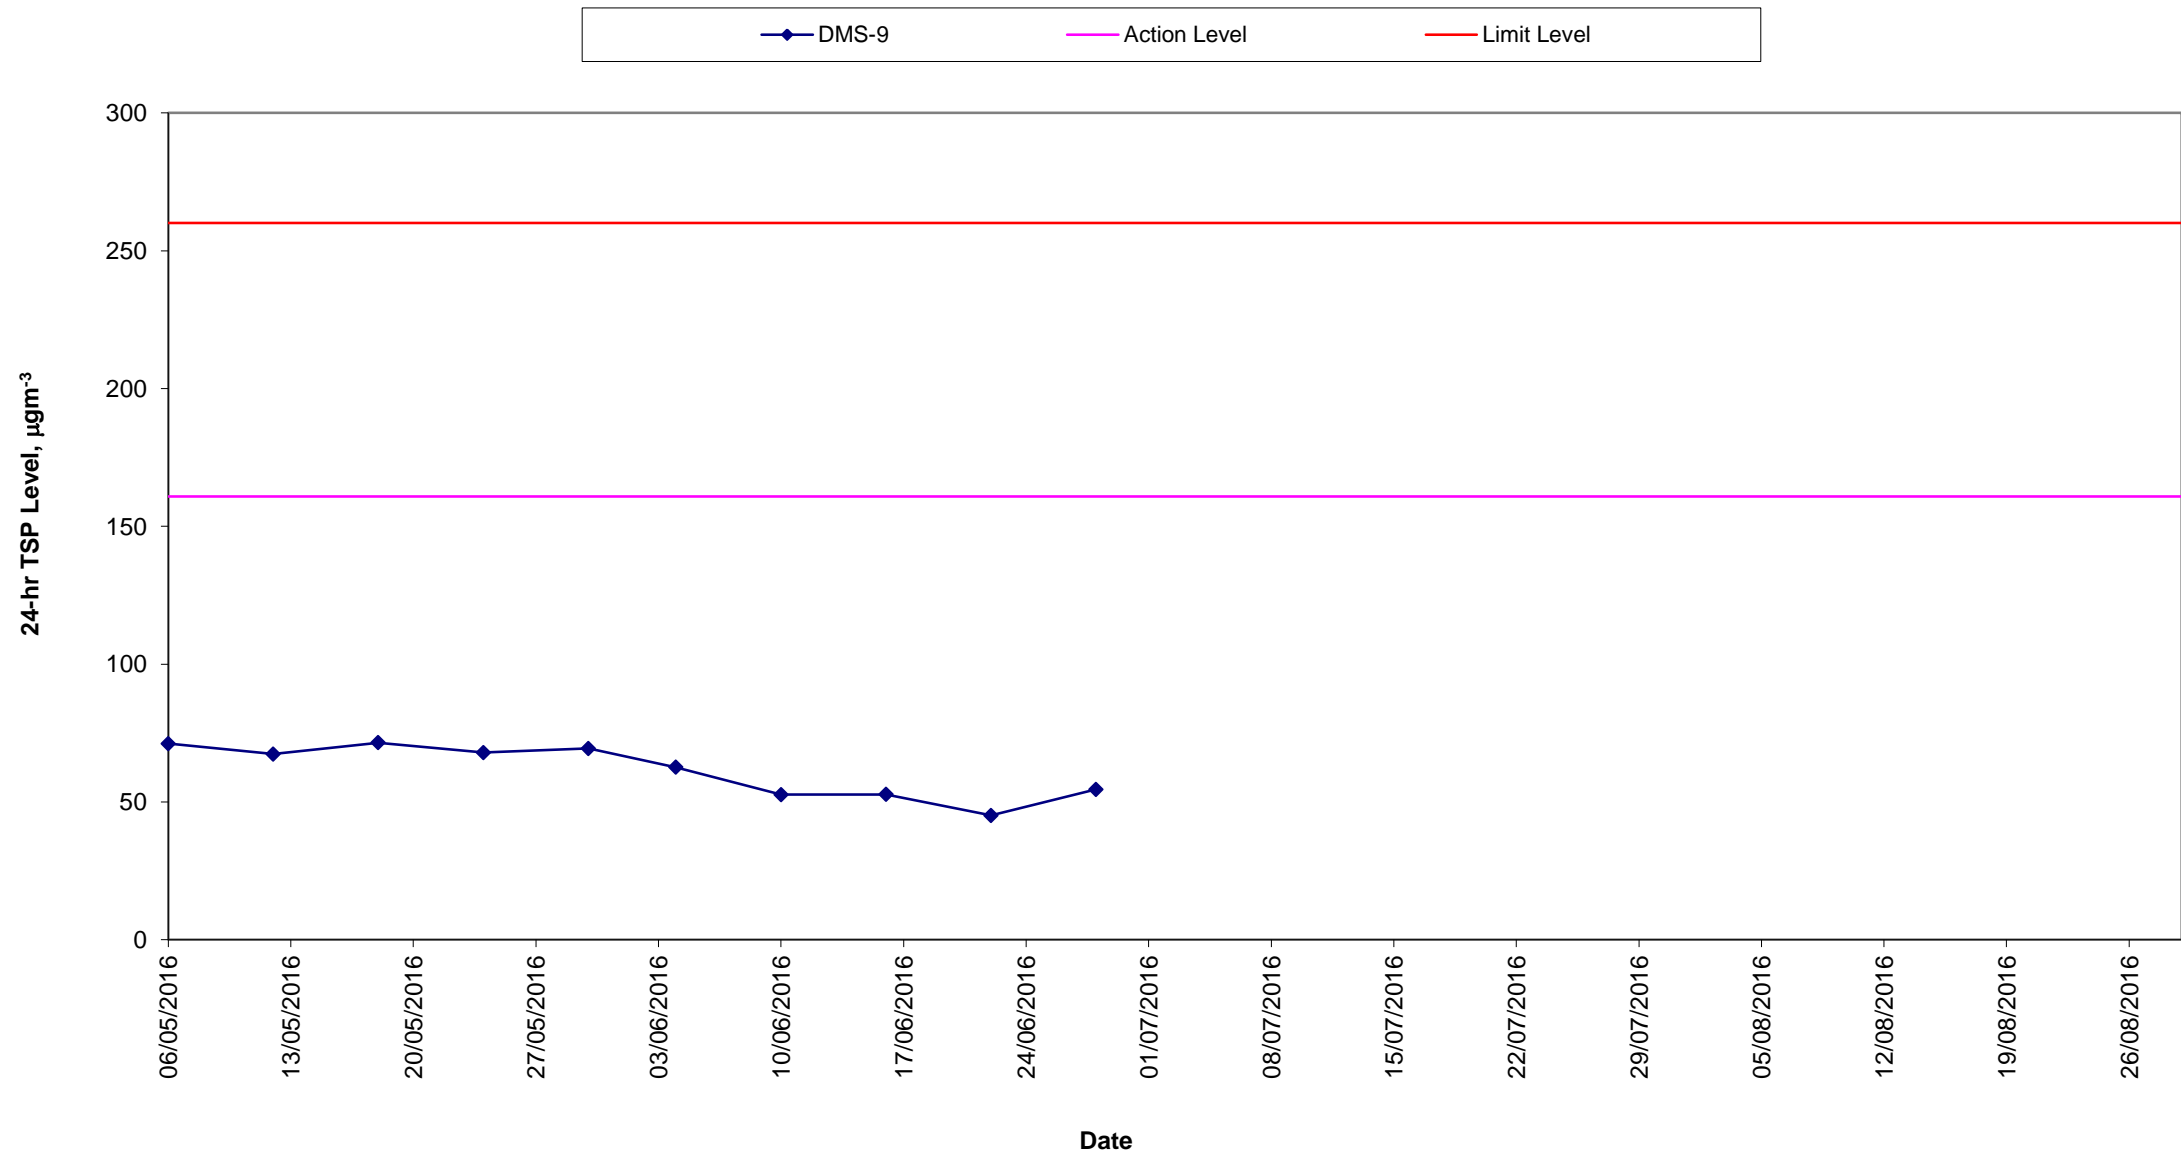
**Construction Dust Monitoring Results for the Past 4 Months  
DMS-9 (No.12 Pau Chung Street)**

- 24-hour averaged dust monitoring at DMS-9 (No. 12 Pau Chung Street) was temporary suspended since July 2016 due to request from the Management Office.

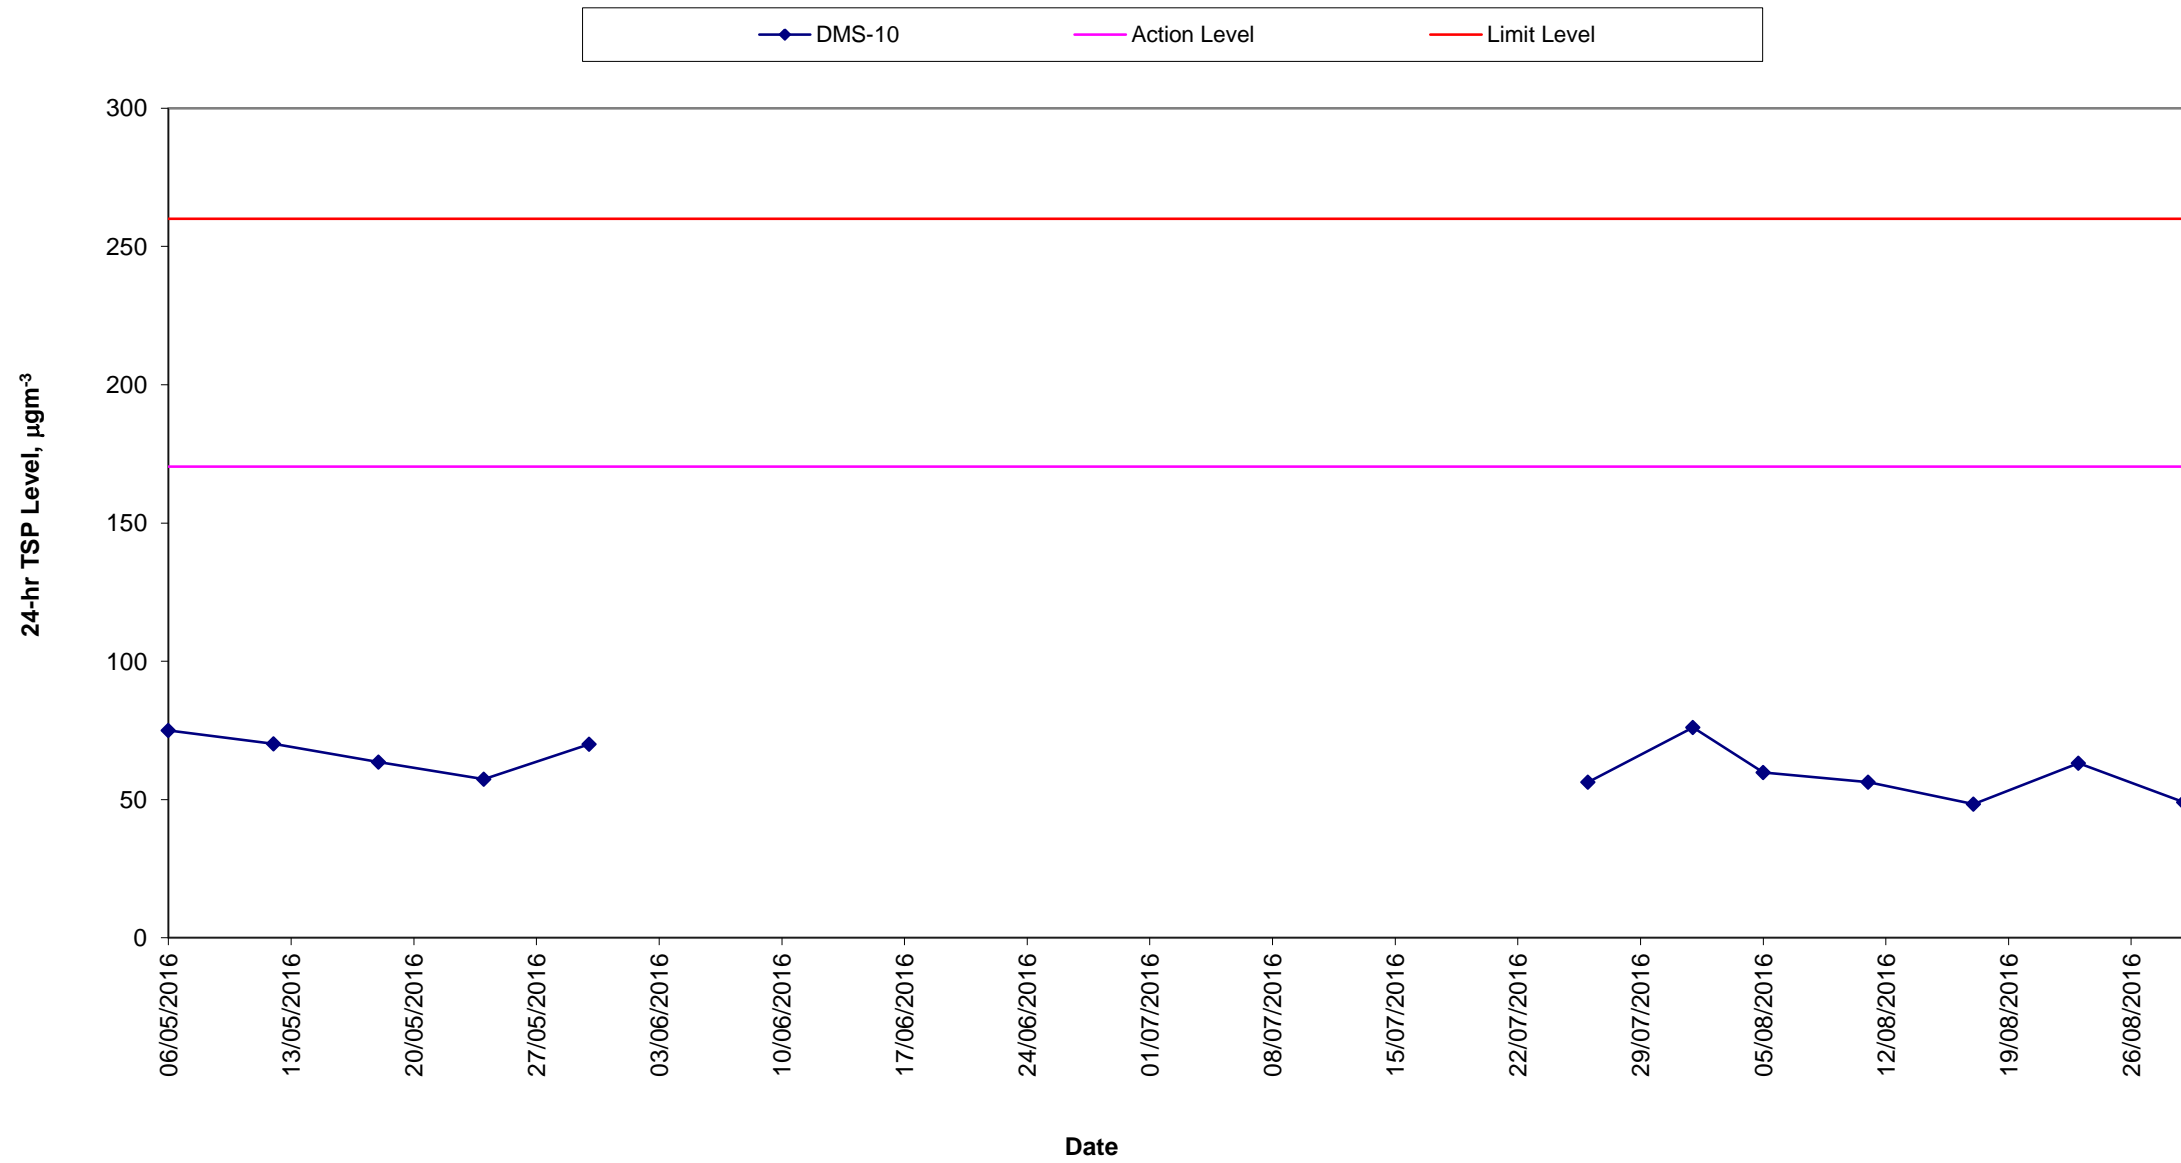
### Construction Dust Monitoring Results for the Past 4 Months DMS-10 (Chat Ma Mansion)

- 24-hour averaged dust monitoring at DMS-10 (Chat Ma Mansion) was temporary suspended since June 2016 due to request from the Management Office and was resumed on 26 July 2016.
