**Shatin to Central Link –  
Tai Wai to Hung Hom Section and  
Mong Kok East to Hung Hom Section**

Monthly EM&A Report No. 48

[Period from 1 to 31 August 2016]

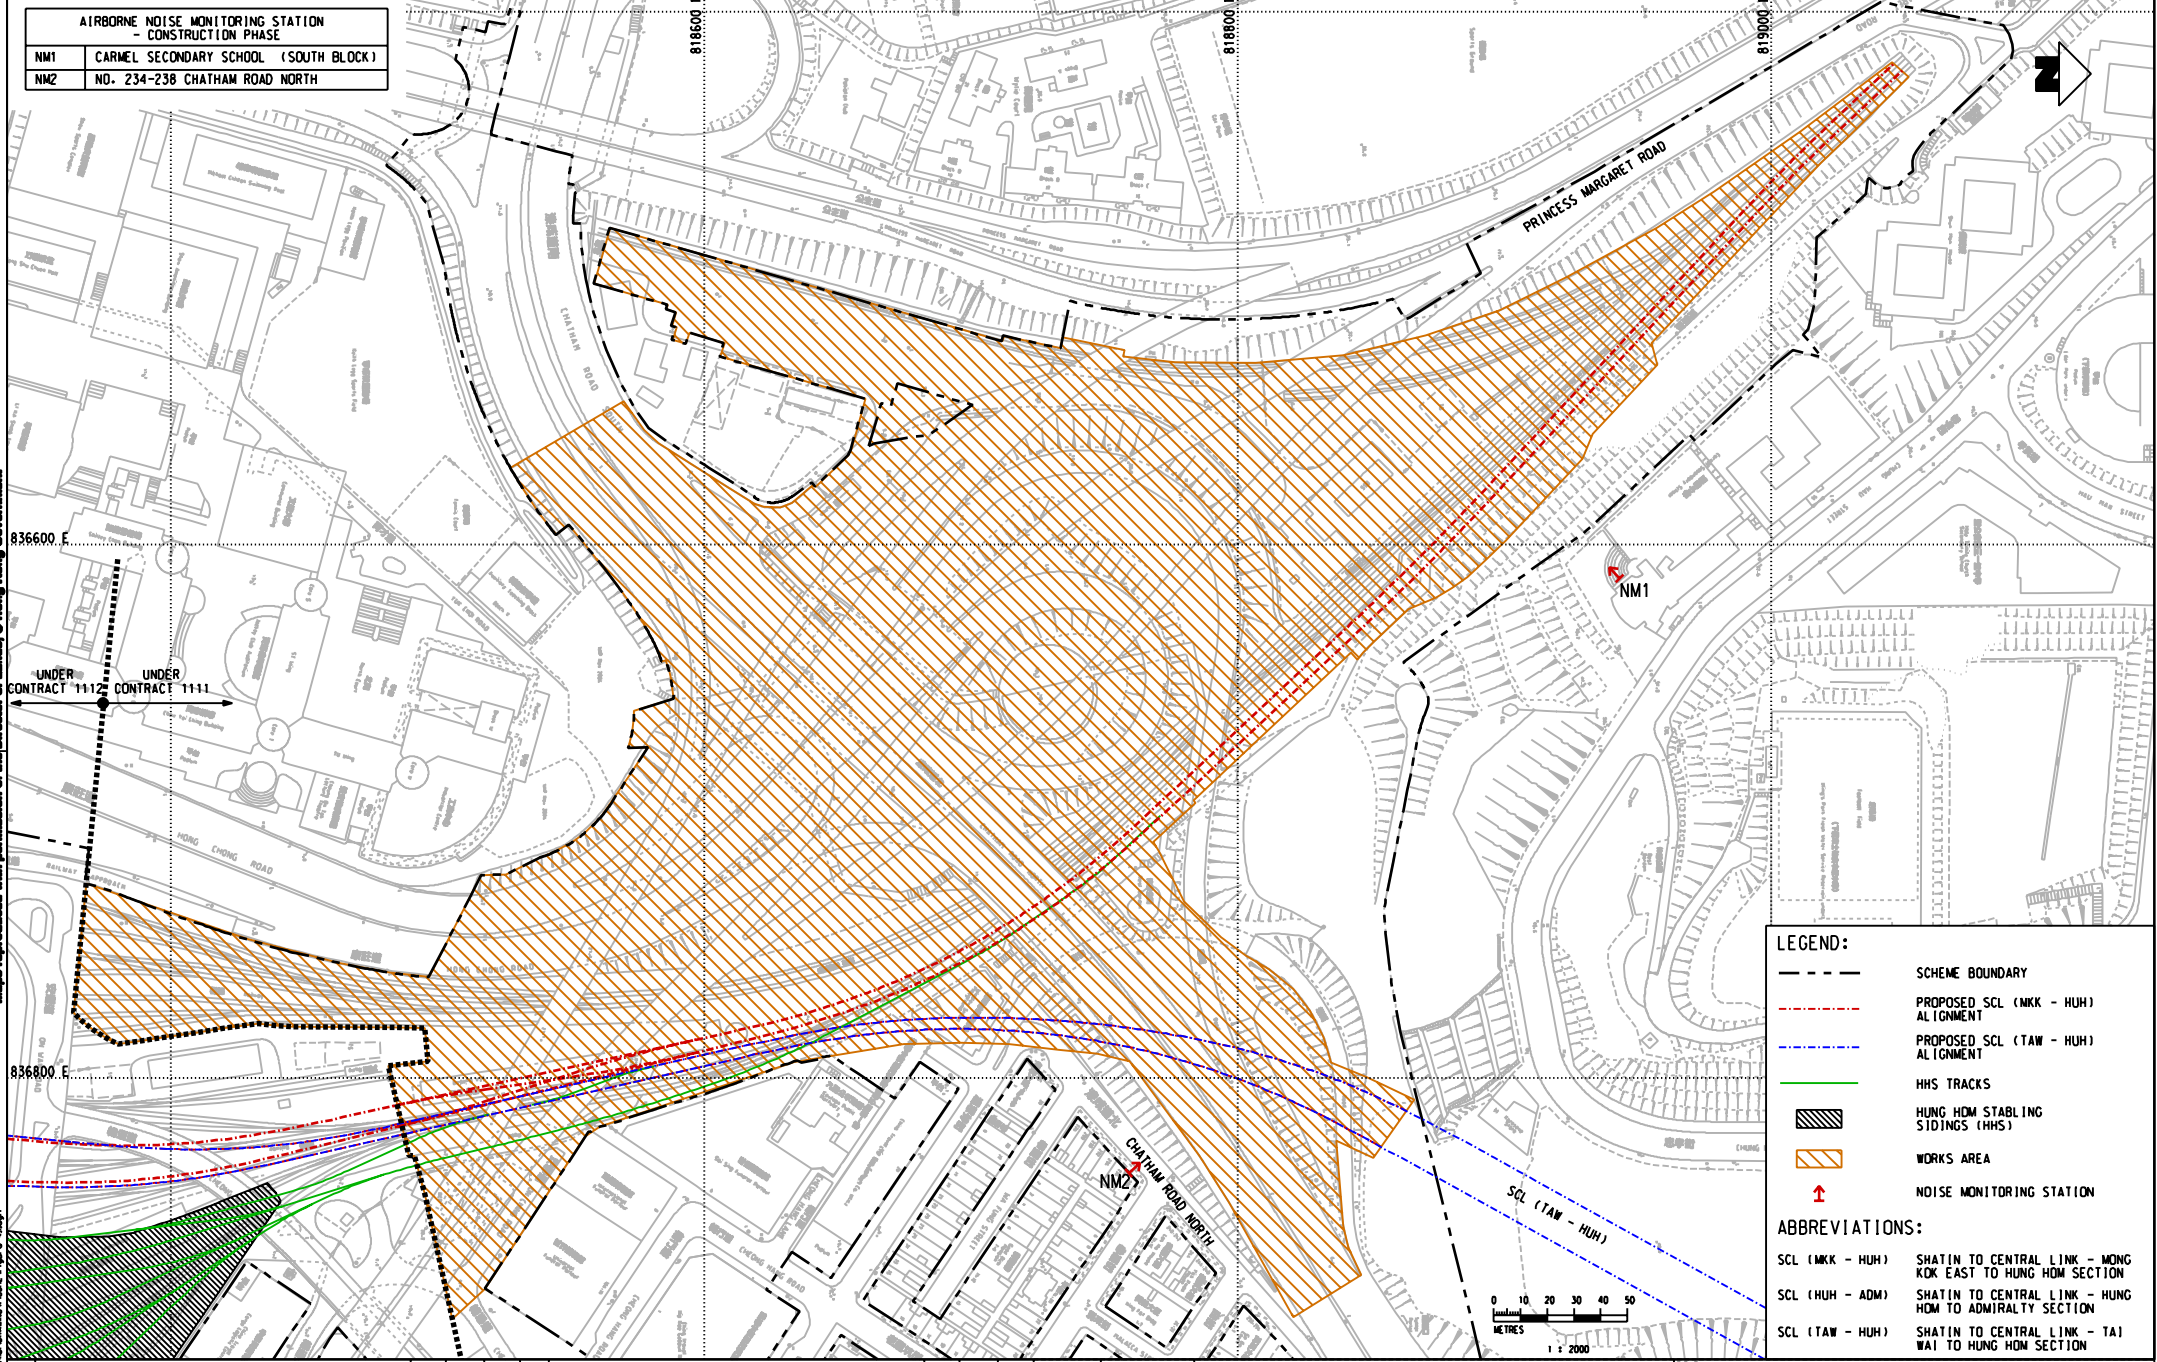
SCALE: 1 : 2000 (A3)  
 FIGURE NO.: **FIGURE 2.1**

AIRBORNE NOISE MONITORING STATION - CONSTRUCTION PHASE	
NM1	CARMEL SECONDARY SCHOOL (SOUTH BLOCK)
NM2	NO. 234-238 CHATHAM ROAD NORTH

- 3.3.2 With reference to the CNMP, continuous noise monitoring should be conducted during period at which the predicted airborne construction noise levels exceed the relevant noise criteria at the respective NSRs. The proposed continuous noise monitoring locations are presented in **Table 3.7** and shown in **Figure 2.1**.

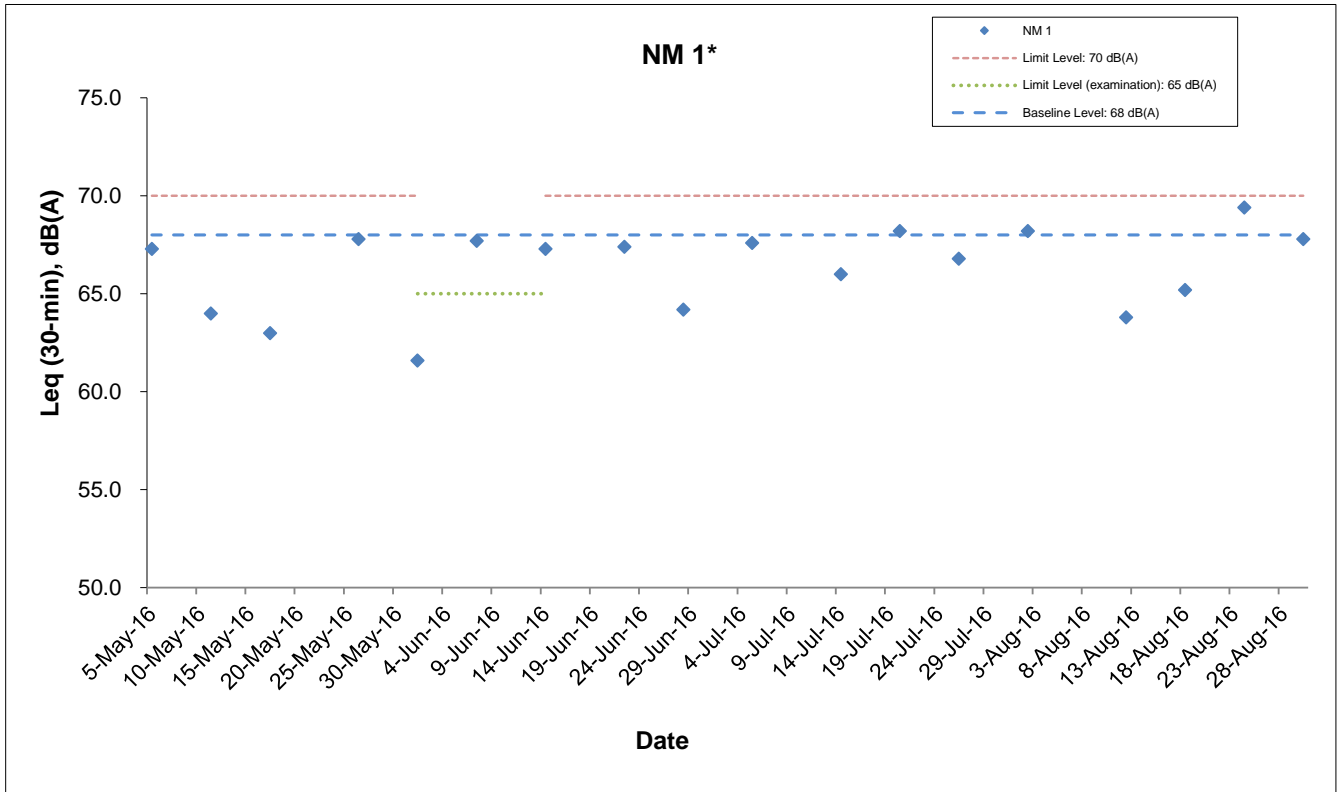
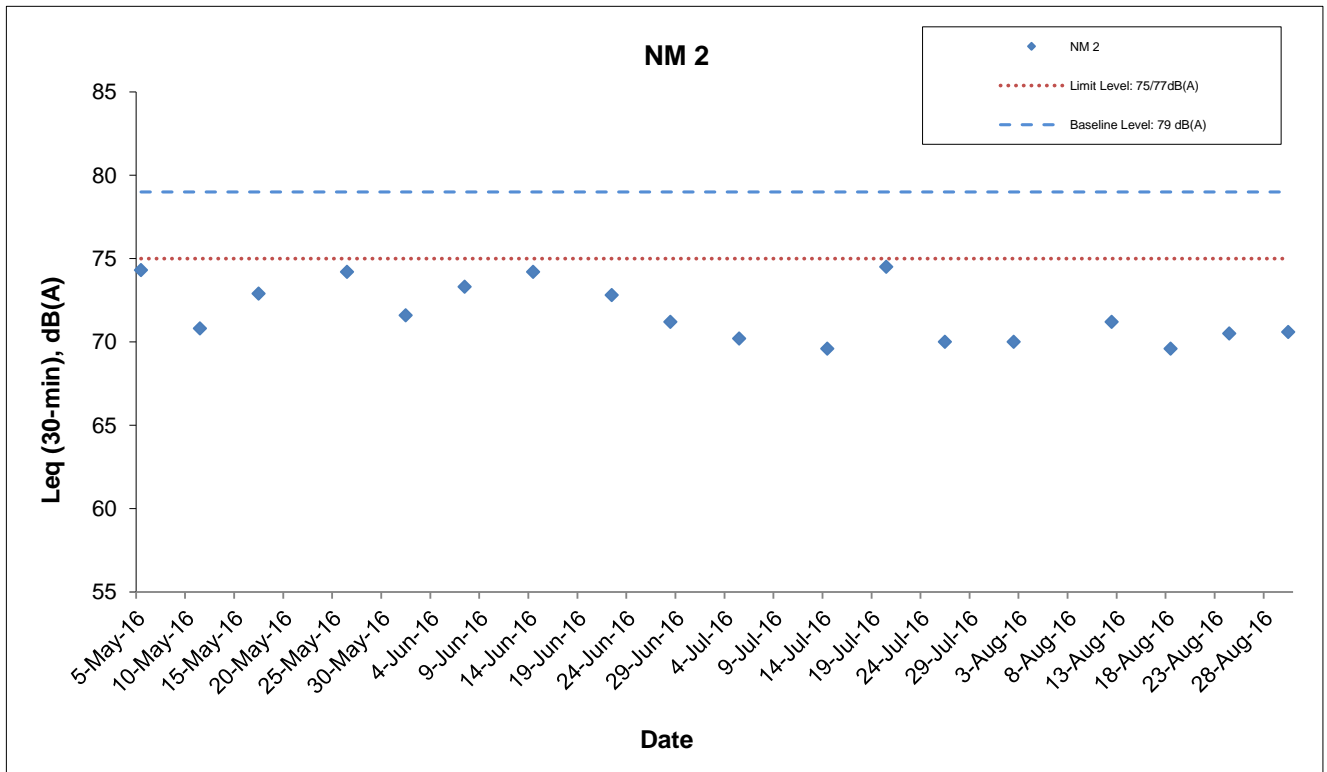
<b>AECOM</b>	<b>Shatin to Central Link Works Contract 1111- Hung Hom North Approach Tunnels</b>	SCALE	N.T.S.	DATE	Aug-16
	<b>Graphical Presentations of Noise Monitoring Results</b>	CHECK	TYUT	DRAWN	OYLW
		JOB NO.	60284101	APPENDIX	H

\* - The noise monitoring results of the measurements are higher than the daytime construction noise criterion. However, the results are not considered as exceedance if they are either below the baseline level or below the limit level after deducting the baseline noise level.

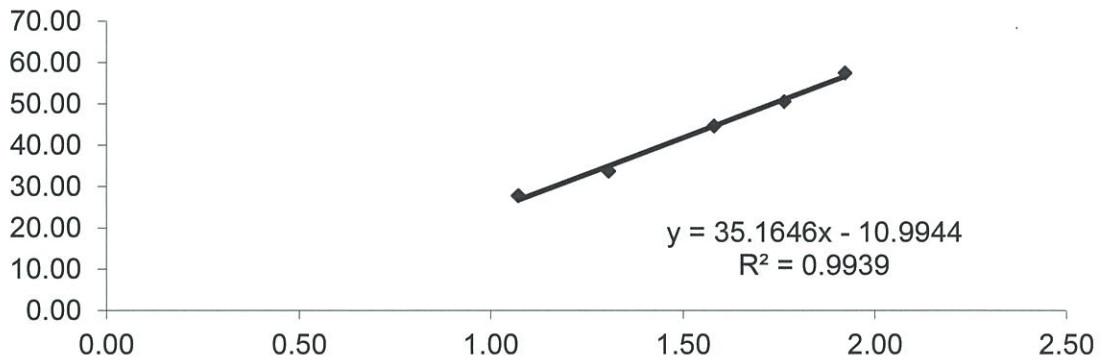
**Calibration Curve**

Resistance Plate No.	Manometer Reading (inch H <sub>2</sub> O)	Flow Recorder Reading (CFM)	Calculated Q <sub>std</sub> (m <sup>3</sup> /min)	Continuous Flow Recorder Reading IC (CFM)
5	4.00	28.00	1.07	27.73
7	6.20	34.00	1.31	33.67
10	9.40	45.00	1.58	44.57
13	11.90	51.00	1.76	50.51
18	14.30	58.00	1.92	57.44

Sampler slope (m) : **35.1646**  
 Sampler intercept (b) : **-10.9944**  
 Correlation coefficient (R<sup>2</sup>) : **0.9939**

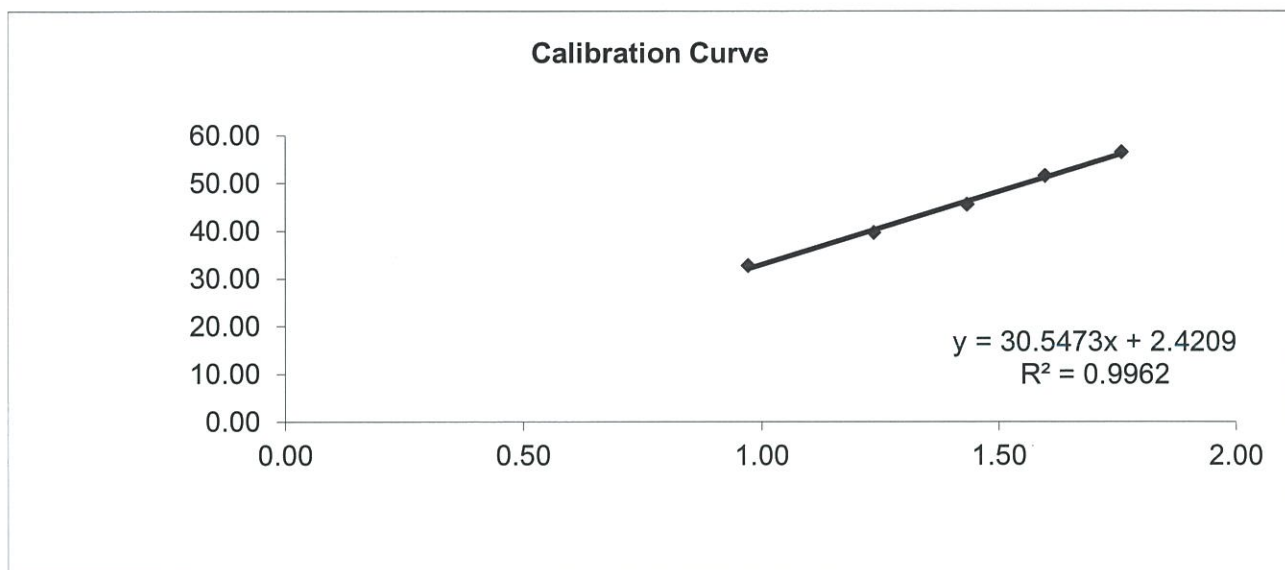
Resistance Plate No.	Manometer Reading (inch H <sub>2</sub> O)	Flow Recorder Reading (CFM)	Calculated Q <sub>std</sub> (m <sup>3</sup> /min)	Continuous Flow Recorder Reading IC (CFM)
5	3.20	33.00	0.97	32.68
7	5.50	40.00	1.24	39.61
10	7.60	46.00	1.43	45.56
13	9.60	52.00	1.60	51.50
18	11.80	57.00	1.76	56.45

Sampler slope (m) :	<b>30.5473</b>
Sampler intercept (b) :	<b>2.4209</b>
Correlation coefficient (R <sup>2</sup> ) :	<b>0.9962</b>

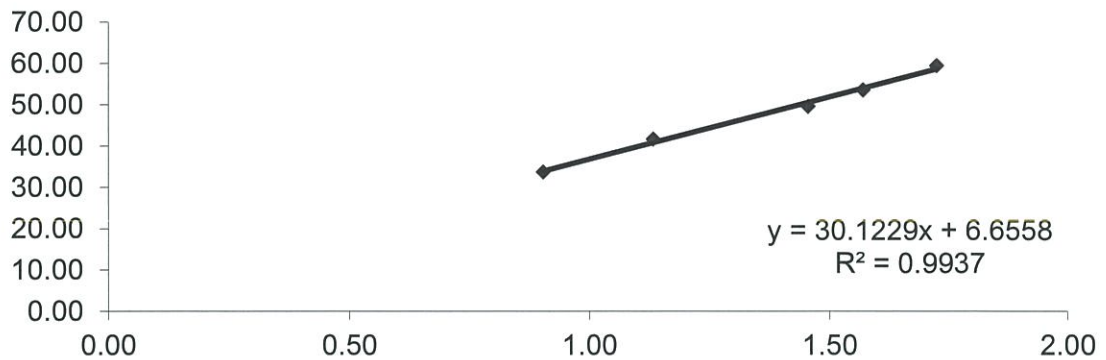
**Calibration Curve**

Resistance Plate No.	Manometer Reading (inch H <sub>2</sub> O)	Flow Recorder Reading (CFM)	Calculated Q <sub>std</sub> (m <sup>3</sup> /min)	Continuous Flow Recorder Reading IC (CFM)
5	3.40	34.00	0.90	33.67
7	5.40	42.00	1.13	41.59
10	9.00	50.00	1.46	49.52
13	10.50	54.00	1.57	53.48
18	12.70	60.00	1.72	59.42

Sampler slope (m) :	<b>30.1229</b>
Sampler intercept (b) :	<b>6.6558</b>
Correlation coefficient (R <sup>2</sup> ) :	<b>0.9937</b>

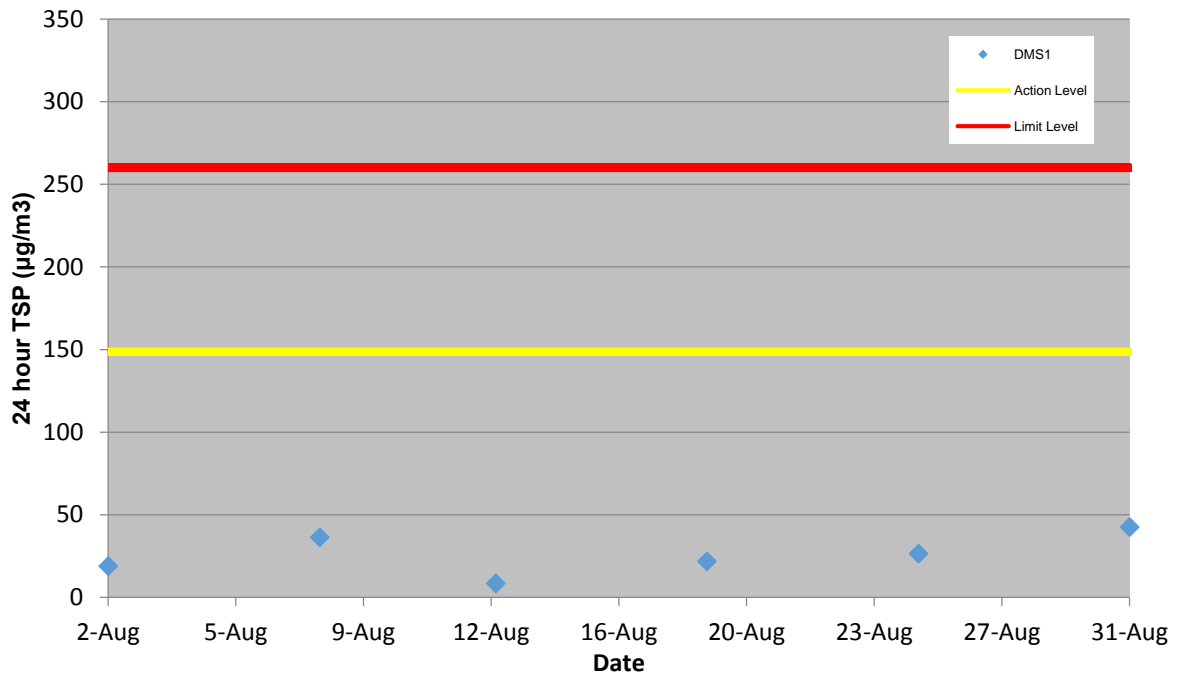
Impact 24-hour TSP Monitoring at Air Monitoring Station DMS-1

Average (µg/m3)	34.3
Max (µg/m3)	48.3
Min (µg/m3)	22.7

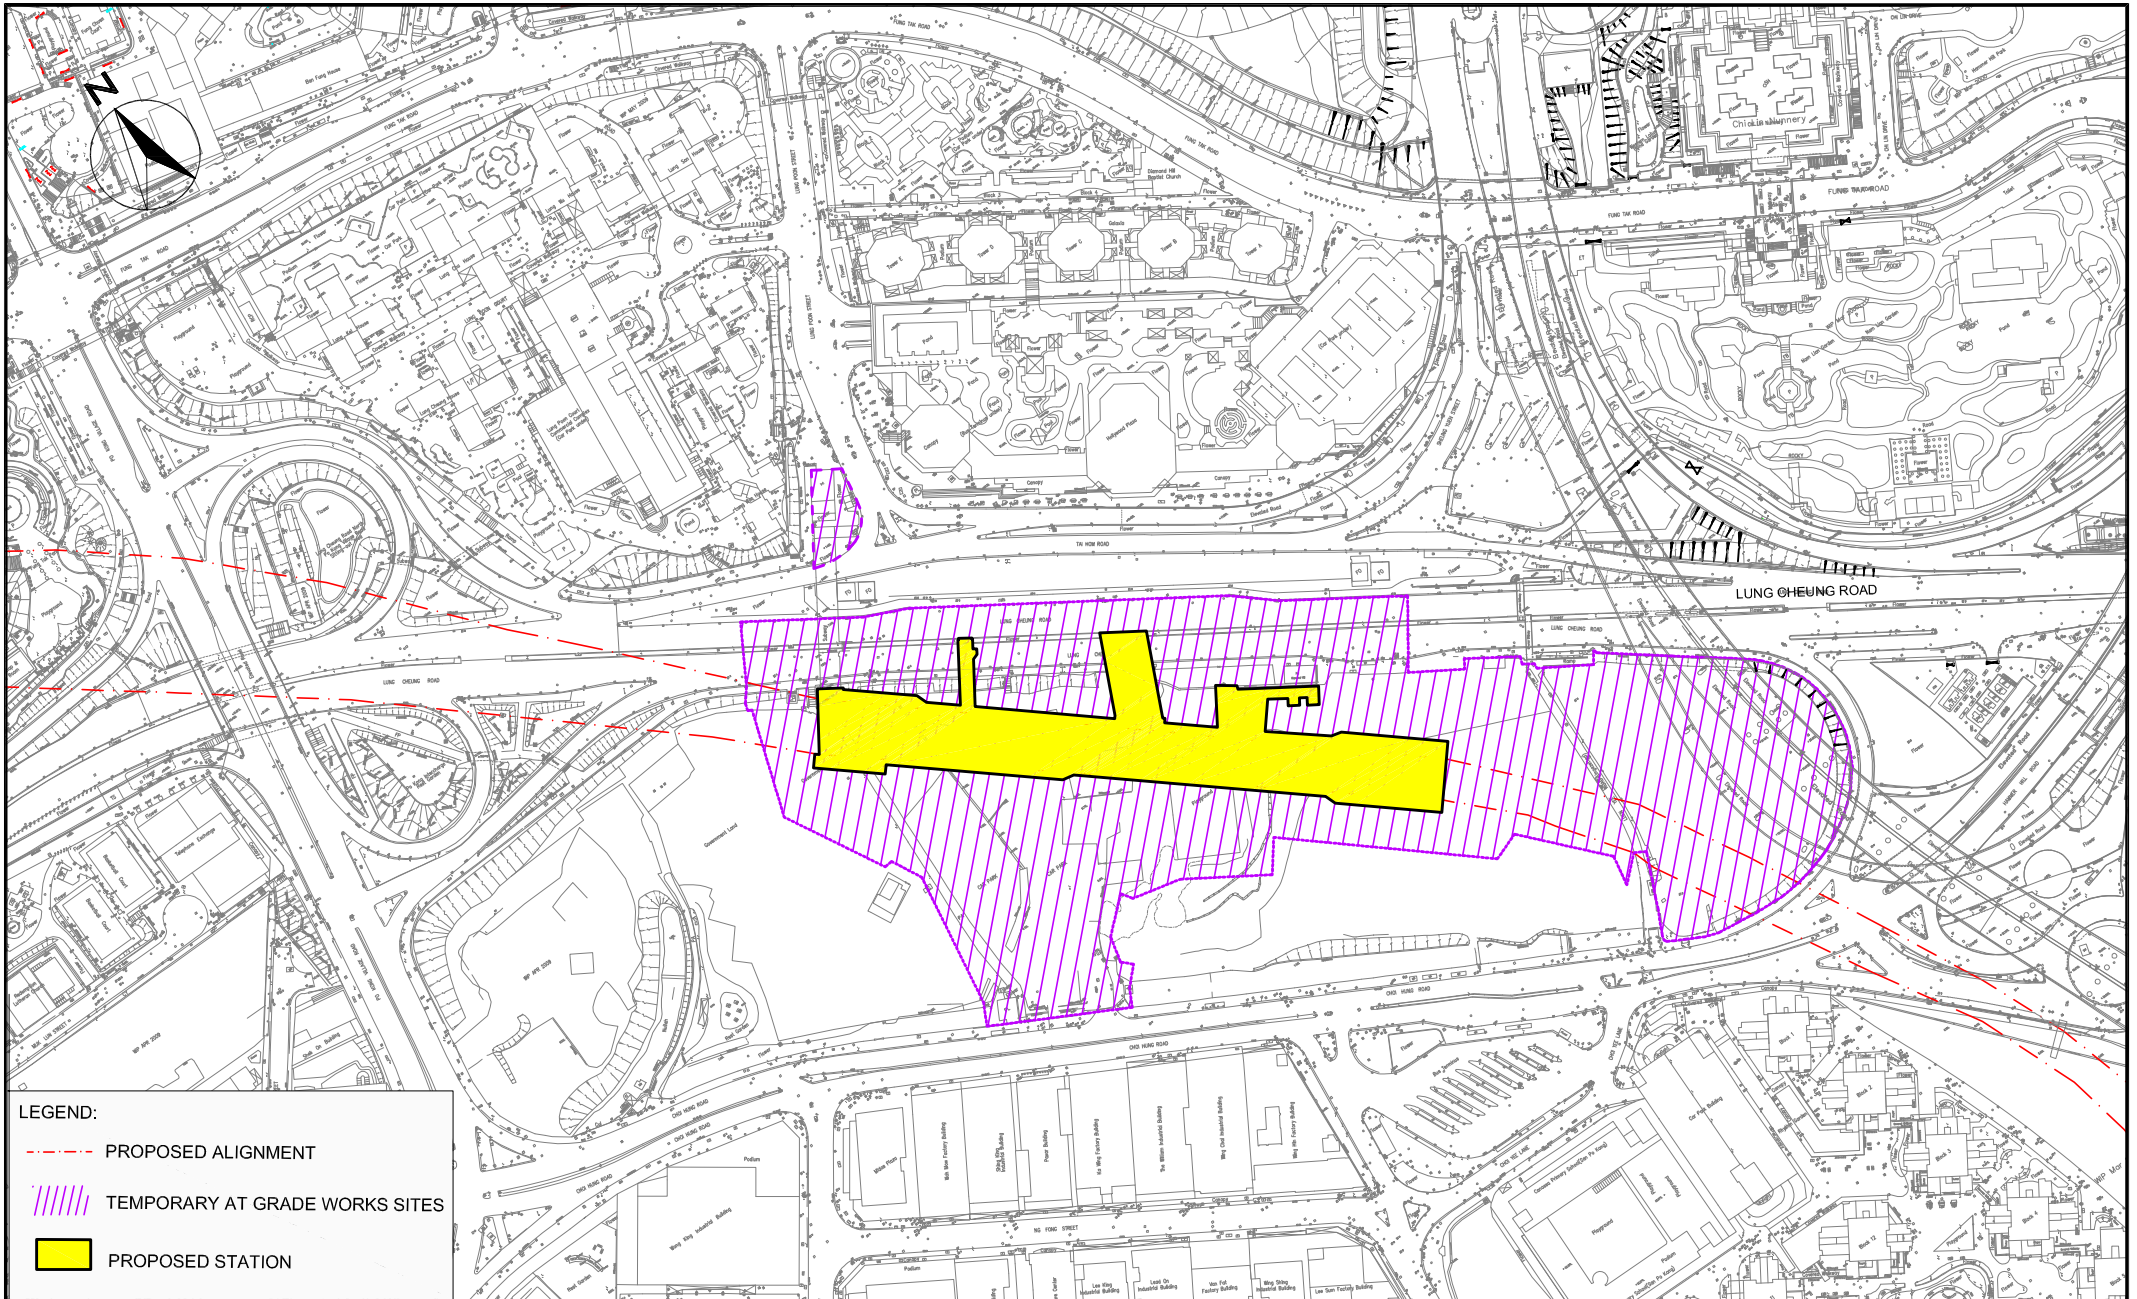
SCALE	1:80	DATE	AUG 2016	
CHECK	BW	DRAWN	JW	
JOB No.	MA12051	FIGURE NO.	1	REV -

SHATIN TO CENTRAL LINK CONTRACT 1106  
DIAMOND HILL STATION

- 2.3 For Works Contract 1106, the works area for the DIH station is located to the northeast of Choi Hung Road next to the existing Kwun Tong Line DIH Station. The DIH station will be constructed by cut-and-cover method. Since July 2016, southern portion of the works area at Choi Hung Road was handover to relevant government department. The latest alignment and works areas for the Works Contract 1106 are shown in **Figure 1**.

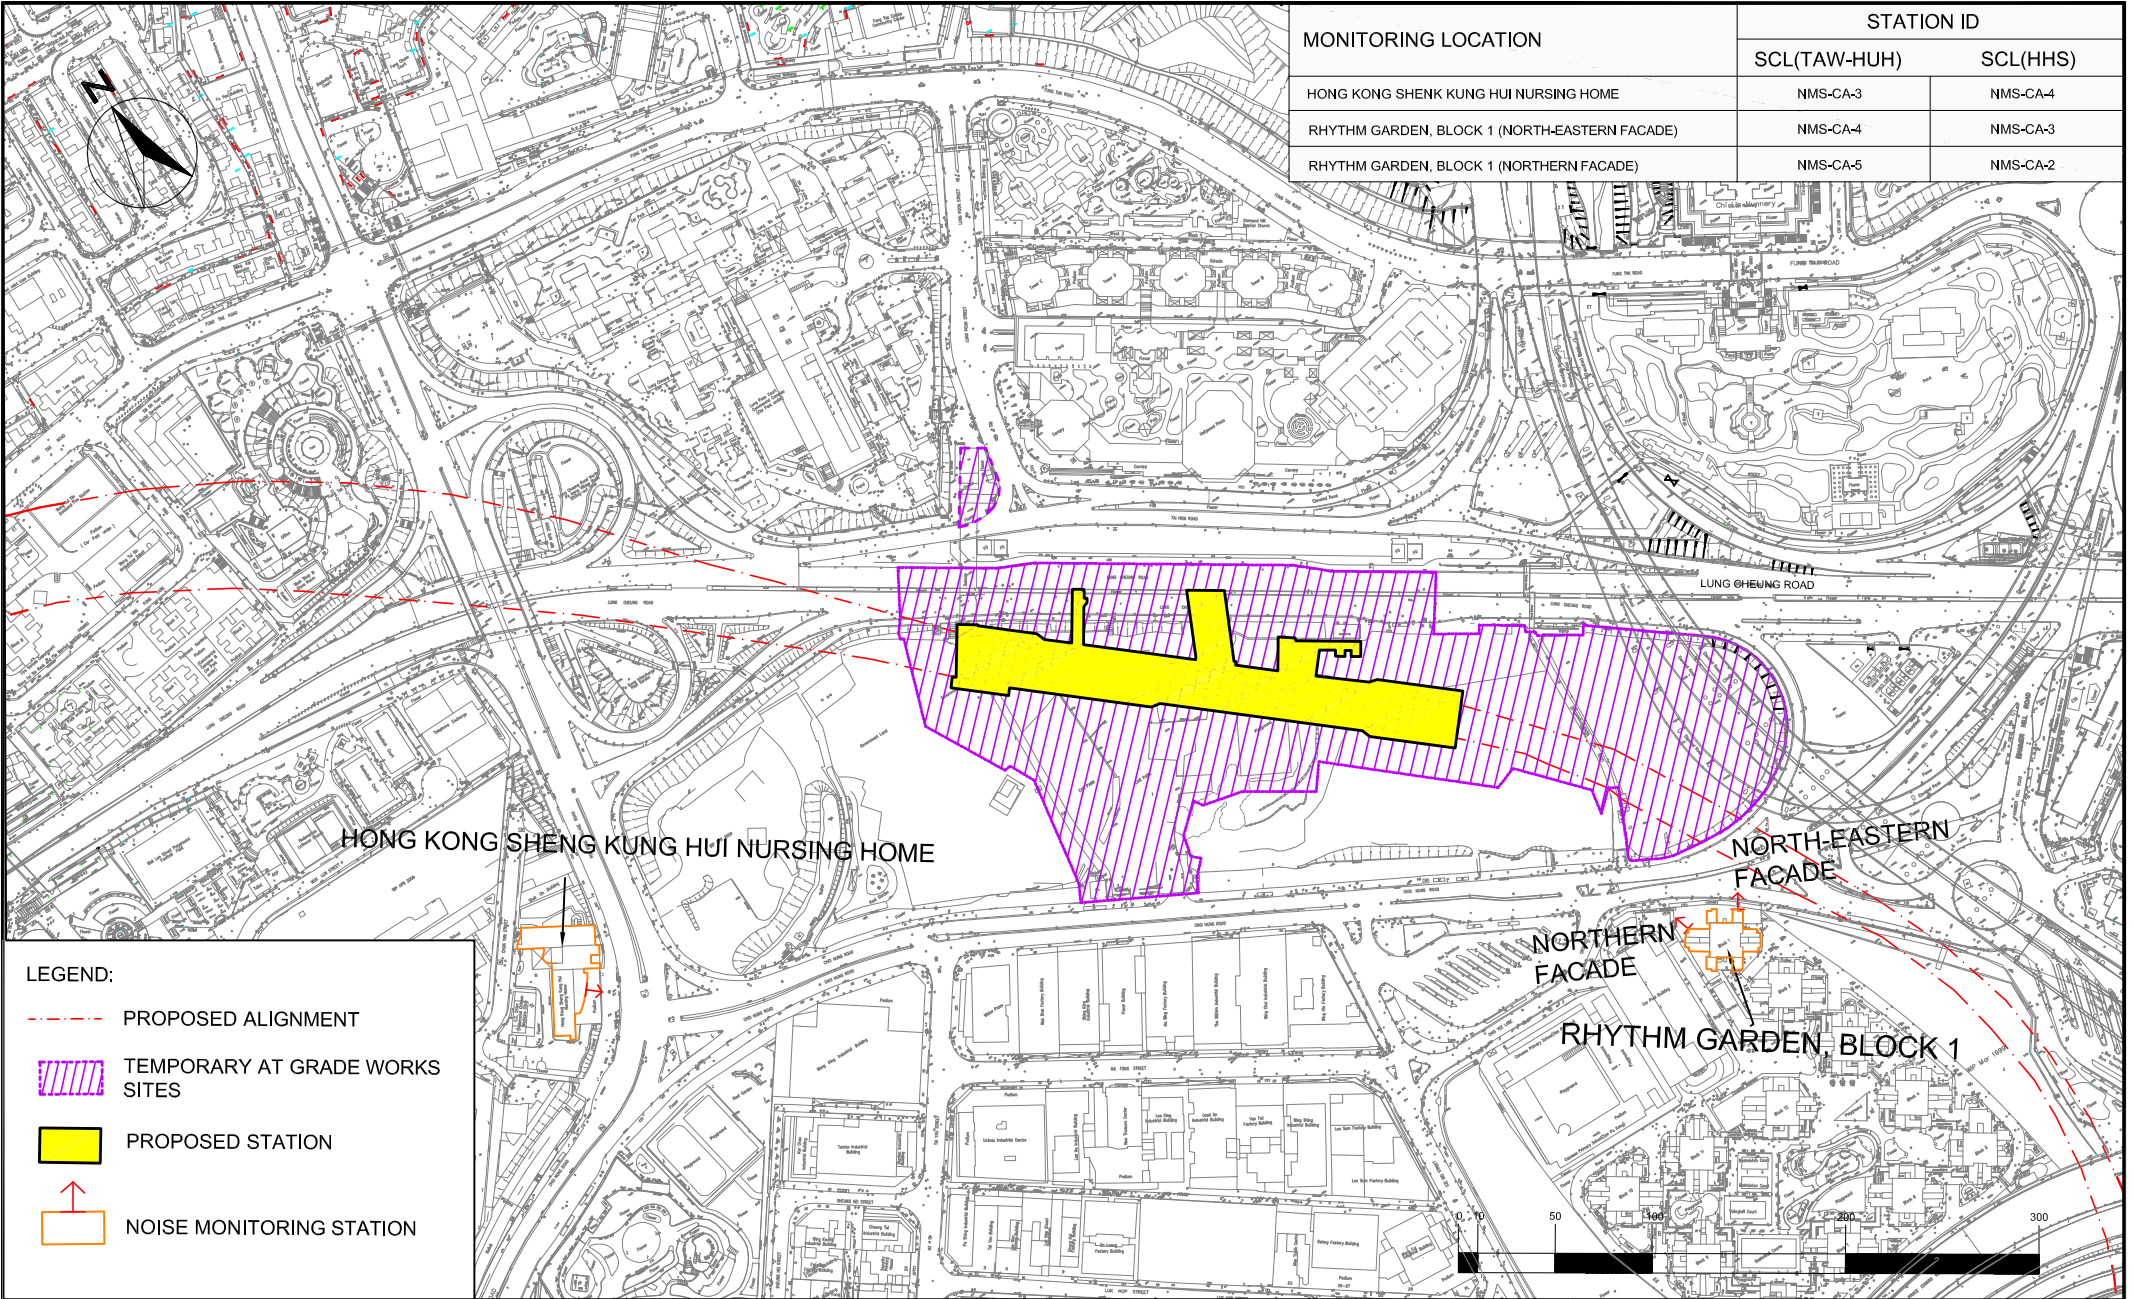
SCALE	1:100	DATE	AUG 2016	
CHECK	BW	DRAWN	JW	
JOB No.	MA12051	FIGURE NO.	2	REV
				-

MONITORING LOCATION	STATION ID	
	SCL(TAW-HUH)	SCL(HHS)
HONG KONG SHENK KUNG HUI NURSING HOME	NMS-CA-3	NMS-CA-4
RHYTHM GARDEN, BLOCK 1 (NORTH-EASTERN FACADE)	NMS-CA-4	NMS-CA-3
RHYTHM GARDEN, BLOCK 1 (NORTHERN FACADE)	NMS-CA-5	NMS-CA-2

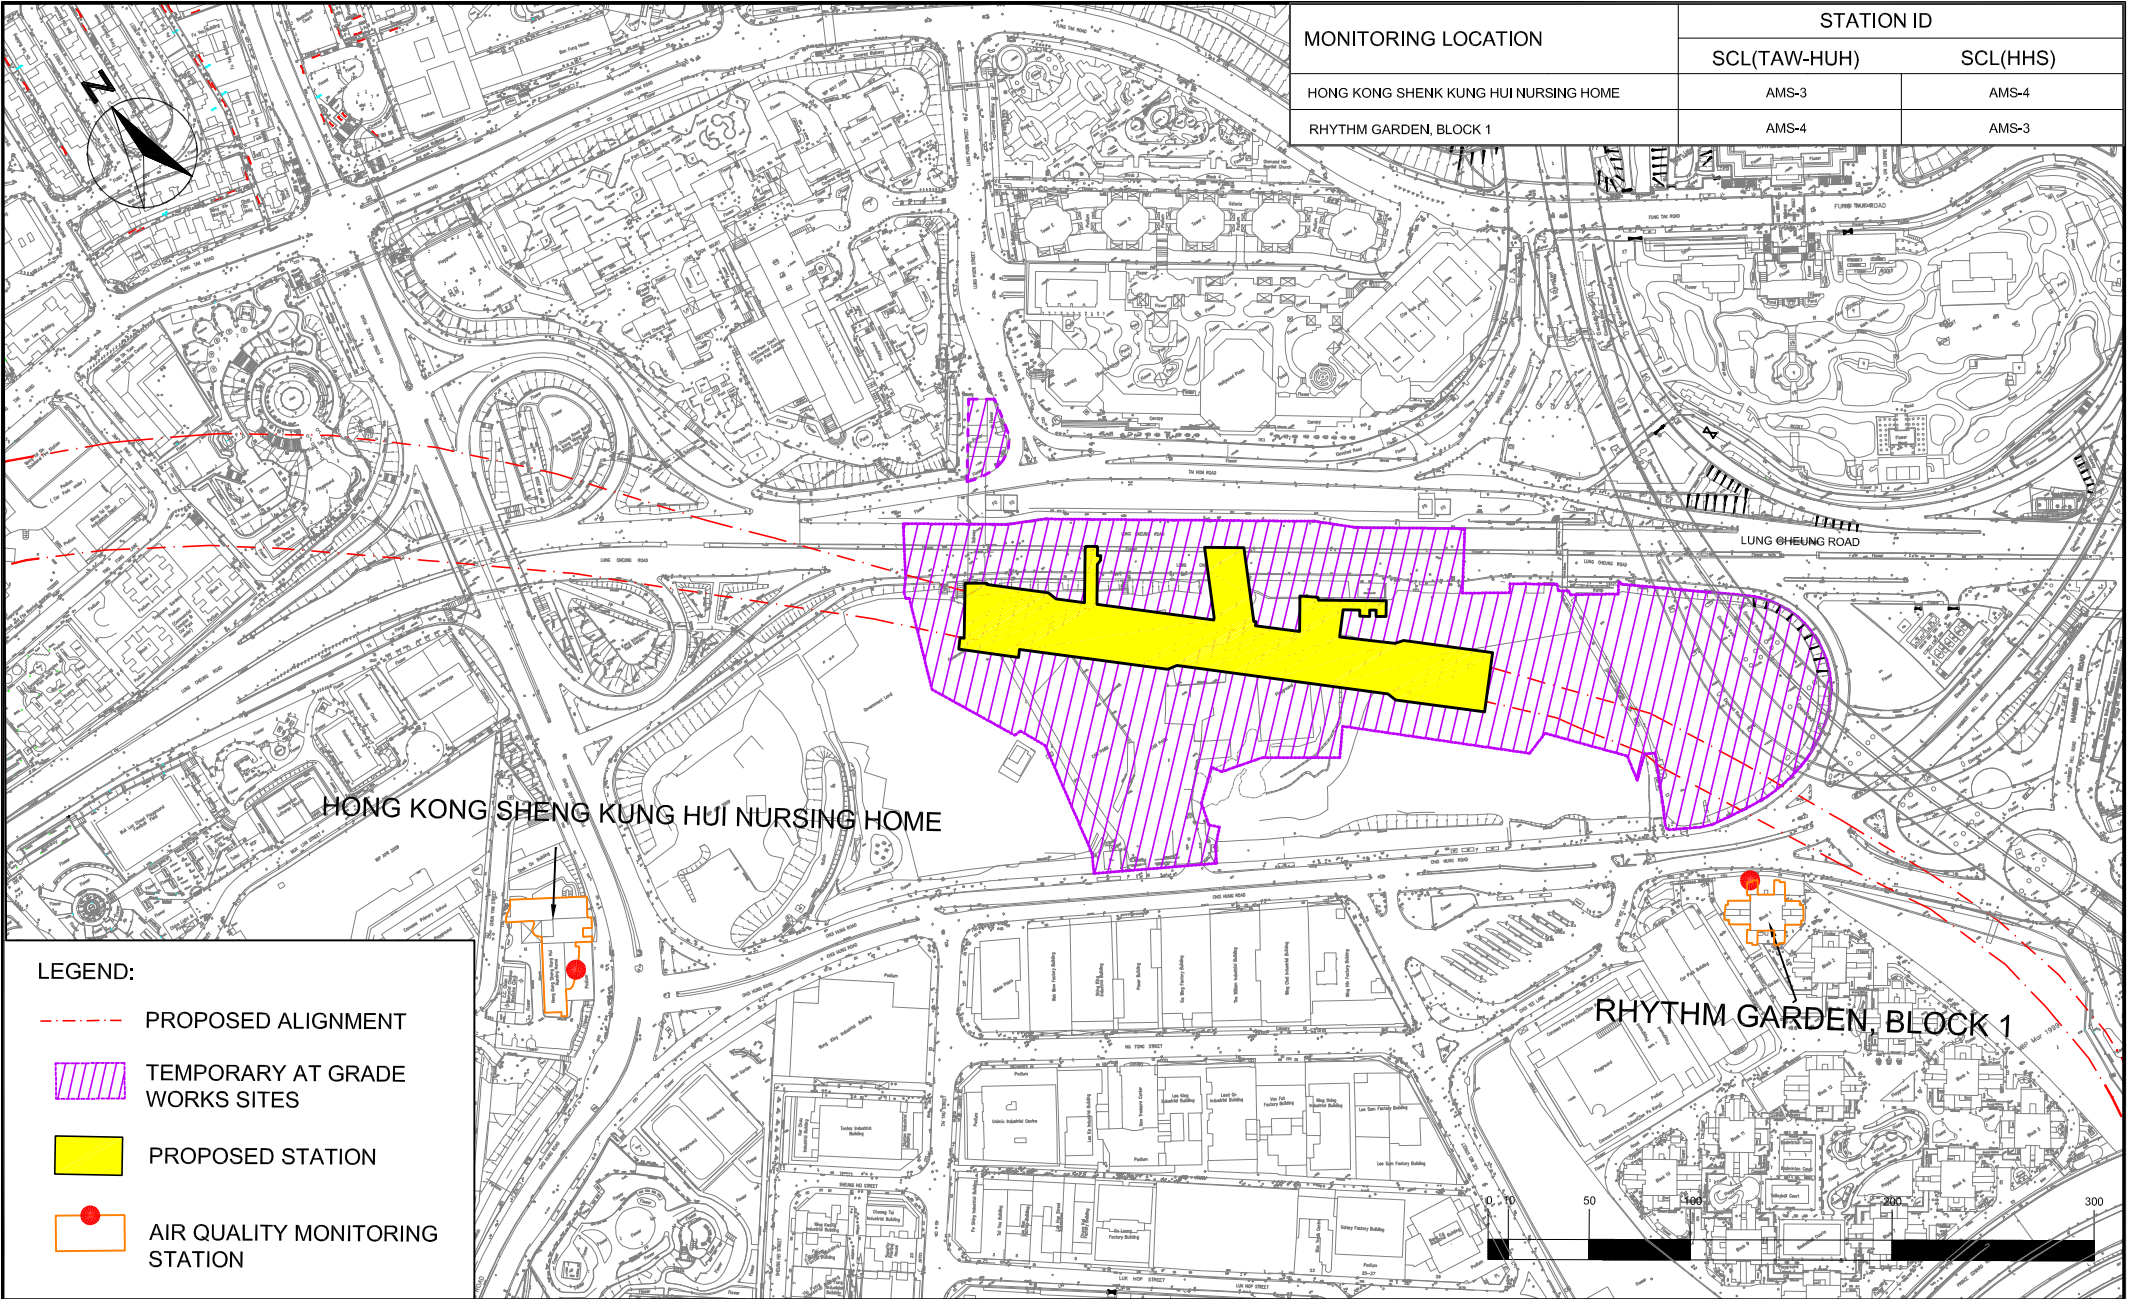
SCALE	1:100	DATE	AUG 2016	
CHECK	BW	DRAWN	JW	
JOB No.	MA12051	FIGURE NO.	3	REV -

MONITORING LOCATION	STATION ID	
	SCL(TAW-HUH)	SCL(HHS)
HONG KONG SHEN KUNG HUI NURSING HOME	AMS-3	AMS-4
RHYTHM GARDEN, BLOCK 1	AMS-4	AMS-3

## LOCATION OF AIR QUALITY MONITORING STATIONS

3.9 The proposed dust monitoring stations for the construction phase of the Project, as recommended in the approved EM&A Manual, are listed in **Table 3.3** and shown in **Figure 3**. The proposed locations have been agreed with the ER, EPD and IEC.

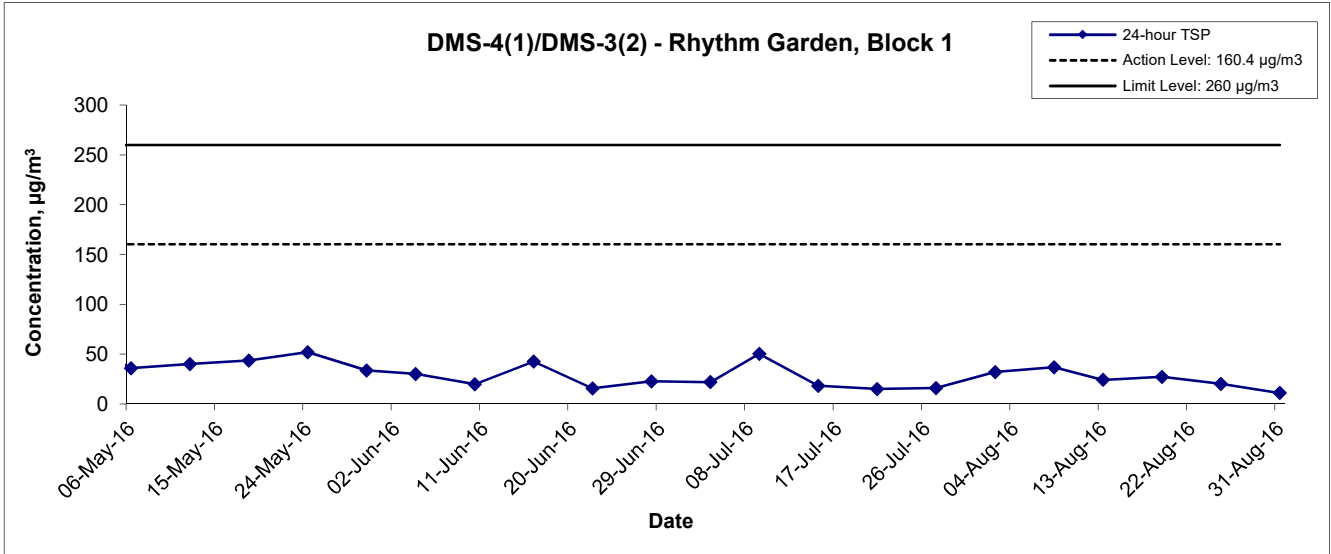
### 24-hour TSP Concentration Levels

- (1) ASR ID as identified in approved EM&A Manual / EIA Report for SCL(TAW-HUH).
- (2) ASR ID as identified in approved EM&A Manual / EIA Report for SCL(HHS).

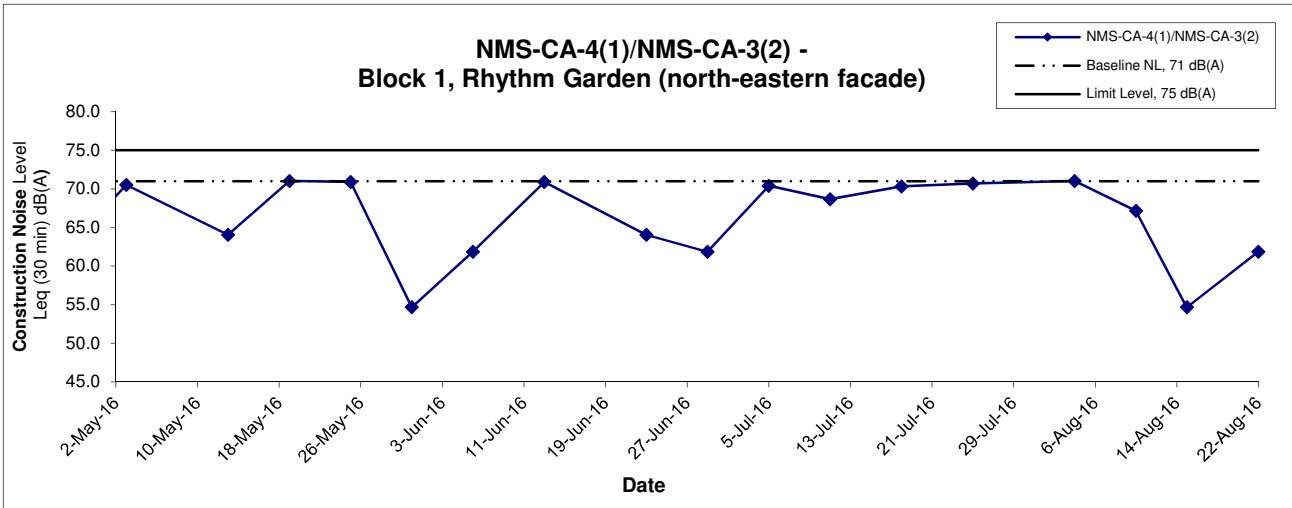
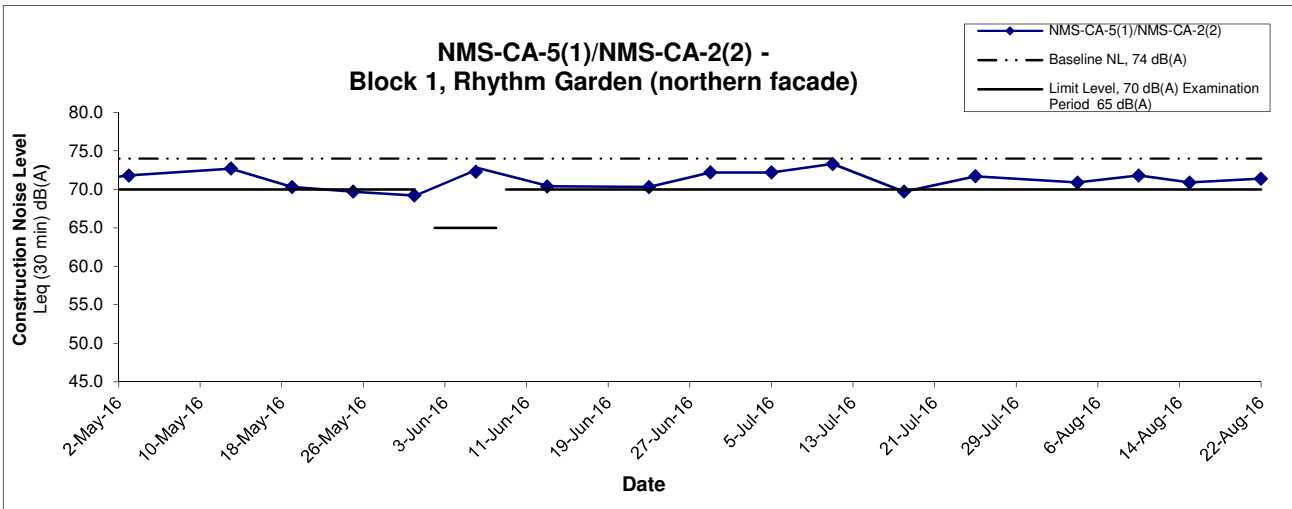
## Noise Levels

- (1) Station ID as identified in approved EM&A Manual / EIA Report for SCL(TAW-HUH).
- (2) Station ID as identified in approved EM&A Manual / EIA Report for SCL(HHS).
- (3) In case of Measured Level  $\leq$  Baseline Level, only Measured Level is presented on the graphical presentation.

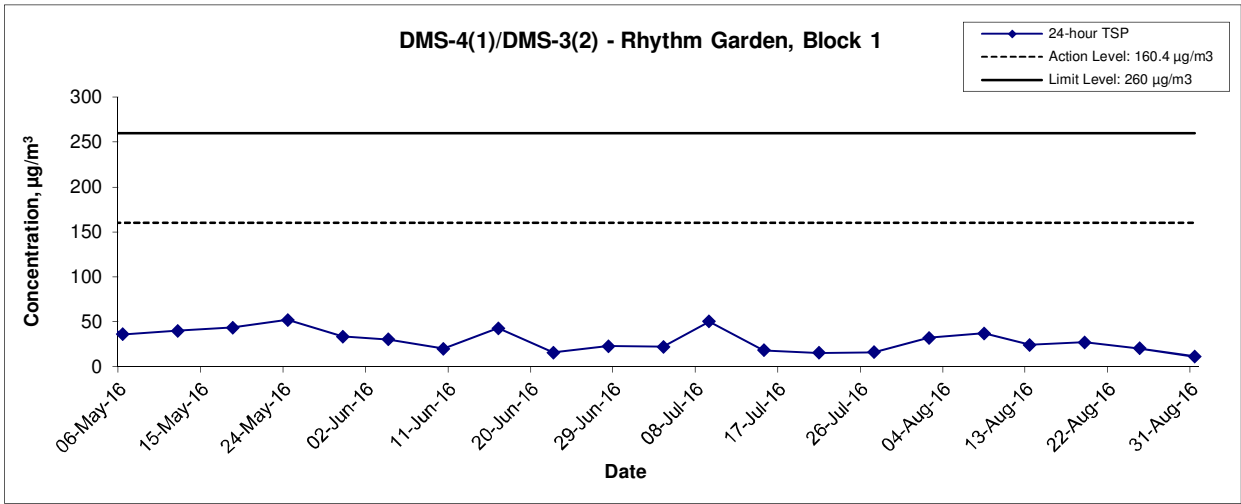
### 24-hour TSP Concentration Levels

- (1) ASR ID as identified in approved EM&A Manual / EIA Report for SCL(TAW-HUH).
- (2) ASR ID as identified in approved EM&A Manual / EIA Report for SCL(HHS).

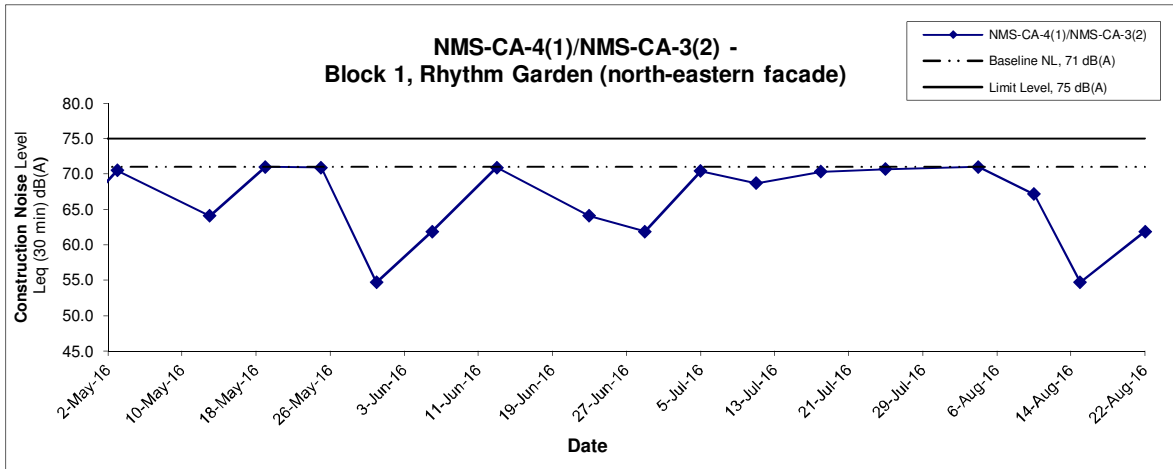
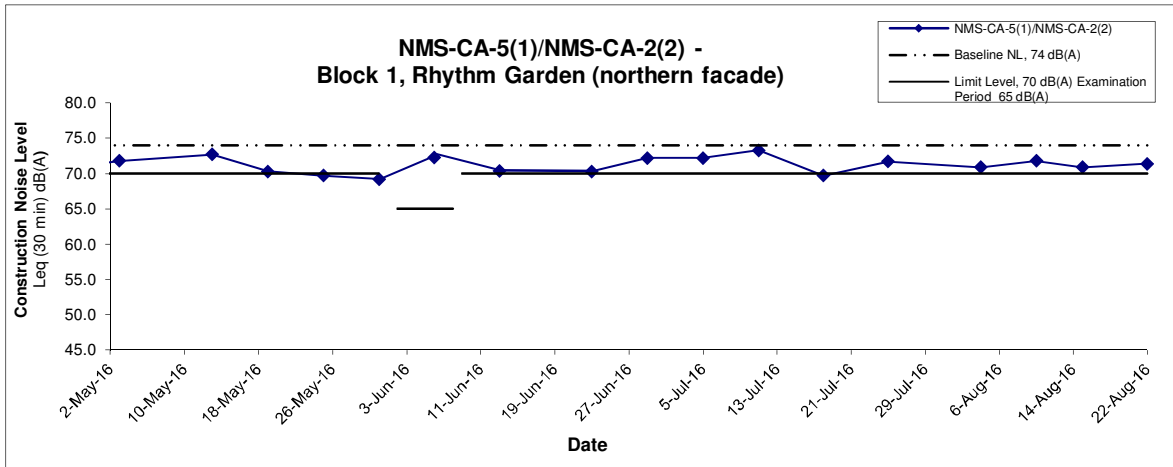
### Noise Levels

- (1) Station ID as identified in approved EM&A Manual / EIA Report for SCL(TAW-HUH).
- (2) Station ID as identified in approved EM&A Manual / EIA Report for SCL(HHS).
- (3) In case of Measured Level ≤ Baseline Level, only Measured Level is presented on the graphical presentation.

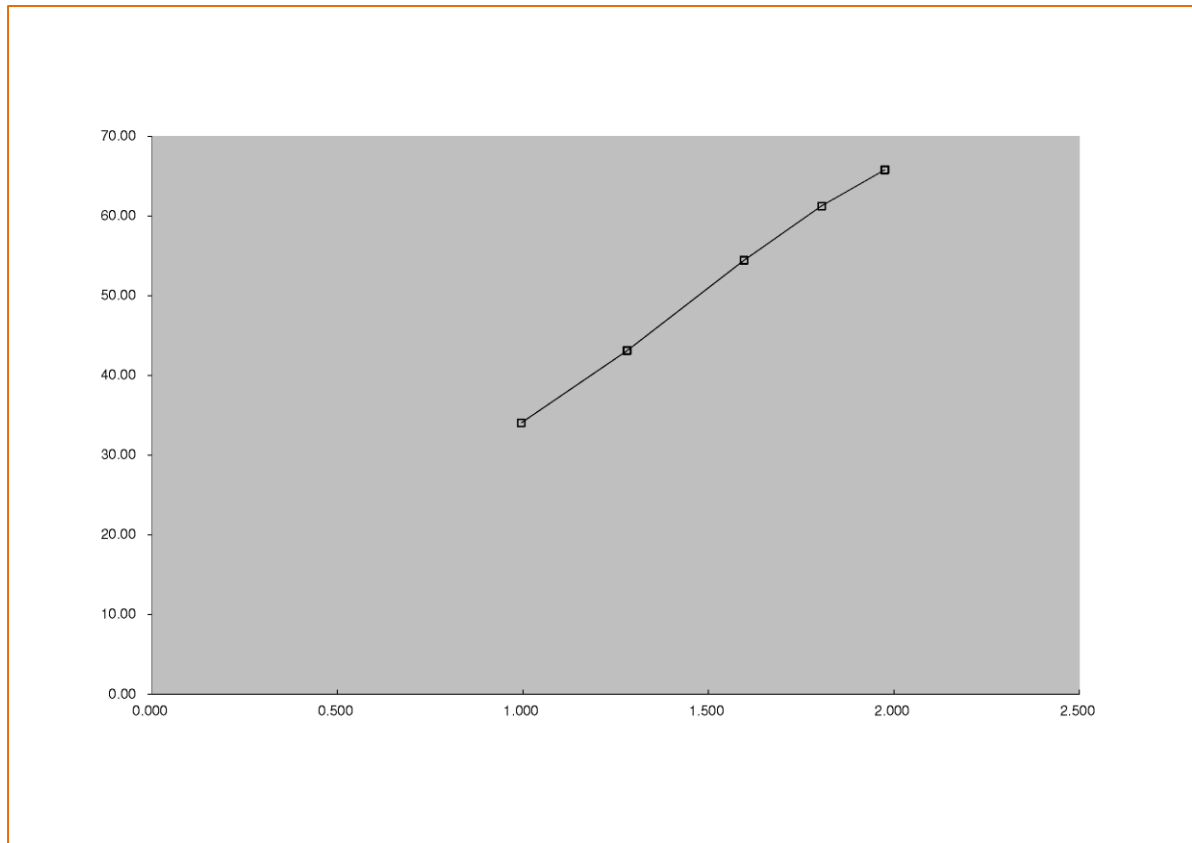
Date: <u>August 8, 2016</u>

TSP Sampler Calibration						
<b>SITE</b>						
Location: <b>Hung Hom</b>		Calibration Date: <b>August 8, 2016</b>				
Sampler: <b>Hunghom MTR TSP</b>		Next Calibration Date: <b>October 8, 2016</b>				
Serial No <b>694-0665</b>		Tech: <b>Sam Wong</b>				
<b>CONDITIONS</b>						
Barometric Pressure (in Hg):	<b>39.50</b>	Corrected Pressure (mm Hg):	<b>1003</b>			
Temperature (deg F):	<b>91</b>	Temperature (deg K):	<b>306</b>			
Average Press. (in Hg):	<b>39.50</b>	Corrected Average (mm Hg):	<b>1003</b>			
Average Temp. (deg F):	<b>91</b>	Average Temp. (deg K):	<b>306</b>			
<b>CALIBRATION ORIFICE</b>						
Make: <b>Tisch</b>	Qstd Slope: <b>2.00411</b>					
Model: <b>TE-5025A</b>	Qstd Intercept: <b>-0.03059</b>					
Serial#: <b>1612</b>	Date Certified: <b>March 14, 2016</b>					
<b>CALIBRATIONS</b>						
Plate or Test #	H2O (in)	Qstd (m3/min)	I (chart)	IC (corrected)	LINEAR REGRESSION	
1	12.00	1.976	58.0	65.79	Slope =	33.0024

2	10.00	1.805	54.0	61.25	Intercept =	1.2081
3	7.80	1.596	48.0	54.44	Corr. coeff.=	0.9992
4	5.00	1.281	38.0	43.10		
5	3.00	0.996	30.0	34.03	# of Observations:	<b>5</b>
<p>Calculations</p> <p>Qstd = 1/m[Sqrt(H2O(Pa/Pstd)(Tstd/Ta))-b]                      IC = I[Sqrt(Pa/Pstd)(Tstd/Ta)]</p> <p>Qstd = standard flow rate                      IC = corrected chart response                      I = actual chart response                      m = calibrator Qstd slope                      b = calibrator Qstd intercept                      Ta = actual temperature during calibration (deg K)                      Pa = actual pressure during calibration (mm Hg)                      Tstd = 298 deg K                      Pstd = 760 mm Hg                      For subsequent calculation of sampler flow:                      1/m((I)[Sqrt(298/Tav)(Pav/760)]-b)</p> <p>m = sampler slope                      b = sampler intercept                      I = chart response                      Tav = daily average temperature                      Pav = daily average pressure</p>
