**Shatin to Central Link –  
Tai Wai to Hung Hom Section and  
Mong Kok East to Hung Hom Section**

Monthly EM&A Report No. 48

[Period from 1 to 31 August 2016]

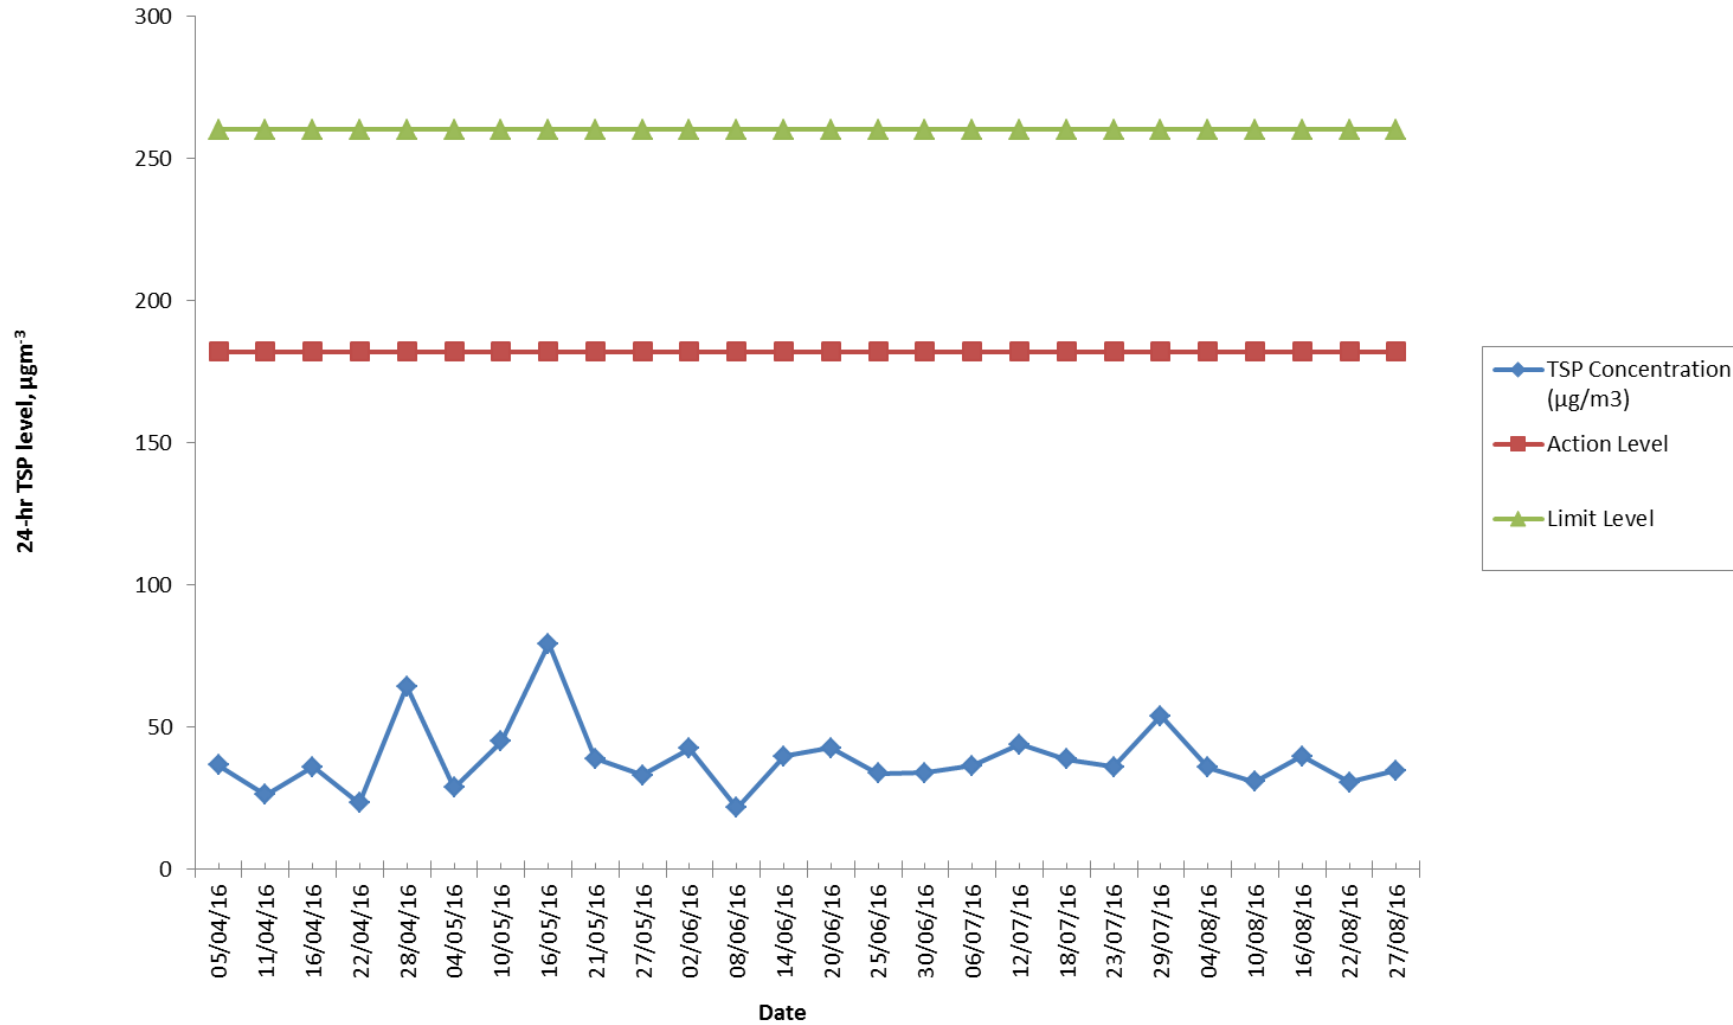
### Construction Dust Monitoring Results for AM2 (Harbourfront Horizon)

Sampling Date	Wt. of paper (g)				Elapse Time			Flow Rate (CFM)			Total Volume (m <sup>3</sup> )	TSP Concentration (µg/m <sup>3</sup> )	Weather	Remark
	Paper No.	Initial Wt.	Final Wt.	Wt. of dust	Initial	Final	Sampling Hour	Initial	Final	Avg Flow Rate				
04/08/16	C232	2.8460	2.9044	0.0584	14529.30	14553.30	24.00	40	40	40.0	1631.05	35.8052	Sunny	-
10/08/16	C247	2.8567	2.9069	0.0502	14553.30	14577.30	24.00	40	40	40.0	1631.05	30.7777	Sunny	-
16/08/16	C249	2.8349	2.8997	0.0648	14577.30	14601.30	24.00	40	40	40.0	1631.05	39.7290	Rainy	-
22/08/16	C248	2.8060	2.8557	0.0497	14601.30	14625.30	24.00	40	40	40.0	1631.05	30.4712	Sunny	-
27/08/16	C250	2.8637	2.9202	0.0565	14625.30	14649.30	24.00	40	40	40.0	1631.05	34.6403	Cloudy	-
