**Shatin to Central Link –
Tai Wai to Hung Hom Section and
Mong Kok East to Hung Hom Section**

Monthly EM&A Report No. 49

[Period from 1 to 30 September 2016]

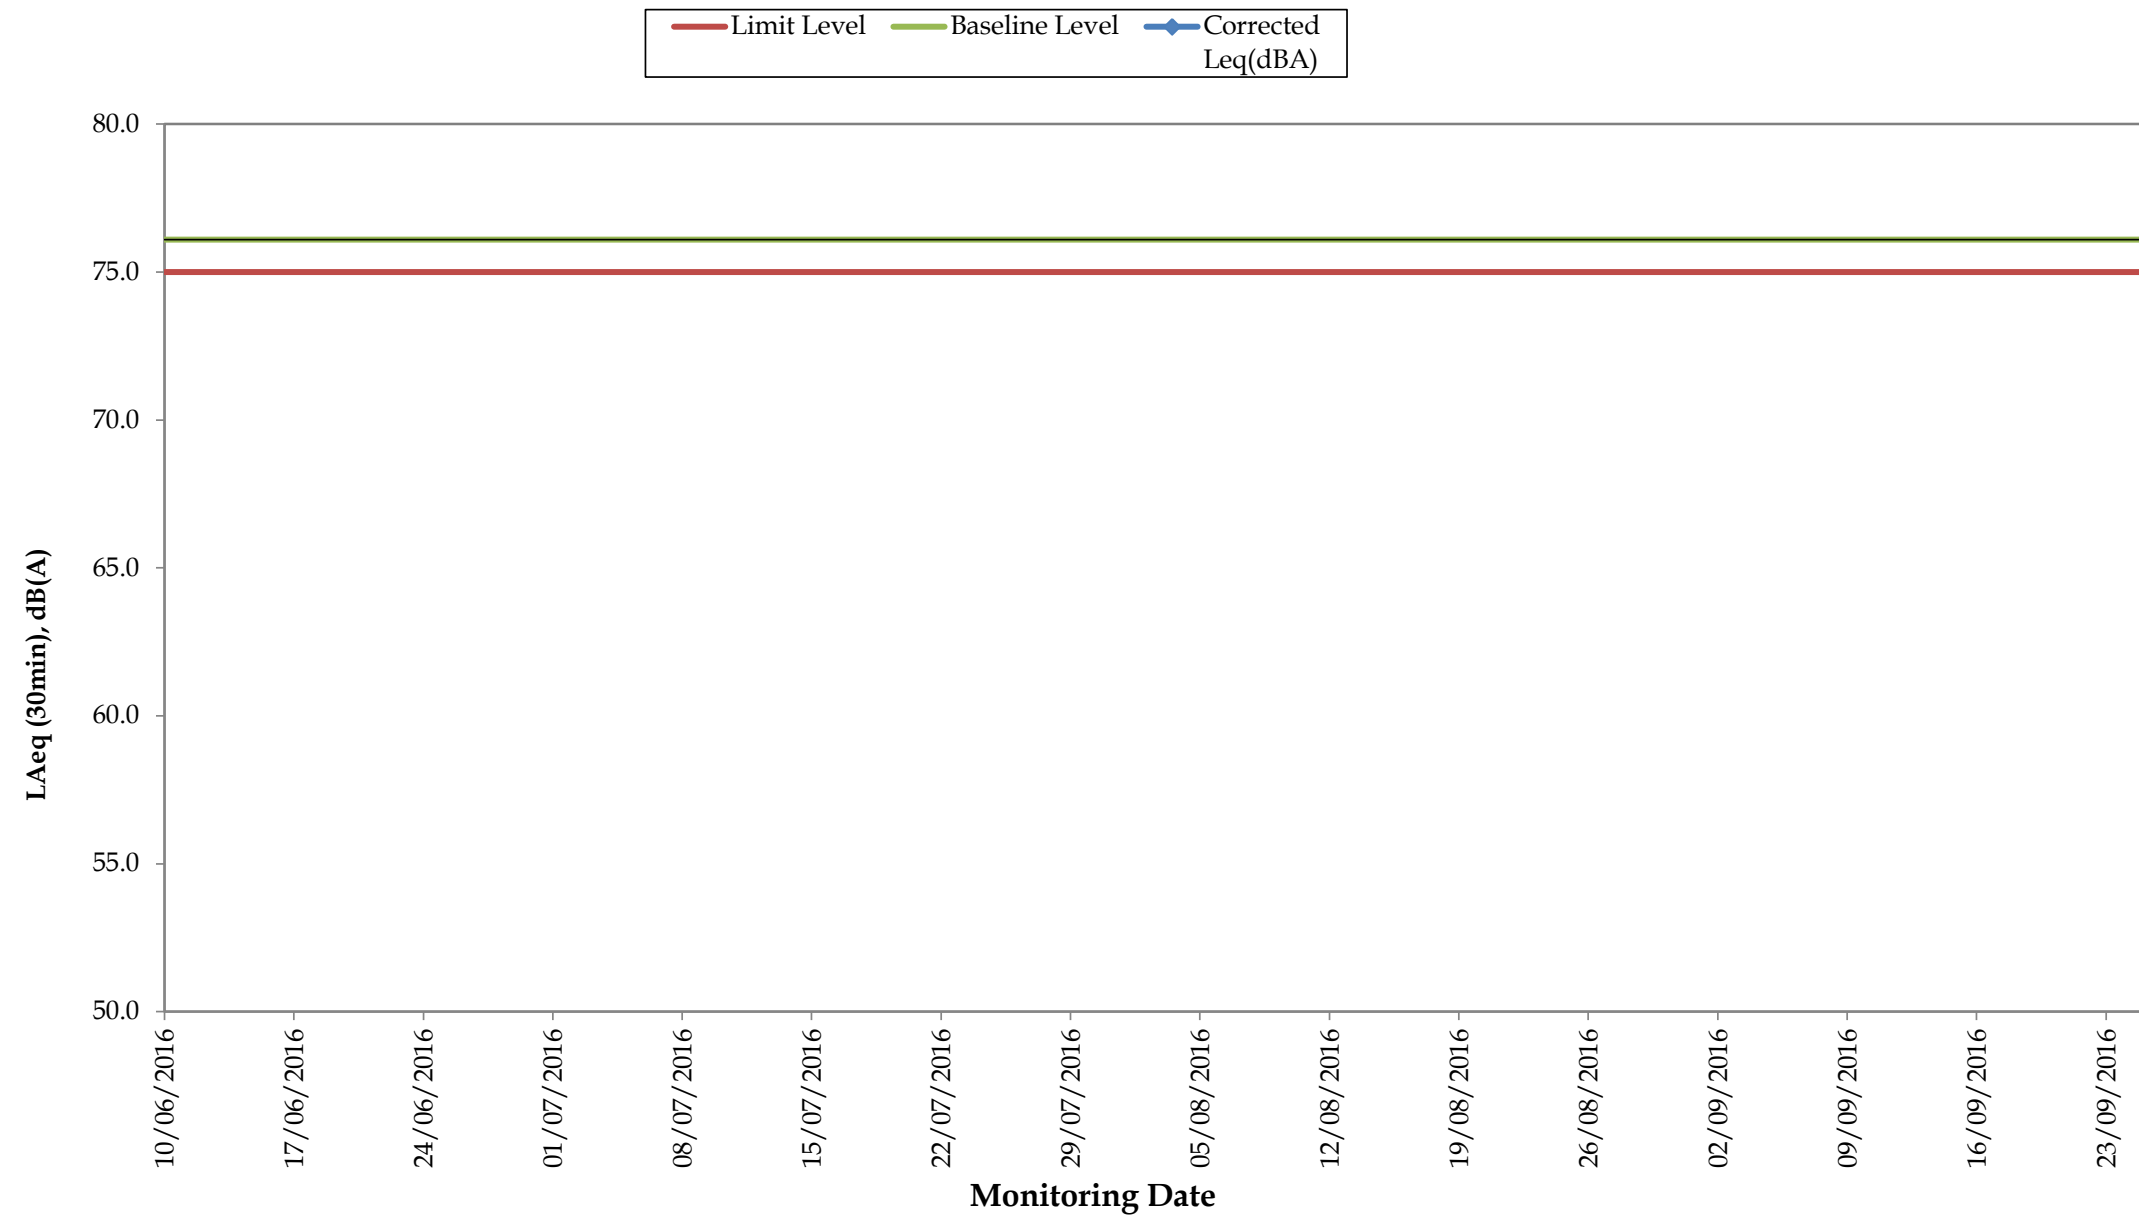
Regular Noise Monitoring Results at NMS-CA-6 (No. 16-23 Nam Kok Road) (LAeq, 30min) for the Past 4 Months

- For those corrected noise levels that are not shown in this graph, the measured noise levels are equal to or below baseline level.

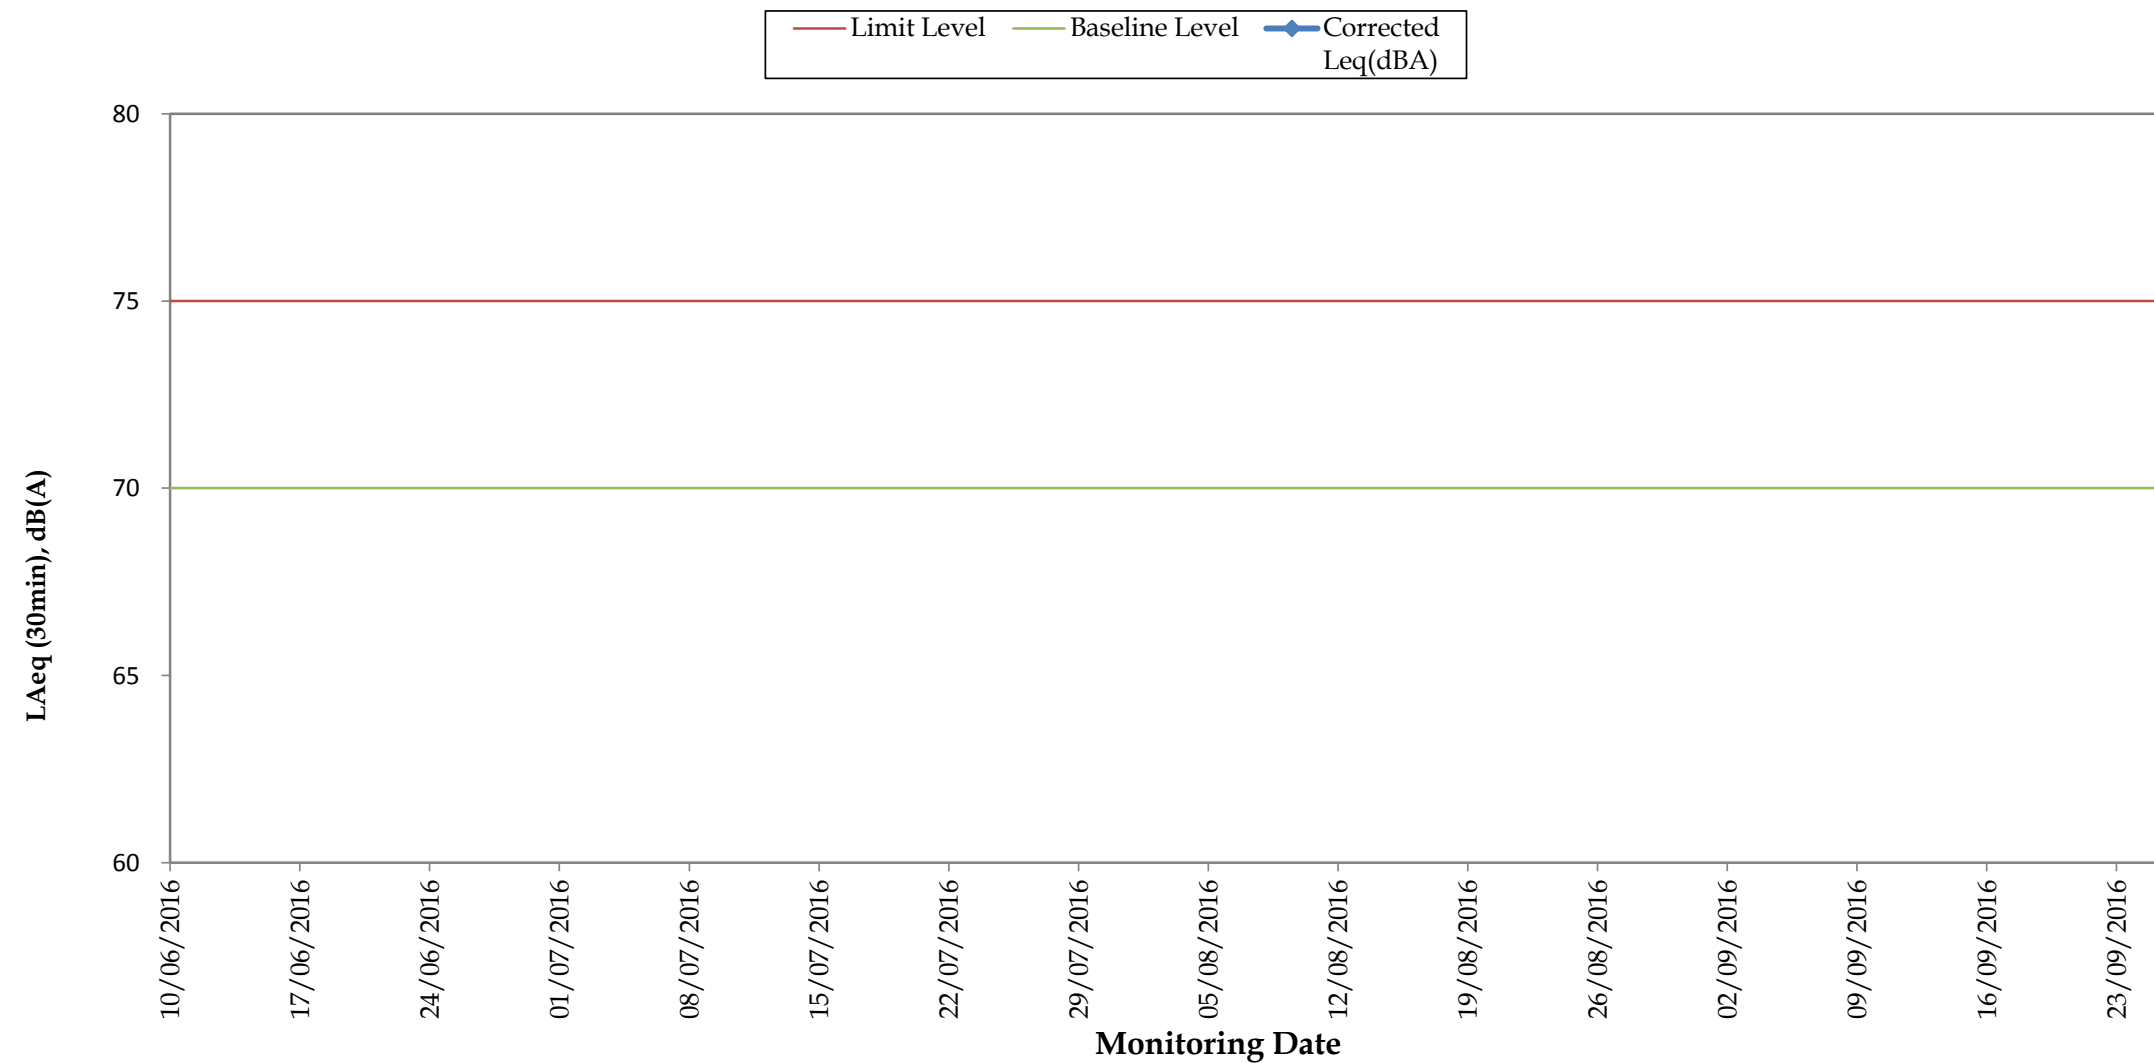
Regular Noise Monitoring Results at NMS-CA-7 (Skytower Tower 2) (LAeq, 30min) for the Past 4 Months

Remarks:

- For those corrected noise levels that are not shown in this graph, the measured noise levels are equal to or below baseline level.

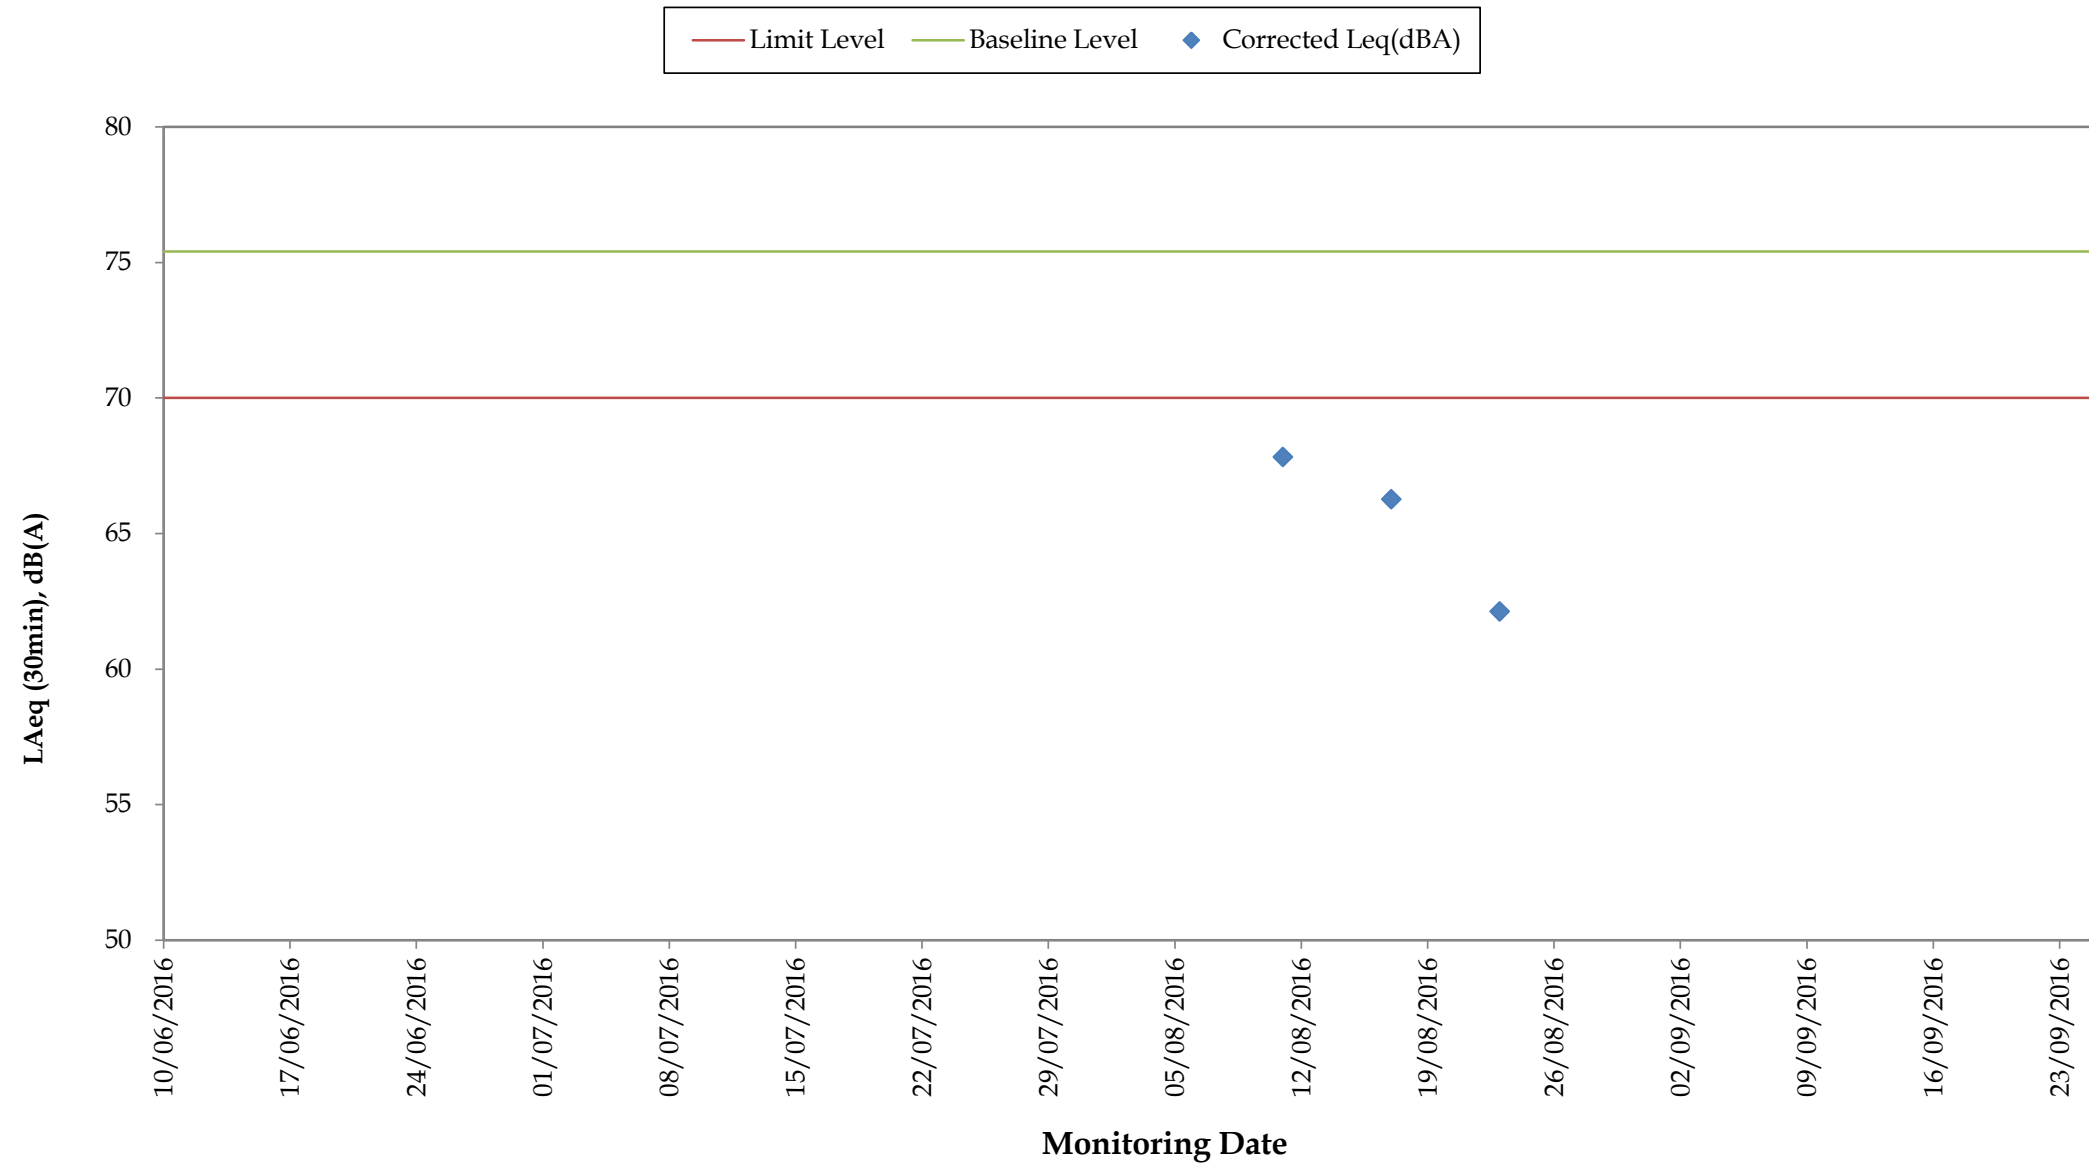
Regular Noise Monitoring Results at NMS-CA- 8 (SKH Good Shepherd Primary School) (LAeq, 30min) for the Past 4 Months

- For those corrected noise levels that are not shown in this graph, the measured noise levels are equal to or below baseline level.
- The limit level was updated from 78dB(A) to 79 dB(A) on 22 Aug 2013 as per the latest CNMP and CNMMP.
- The limit level was updated from 79dB(A) to 70dB(A)/65dB(A) (during normal/examination period) from April 2016, as the continuous noise monitoring was completed in March 2016 according to the latest CNMP

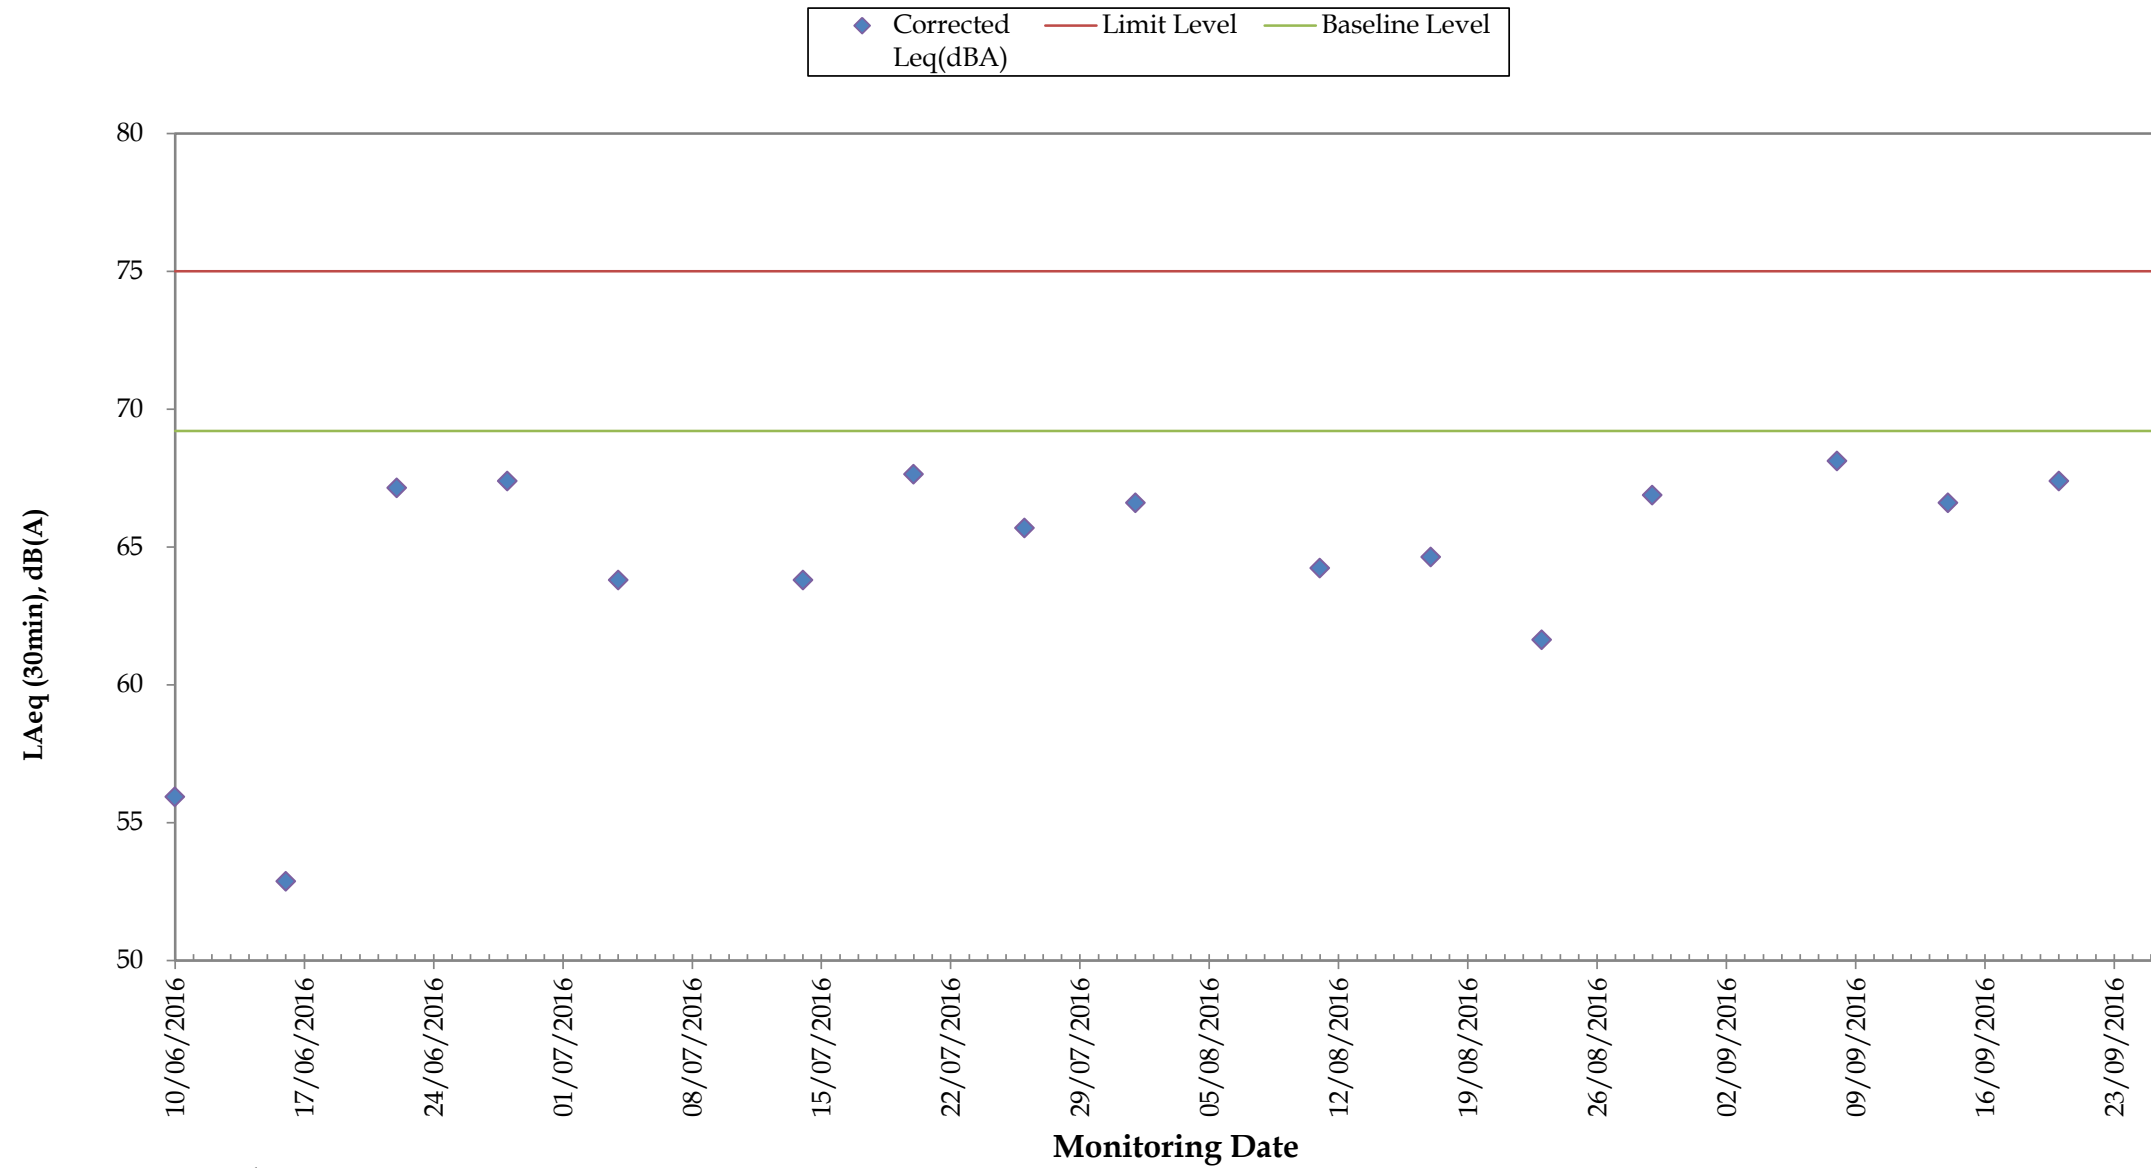
Regular Noise Monitoring Results at NMS-CA-9 (Kong Yiu Mansion) (LAeq, 30min)) for the Past 4 Months

Remarks:

- For those corrected noise levels that are not shown in this graph, the measured noise levels are equal to or below baseline level.

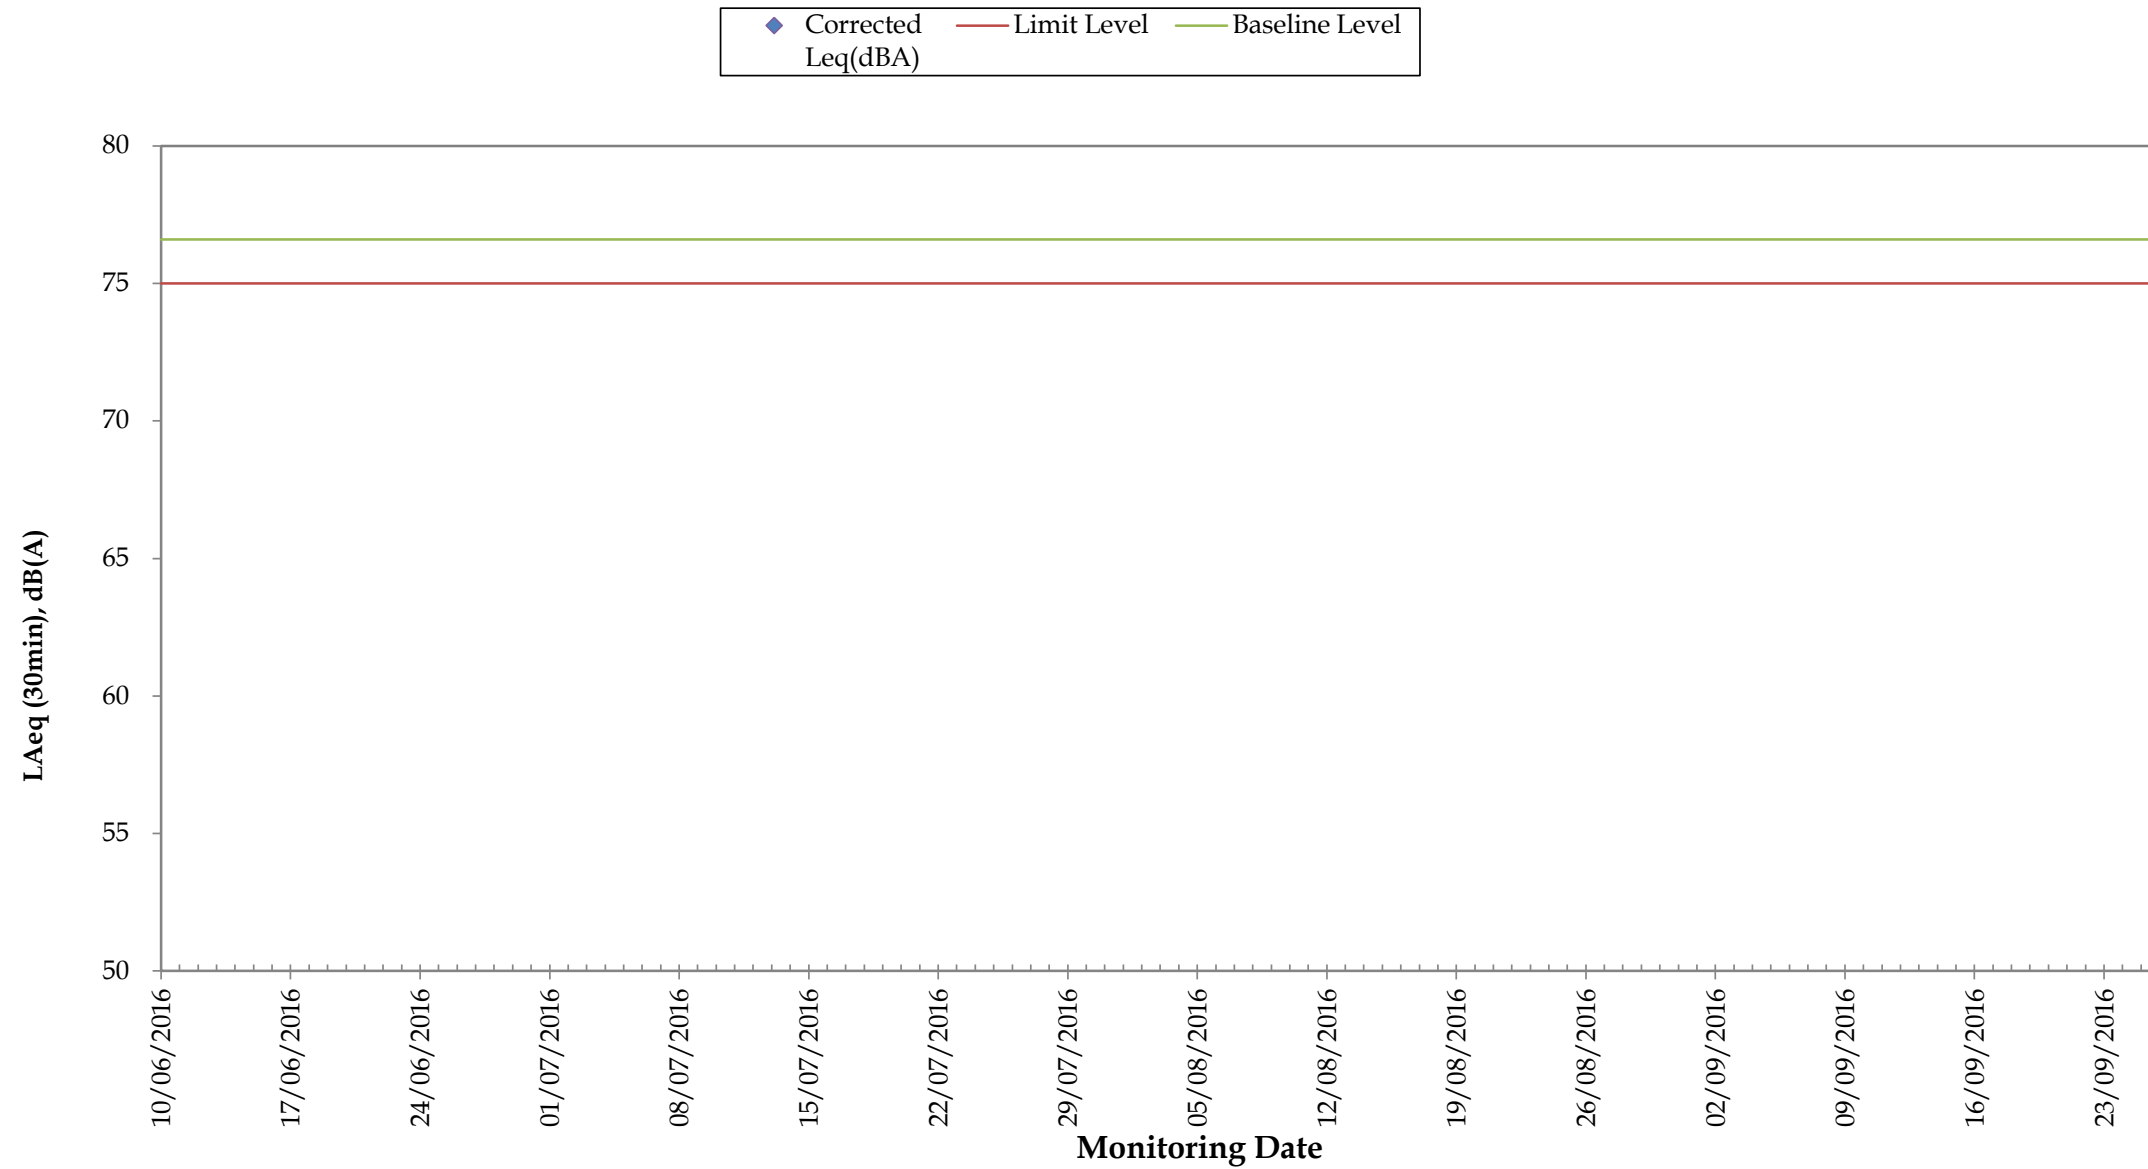
Regular Noise Monitoring Results at NMS-CA-10 (Chat Ma Mansion) (LAeq, 30min) for the Past 4 Months

- For those corrected noise levels that are not shown in this graph, the measured noise levels are equal to or below baseline level.
- Noise monitoring at NMS-CA-10 (Chat Ma Mansion) was temporarily suspended since June 2016 due to request from the Management Office and was resumed on 26 July 2016.

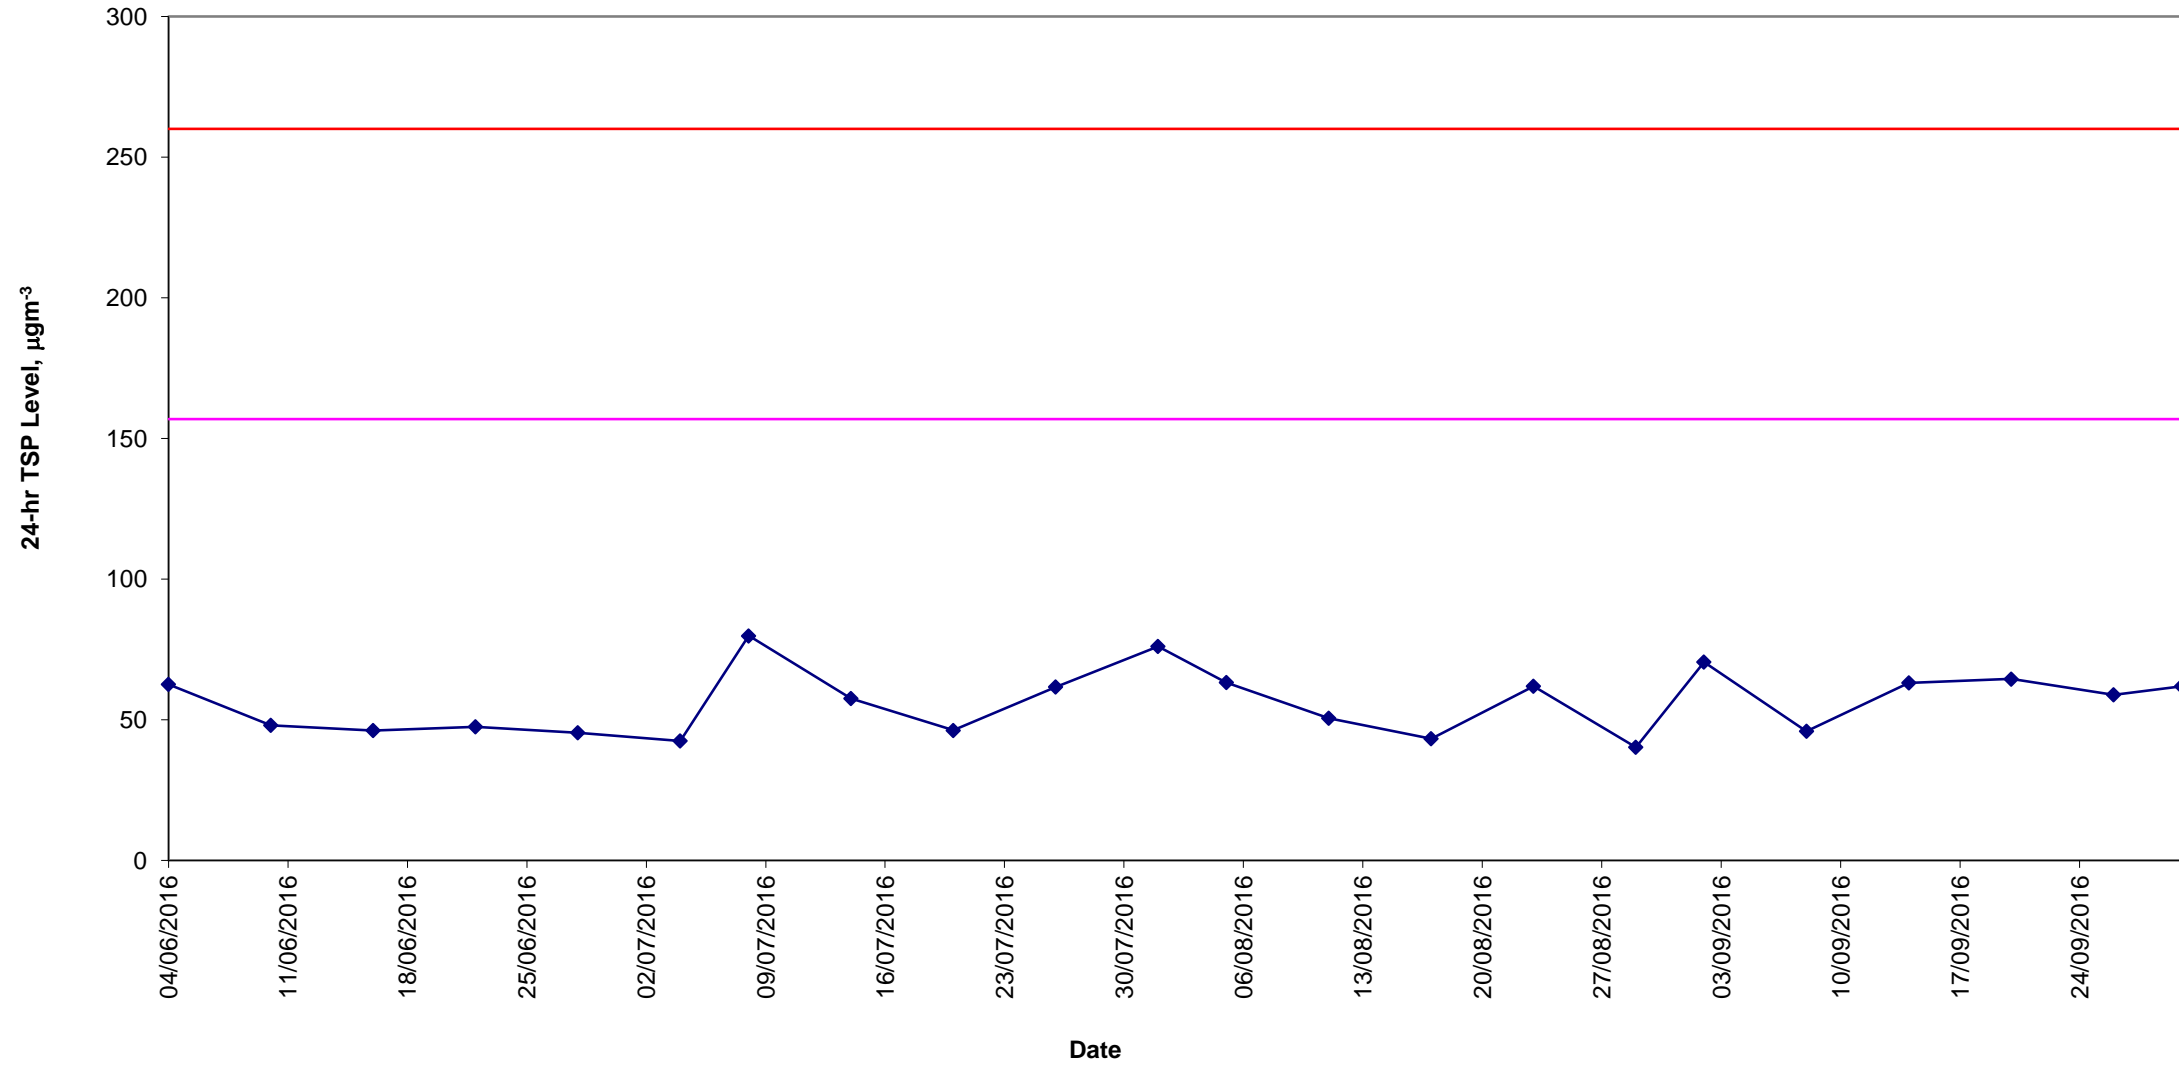
Construction Dust Monitoring Results for the Past 4 Months DMS-6 (Katherine Building)

◆ DMS-6 ◆ Action Level ◆ Limit Level

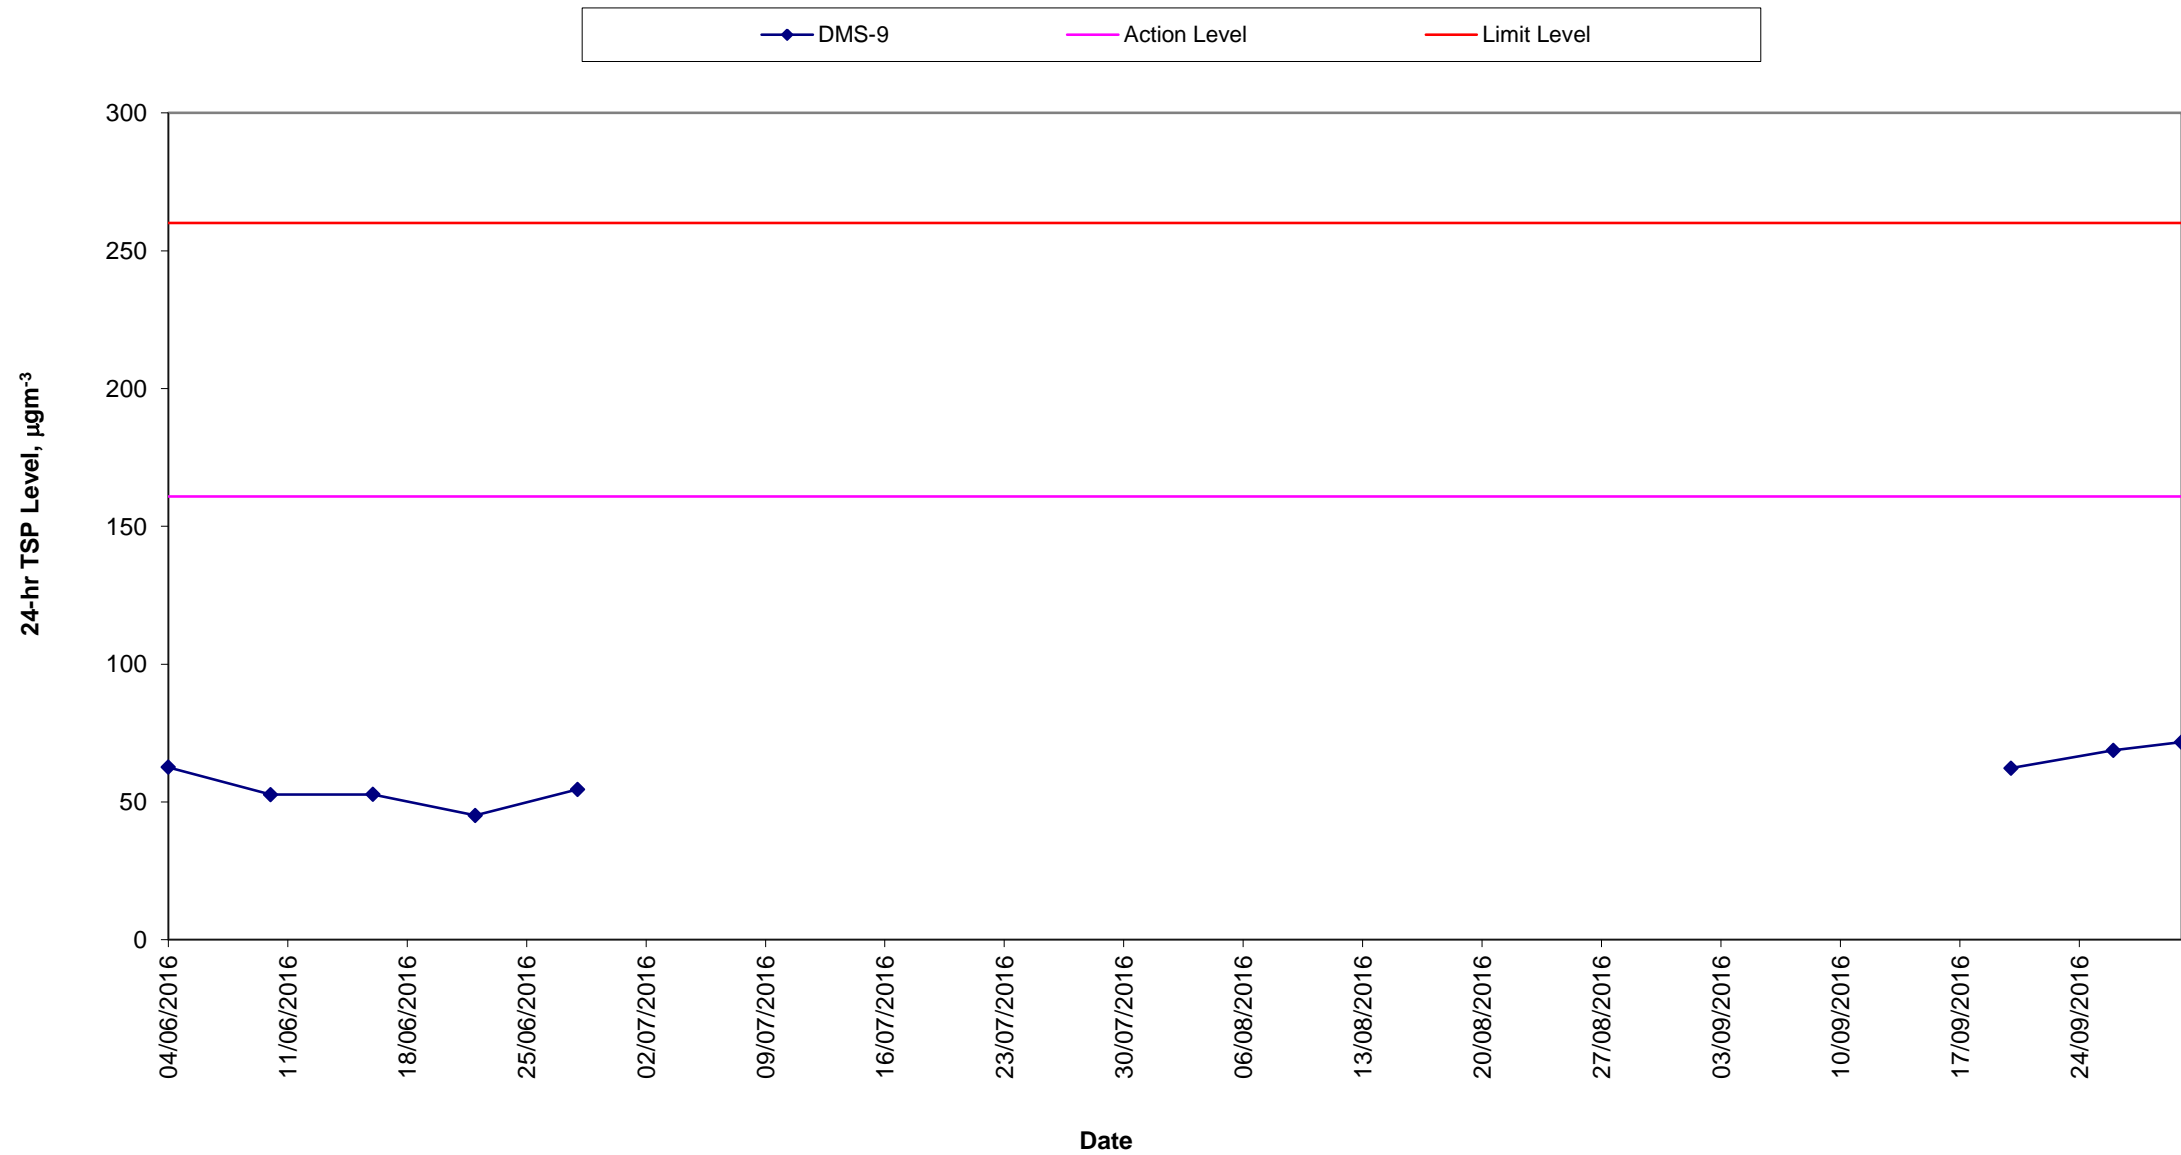
Construction Dust Monitoring Results for the Past 4 Months DMS-9 (No.12 Pau Chung Street)

- 24-hour averaged dust monitoring at DMS-9 (No. 12 Pau Chung Street) was temporary suspended since July 2016 due to request from the Management Office and was resumed on 20 September 2016.

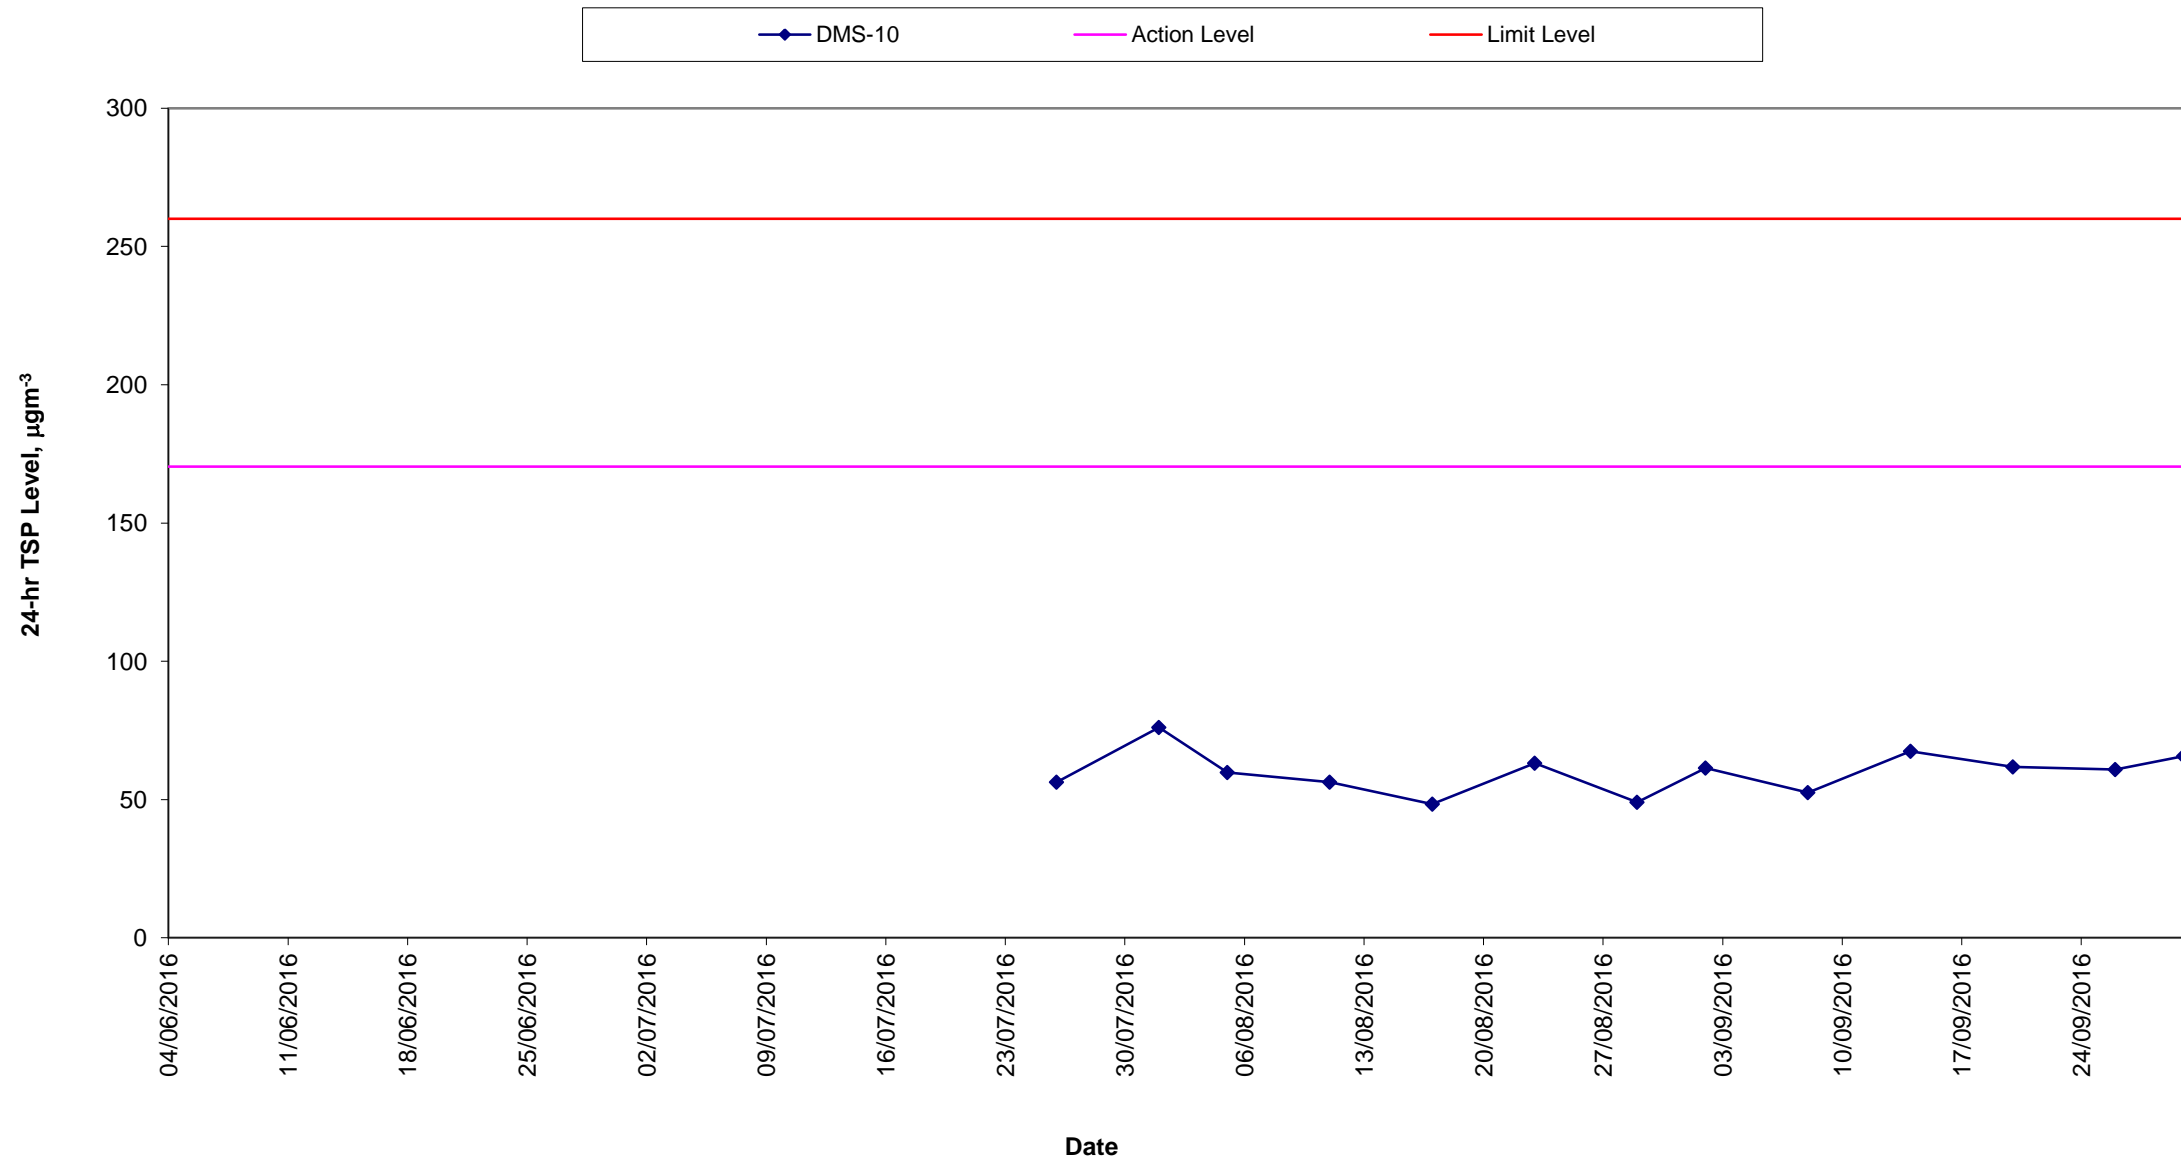
Construction Dust Monitoring Results for the Past 4 Months DMS-10 (Chat Ma Mansion)

- 24-hour averaged dust monitoring at DMS-10 (Chat Ma Mansion) was temporary suspended since June 2016 due to request from the Management Office and was resumed on 26 July 2016.
