**Shatin to Central Link –
Tai Wai to Hung Hom Section and
Mong Kok East to Hung Hom Section**

Monthly EM&A Report No. 49

[Period from 1 to 30 September 2016]

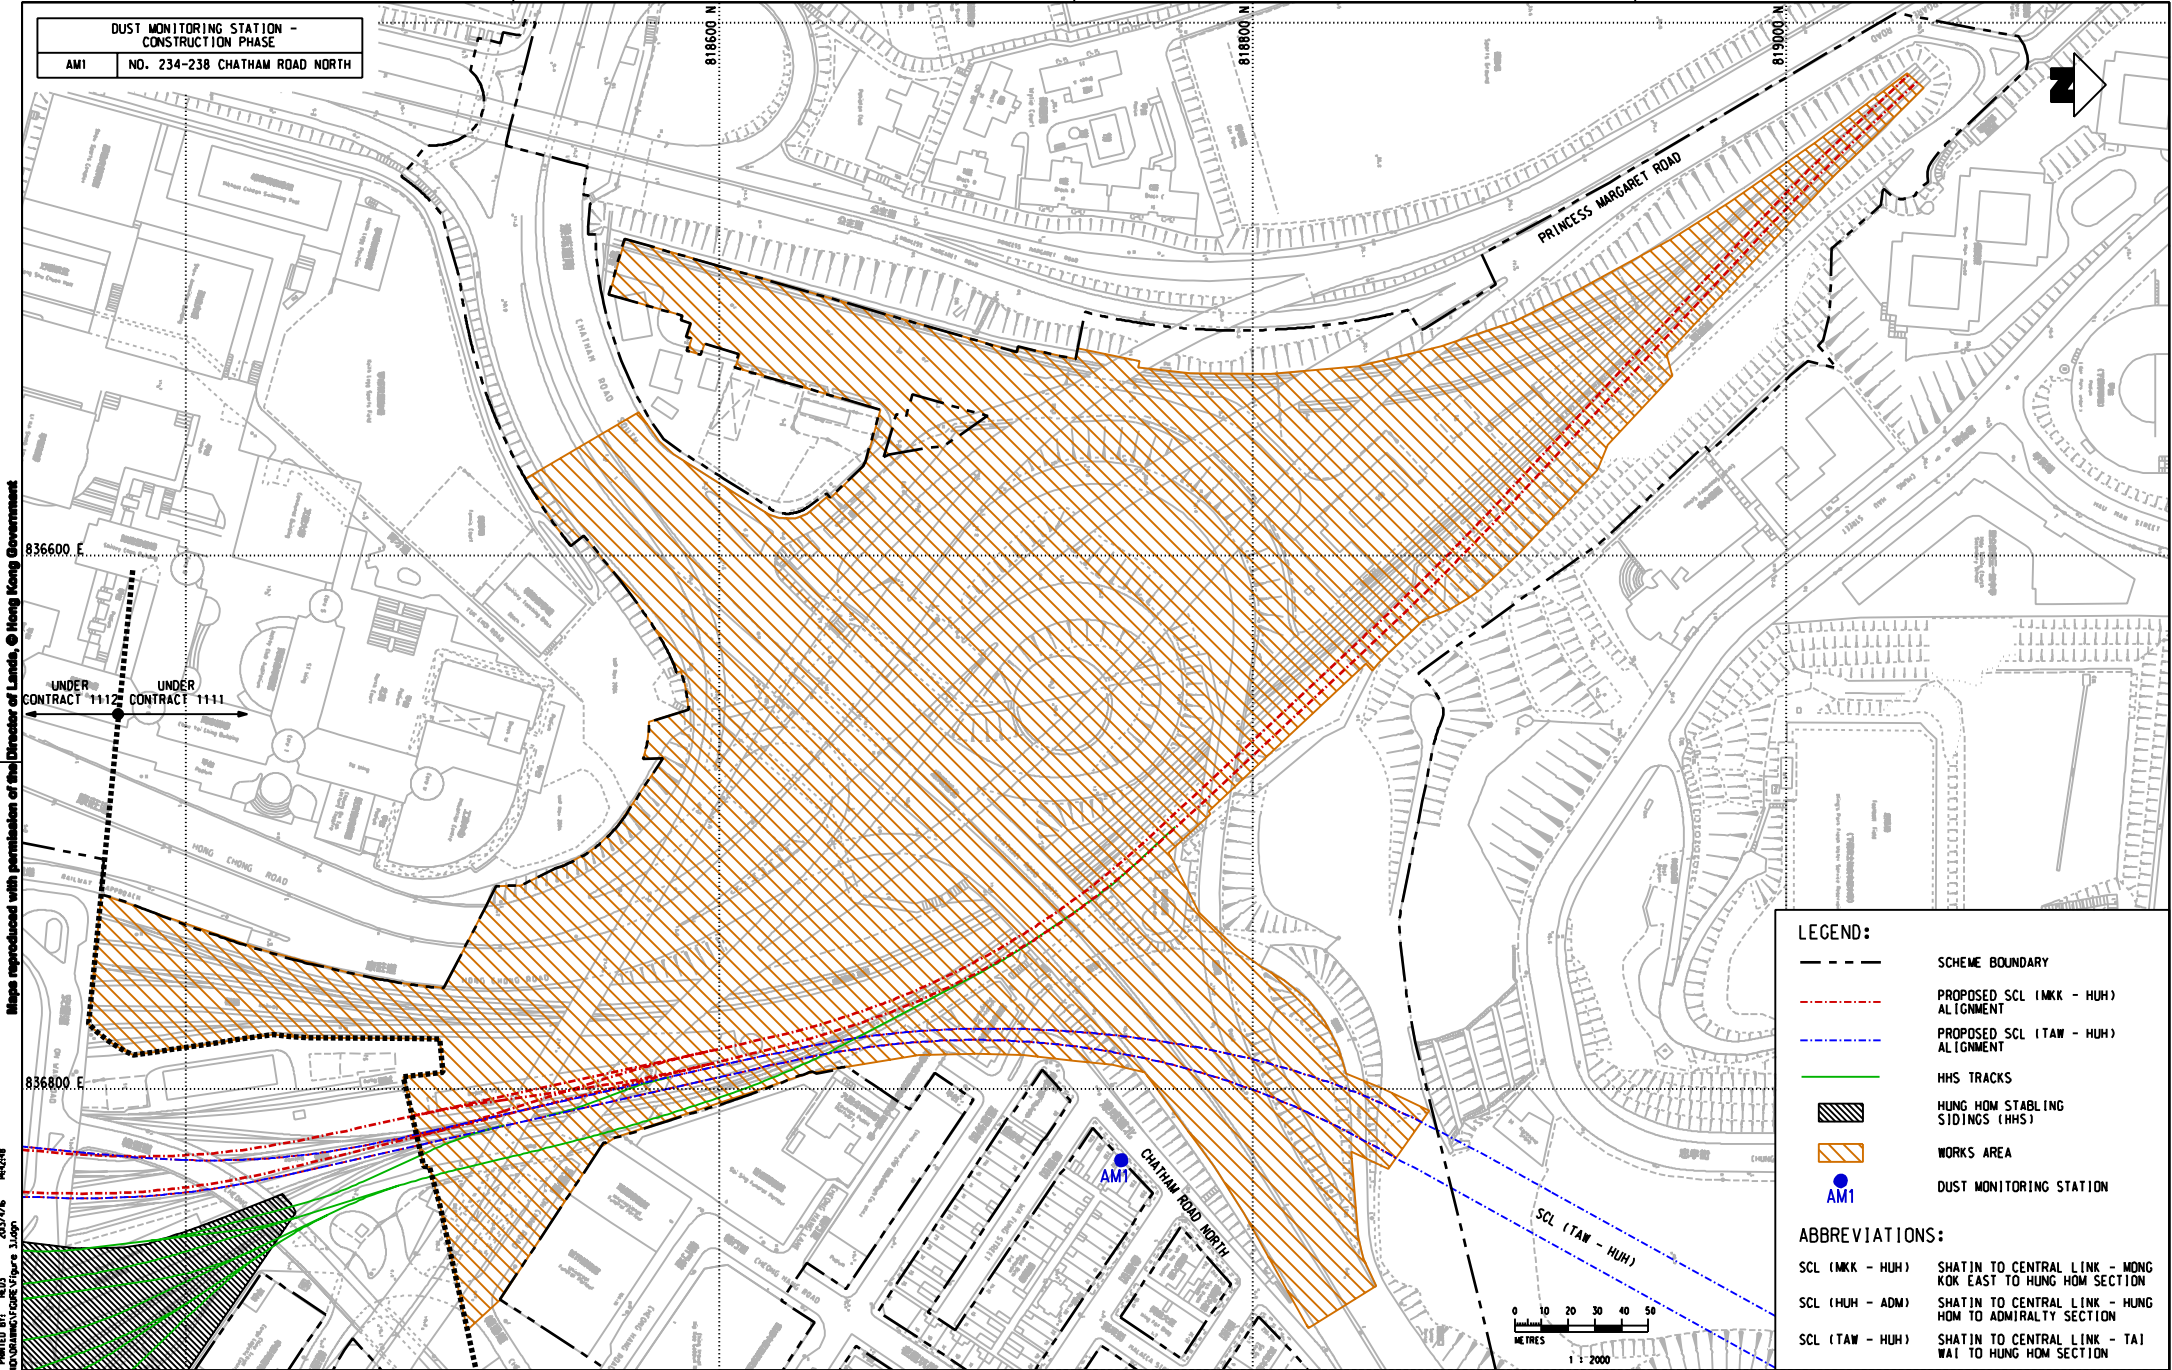
SCALE: 1 : 2000 (A3)
FIGURE NO.: **FIGURE 2.1**
REV: -

- 3.1.3 One monitoring station was set up at the proposed location in accordance with the approved EM&A Manuals for SCL (TAW-HUH), SCL (MKK-HUH) and SCL (HHS) as well as the works areas of the Project. The location of the construction dust monitoring station is summarised in **Table 3.2** and shown in **Figure 2.1**.

- 3.3.2 With reference to the CNMP, continuous noise monitoring should be conducted during period at which the predicted airborne construction noise levels exceed the relevant noise criteria at the respective NSRs. The proposed continuous noise monitoring locations are presented in **Table 3.7** and shown in **Figure 2.1**.

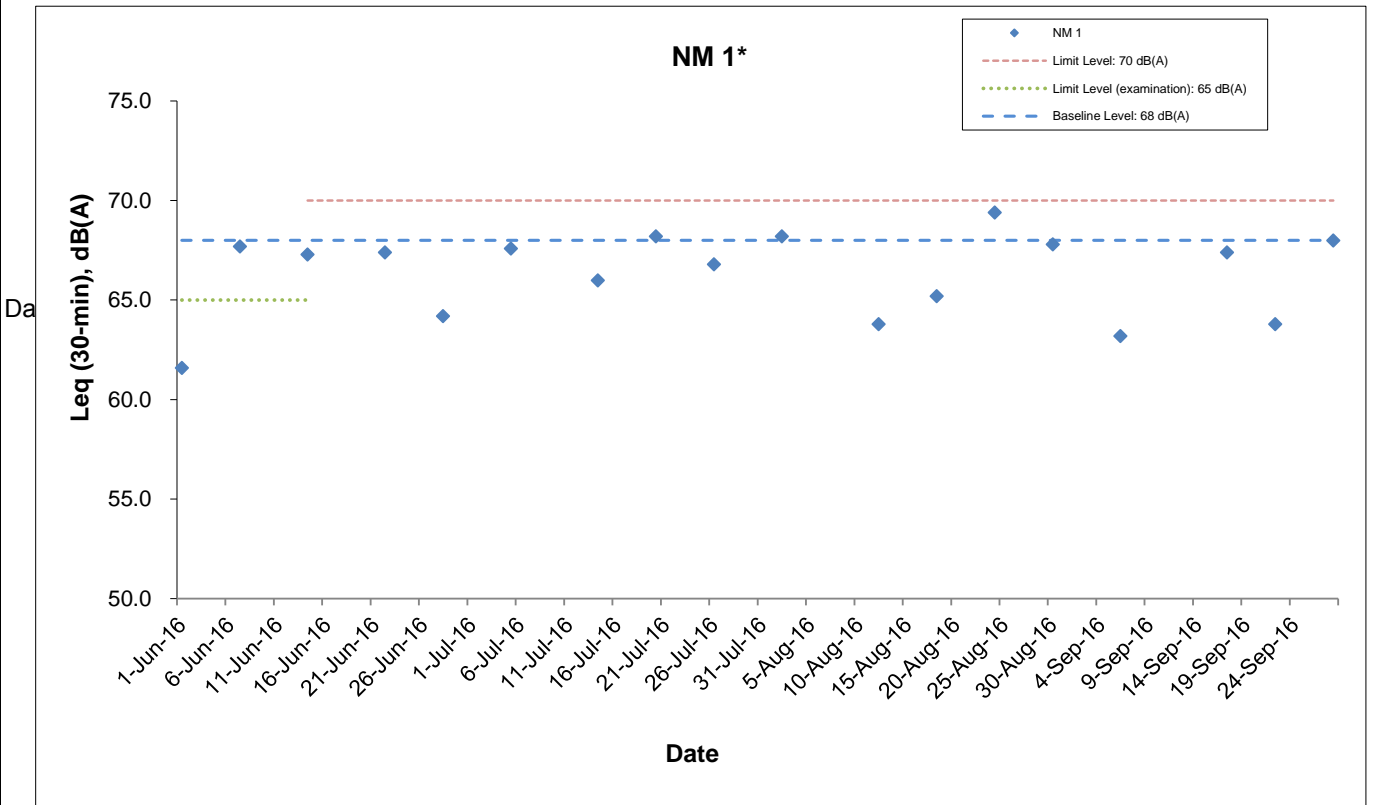
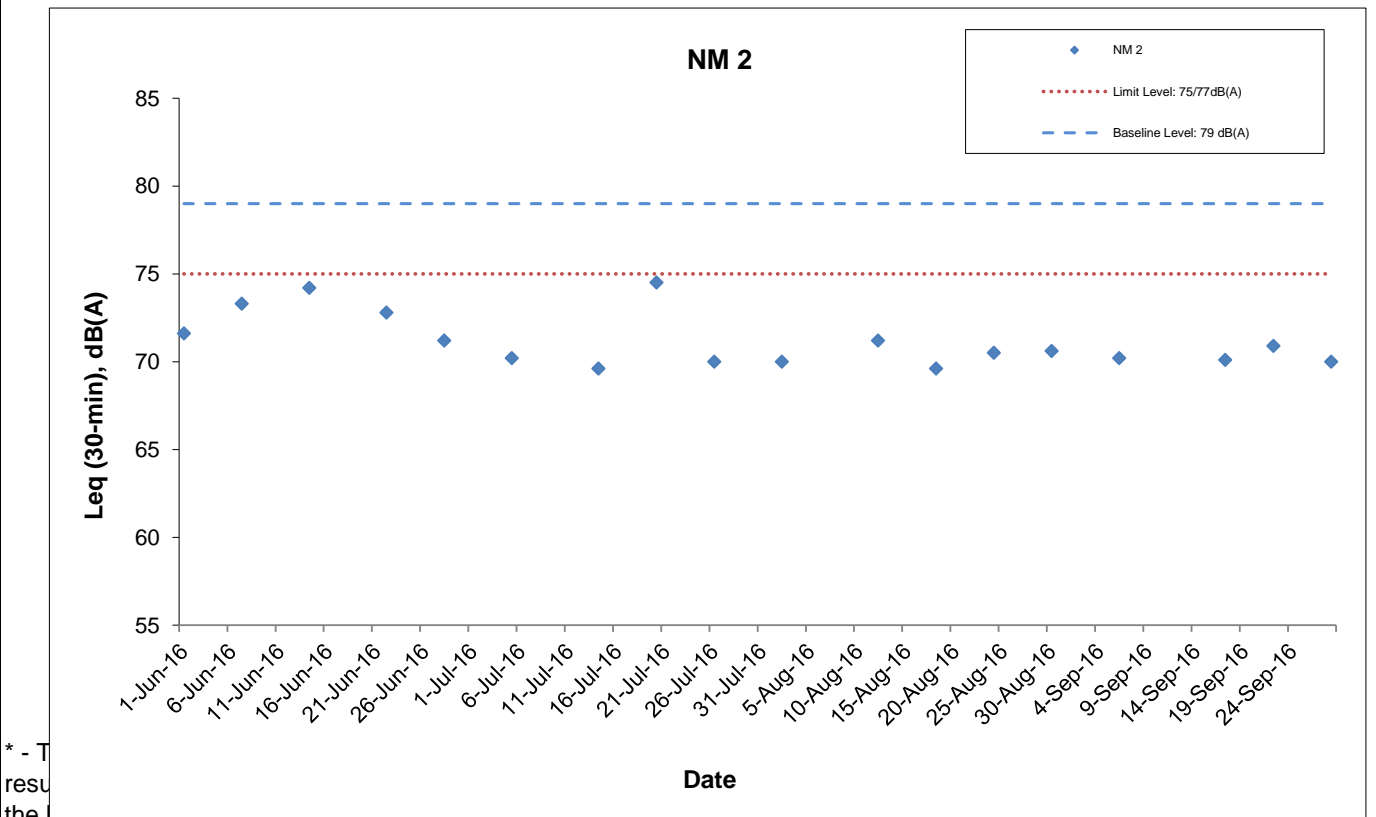
AECOM	Shatin to Central Link Works Contract 1111- Hung Hom North Approach Tunnels	SCALE	N.T.S.	DATE	Oct-16
	Graphical Presentations of Noise Monitoring Results	CHECK	TYUT	DRAWN	OYLW
		JOB NO.	60284101	APPENDIX	H

* - The results shown are the maximum noise level.

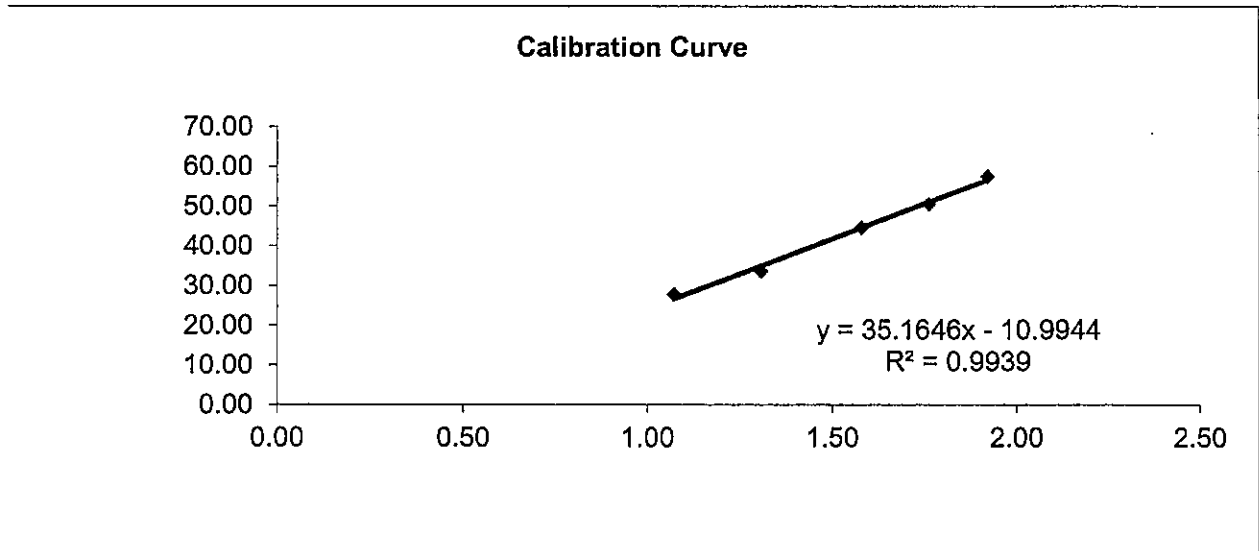
Calibration date	11-Jul-16	Barometric pressure	754.4 mm Hg
Next Calibration date	9-Sep-16	Temperature (°C)	28.6 °C
Sampler location	DMS1 - Thomas Cheung School	Temperature (K)	301.6 K
Sampler model	TE-5170	P _{std}	760 mm Hg
Sampler serial number	3763	T _{std}	298 K
Calibrator model		TE-5025A	
Calibrator serial number		2421	
Slope of the standard curve, m _s		2.07019	
Intercept of the standard curve, b _s		-0.04612

Resistance Plate No.	Manometer Reading (inch H ₂ O)	Flow Recorder Reading (CFM)	Calculated Q _{std} (m ³ /min)	Continuous Flow Recorder Reading IC (CFM)
5	4.00	28.00	1.07	27.73
7	6.20	34.00	1.31	33.67
10	9.40	45.00	1.58	44.57
13	11.90	51.00	1.76	50.51
18	14.30	58.00	1.92	57.44

Sampler slope (m) : **35.1646**
 Sampler intercept (b) : **-10.9944**
 Correlation coefficient (R²) : **0.9939**

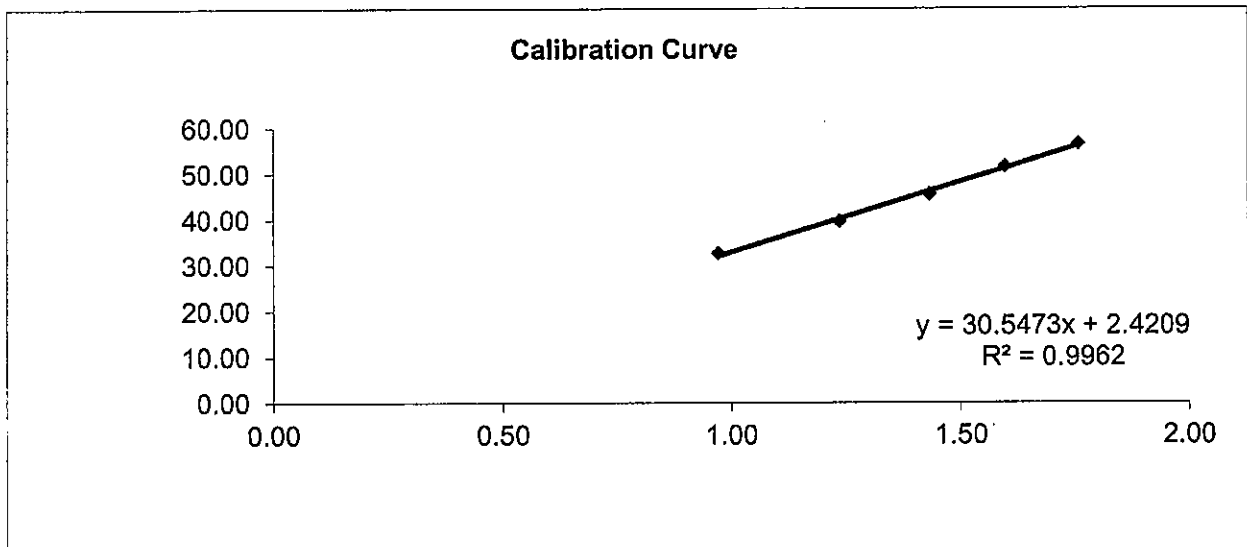
Calibrator model	TE-5025A
Calibrator serial number	2421
Slope of the standard curve, m _s	2.07019
Intercept of the standard curve, b _s	-0.04612

Resistance Plate No.	Manometer Reading (inch H ₂ O)	Flow Recorder Reading (CFM)	Calculated Q _{std} (m ³ /min)	Continuous Flow Recorder Reading IC (CFM)
5	3.20	33.00	0.97	32.68
7	5.50	40.00	1.24	39.61
10	7.60	46.00	1.43	45.56
13	9.60	52.00	1.60	51.50
18	11.80	57.00	1.76	56.45

Sampler slope (m) : **30.5473**
 Sampler intercept (b) : **2.4209**
 Correlation coefficient (R²) : **0.9962**

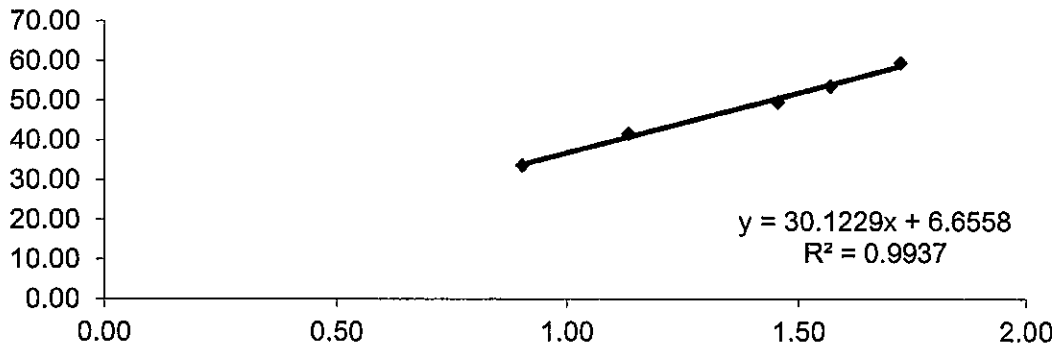
Calibration Curve

Resistance Plate No.	Manometer Reading (inch H ₂ O)	Flow Recorder Reading (CFM)	Calculated Q _{std} (m ³ /min)	Continuous Flow Recorder Reading IC (CFM)
5	3.40	34.00	0.90	33.67
7	5.40	42.00	1.13	41.59
10	9.00	50.00	1.46	49.52
13	10.50	54.00	1.57	53.48
18	12.70	60.00	1.72	59.42

Sampler slope (m) : **30.1229**
 Sampler intercept (b) : **6.6558**
 Correlation coefficient (R²) : **0.9937**

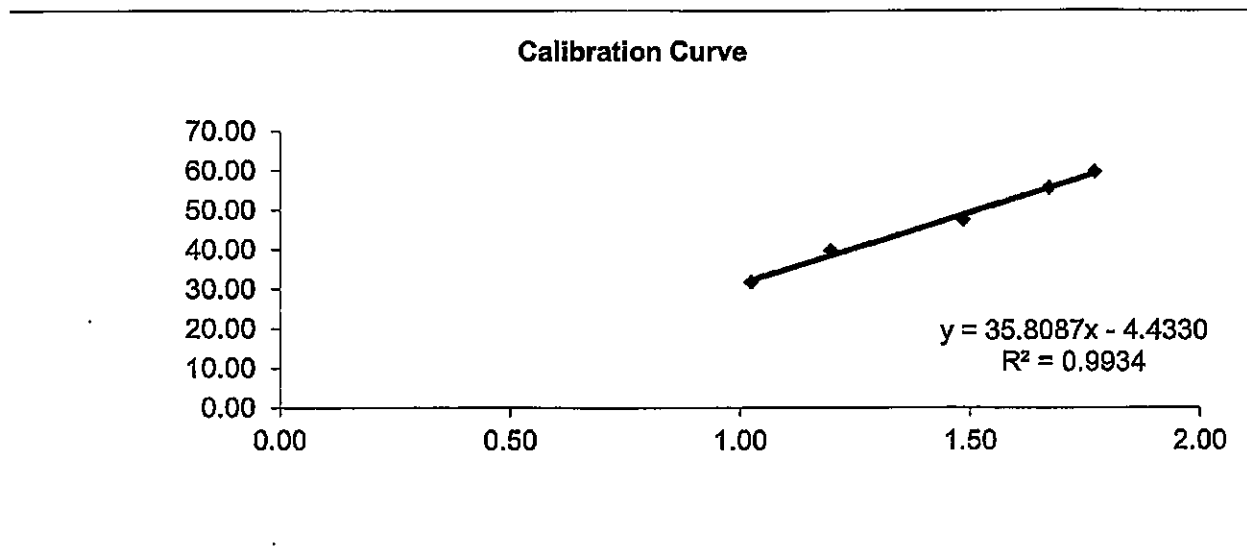
Calibration date	8-Sep-16	Barometric pressure	756 mm Hg
Next Calibration date	7-Nov-16	Temperature (°C)	28.1 °C
Sampler location	DMS1 - Thomas Cheung School	Temperature (K)	301.1 K
Sampler model	TE-5170	P _{std}	760 mm Hg
Sampler serial number	3763	T _{std}	298 K
Calibrator model		TE-5025A	
Calibrator serial number		2421	
Slope of the standard curve, m _s		2.07019	
Intercept of the standard curve, b _s		-0.04612

Resistance Plate No.	Manometer Reading (inch H ₂ O)	Flow Recorder Reading (CFM)	Calculated Q _{std} (m ³ /min)	Continuous Flow Recorder Reading IC (CFM)
5	3.60	32.00	1.02	31.75
7	5.10	40.00	1.20	39.69
10	8.20	48.00	1.49	47.63
13	10.60	56.00	1.67	55.56
18	12.00	60.00	1.77	59.53

Linear Regression
 Sampler slope (m) : 35.8087
 Sampler intercept (b) : -4.4330
 Correlation coefficient (R²) : 0.9934

Correlation coefficient is greater than 0.9900 and the calibration result is accepted.

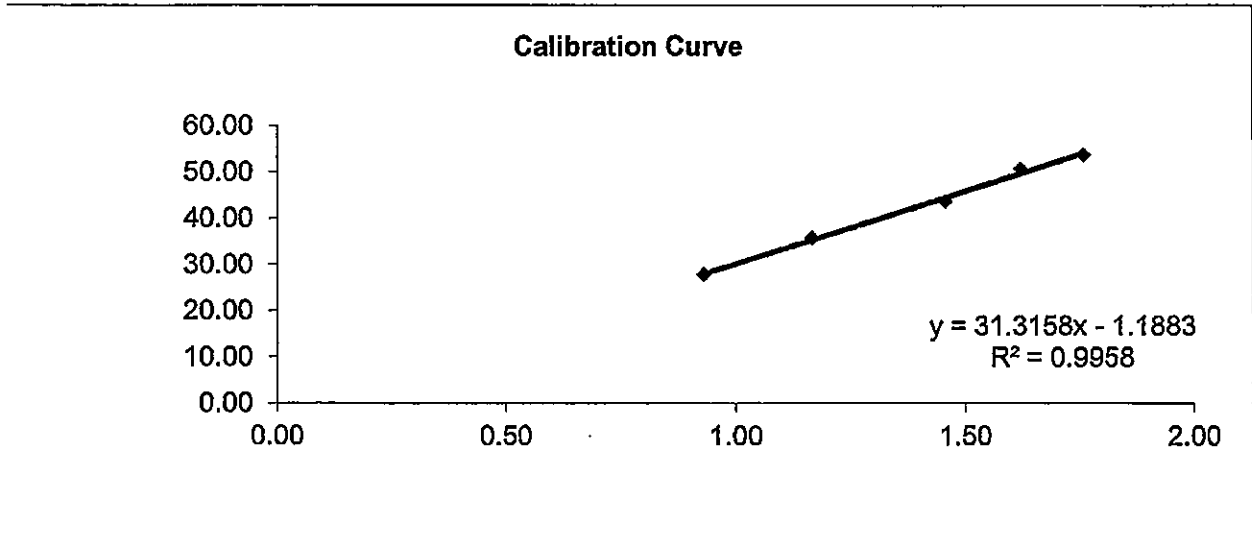
Calibration date	8-Sep-16	Barometric pressure	756 mm Hg
Next Calibration date	7-Nov-16	Temperature (°C)	28.1 °C
Sampler location	DMS3 - Sheng Kung Hui Nursing H	Temperature (K)	301.1 K
Sampler model	TE-5170	P _{std}	760 mm Hg
Sampler serial number	3762	T _{std}	298 K
Calibrator model	TE-5025A		
Calibrator serial number	2421		
Slope of the standard curve, m _s	2.07019		
Intercept of the standard curve, b _s	-0.04612

Resistance Plate No.	Manometer Reading (inch H ₂ O)	Flow Recorder Reading (CFM)	Calculated Q _{std} (m ³ /min)	Continuous Flow Recorder Reading IC (CFM)
5	3.60	28.00	0.93	27.78
7	5.70	36.00	1.16	35.72
10	9.00	44.00	1.46	43.66
13	11.20	51.00	1.62	50.60
18	13.20	54.00	1.76	53.58

Sampler slope (m) : **31.3158**
 Sampler intercept (b) : **-1.1883**
 Correlation coefficient (R²) : **0.9958**

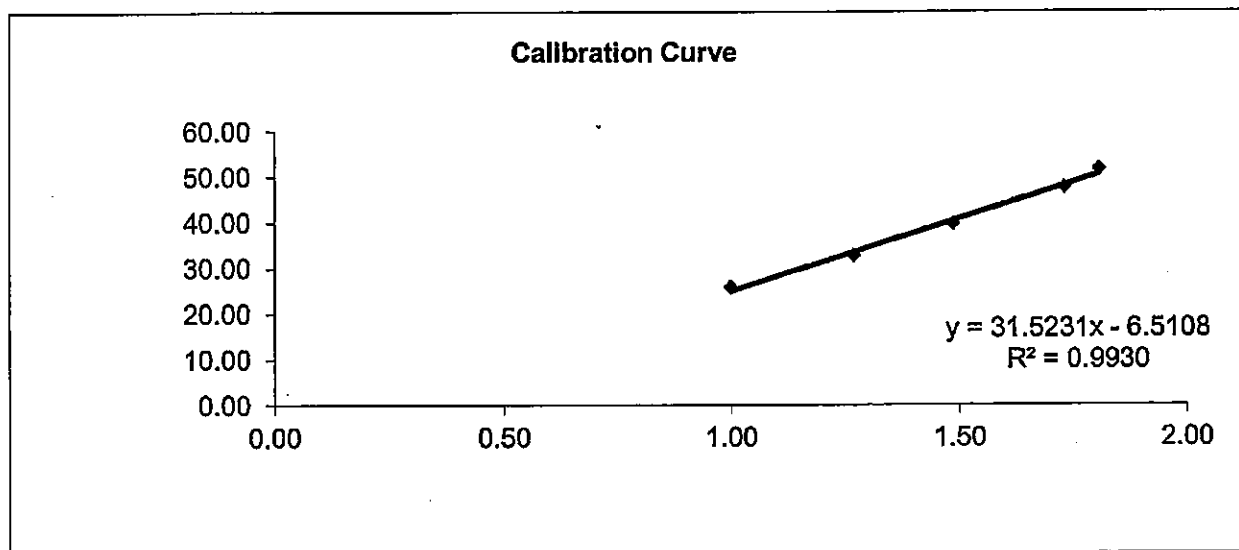
Calibration date	8-Sep-16	Barometric pressure	756 mm Hg
Next Calibration date	7-Nov-16	Temperature (°C)	28.1 °C
Sampler location	DMS2 - Price Memorial Catholic Pri	Temperature (K)	301.1 K
Sampler model	TE-5170	P _{std}	760 mm Hg
Sampler serial number	3761	T _{std}	298 K
Calibrator model	TE-5025A		
Calibrator serial number	2421		
Slope of the standard curve, m _s	2.07019		
Intercept of the standard curve, b _s	-0.04612

Resistance Plate No.	Manometer Reading (inch H ₂ O)	Flow Recorder Reading (CFM)	Calculated Q _{std} (m ³ /min)	Continuous Flow Recorder Reading IC (CFM)
5	3.40	26.00	1.00	25.80
7	5.80	33.00	1.27	32.74
10	8.20	40.00	1.49	39.69
13	11.40	48.00	1.73	47.63
18	12.50	52.00	1.81	51.60

Sampler slope (m) : 31.5231
 Sampler Intercept (b) : -6.5108
 Correlation coefficient (R²) : 0.9930

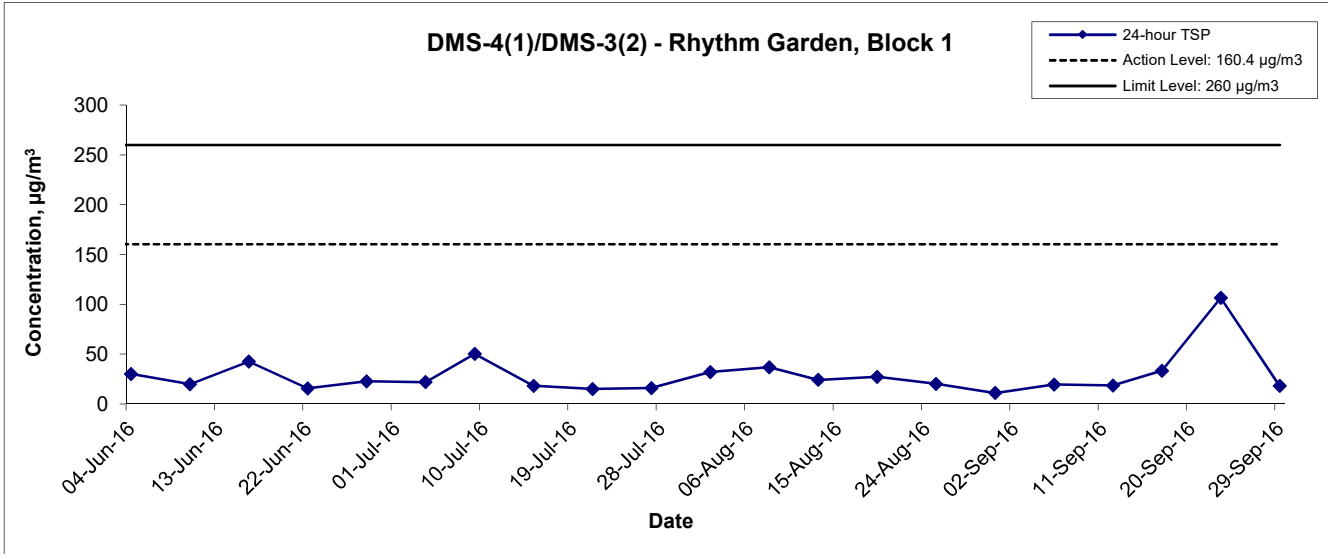
24-hour TSP Concentration Levels

Remarks:

- (1) ASR ID as identified in approved EM&A Manual / EIA Report for SCL(TAW-HUH).
- (2) ASR ID as identified in approved EM&A Manual / EIA Report for SCL(HHS).

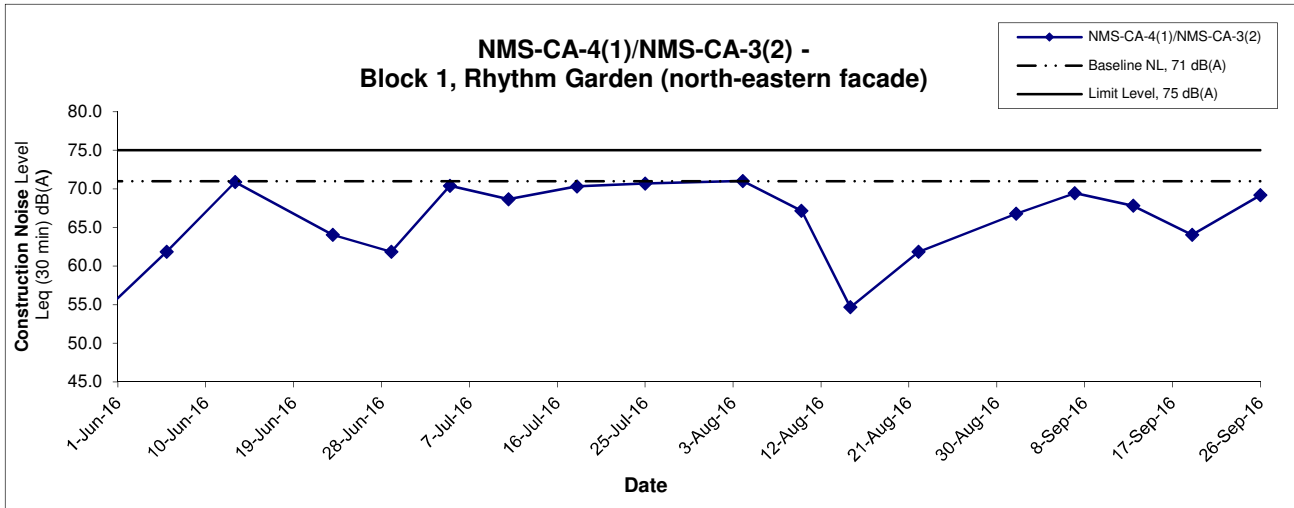
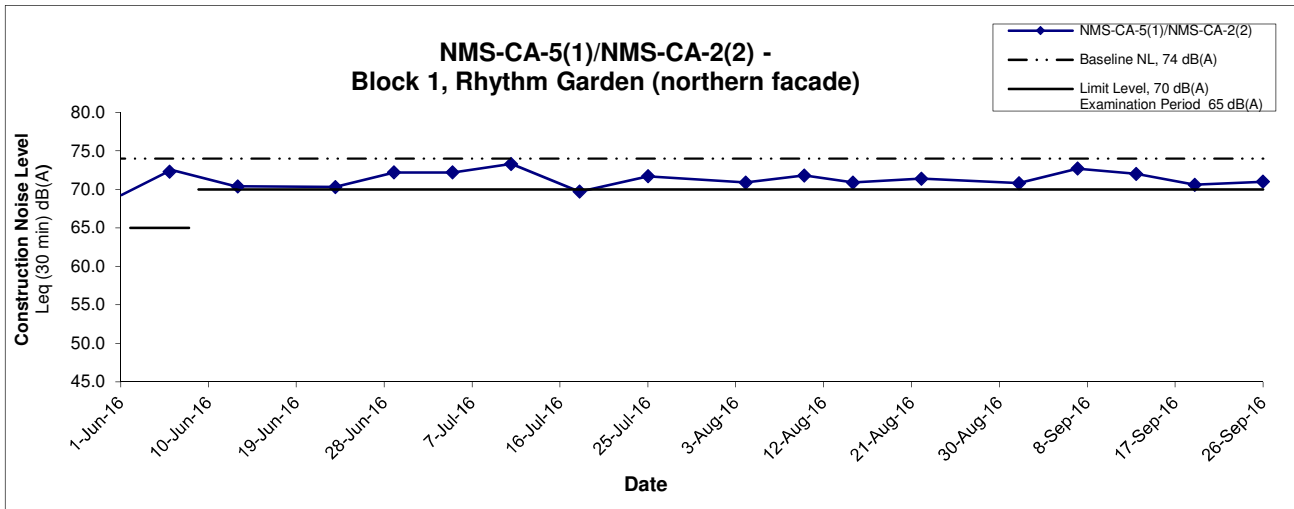
Noise Levels

Remarks:

- (1) Station ID as identified in approved EM&A Manual / EIA Report for SCL(TAW-HUH).
- (2) Station ID as identified in approved EM&A Manual / EIA Report for SCL(HHS).
- (3) In case of Measured Level \leq Baseline Level, only Measured Level is presented on the graphical presentation.

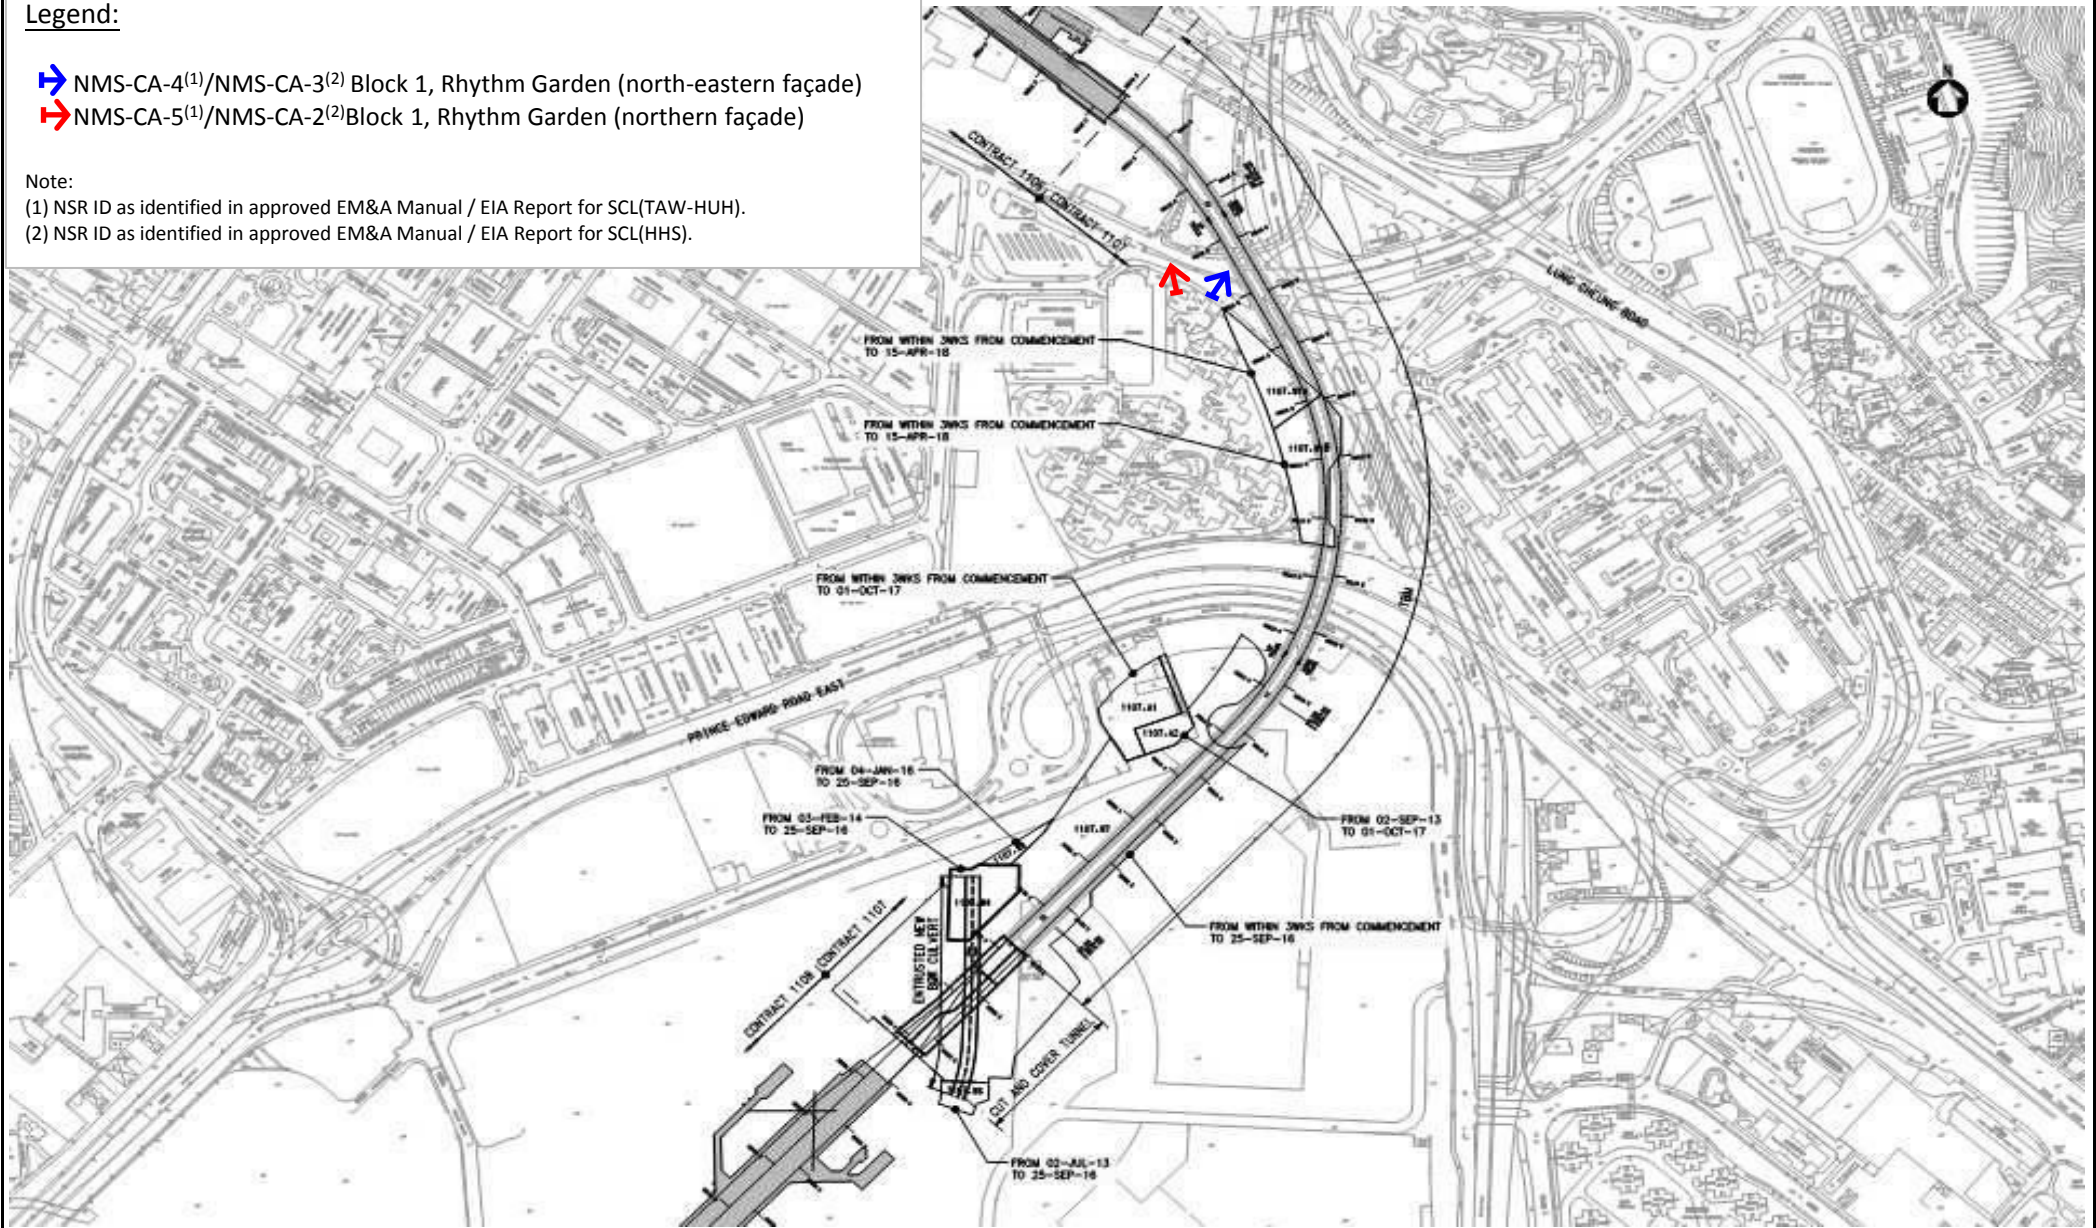
Title MTR SCL Works Contract 1107 Diamond Hill to Kai Tak Tunnels Locations of Construction Noise Monitoring	Scale	N.T.S	Project No.	MA13018
	Date	May-13	Figure	2

- (1) NSR ID as identified in approved EM&A Manual / EIA Report for SCL(TAW-HUH).
- (2) NSR ID as identified in approved EM&A Manual / EIA Report for SCL(HHS).

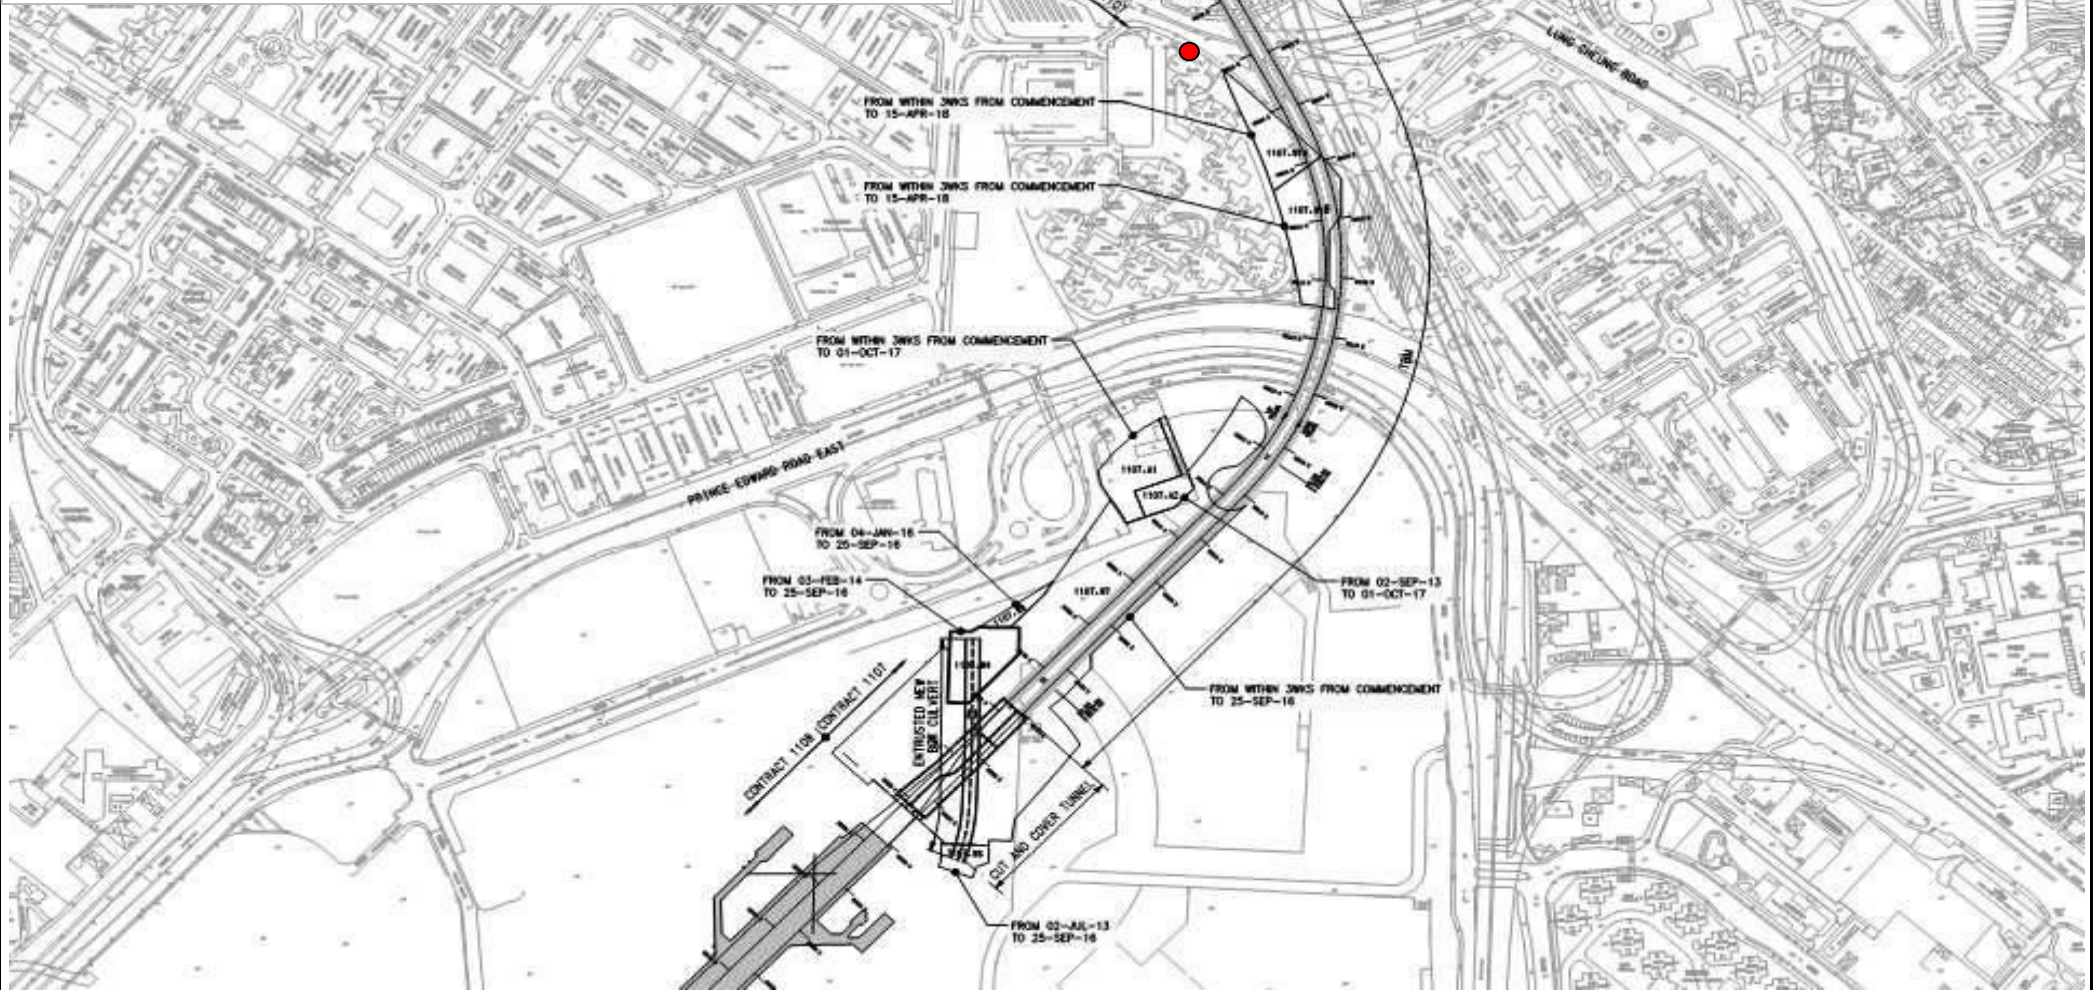
Title	MTR SCL Works Contract 1107 Diamond Hill to Kai Tak Tunnels Location of Dust Monitoring		Scale	N.T.S	Project No.	MA13018	CINOTECH
	Date	May-13	Figure	3

3.9 The proposed dust monitoring stations for the construction phase of the Project, as recommended in the approved EM&A Manual, are listed in **Table 3.3** and shown in **Figure 3**. The proposed locations have been agreed with the ER, EPD and IEC.

- (1) ASR ID as identified in approved EM&A Manual / EIA Report for SCL(TAW-HUH).
- (2) ASR ID as identified in approved EM&A Manual / EIA Report for SCL(HHS).

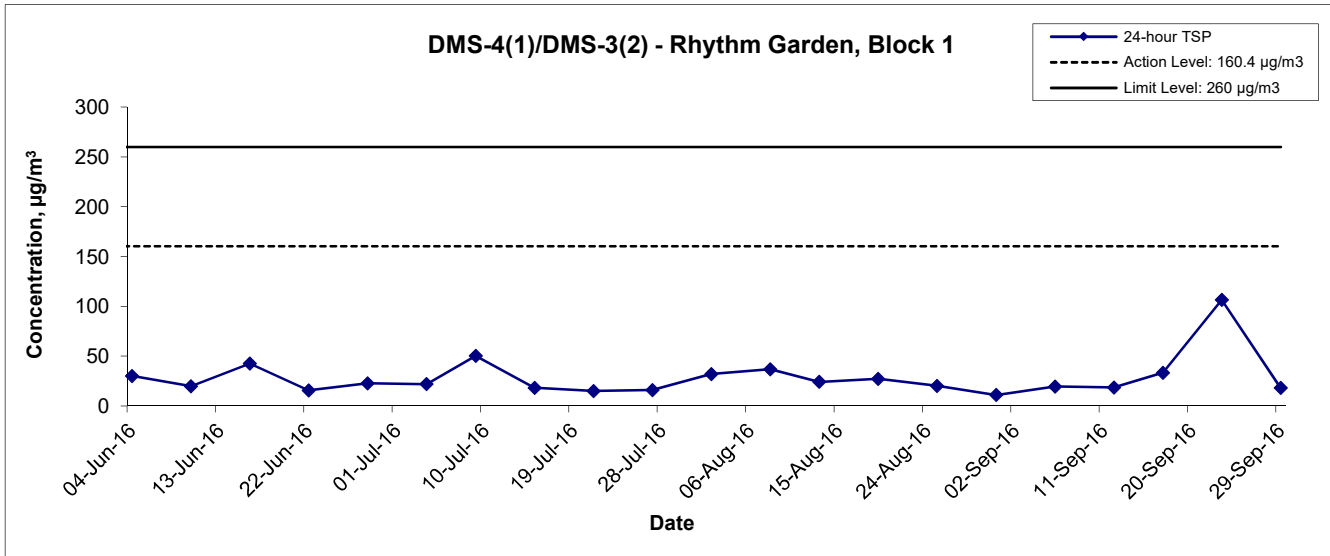
24-hour TSP Concentration Levels

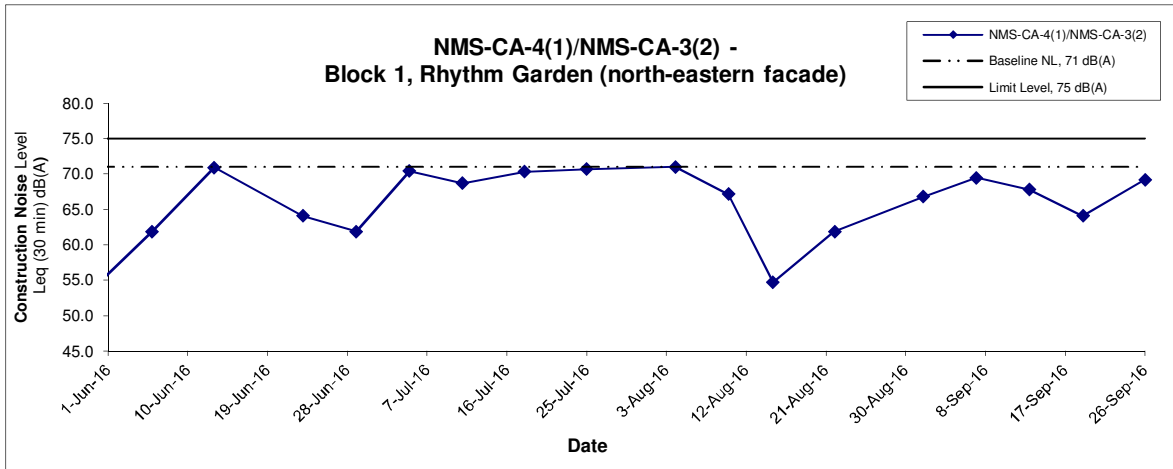
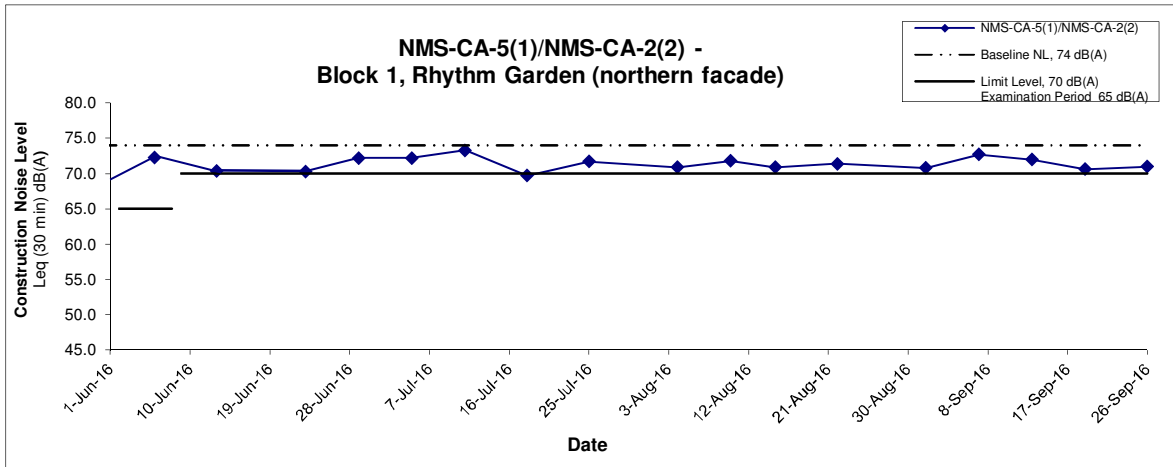
Noise Levels

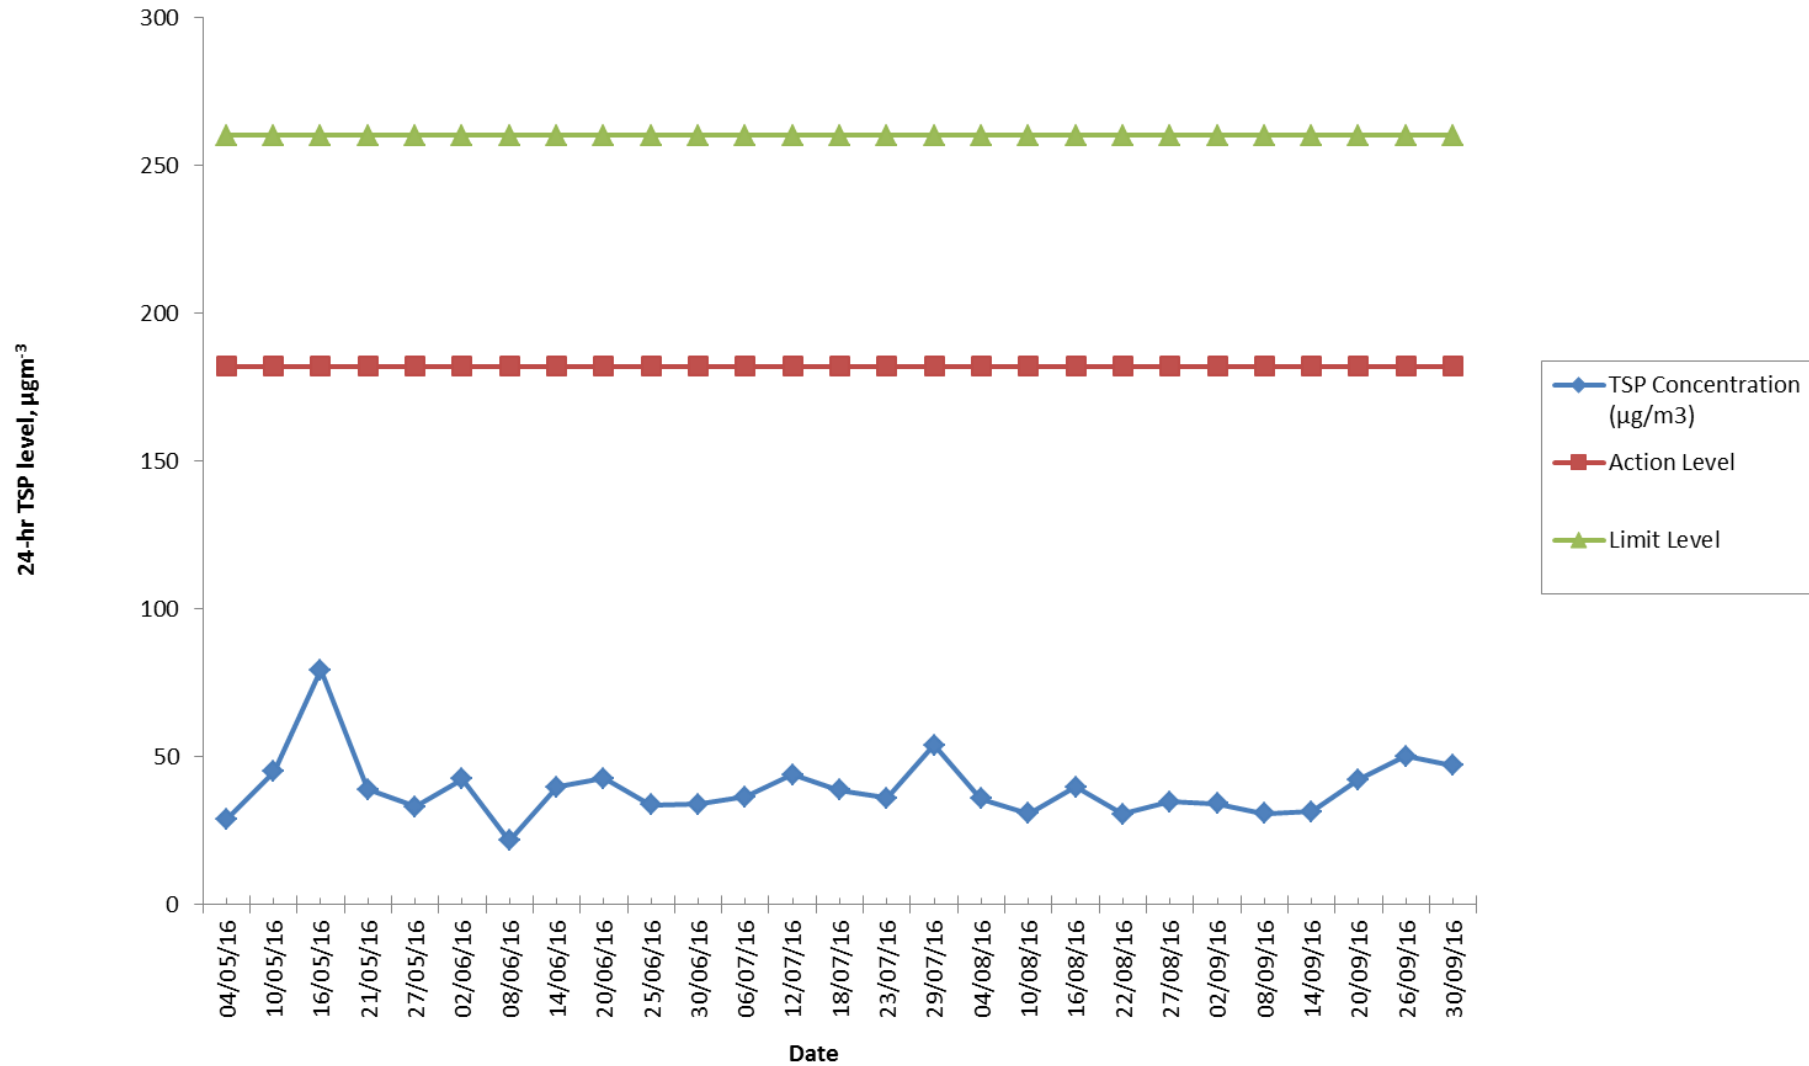
Construction Dust Monitoring Results for AM2 (Harbourfront Horizon)
