**Shatin to Central Link –
Tai Wai to Hung Hom Section and
Mong Kok East to Hung Hom Section**

Monthly EM&A Report No. 51

[Period from 1 to 30 November 2016]

**Monthly EM&A Report No. 51
(Revised)**

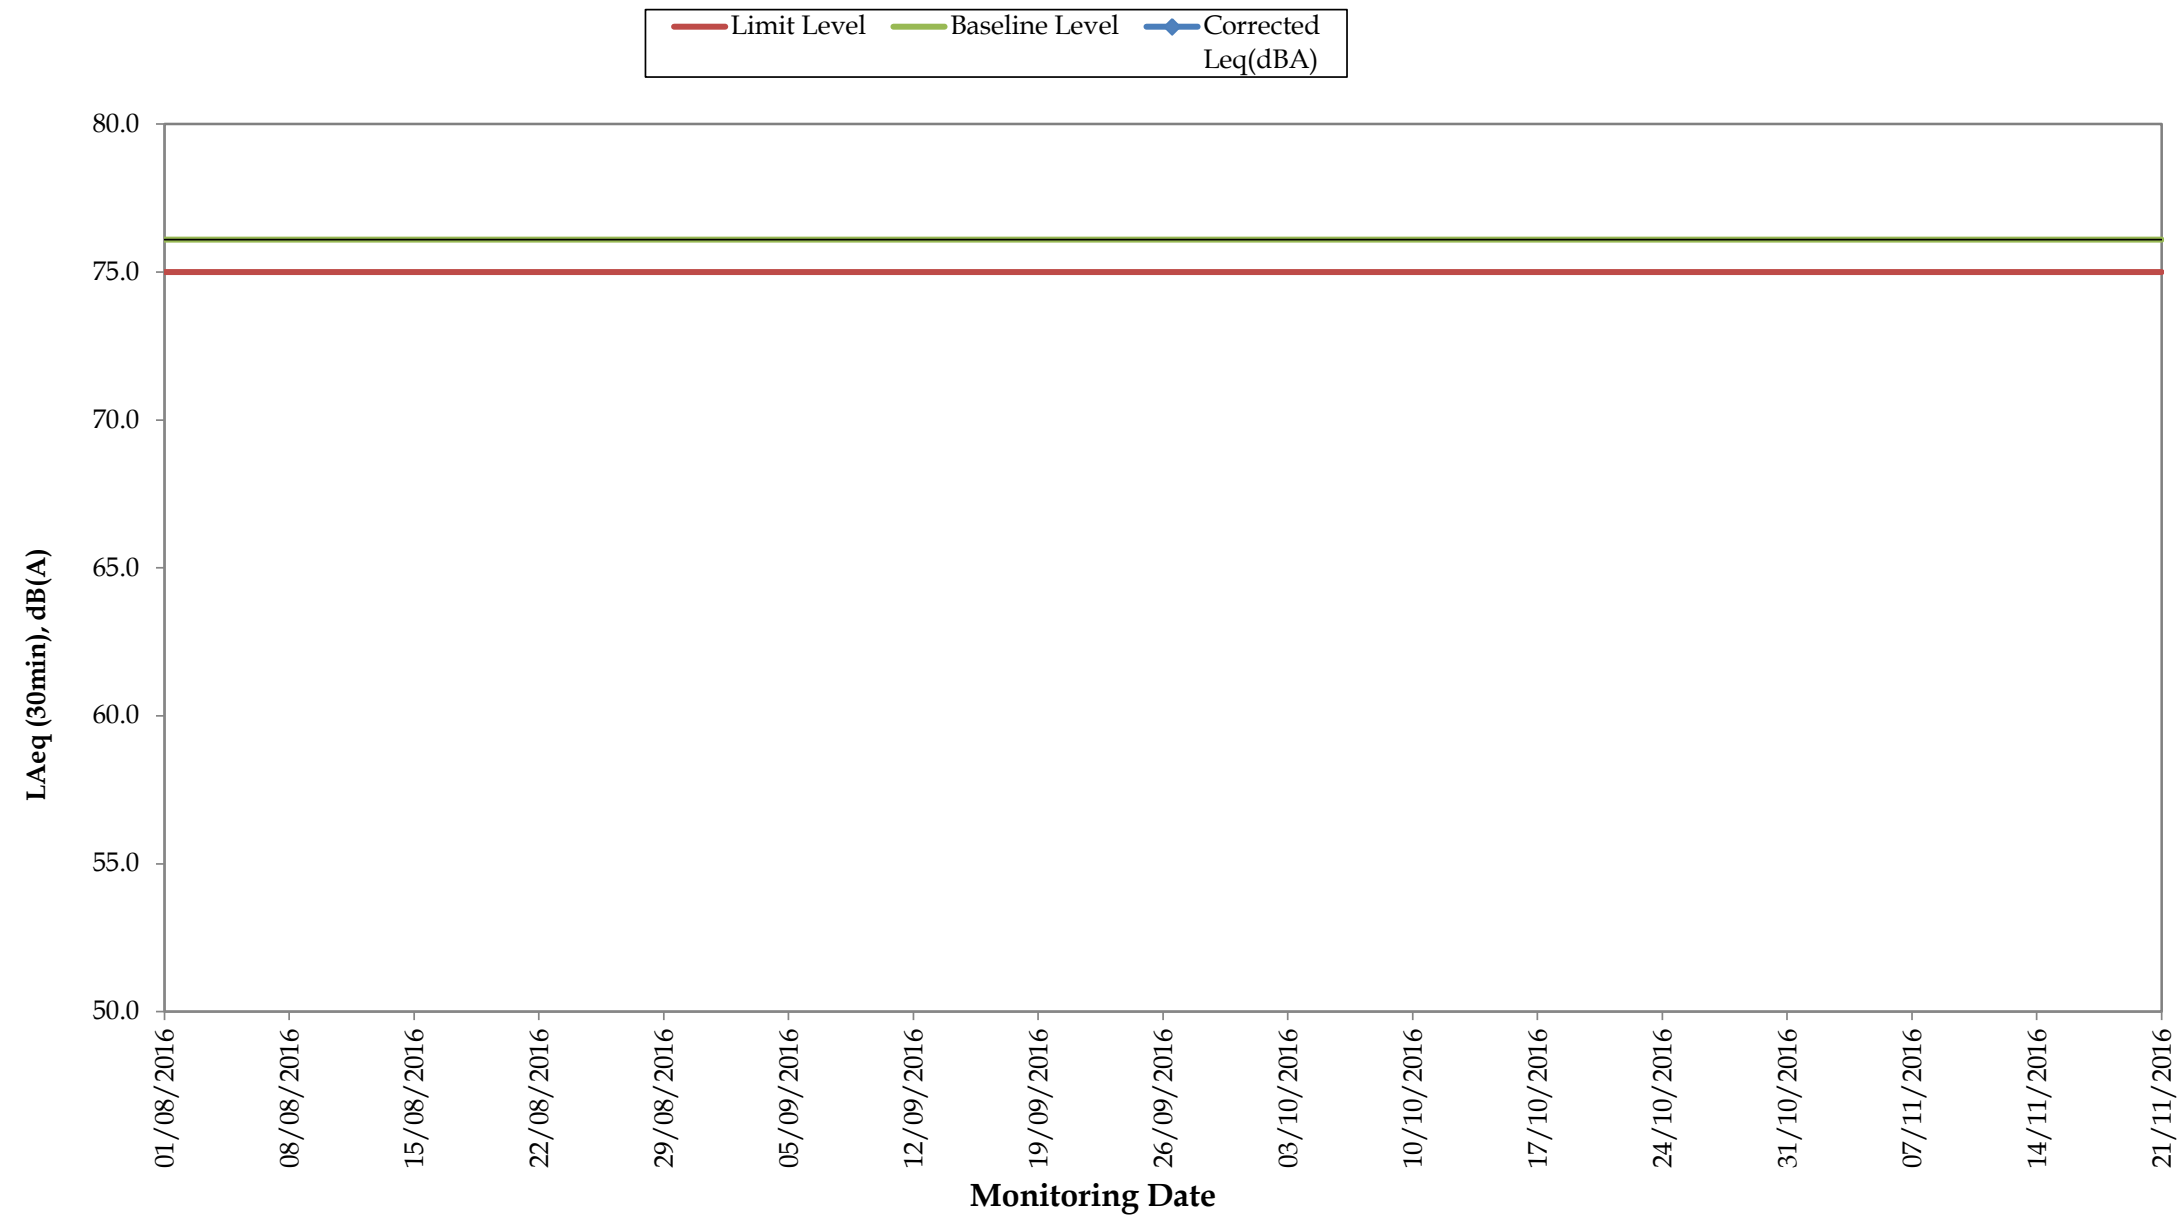
Regular Noise Monitoring Results at NMS-CA-6 (No. 16-23 Nam Kok Road) (LAeq, 30min) for the Past 4 Months

- For those corrected noise levels that are not shown in this graph, the measured noise levels are equal to or below baseline level.

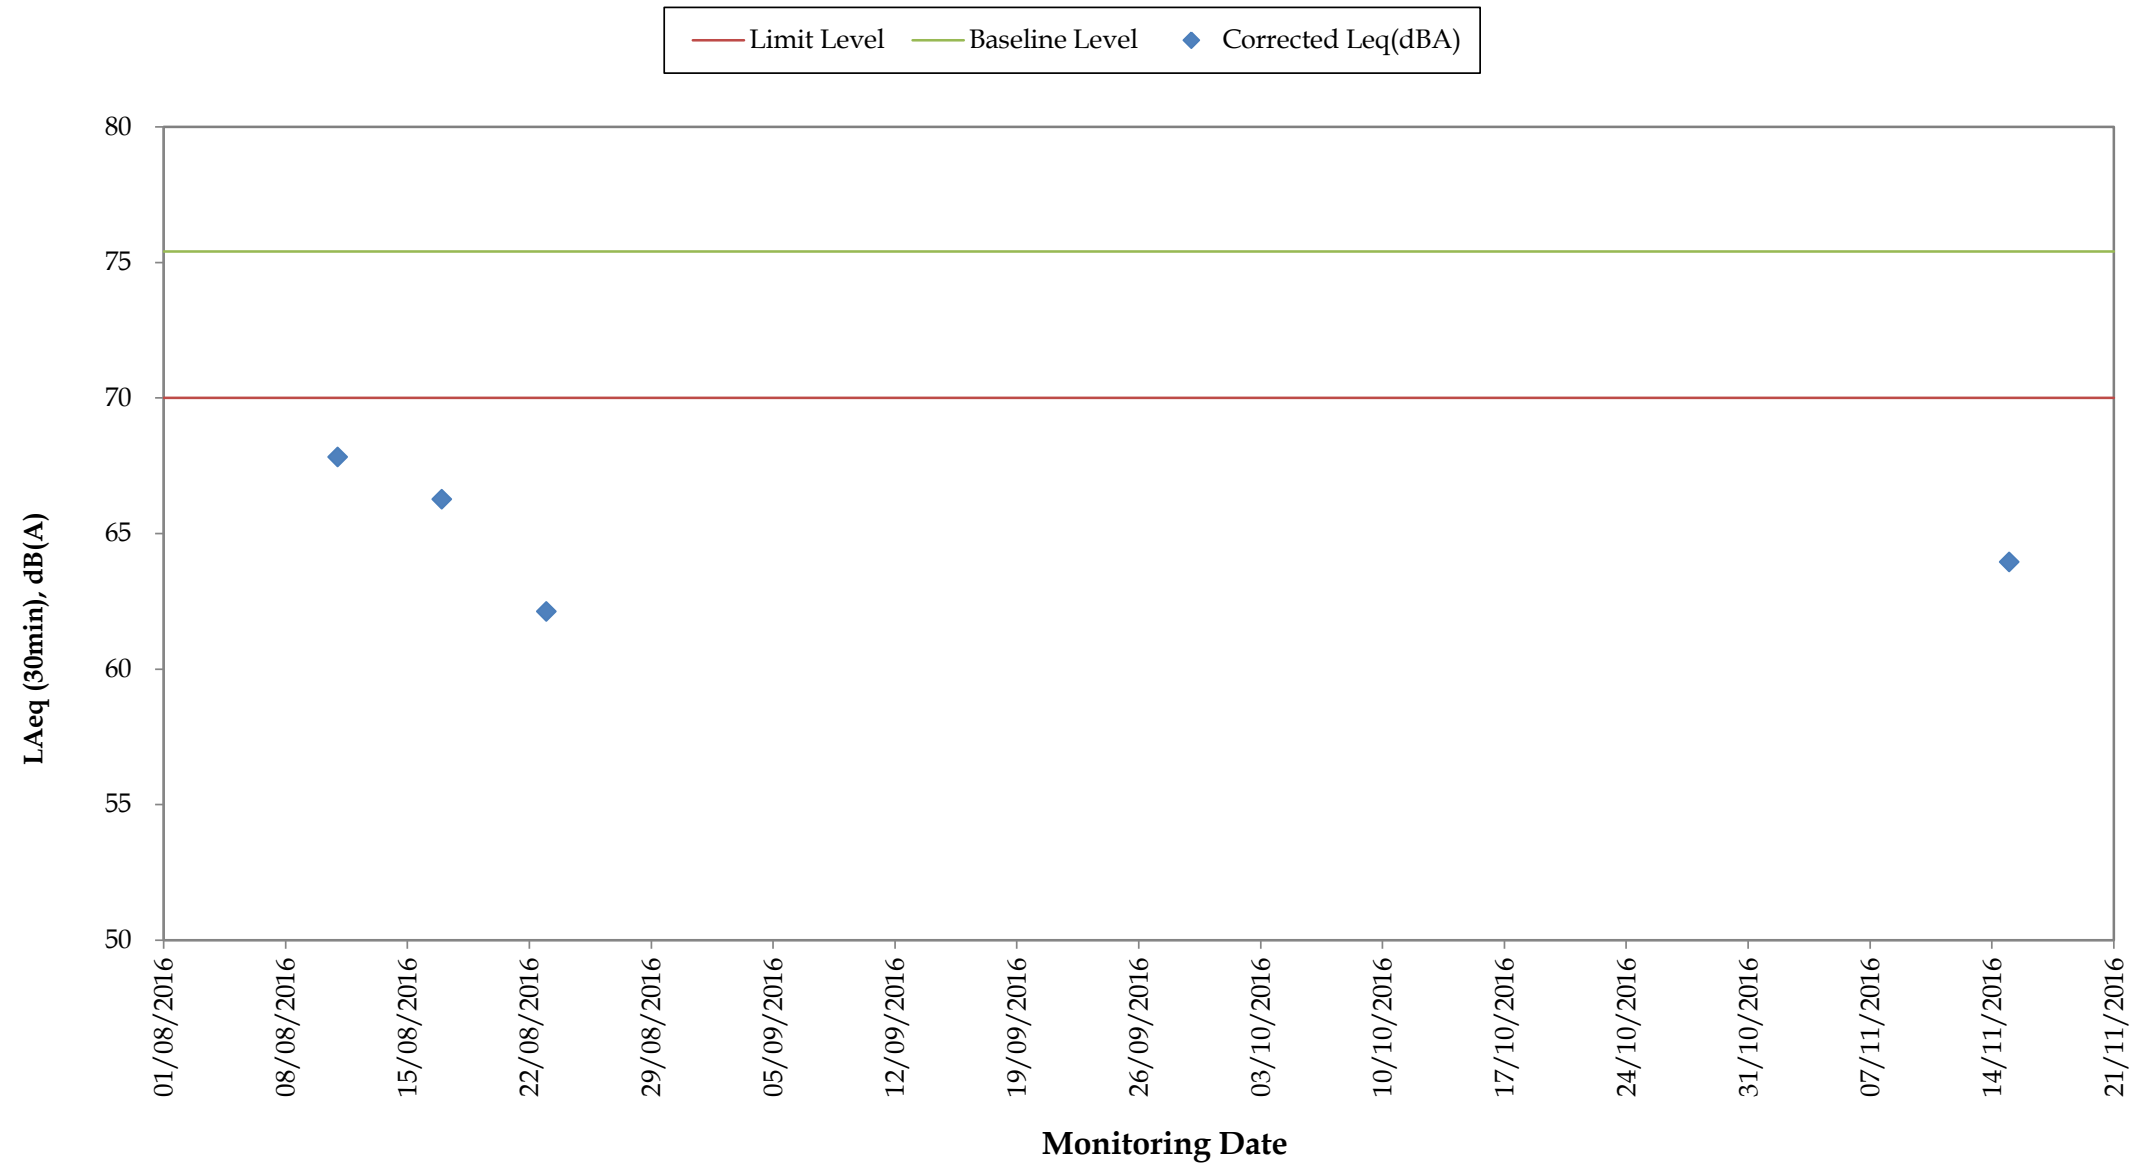
Regular Noise Monitoring Results at NMS-CA- 8 (SKH Good Shepherd Primary School) (LAeq, 30min) for the Past 4 Months

- For those corrected noise levels that are not shown in this graph, the measured noise levels are equal to or below baseline level.
- The limit level was updated from 78dB(A) to 79 dB(A) on 22 Aug 2013 as per the latest CNMP and CNMMP.
- The limit level was updated from 79dB(A) to 70dB(A)/65dB(A) (during normal/examination period) from April 2016, as the continuous noise monitoring was completed in March 2016 according to the latest CNMP

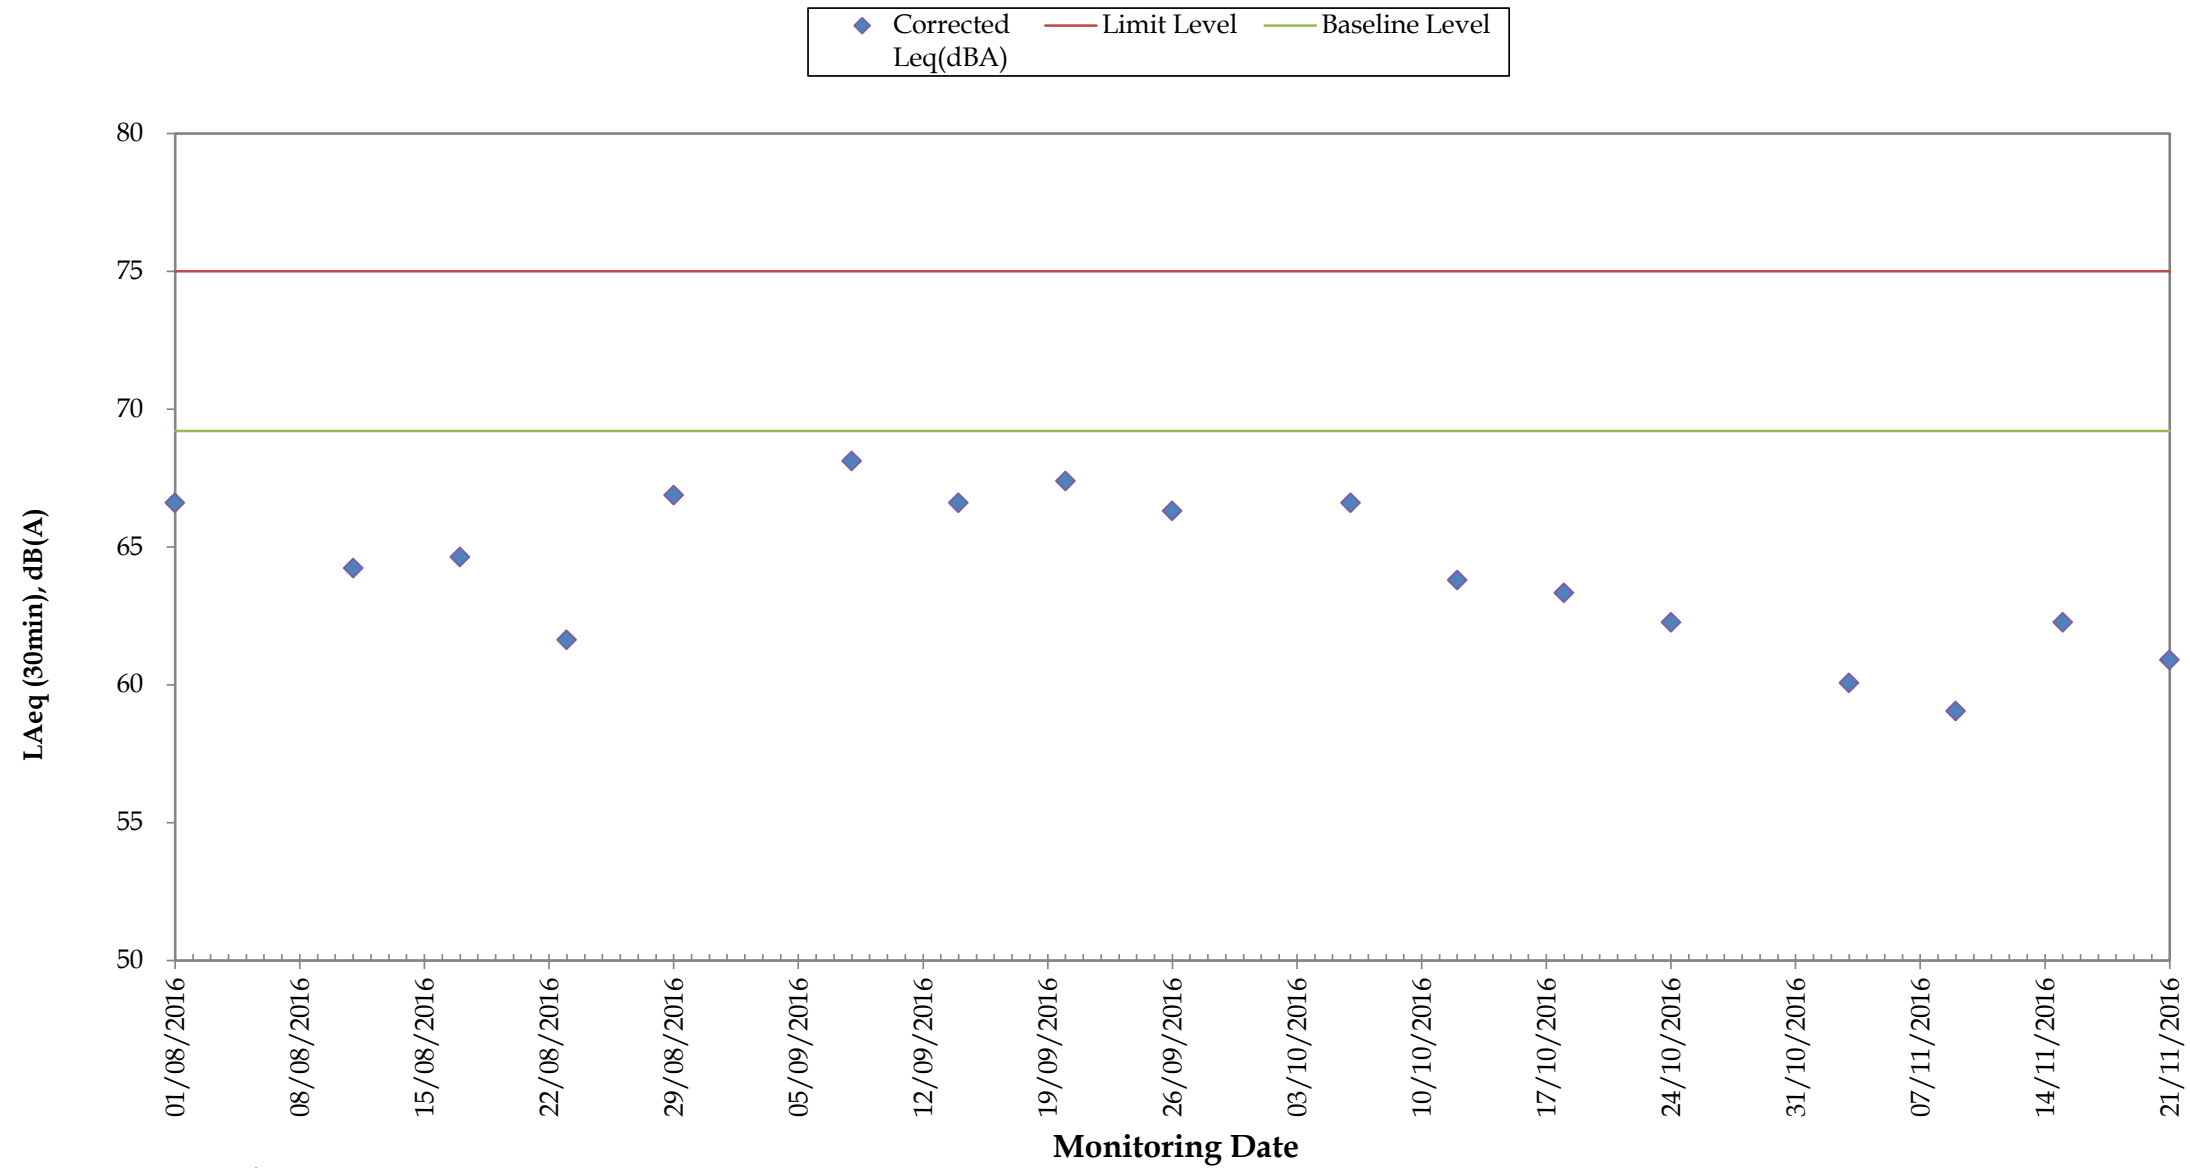
Regular Noise Monitoring Results at NMS-CA-9 (Kong Yiu Mansion) (LAeq, 30min)) for the Past 4 Months

- For those corrected noise levels that are not shown in this graph, the measured noise levels are equal to or below baseline level.

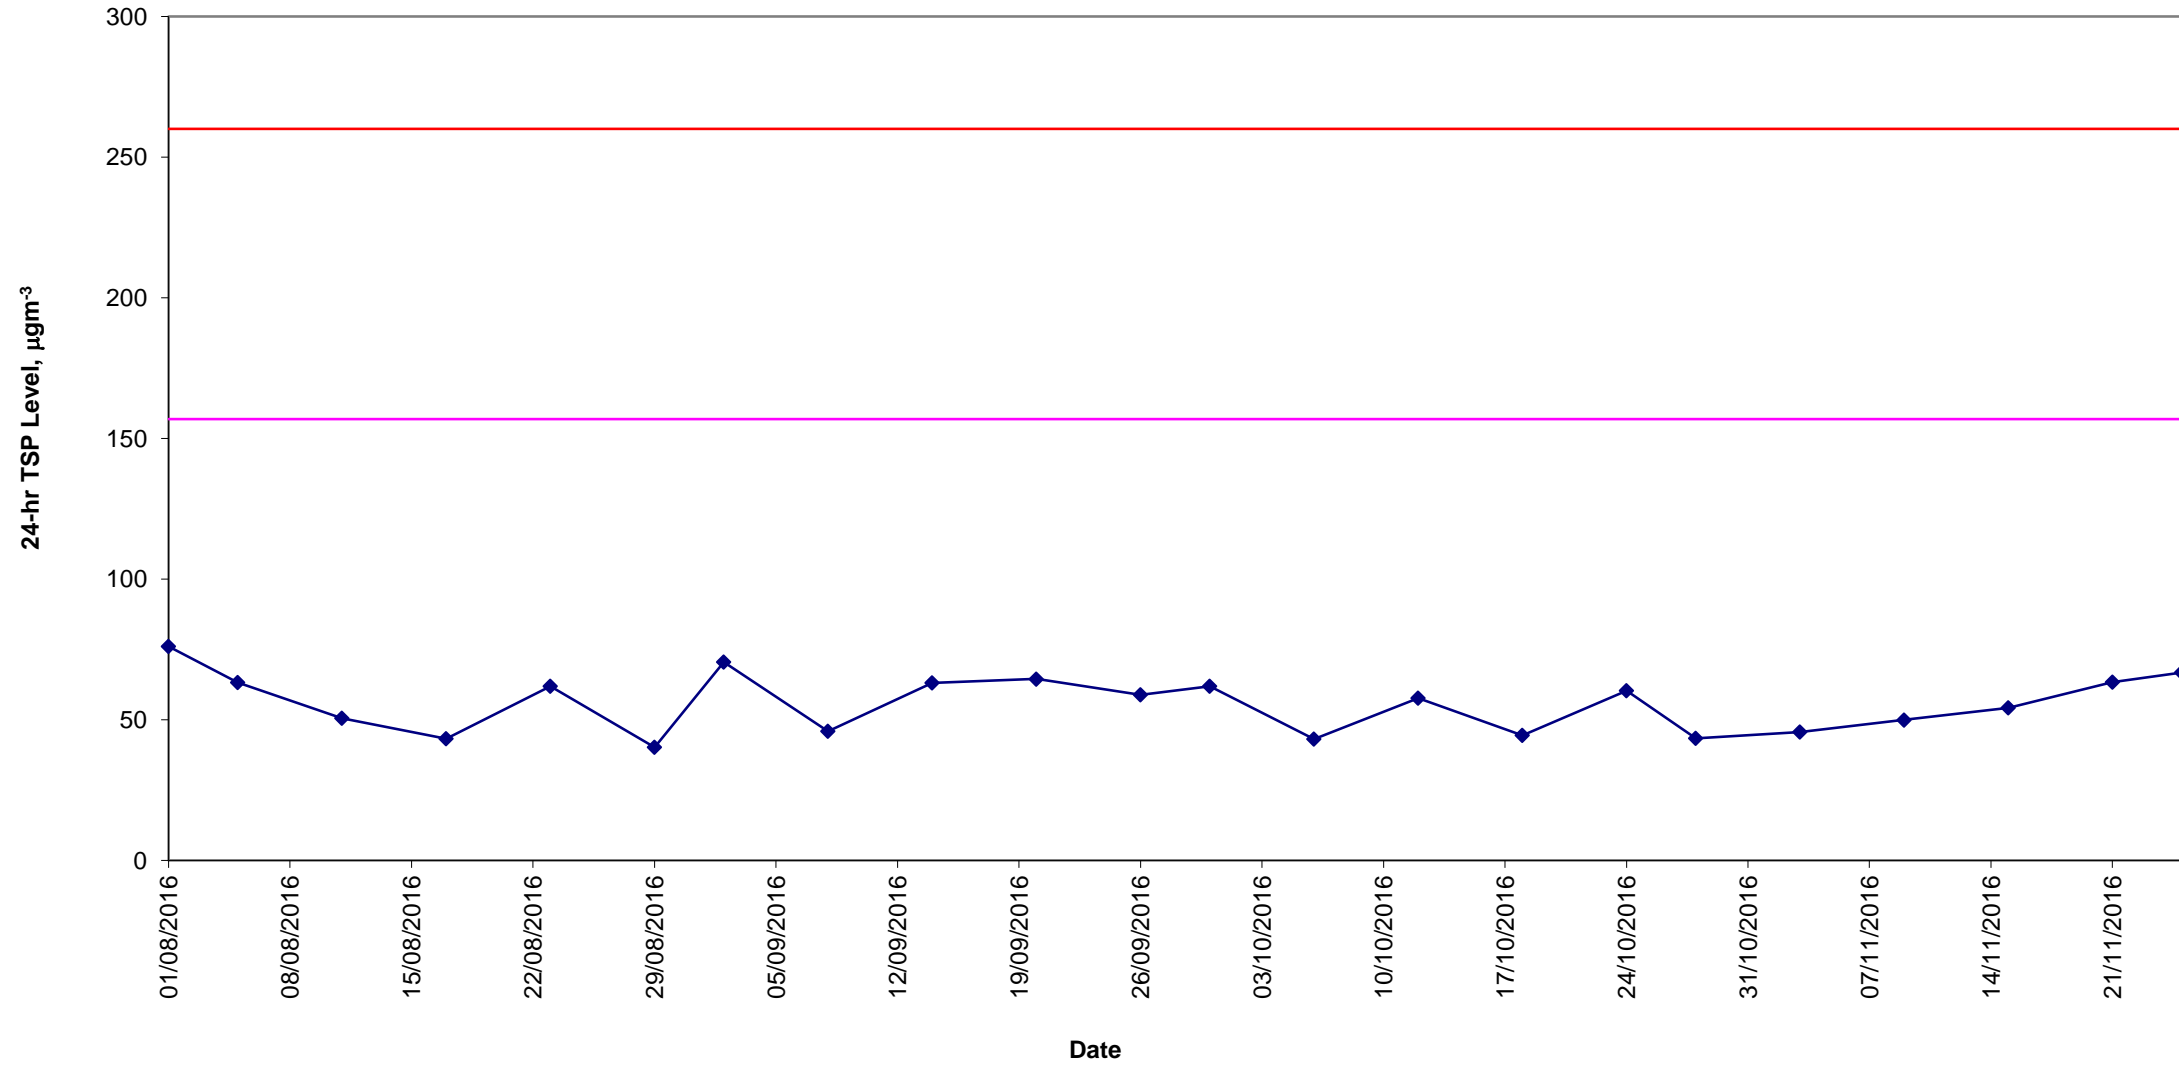
Construction Dust Monitoring Results for the Past 4 Months DMS-6 (Katherine Building)

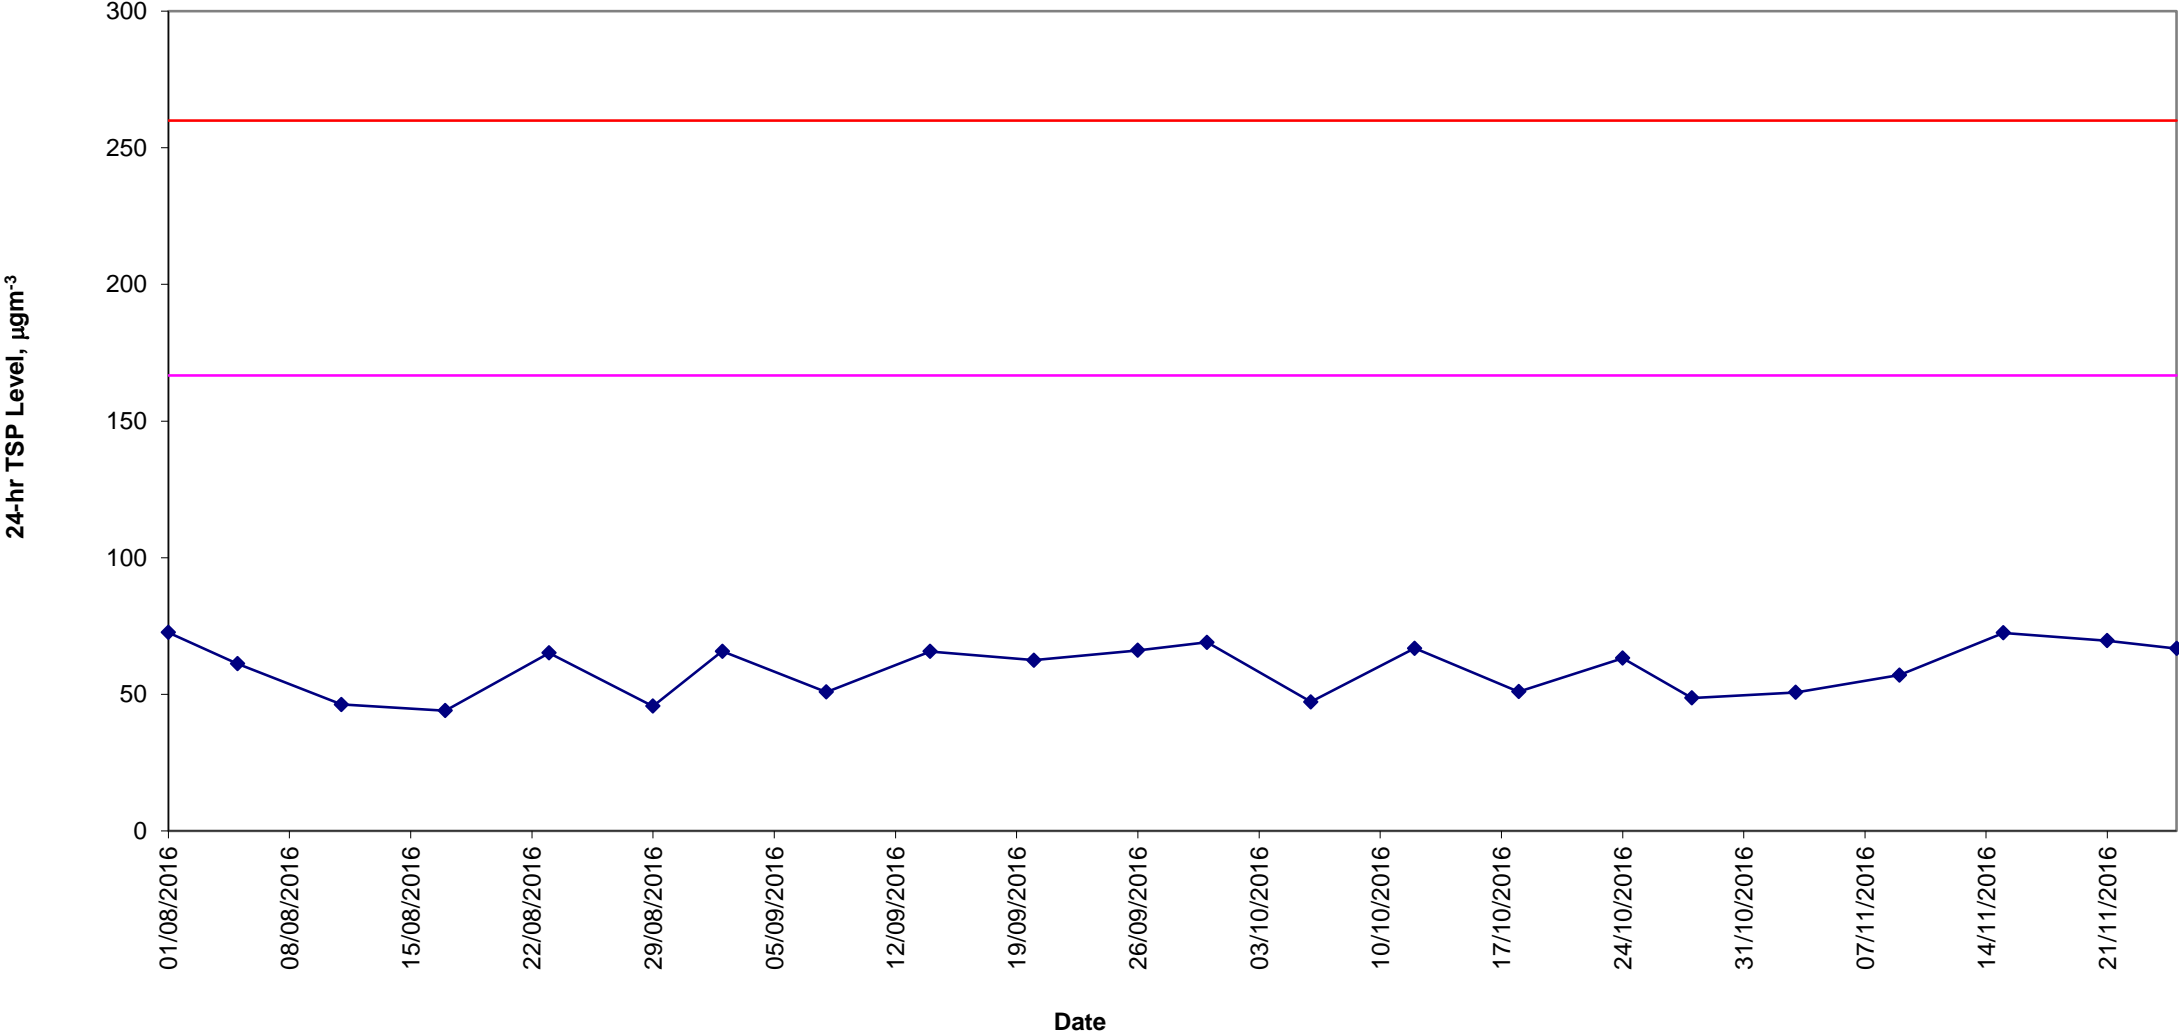
Construction Dust Monitoring Results for the Past 4 Months
DMS- 7 (Parc 22)

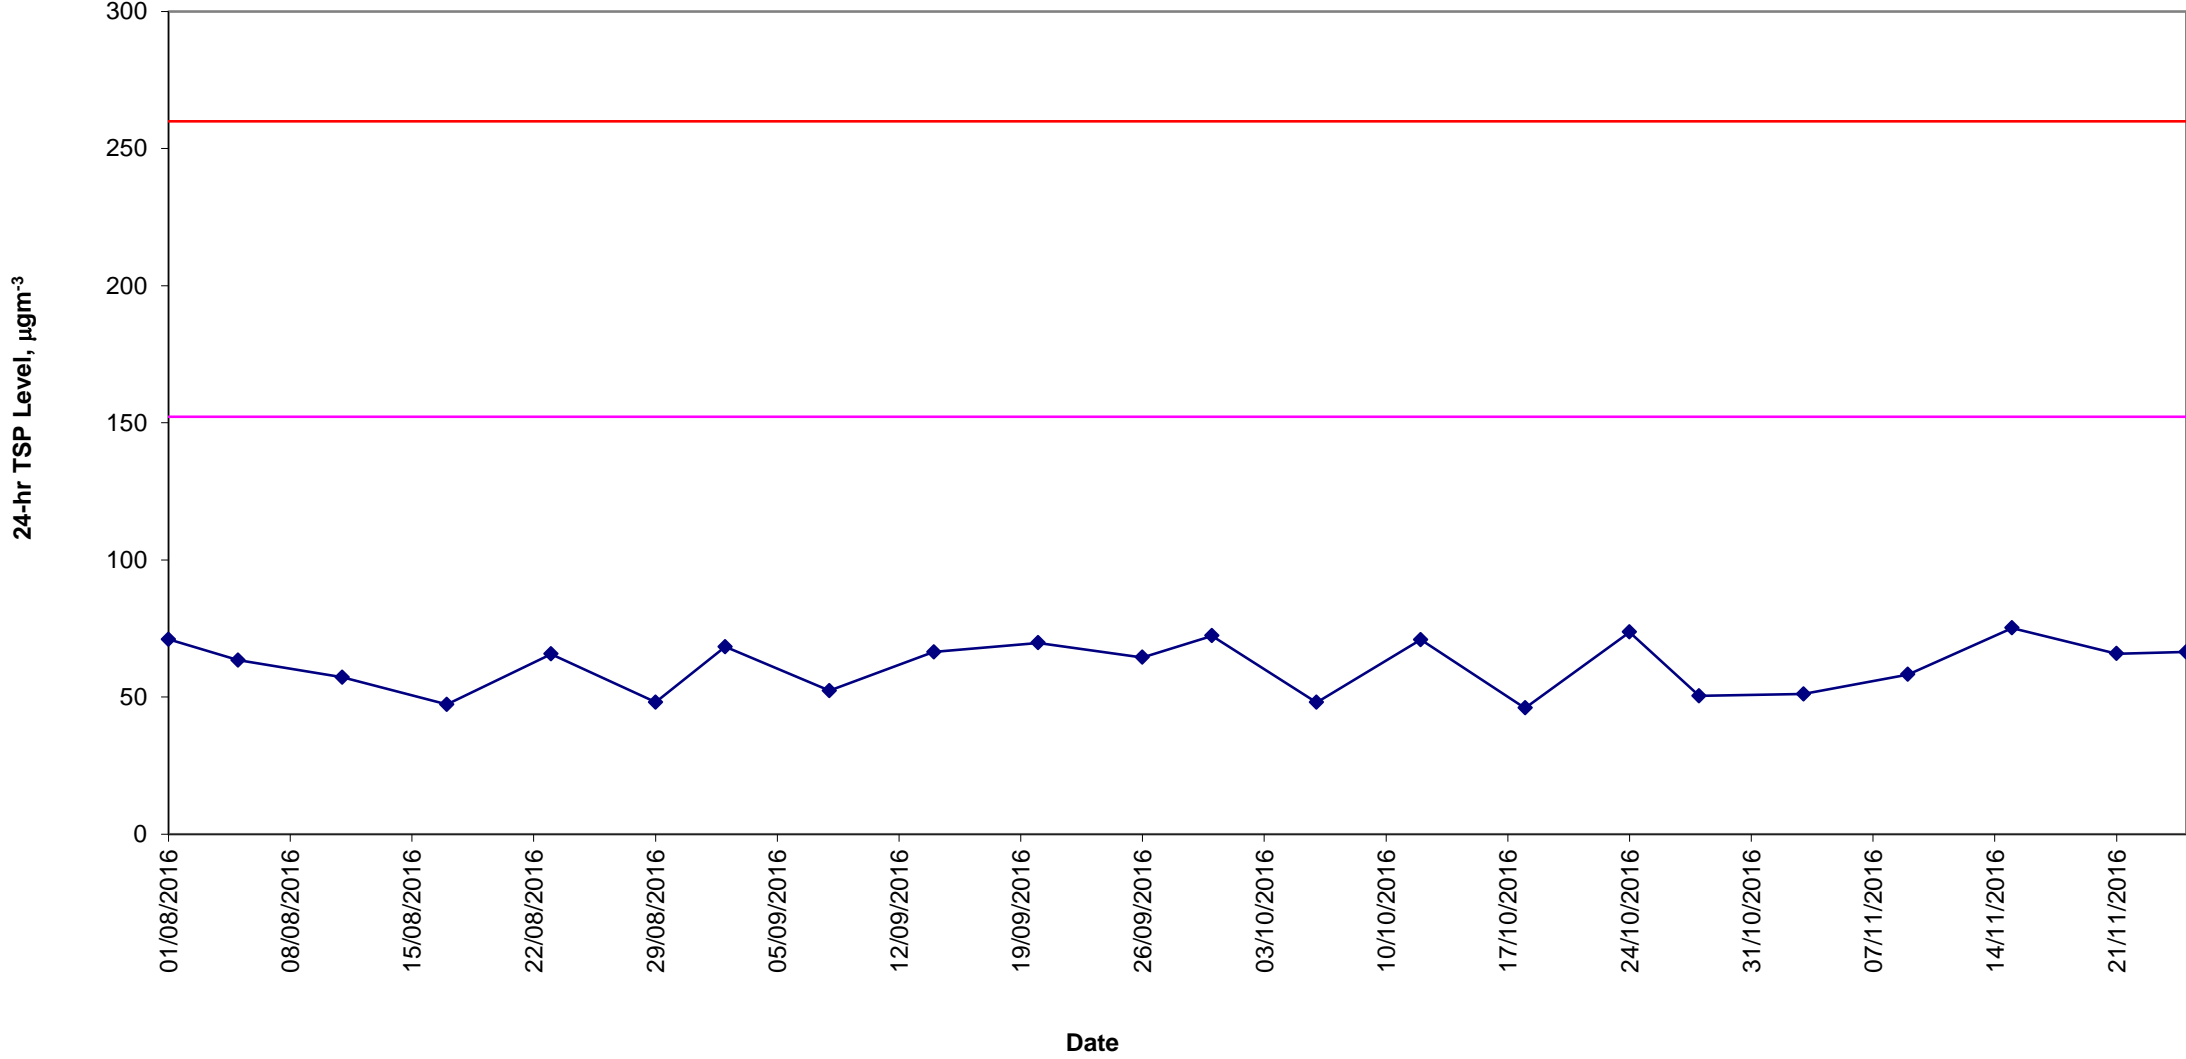
**Construction Dust Monitoring Results for the Past 4 Months
DMS-8 (SKH Good Shepherd Primary School)**

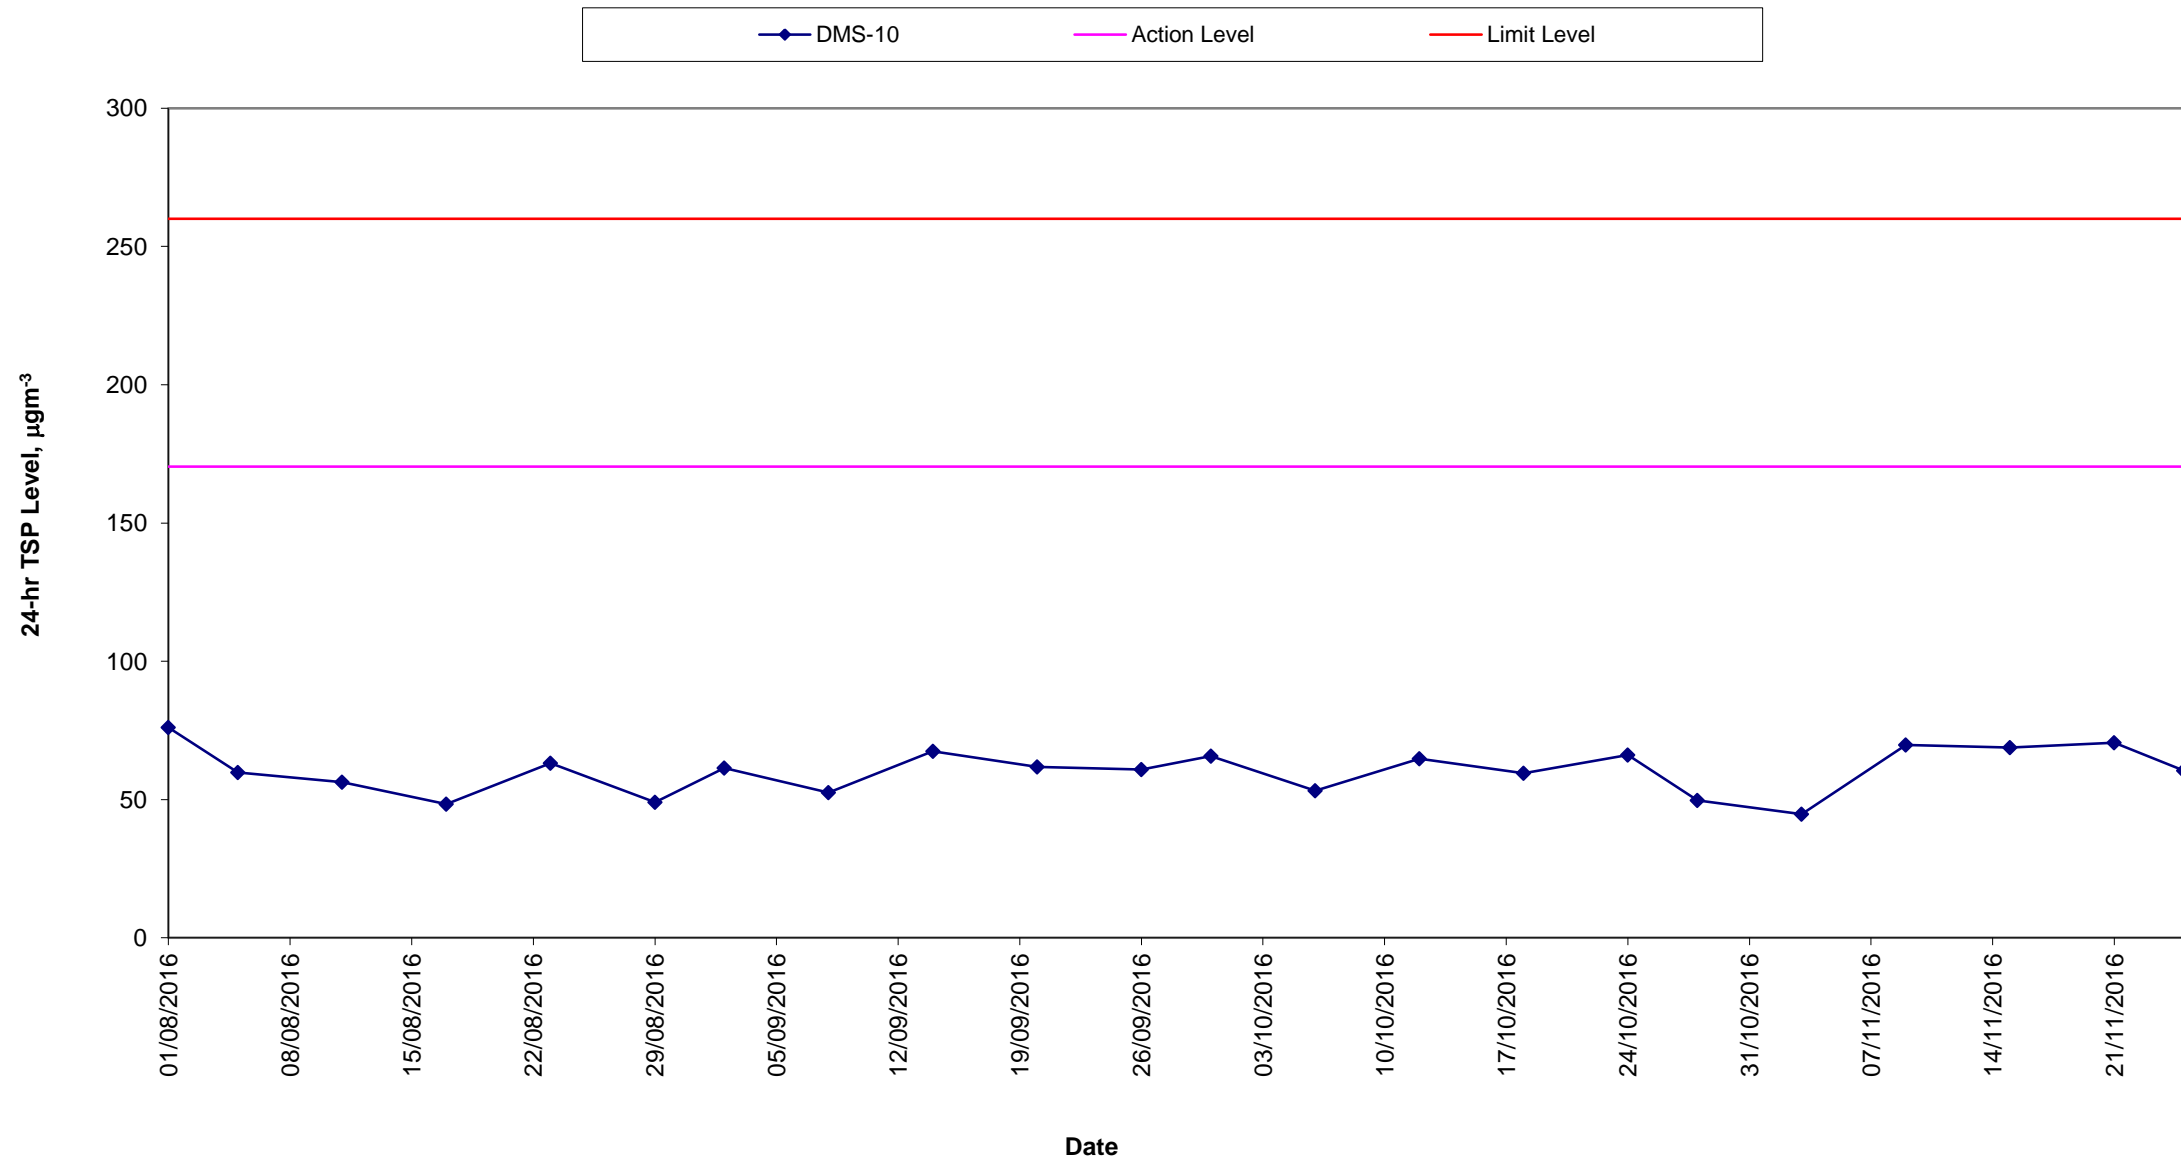
Construction Dust Monitoring Results for the Past 4 Months DMS-10 (Chat Ma Mansion)

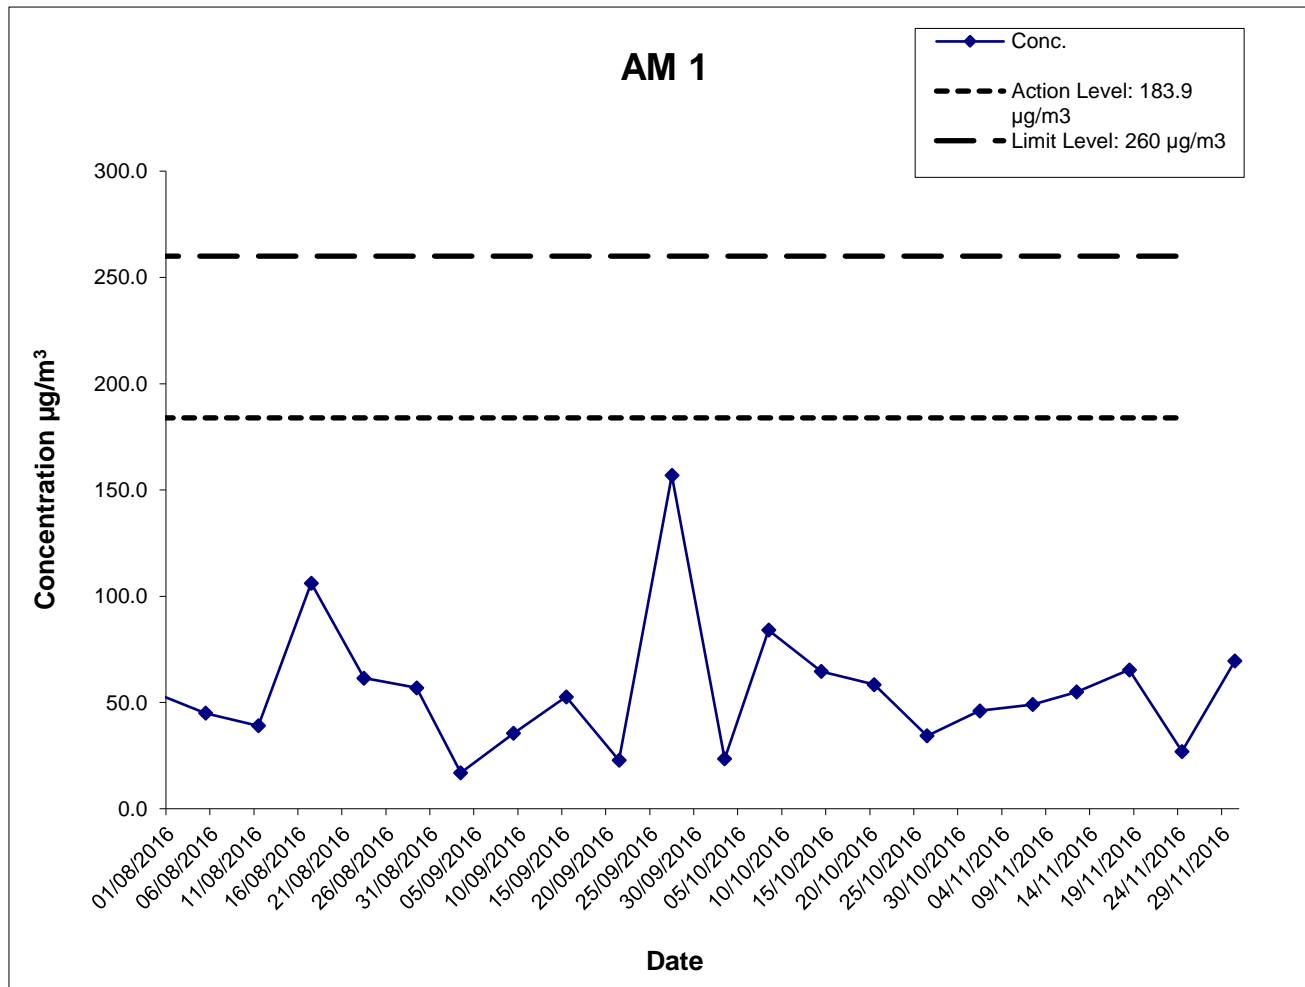
AECOM	Shatin to Central Link Works Contract 1111- Hung Hom North Approach Tunnels	SCALE	N.T.S.	DATE	Dec-16
	Graphical Presentations of Impact 24-hour TSP Monitoring Results	CHECK	TYUT	DRAWN	YIPLWO
		JOB NO.	60284101	APPENDIX No. G	Rev. -

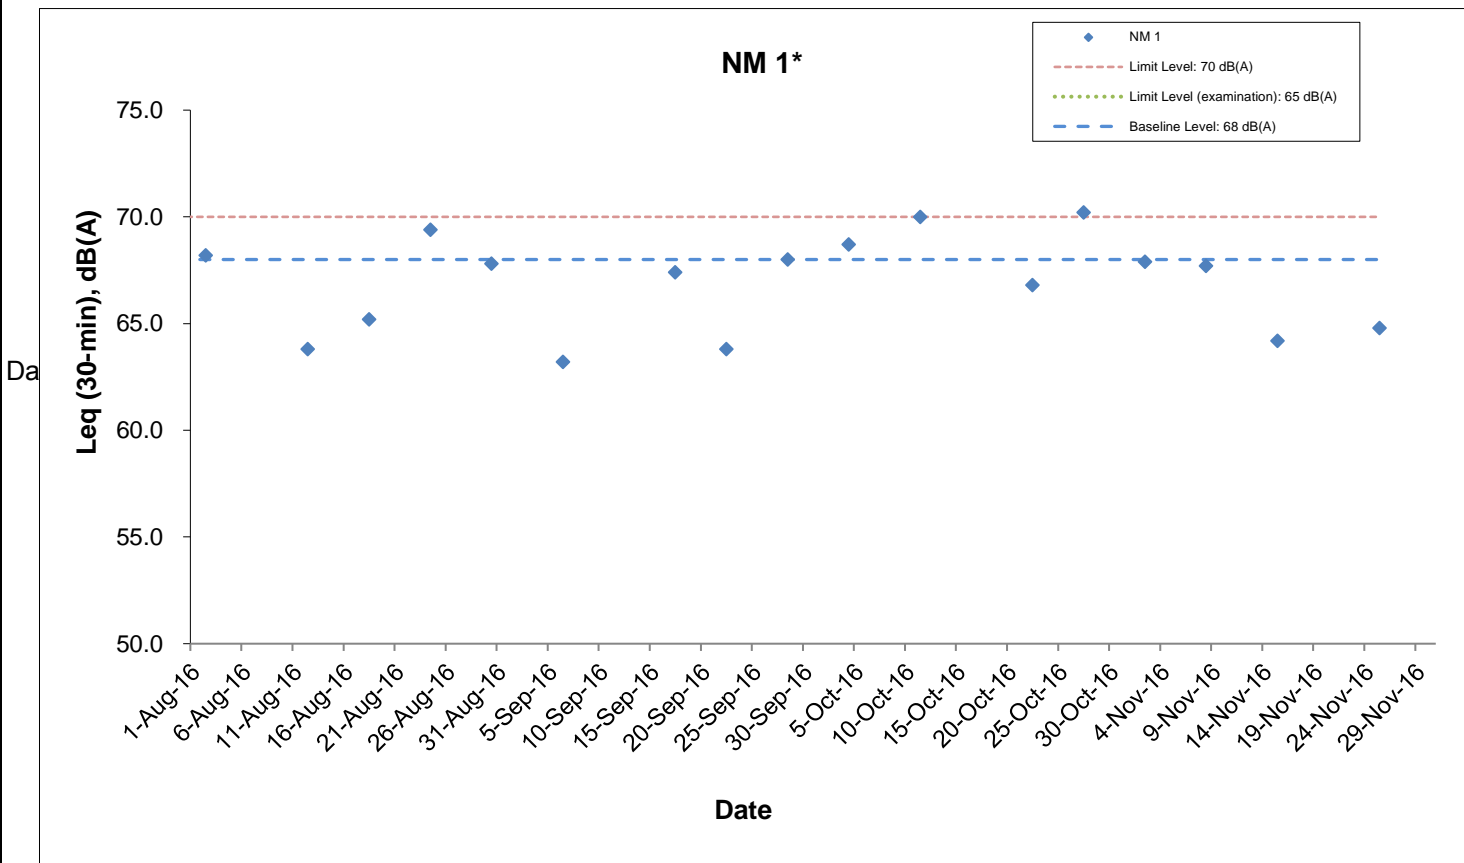
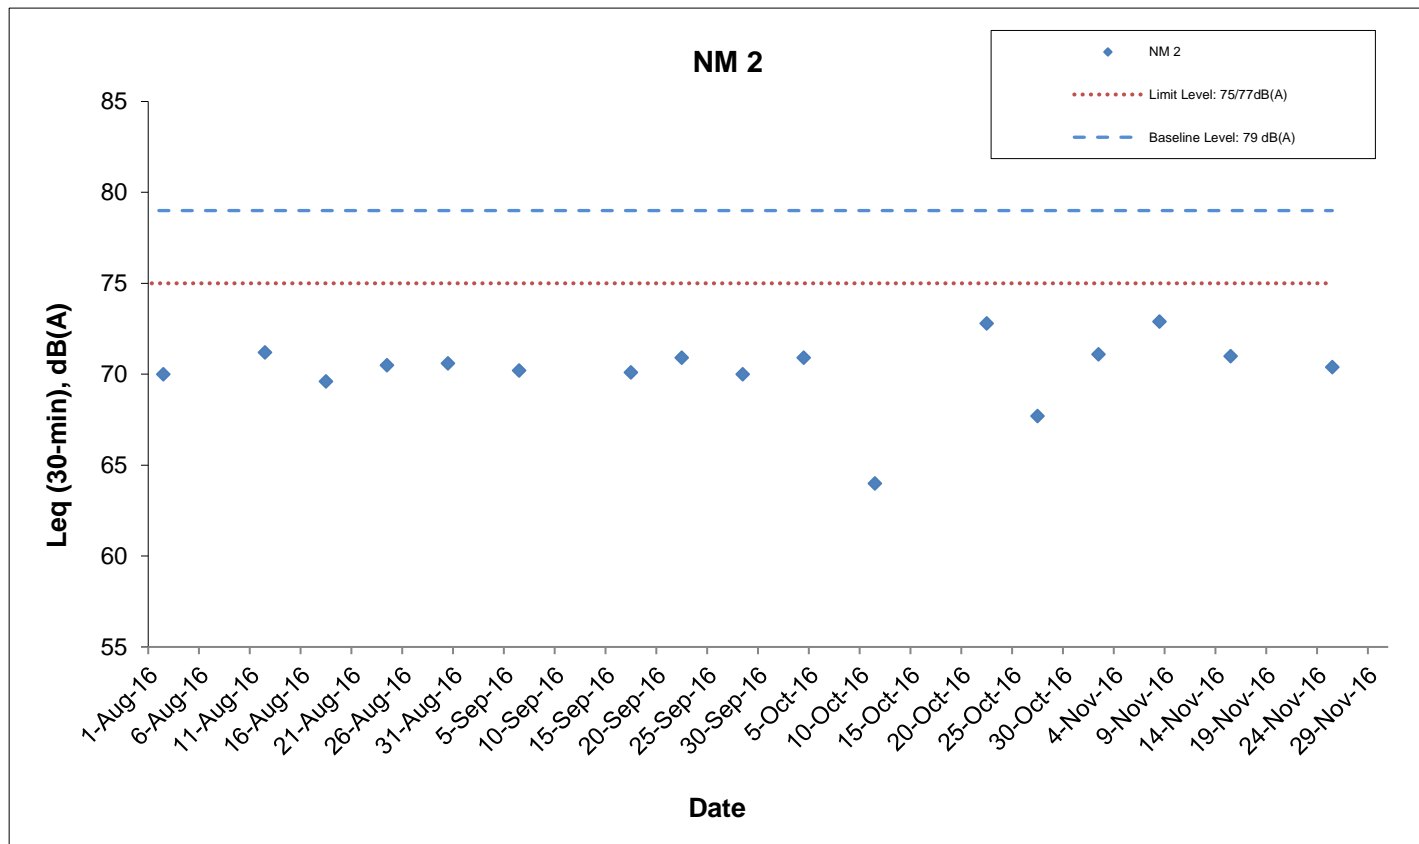
Appendix H Regular Construction Noise Monitoring Results

* - The noise monitoring results of the measurements are higher than the daytime construction noise criterion. However, the results are not considered as exceedance if they are either below the baseline level or below the limit level after deducting the baseline noise level.

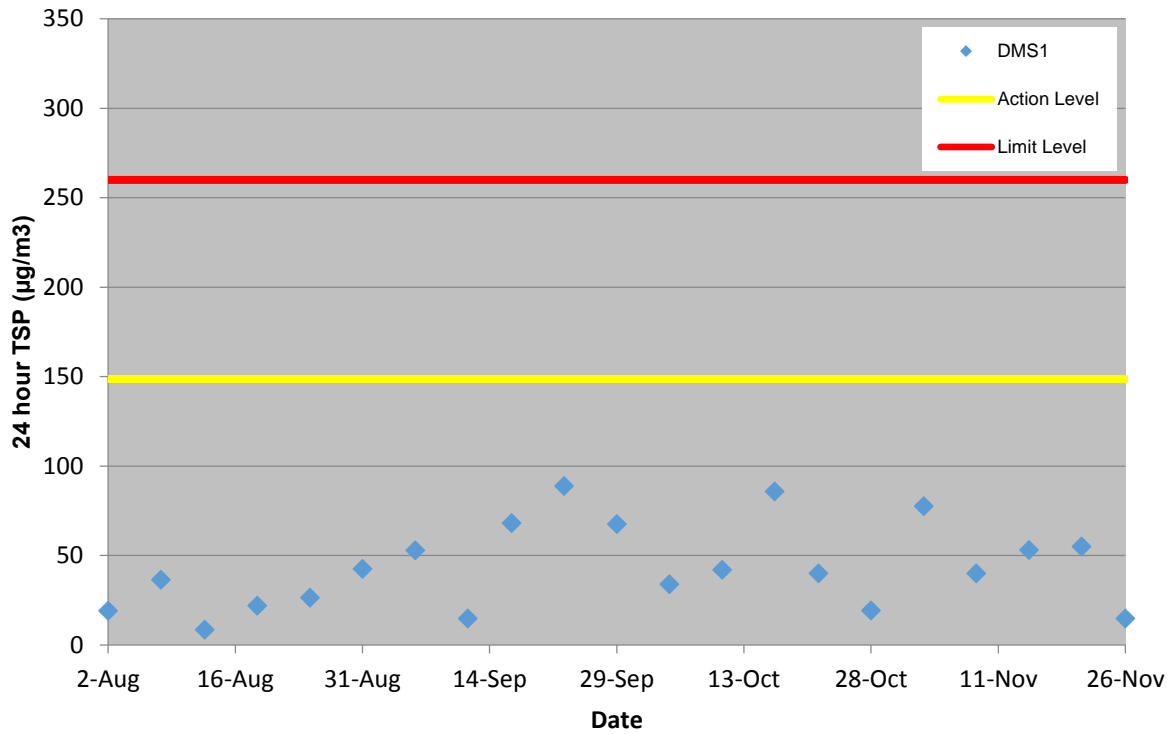
Impact 24-hour TSP Monitoring at Air Monitoring Station DMS-1
From August 2016 to November 2016
