**Shatin to Central Link –
Tai Wai to Hung Hom Section and
Mong Kok East to Hung Hom Section**

Monthly EM&A Report No. 51

[Period from 1 to 30 November 2016]

**Monthly EM&A Report No. 51
(Revised)**

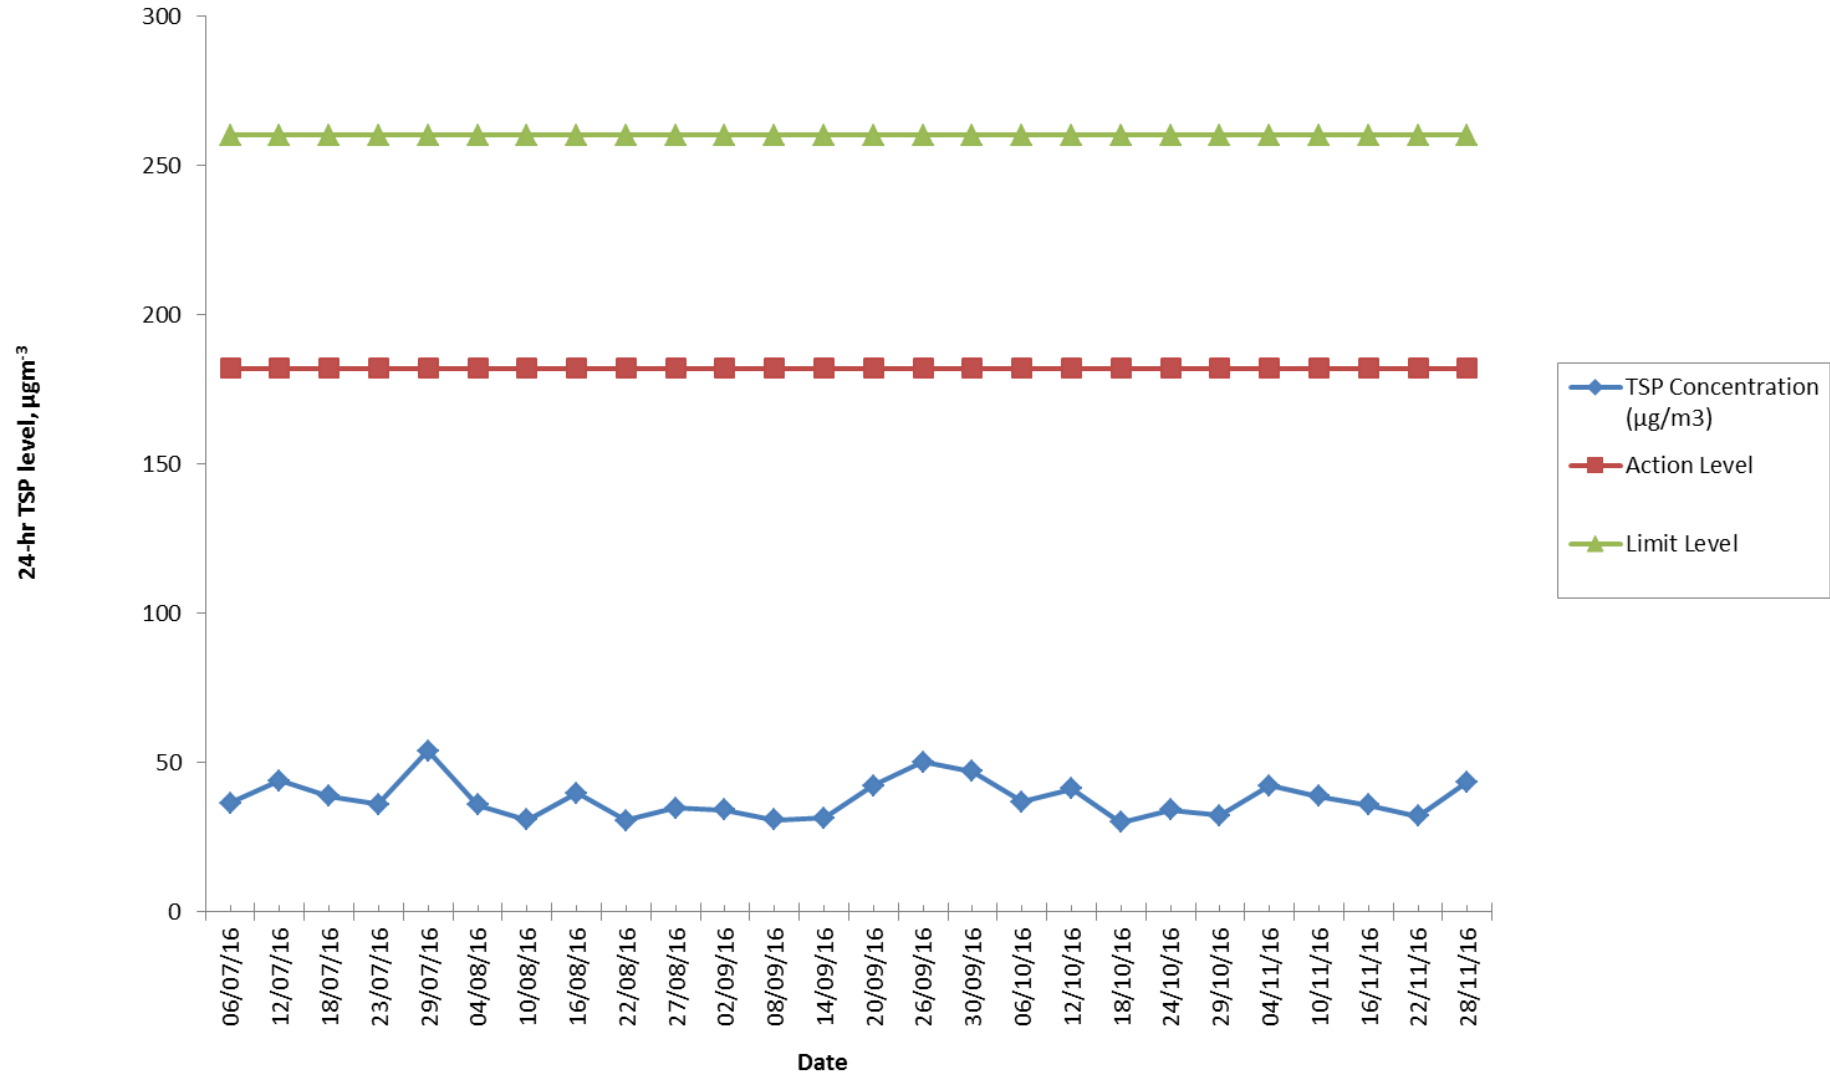
Construction Dust Monitoring Results for AM2 (Harbourfront Horizon)
