**Shatin to Central Link –  
Tai Wai to Hung Hom Section and  
Mong Kok East to Hung Hom Section**

Monthly EM&A Report No. 52

[Period from 1 to 31 December 2016]

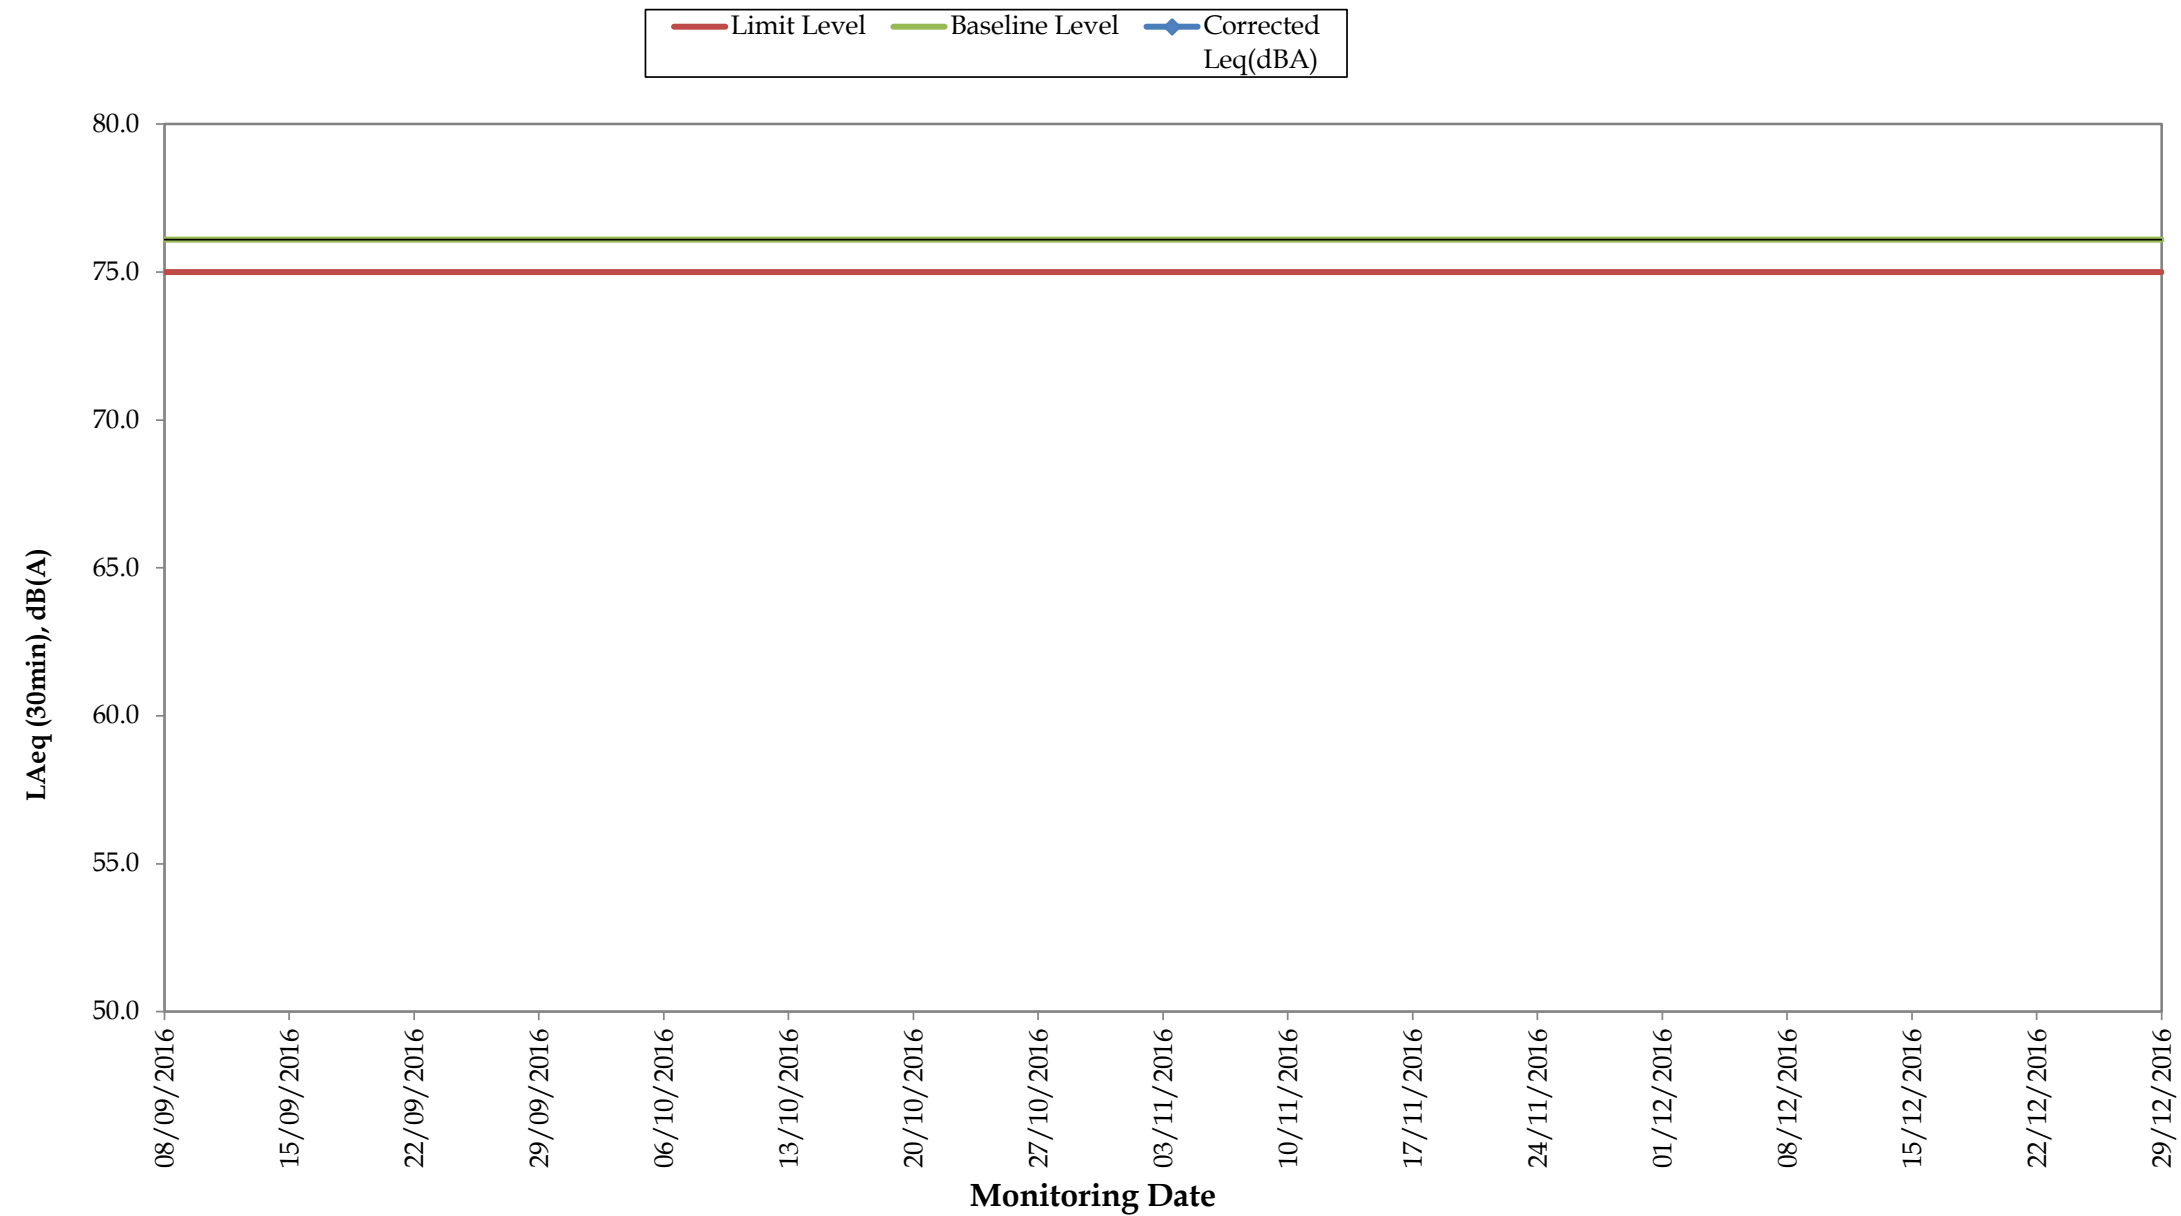
## Regular Noise Monitoring Results at NMS-CA-6 (No. 16-23 Nam Kok Road) (LAeq, 30min) for the Past 4 Months

- For those corrected noise levels that are not shown in this graph, the measured noise levels are equal to or below baseline level.

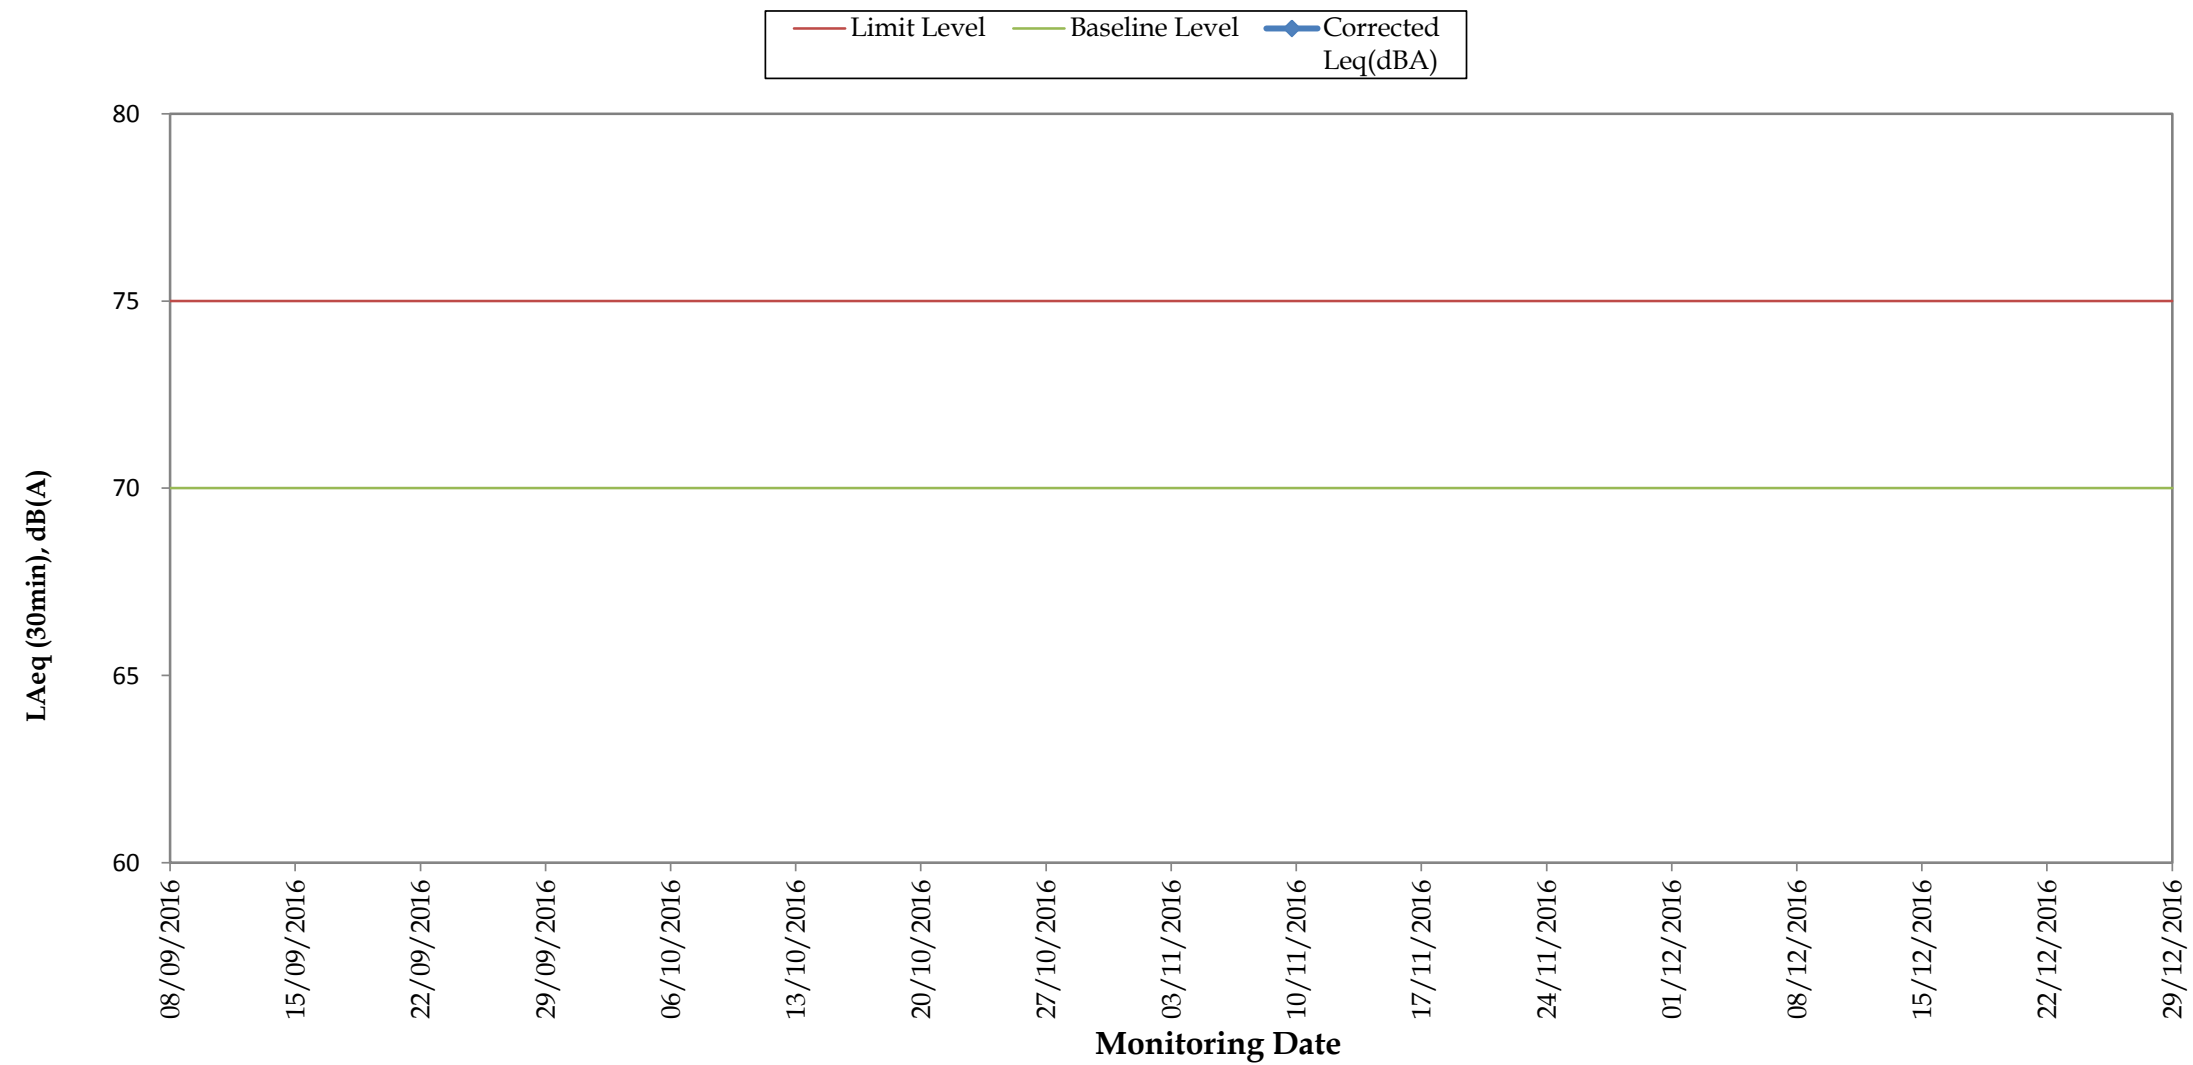
## Regular Noise Monitoring Results at NMS-CA-7 (Skytower Tower 2) (LAeq, 30min) for the Past 4 Months

- For those corrected noise levels that are not shown in this graph, the measured noise levels are equal to or below baseline level.

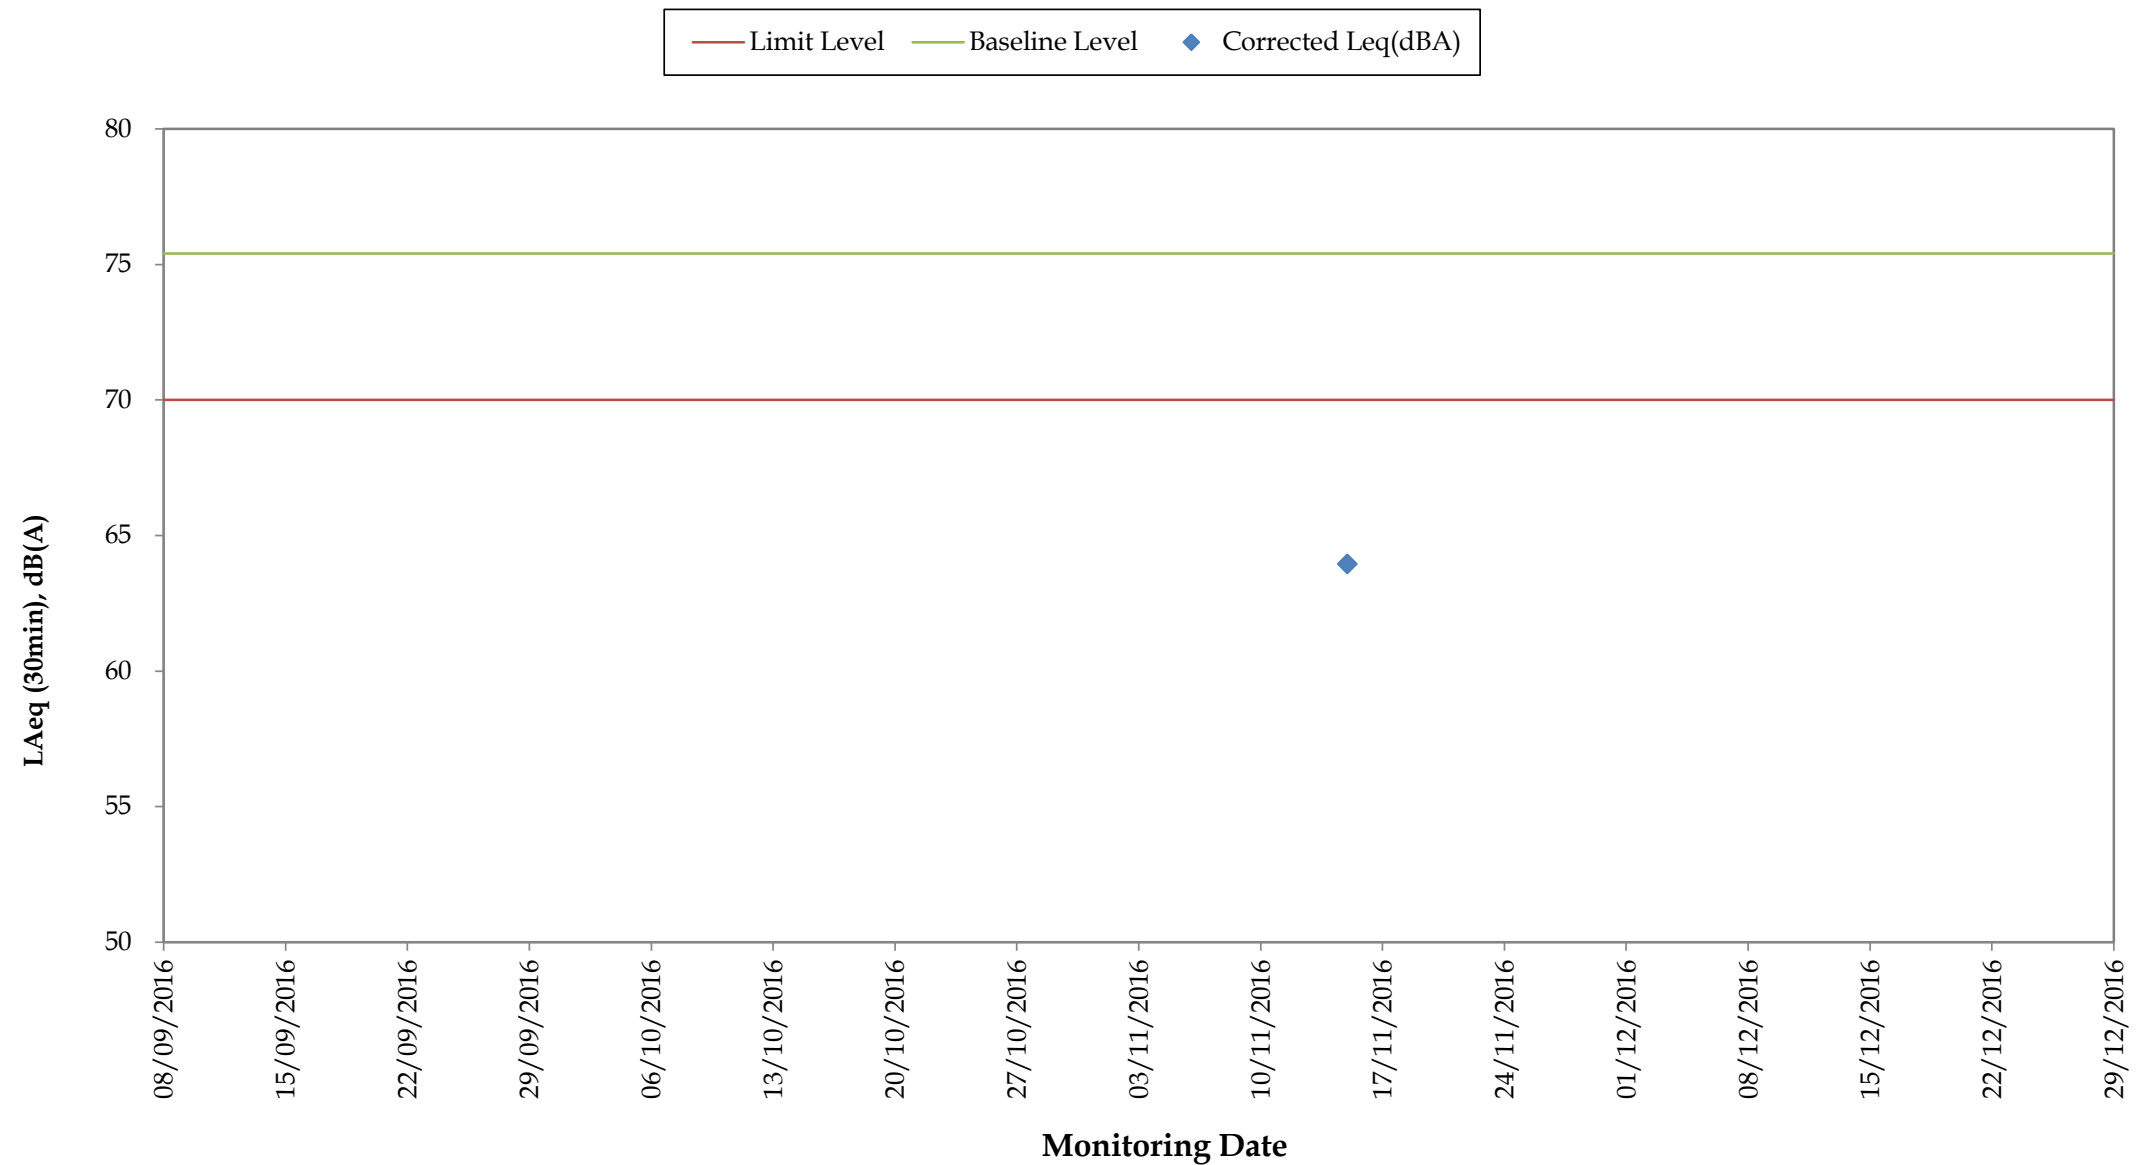
## Regular Noise Monitoring Results at NMS-CA- 8 (SKH Good Shepherd Primary School) (LAeq, 30min) for the Past 4 Months

- For those corrected noise levels that are not shown in this graph, the measured noise levels are equal to or below baseline level.
- The limit level was updated from 78dB(A) to 79 dB(A) on 22 Aug 2013 as per the latest CNMP and CNMMP.
- The limit level was updated from 79dB(A) to 70dB(A)/65dB(A) (during normal/examination period) from April 2016, as the continuous noise monitoring was completed in March 2016 according to the latest CNMP

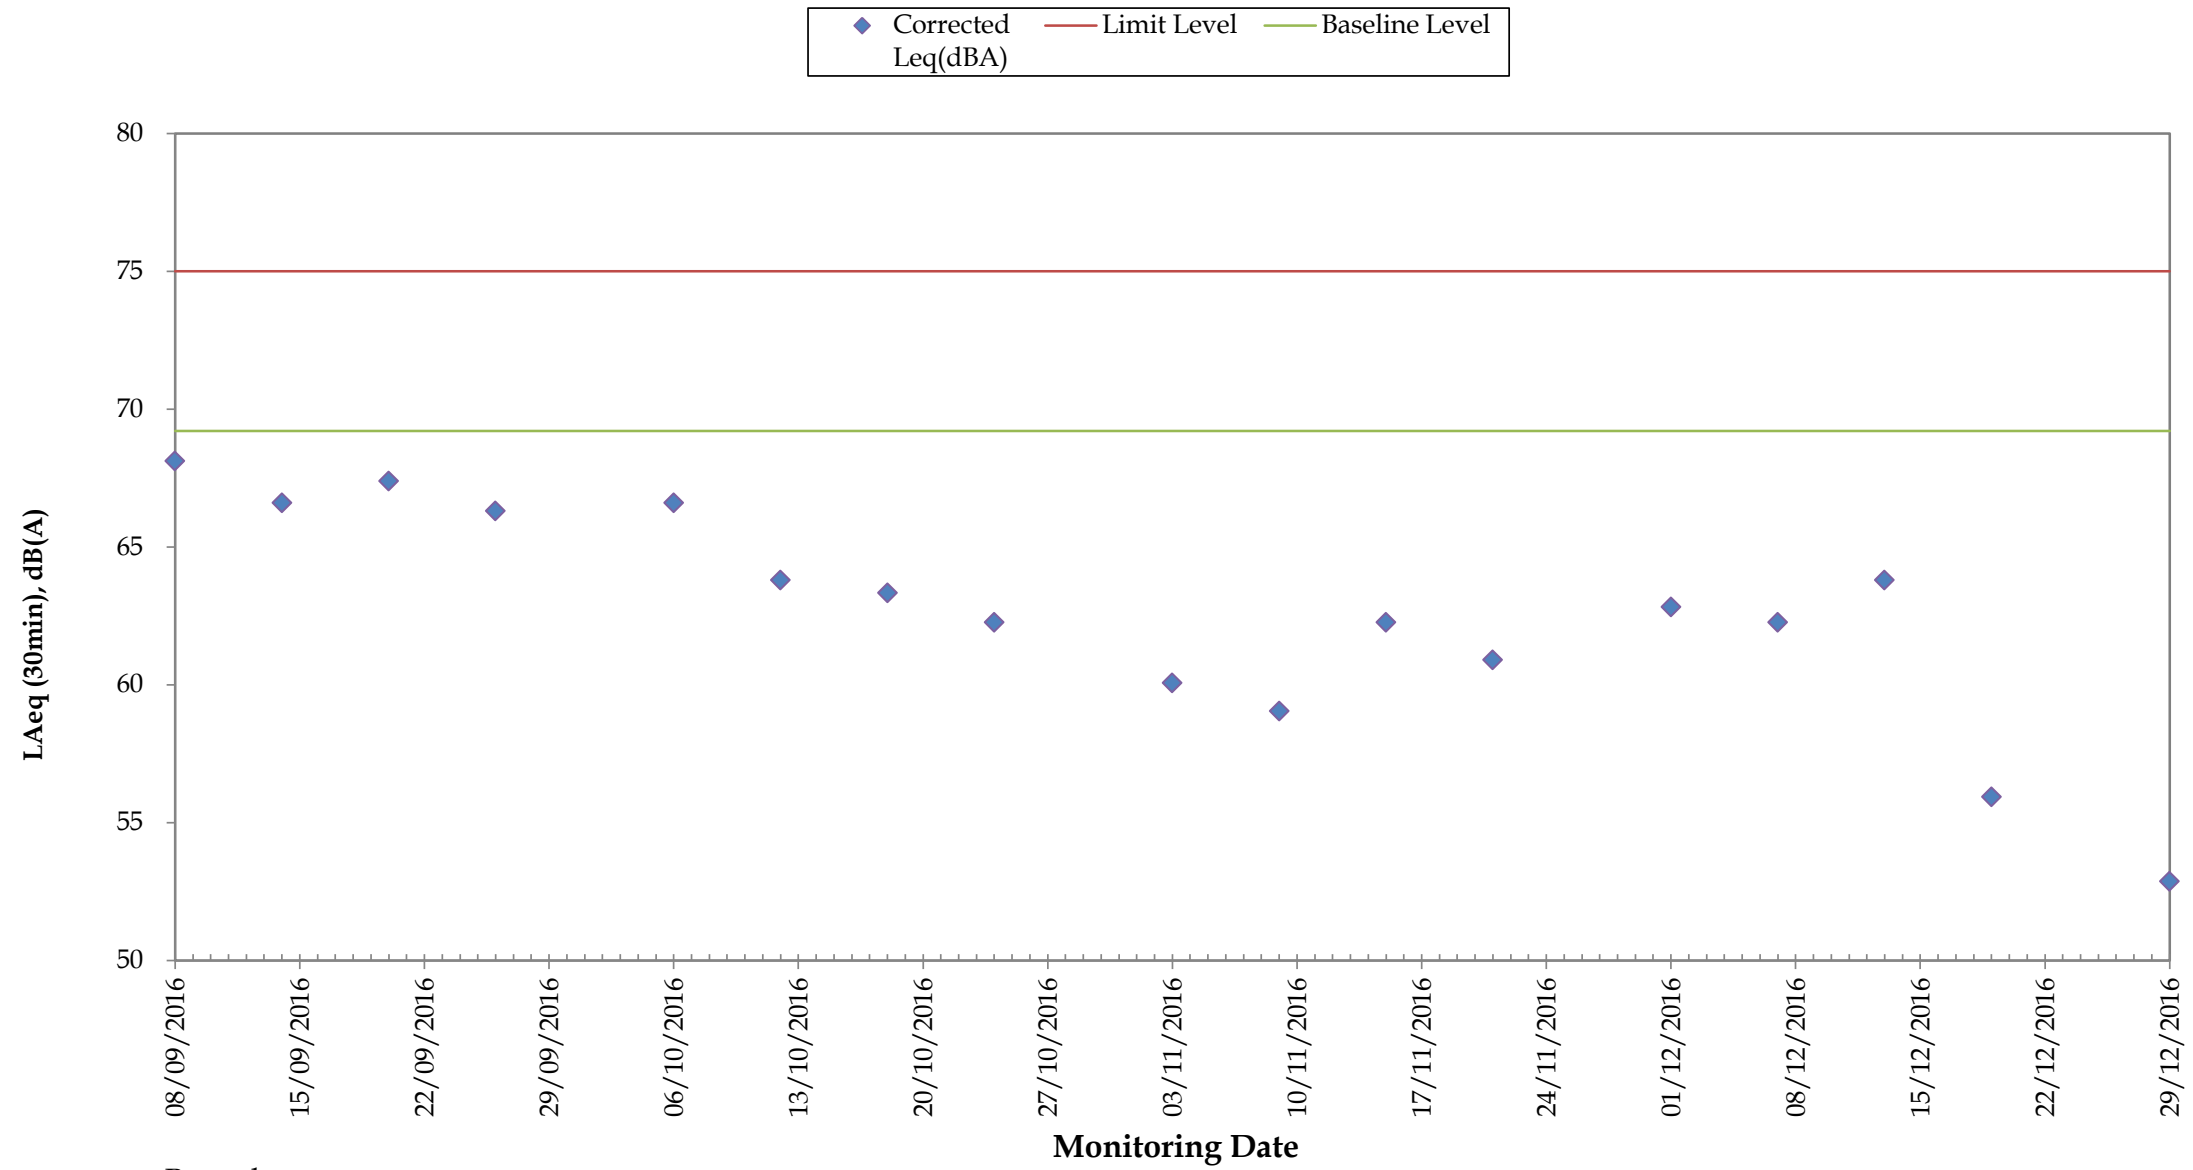
### Regular Noise Monitoring Results at NMS-CA-9 (Kong Yiu Mansion) (LAeq, 30min) ) for the Past 4 Months

- For those corrected noise levels that are not shown in this graph, the measured noise levels are equal to or below baseline level.

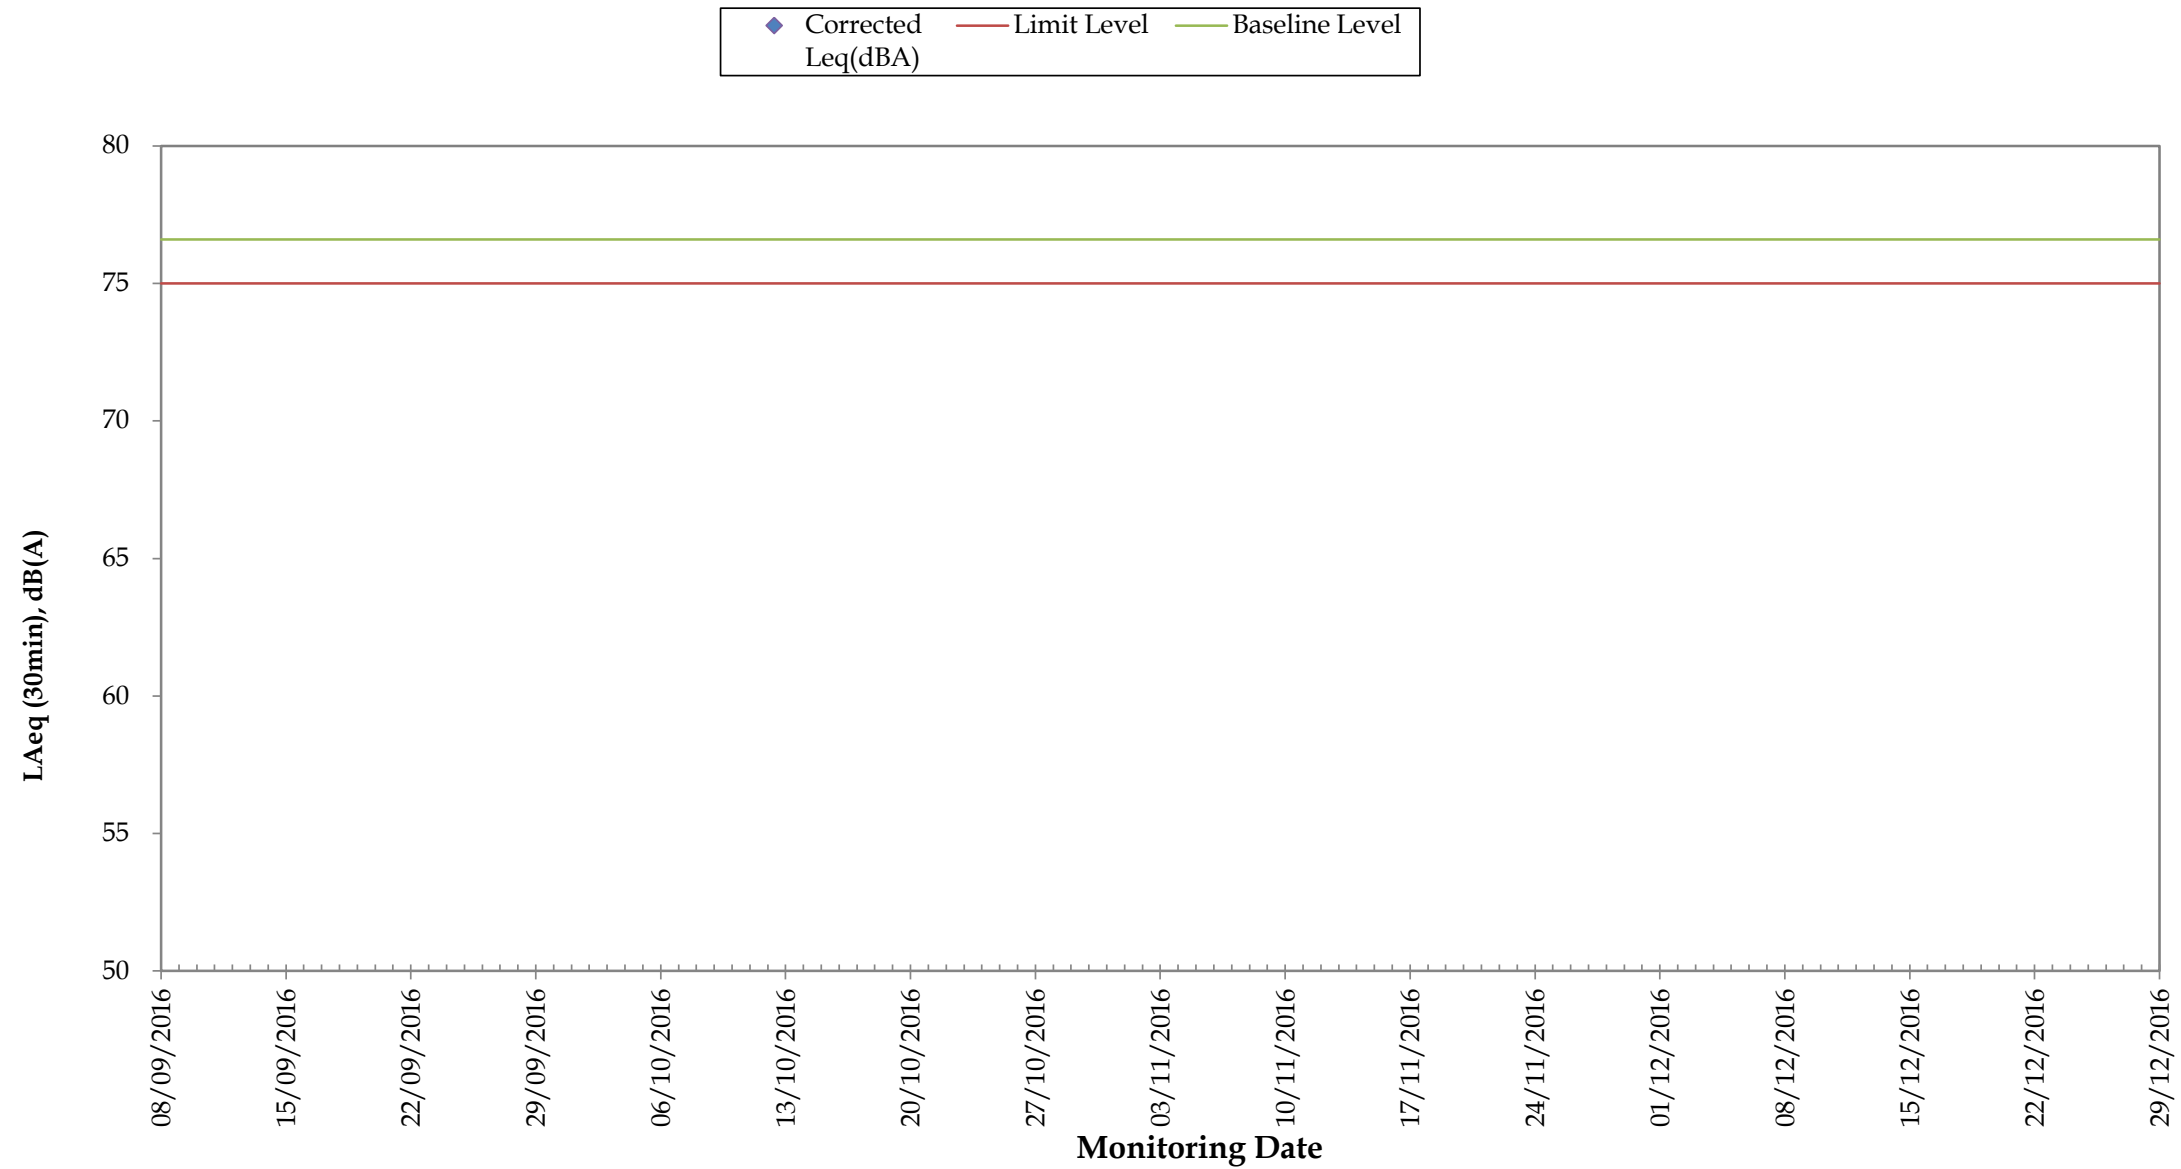
## Regular Noise Monitoring Results at NMS-CA-10 (Chat Ma Mansion) (LAeq, 30min) for the Past 4 Months

- For those corrected noise levels that are not shown in this graph, the measured noise levels are equal to or below baseline level.

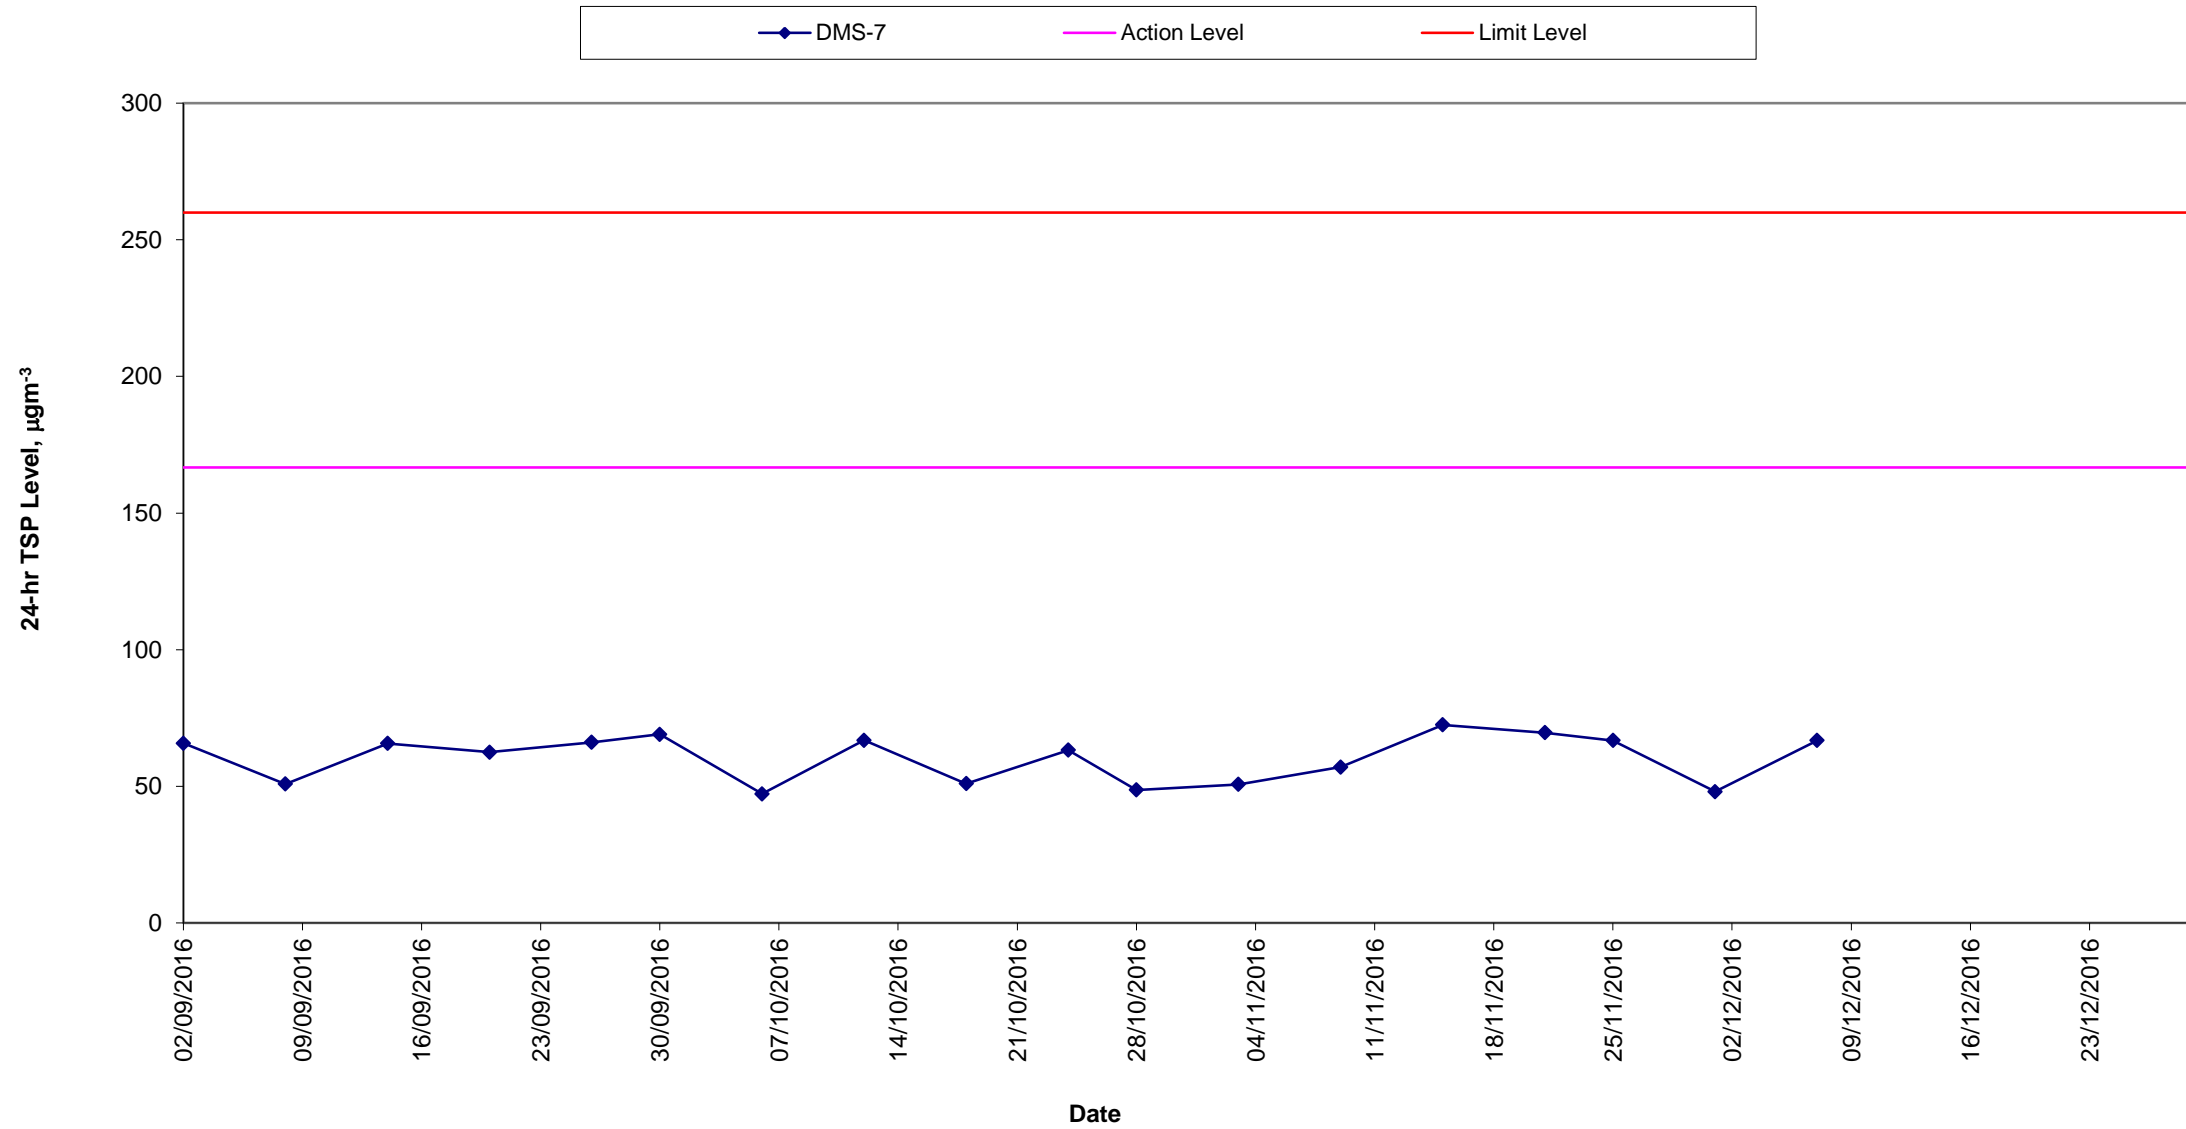
### Construction Dust Monitoring Results for the Past 4 Months DMS- 7 (Parc 22)

- 24-hour averaged dust monitoring at DMS-7 (Parc-22) was temporary suspended since 13 December 2016 due to request from the Management Office.

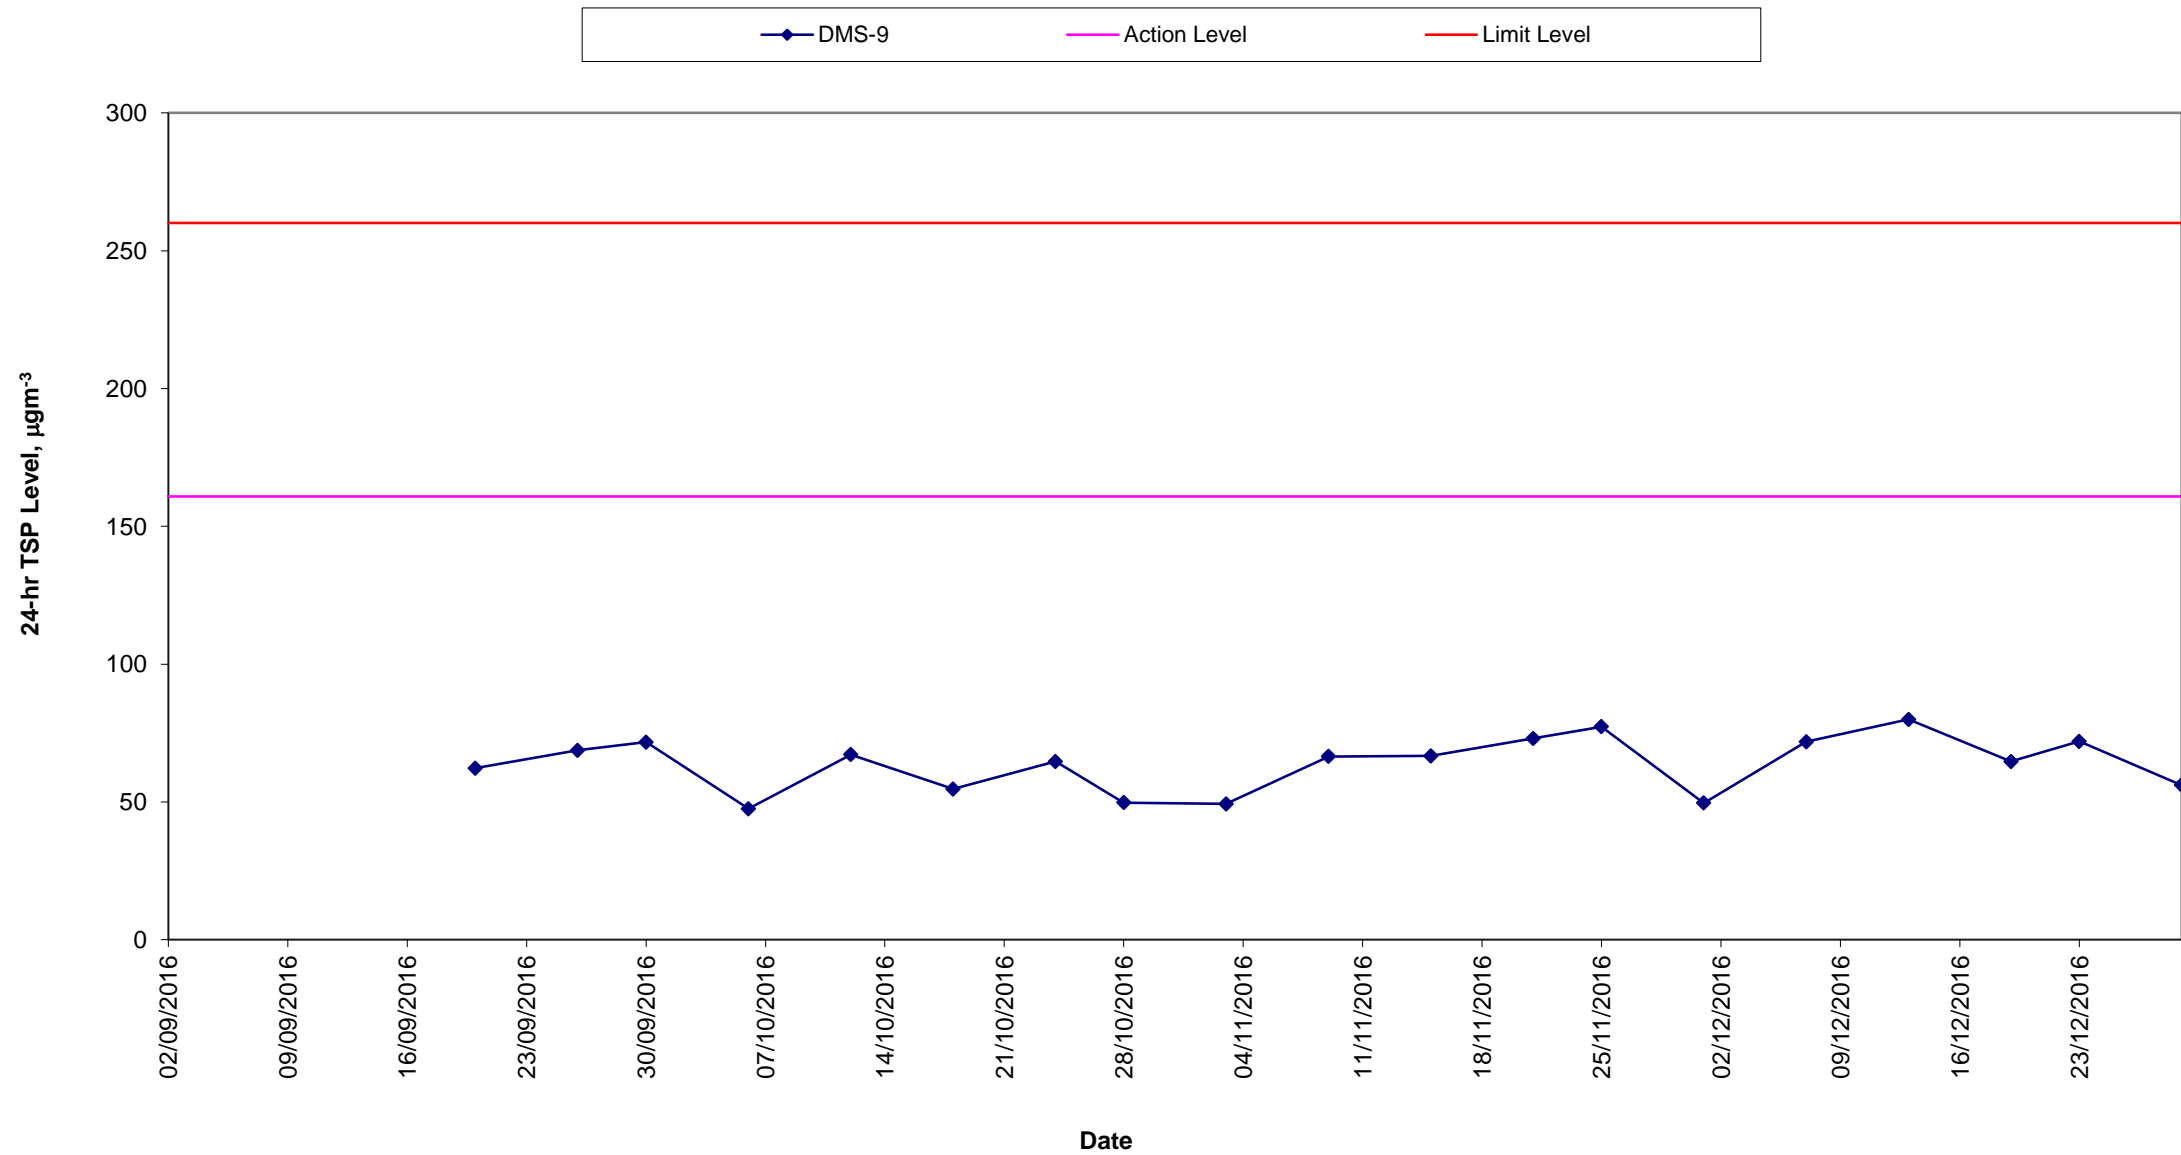
### Construction Dust Monitoring Results for the Past 4 Months DMS-9 (No.12 Pau Chung Street)

- 24-hour averaged dust monitoring at DMS-9 (No. 12 Pau Chung Street) was temporary suspended since July 2016 due to request from the Management Office and was resumed on 20 September 2016.

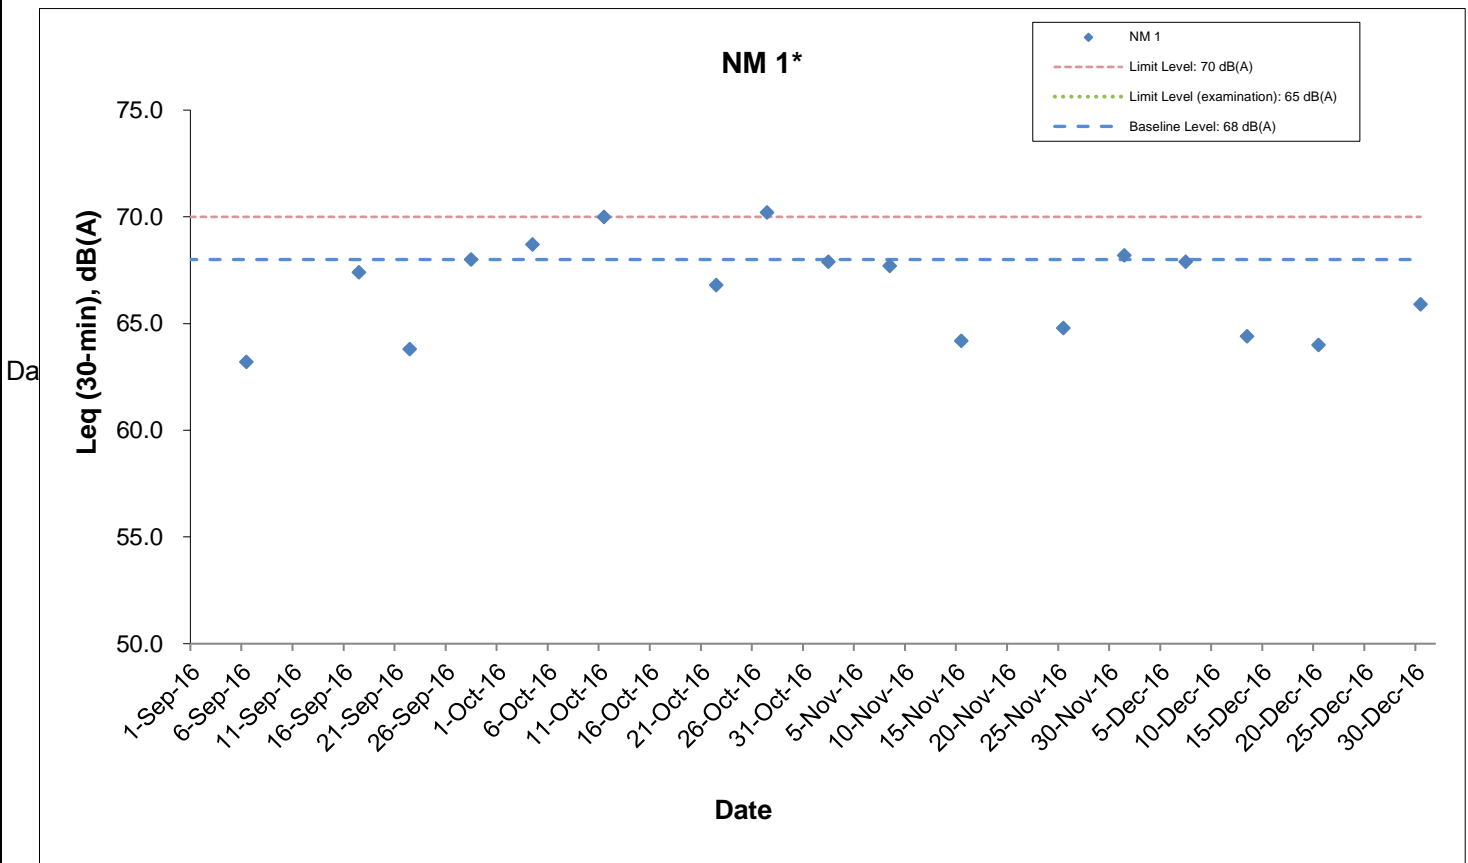
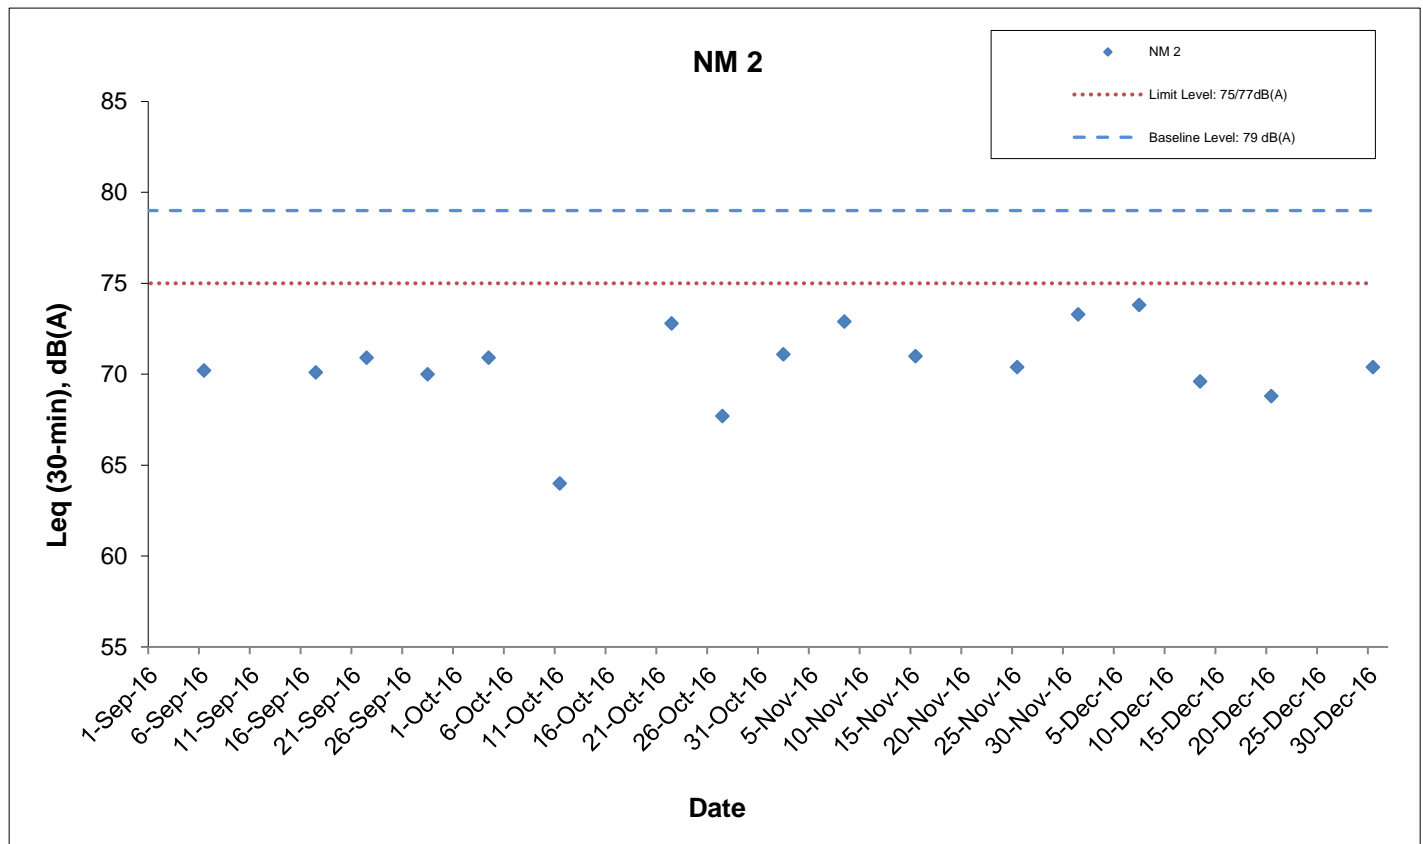
# Appendix H Regular Construction Noise Monitoring Results

\* - The noise monitoring results of the measurements are higher than the daytime construction noise criterion. However, the results are not considered as exceedance if they are either below the baseline level or below the limit level after deducting the baseline noise level.
