**Shatin to Central Link –
Tai Wai to Hung Hom Section and
Mong Kok East to Hung Hom Section**

Monthly EM&A Report No. 53

[Period from 1 to 31 January 2017]

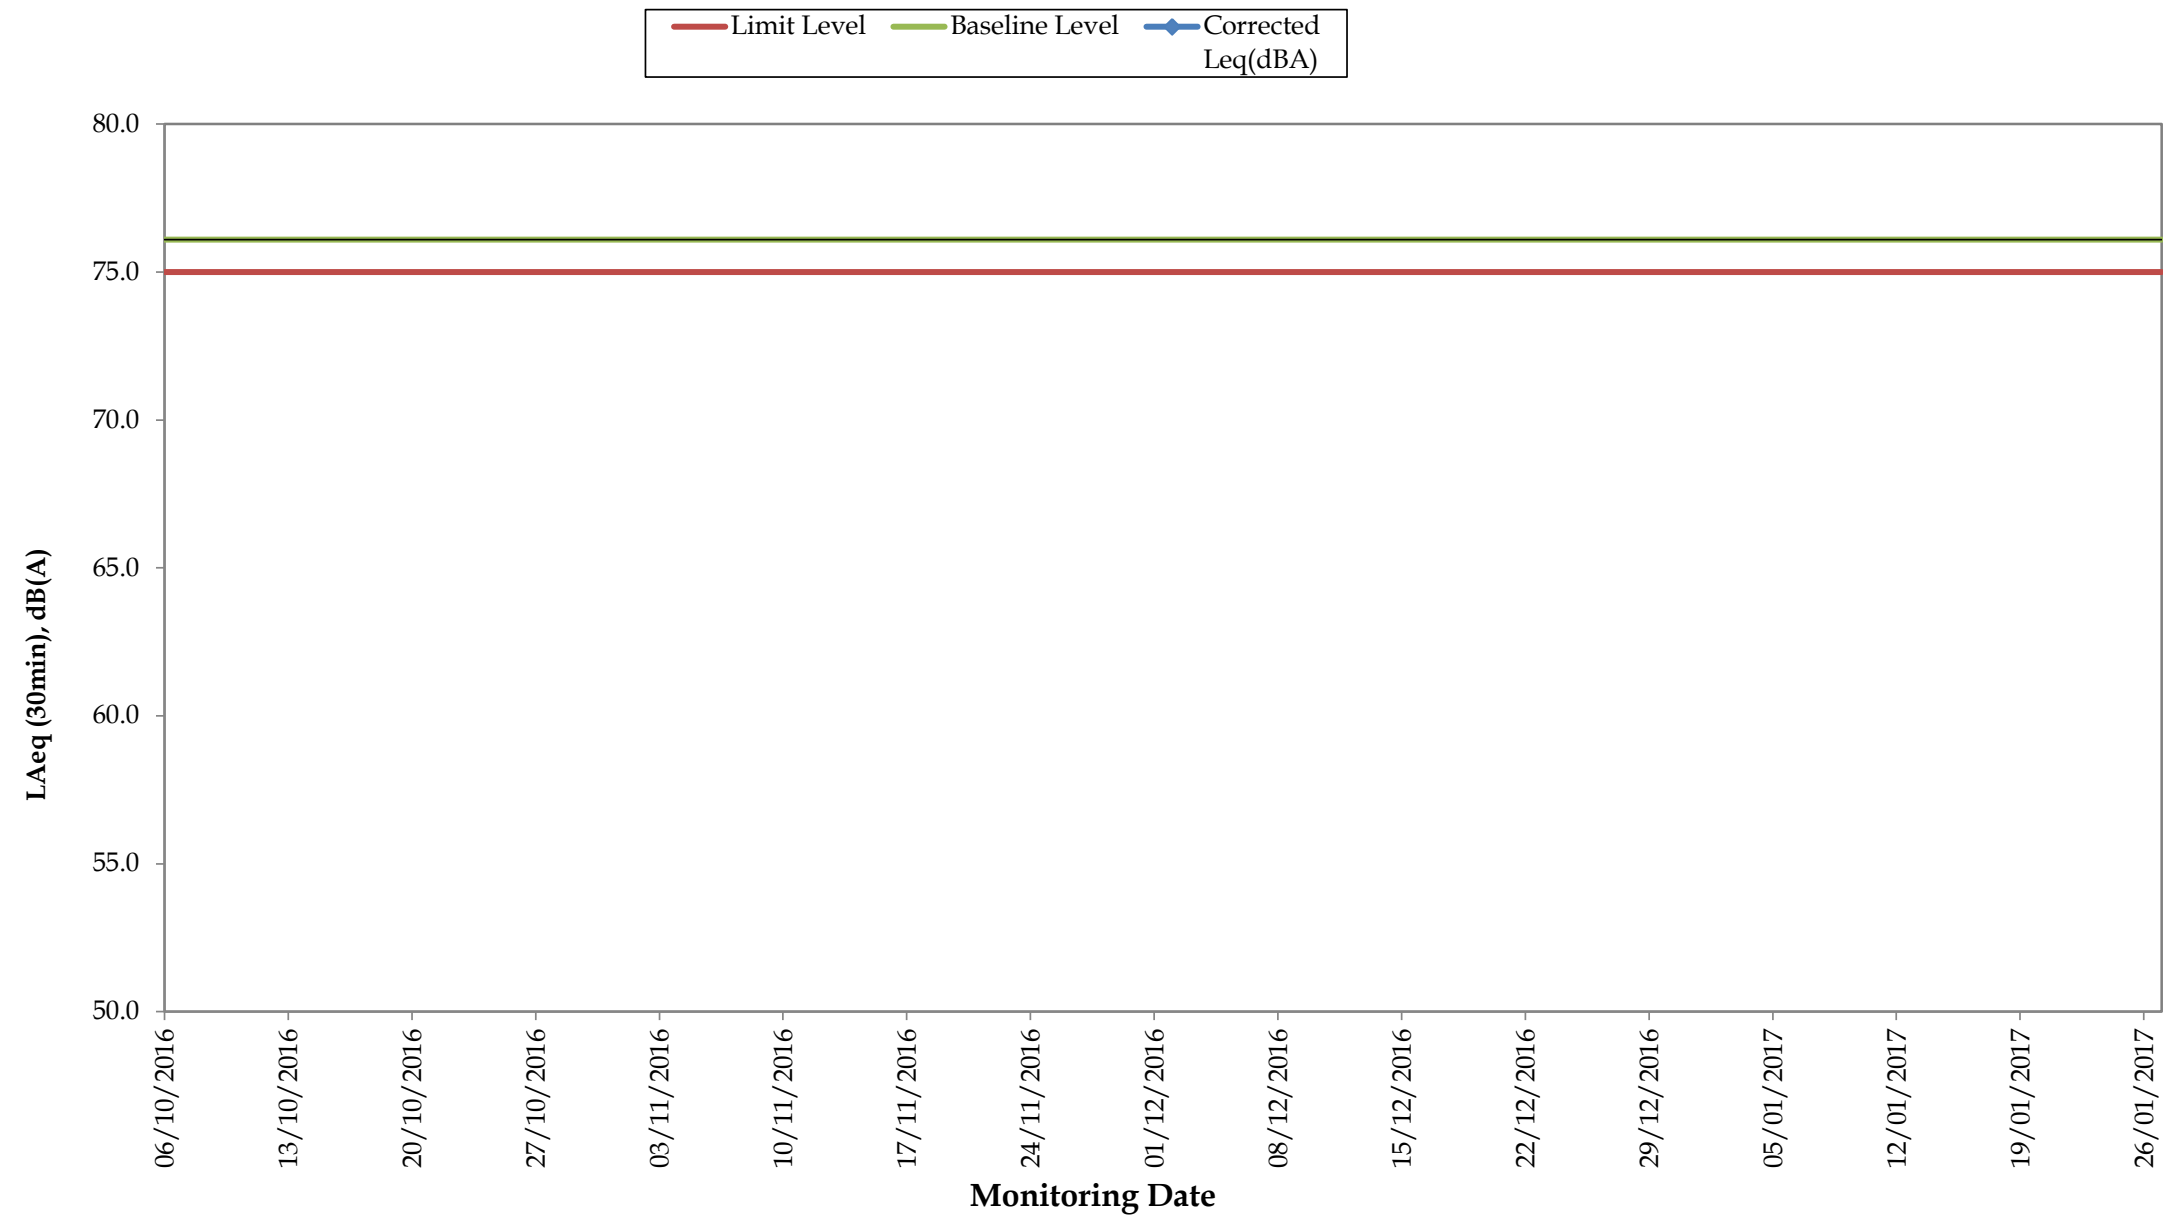
Regular Noise Monitoring Results at NMS-CA-6 (No. 16-23 Nam Kok Road) (LAeq, 30min) for the Past 4 Months

- For those corrected noise levels that are not shown in this graph, the measured noise levels are equal to or below baseline level.

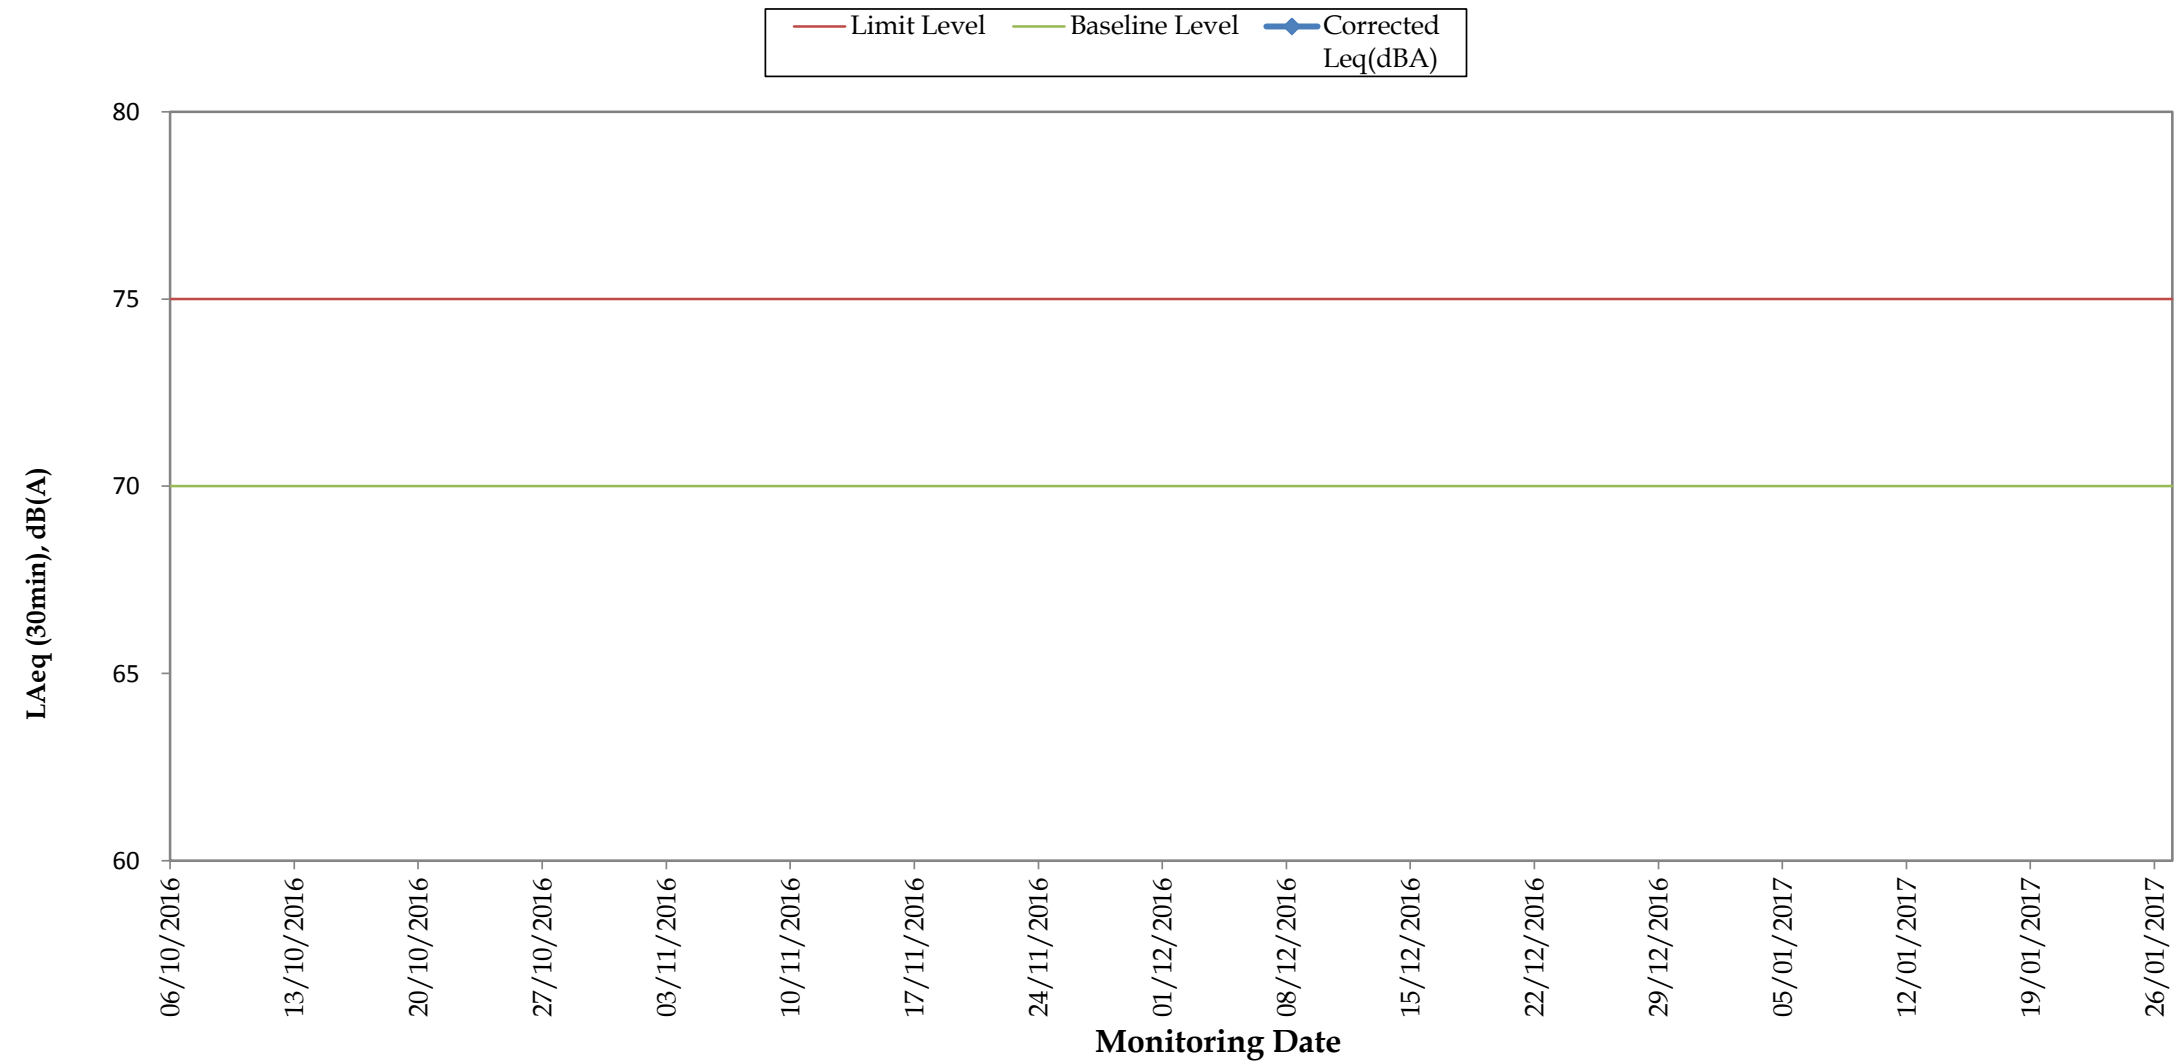
Regular Noise Monitoring Results at NMS-CA-7 (Skytower Tower 2) (LAeq, 30min) for the Past 4 Months

- For those corrected noise levels that are not shown in this graph, the measured noise levels are equal to or below baseline level.

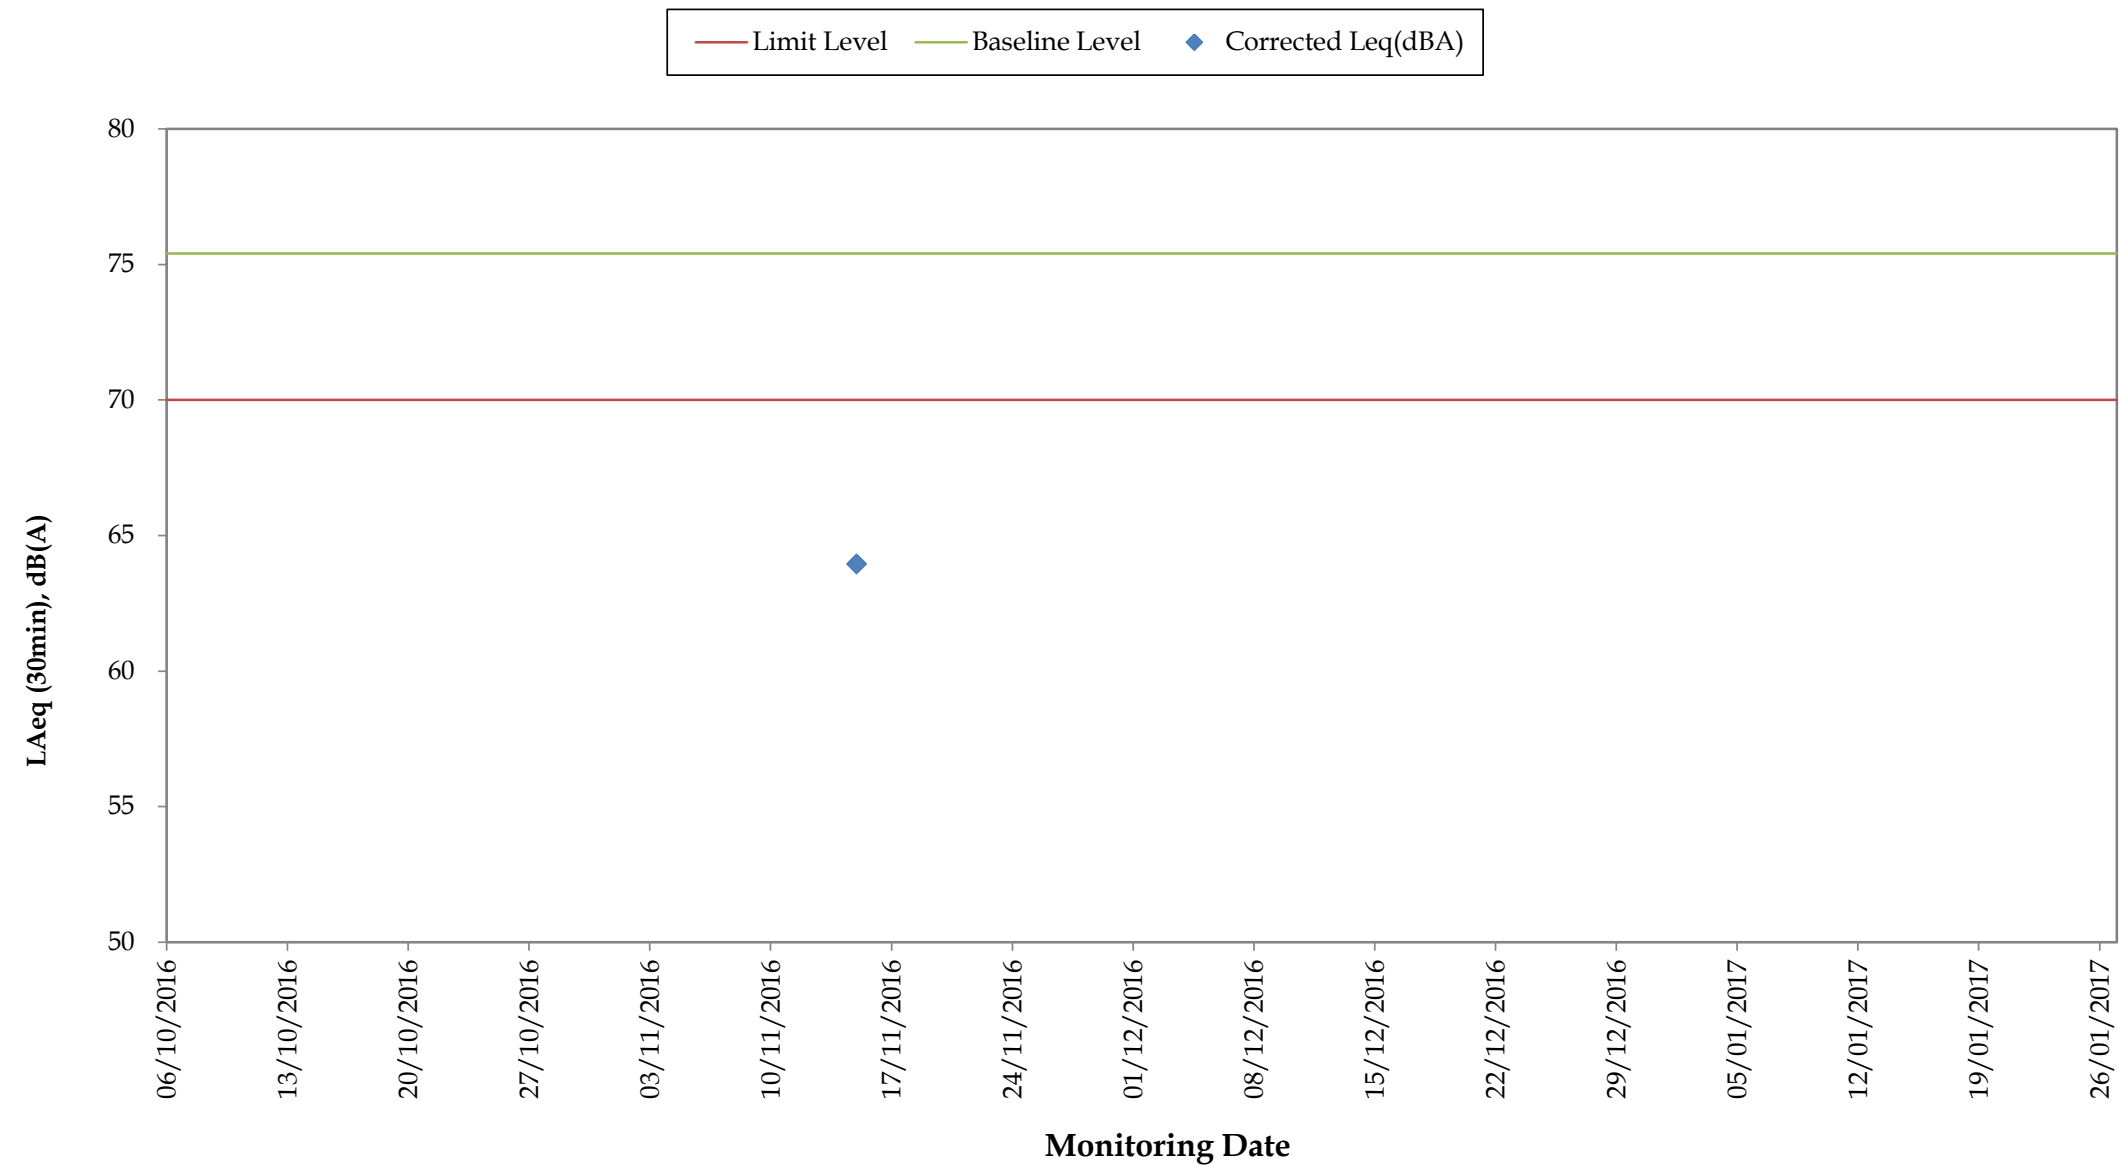
Regular Noise Monitoring Results at NMS-CA- 8 (SKH Good Shepherd Primary School) (LAeq, 30min) for the Past 4 Months

- For those corrected noise levels that are not shown in this graph, the measured noise levels are equal to or below baseline level.
- The limit level was updated from 78dB(A) to 79 dB(A) on 22 Aug 2013 as per the latest CNMP and CNMMP.
- The limit level was updated from 79dB(A) to 70dB(A)/65dB(A) (during normal/examination period) from April 2016, as the continuous noise monitoring was completed in March 2016 according to the latest CNMP

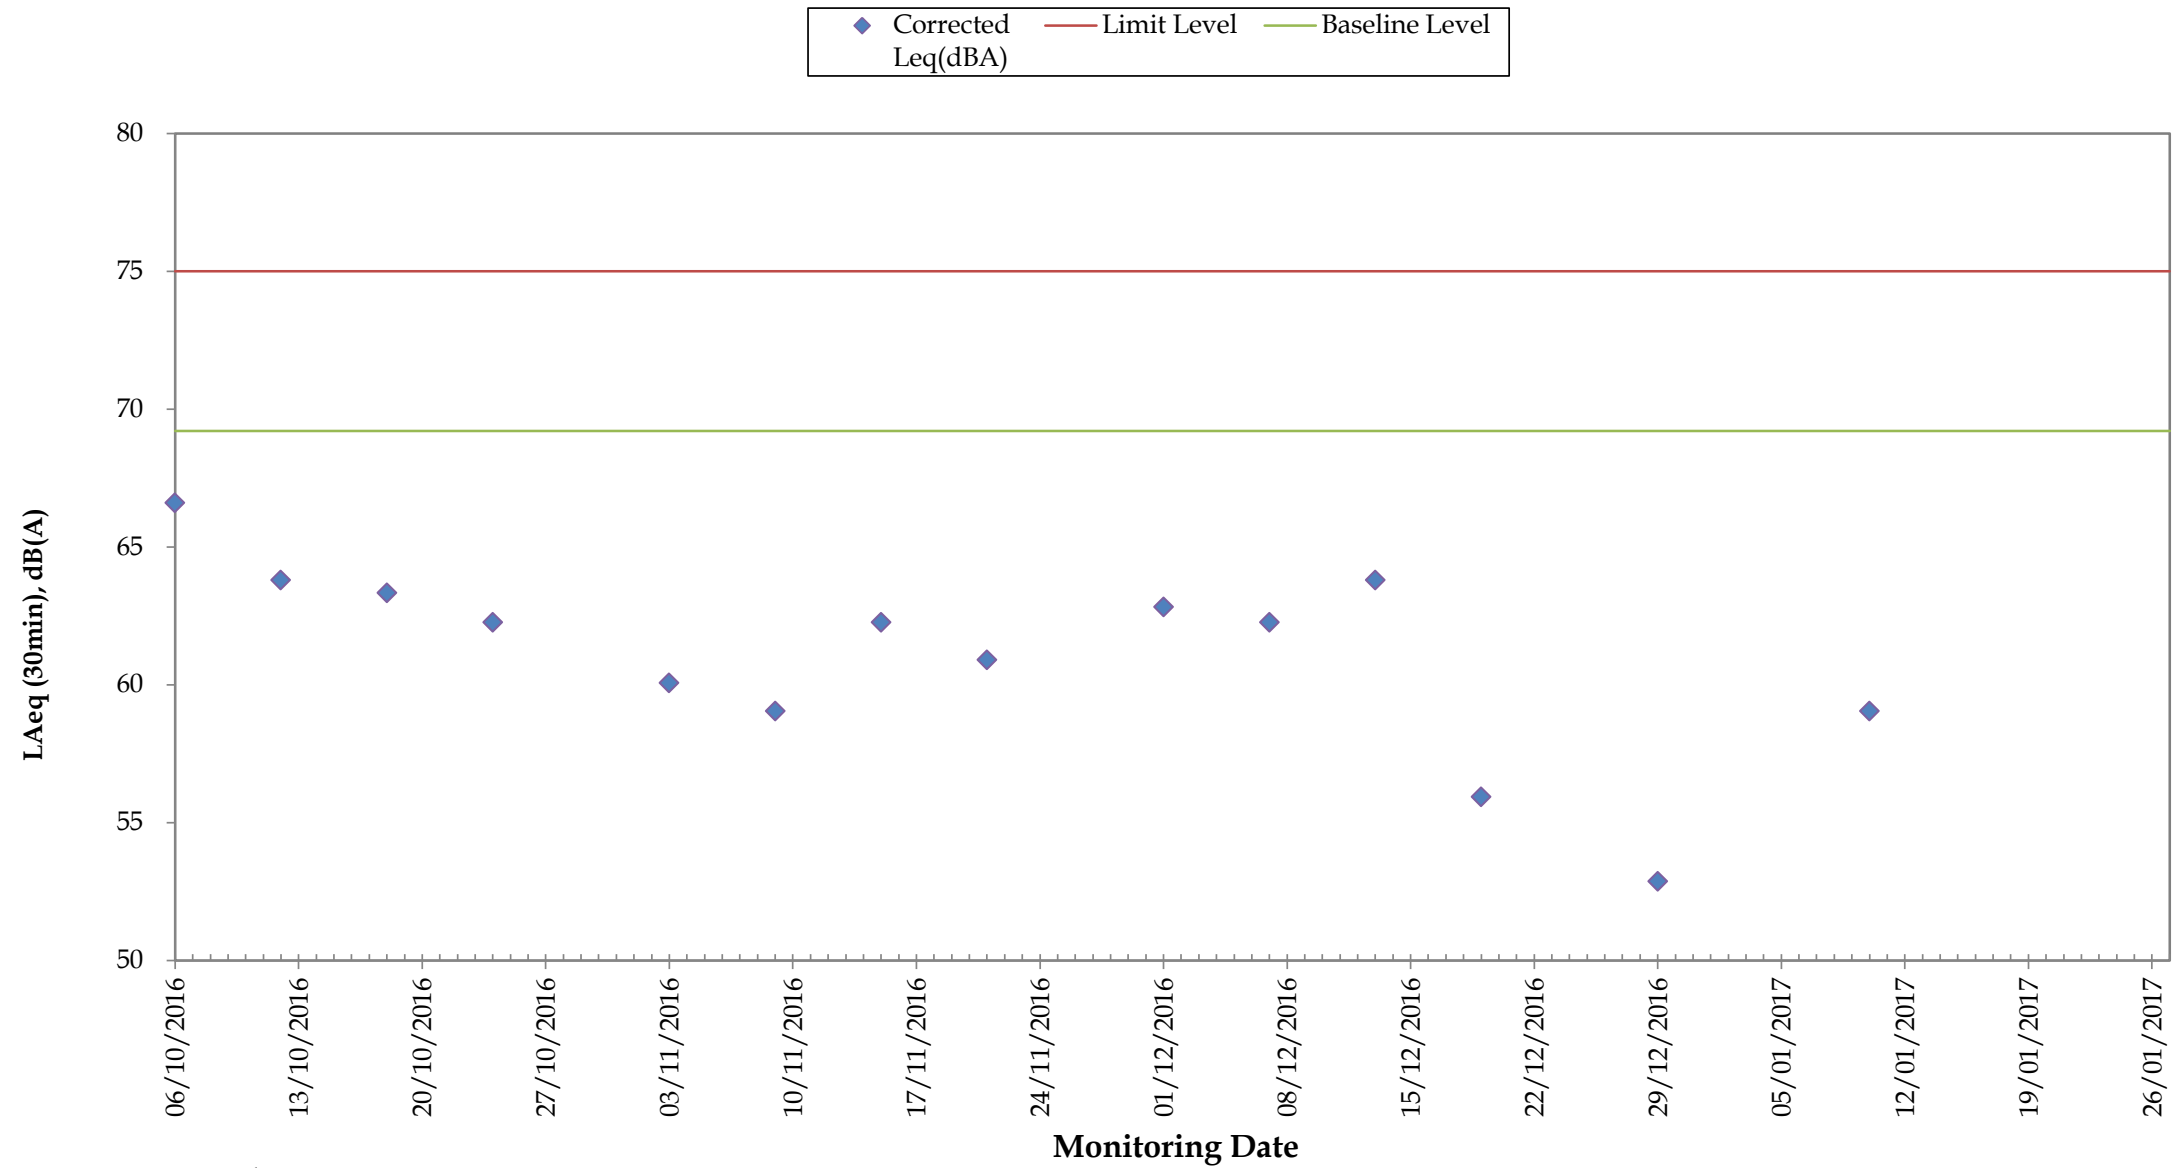
Regular Noise Monitoring Results at NMS-CA-9 (Kong Yiu Mansion) (LAeq, 30min)) for the Past 4 Months

- For those corrected noise levels that are not shown in this graph, the measured noise levels are equal to or below baseline level.

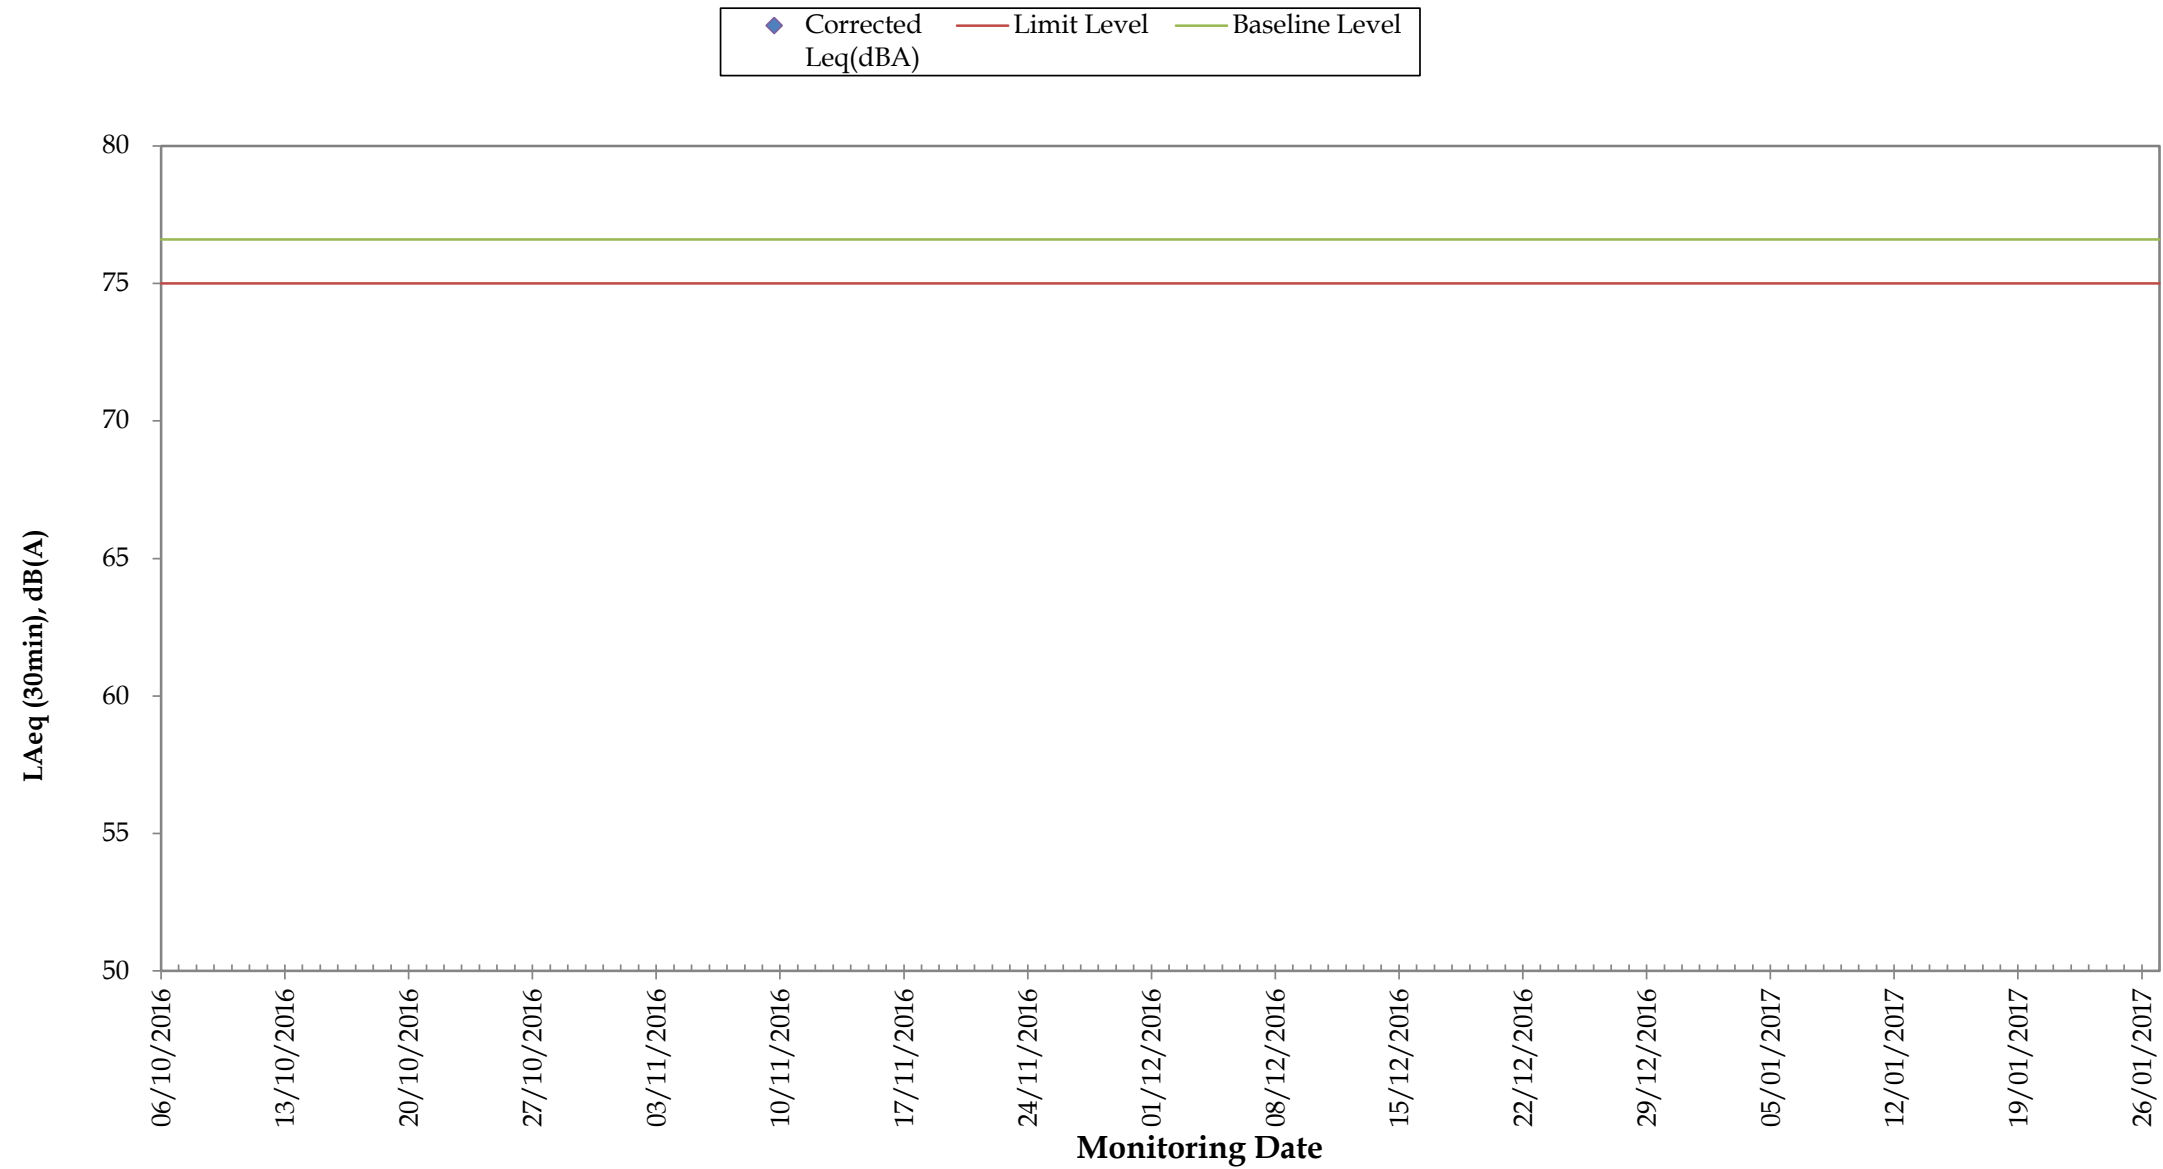
Regular Noise Monitoring Results at NMS-CA-10 (Chat Ma Mansion) (LAeq, 30min) for the Past 4 Months

- For those corrected noise levels that are not shown in this graph, the measured noise levels are equal to or below baseline level.

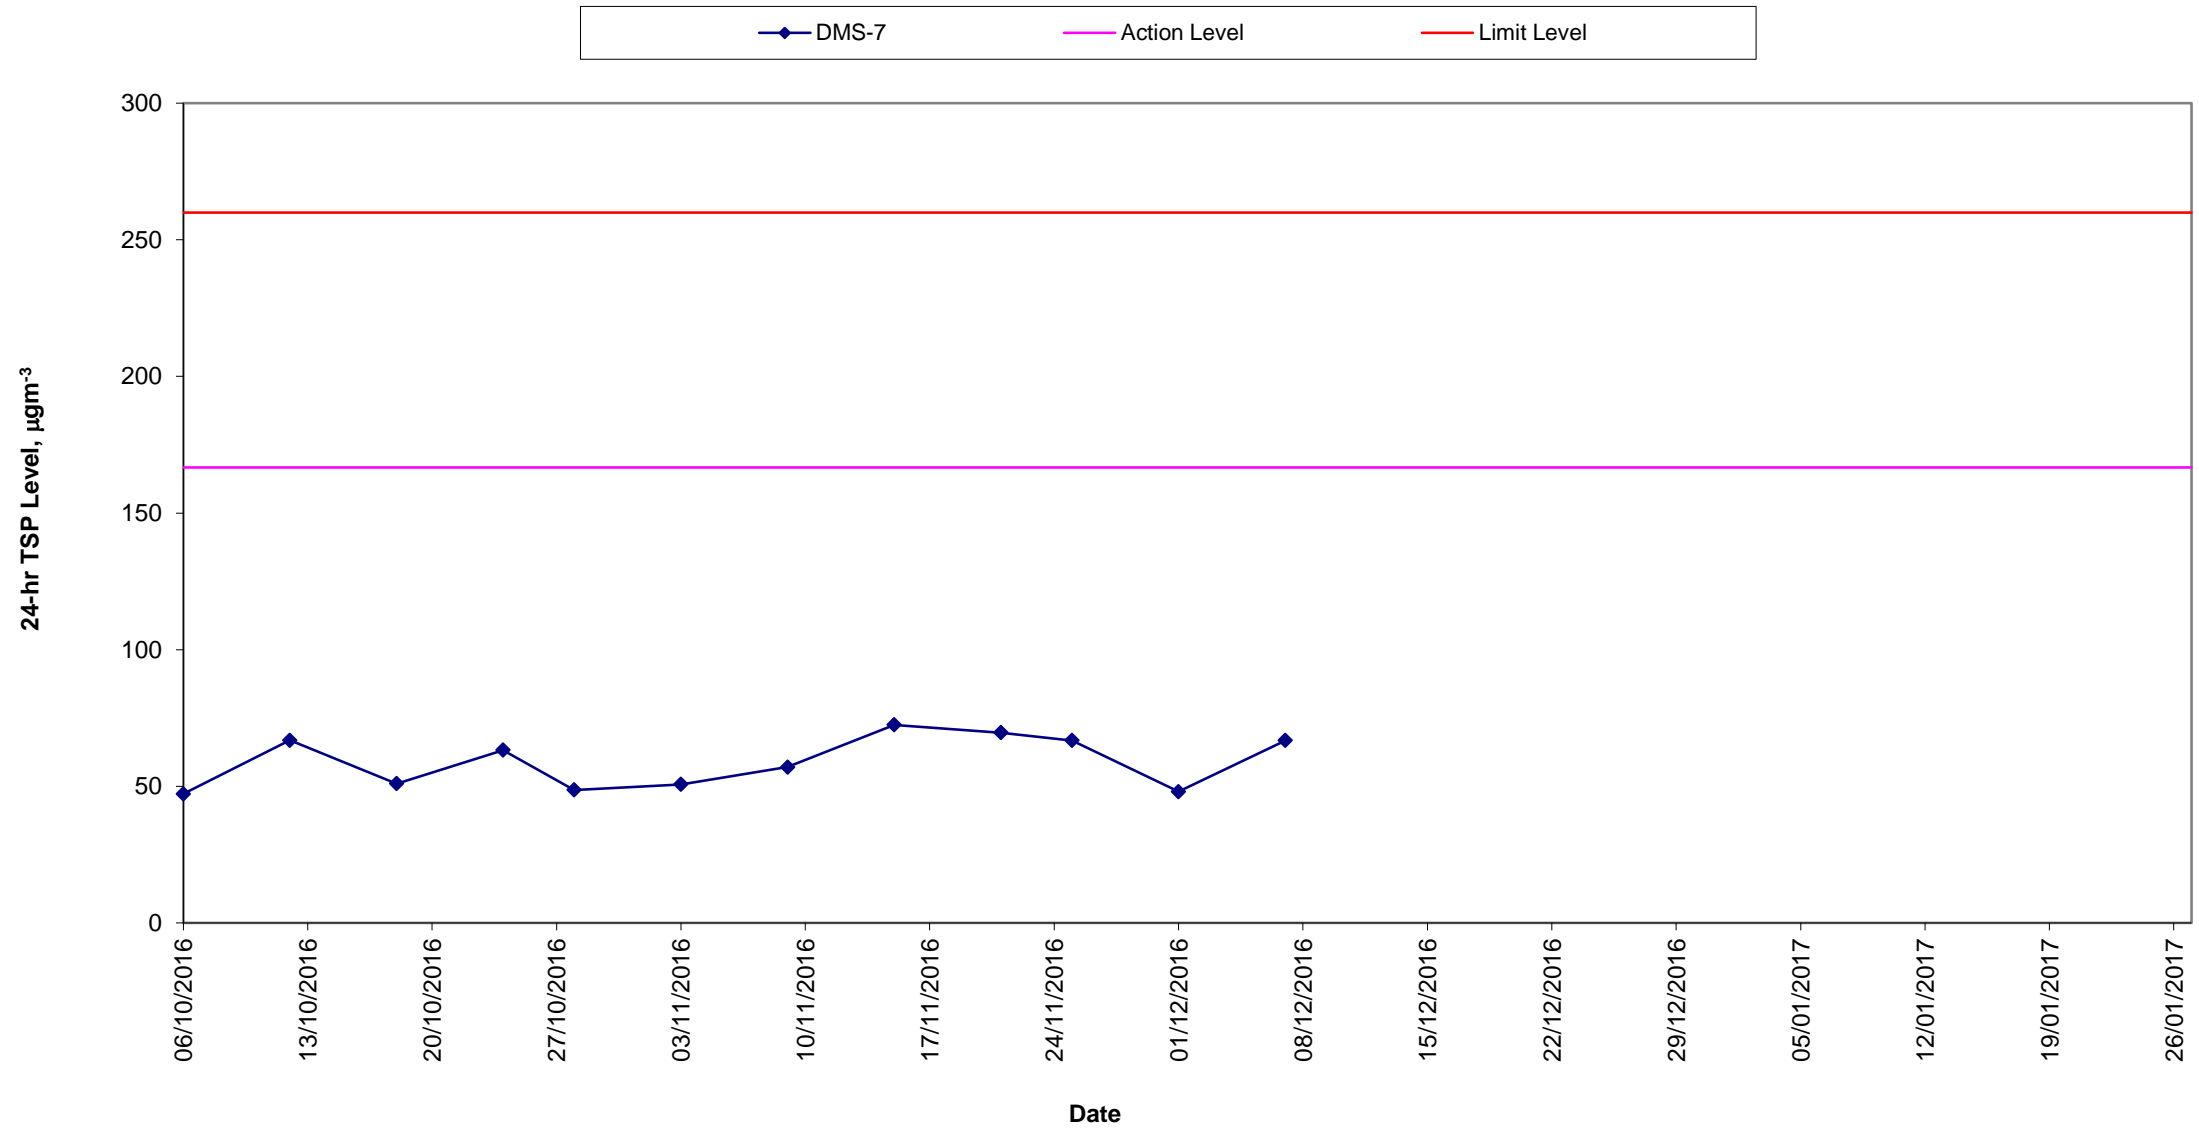
Construction Dust Monitoring Results for the Past 4 Months DMS- 7 (Parc 22)

- 24-hour averaged dust monitoring at DMS-7 (Parc-22) was temporary suspended since 13 December 2016 due to request from the Management Office.
