MTRCL Contract C3840-13C Tsim Sha Tsui Station
Carnarvon Road Subway and Entrances Modification Works

Monthly EM&A Report (January 2016)

Report No EB001340R00321

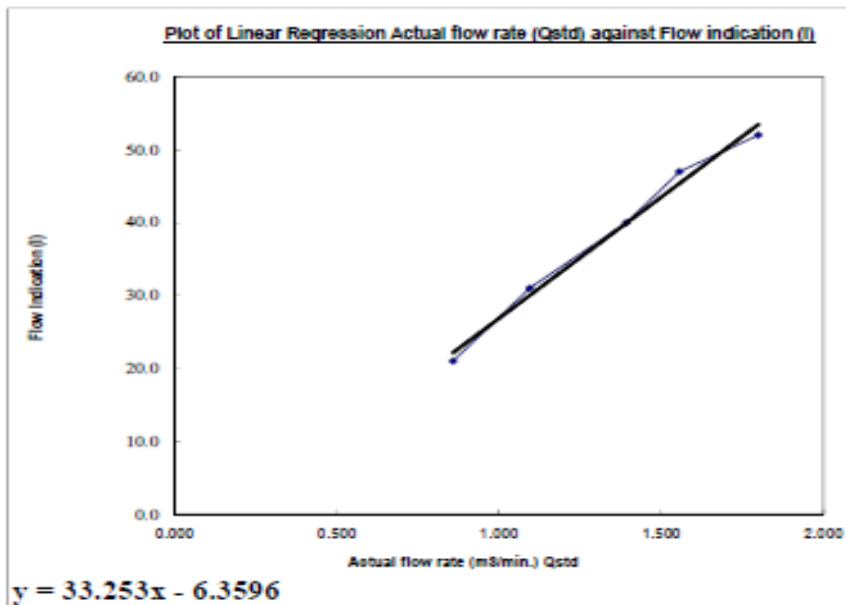
Sample no.	Pressure Drop (H), inch	Flow (corrected), m3/min	Actual flow rate (Qstd), m3/min	Flow indication (I), arbitrary
1	12.6	3.620	1.799	52.0
2	9.4	3.126	1.556	47.0
3	7.5	2.793	1.392	40.0
4	4.6	2.187	1.094	31.0
5	2.8	1.706	0.858	21.0

Correlation Coefficient : 0.9943

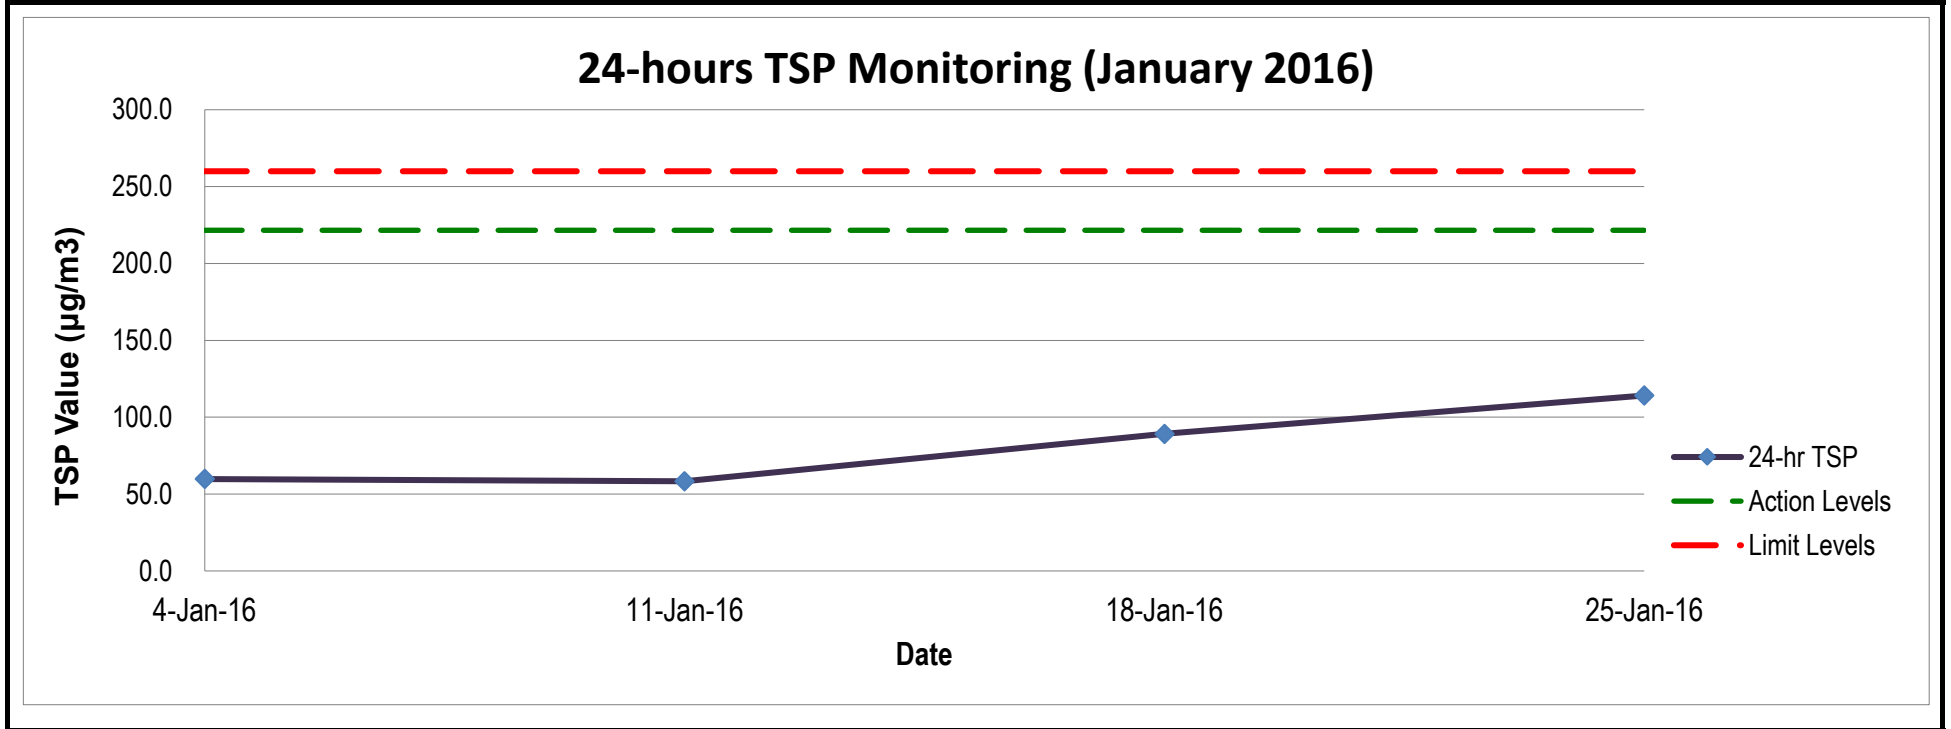
(A) Construction Air Quality Monitoring : 24-hour TSP

Location	Monitoring Date	Start Time (hh:mm)	Weather Conditions	Temperature (°C)	Elapse Time			Flow Rate (CFM)			Total Suspended Particulates (µg/m ³)	
					Initial	Final	Sampling Hours	Initial	Final	Average	Results	Action/Limit Levels
K11 Art Mall	4-Jan-16	9:20	Rainy	16.0	627478	629936	24	39	41	40	59.8	221.6/260
	11-Jan-16	9:24	Overcast	16.8	629936	632392	24	38	39	39	58.3	221.6/260
	18-Jan-16	10:27	Cloudy	15.8	632392	634849	24	38	39	39	89.2	221.6/260
	25-Jan-16	10:31	Cloudy	19.2	634849	637305	24	39	40	40	114.1	221.6/260
