MTRCL Contract C3840-13C Tsim Sha Tsui Station
Carnarvon Road Subway and Entrances Modification Works

Monthly EM&A Report (March 2016)

Report No EB001340R00354

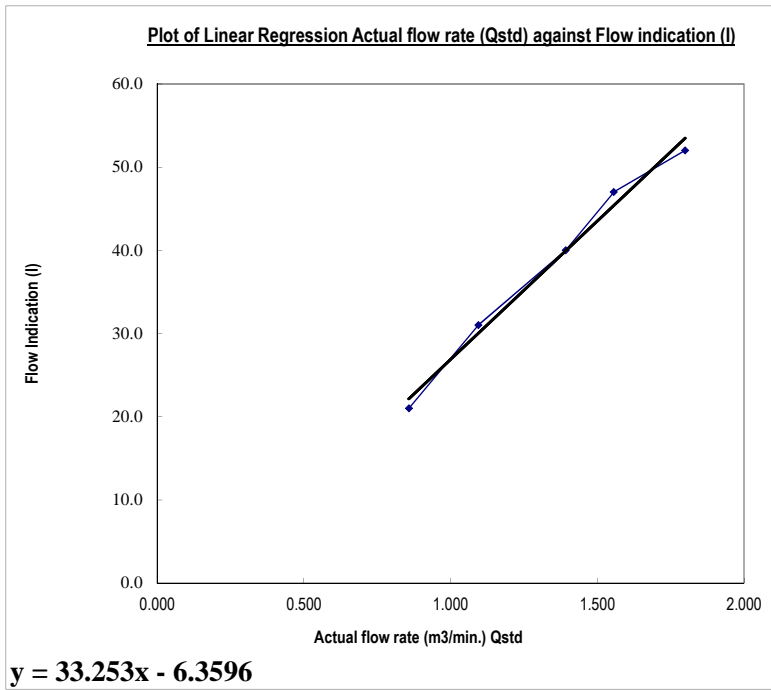
High Volume Air Sampler Calibration Worksheet

Project Title: MTR Tsim Sha Tsui Station Carnarvon Road Subway and Entrances
 Modification Works
 Monitoring Location: K11 Commercial Complex
 Calibration Date: 18-Dec-15
 Calibration Due Date: 18-Mar-16
 Time: 16:15

Sample no.	Pressure Drop (H), inch	Flow (corrected), m3/min	Actual flow rate (Qstd), m3/min	Flow indication (I), arbitrary
1	12.6	3.620	1.799	52.0
2	9.4	3.126	1.556	47.0
3	7.5	2.793	1.392	40.0
4	4.6	2.187	1.094	31.0
5	2.8	1.706	0.858	21.0

Correlation Coefficient : 0.9943
