MTRCL Contract C3840-13C Tsim Sha Tsui Station
Carnarvon Road Subway and Entrances Modification Works

Monthly EM&A Report (April 2016)

Report No EB001340R00361

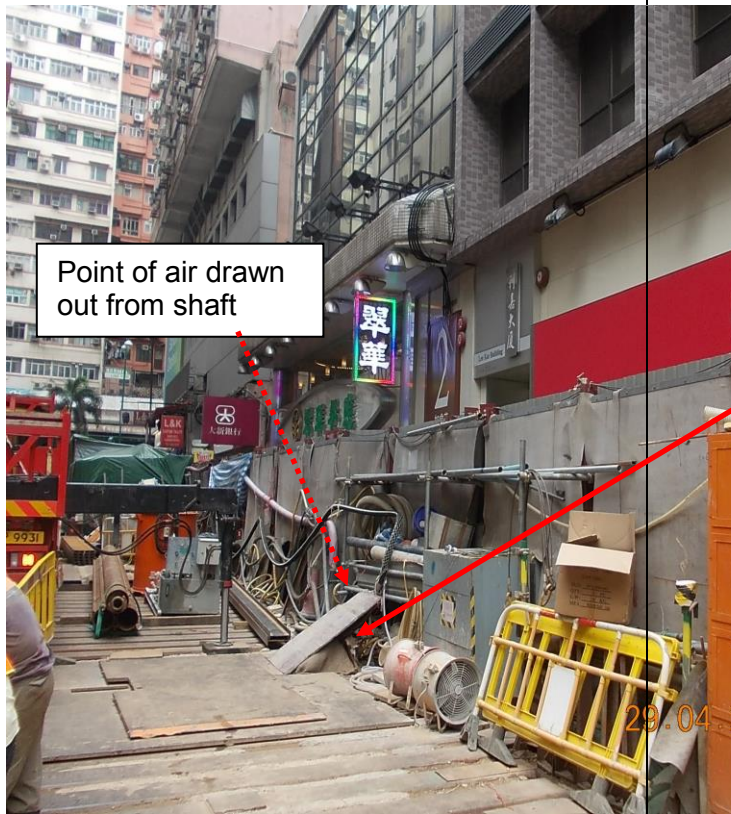
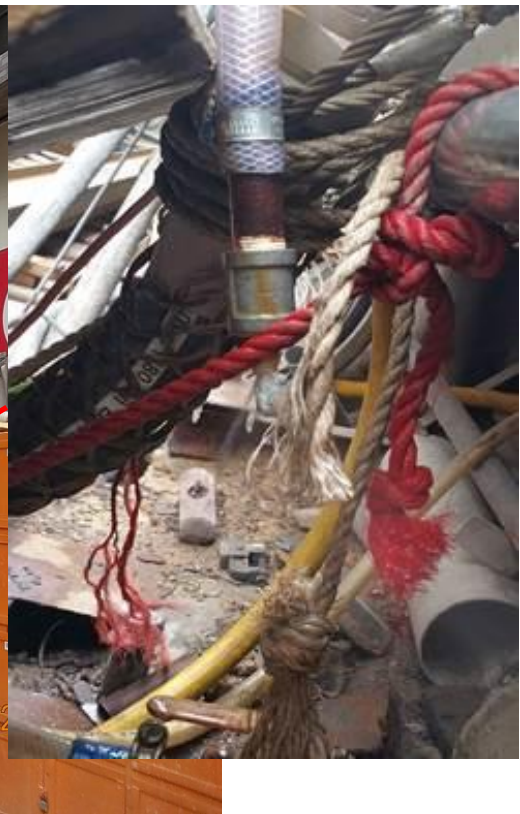
Photo 3

Close-up of Mist diffuser

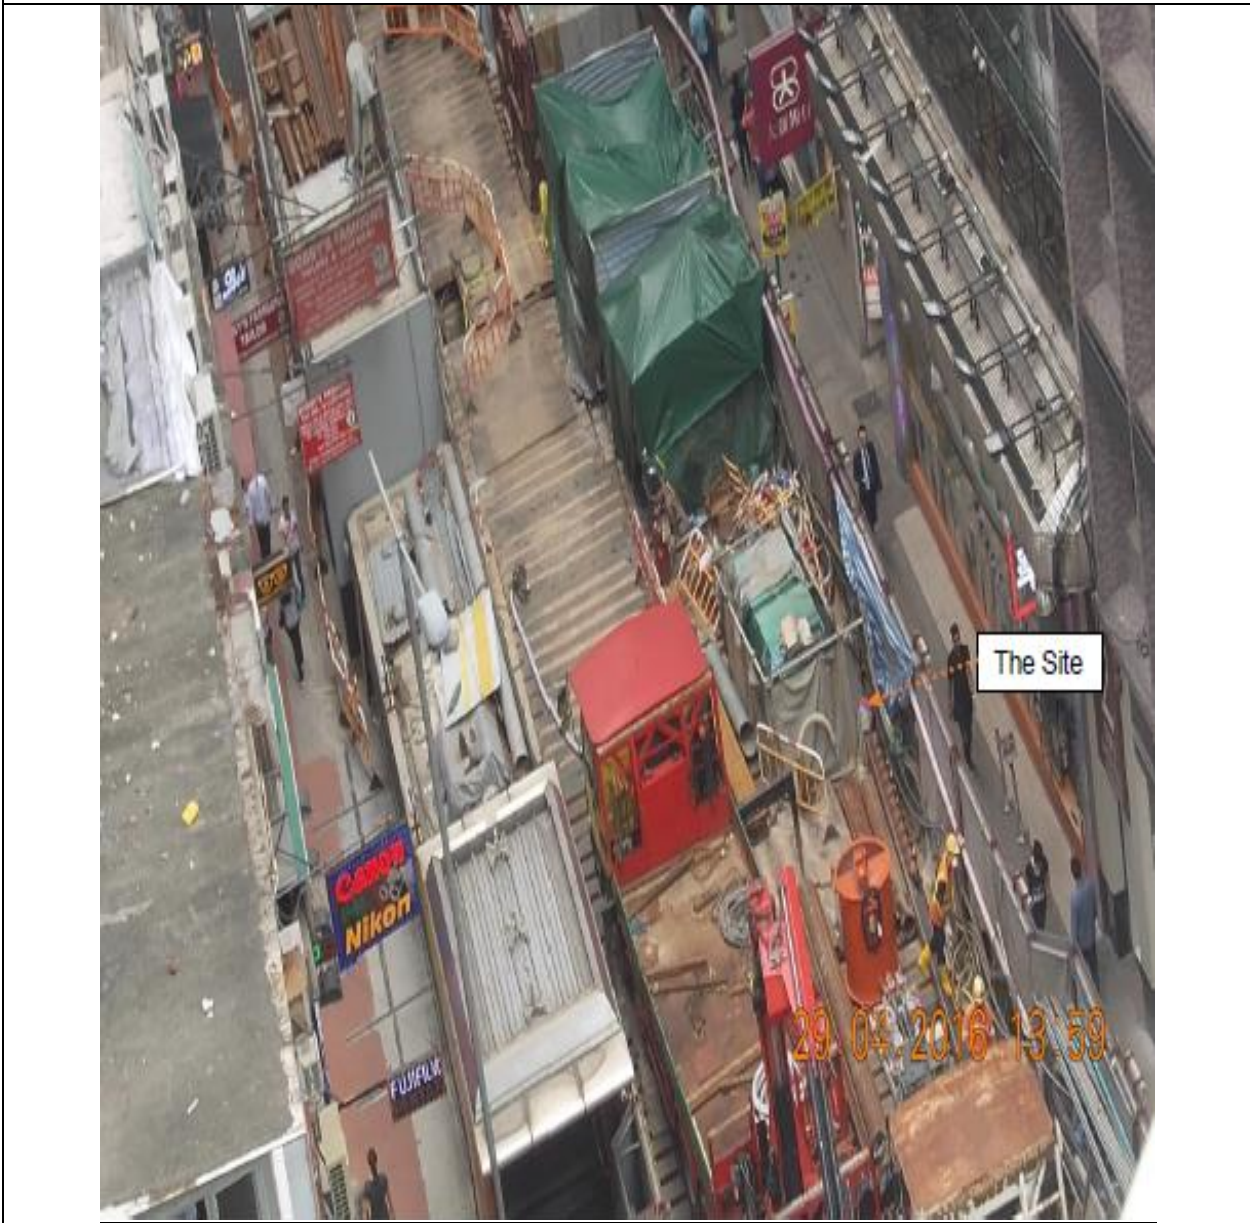
Photo 8 Free of construction dust within the site as a result of implementation of effective dust suppression measures
