MTRCL Contract C3840-13C Tsim Sha Tsui
Station Carnarvon Road Subway and Entrances
Modification Works

Monthly EM&A Report (August 2016)

Report No EB001340R00414

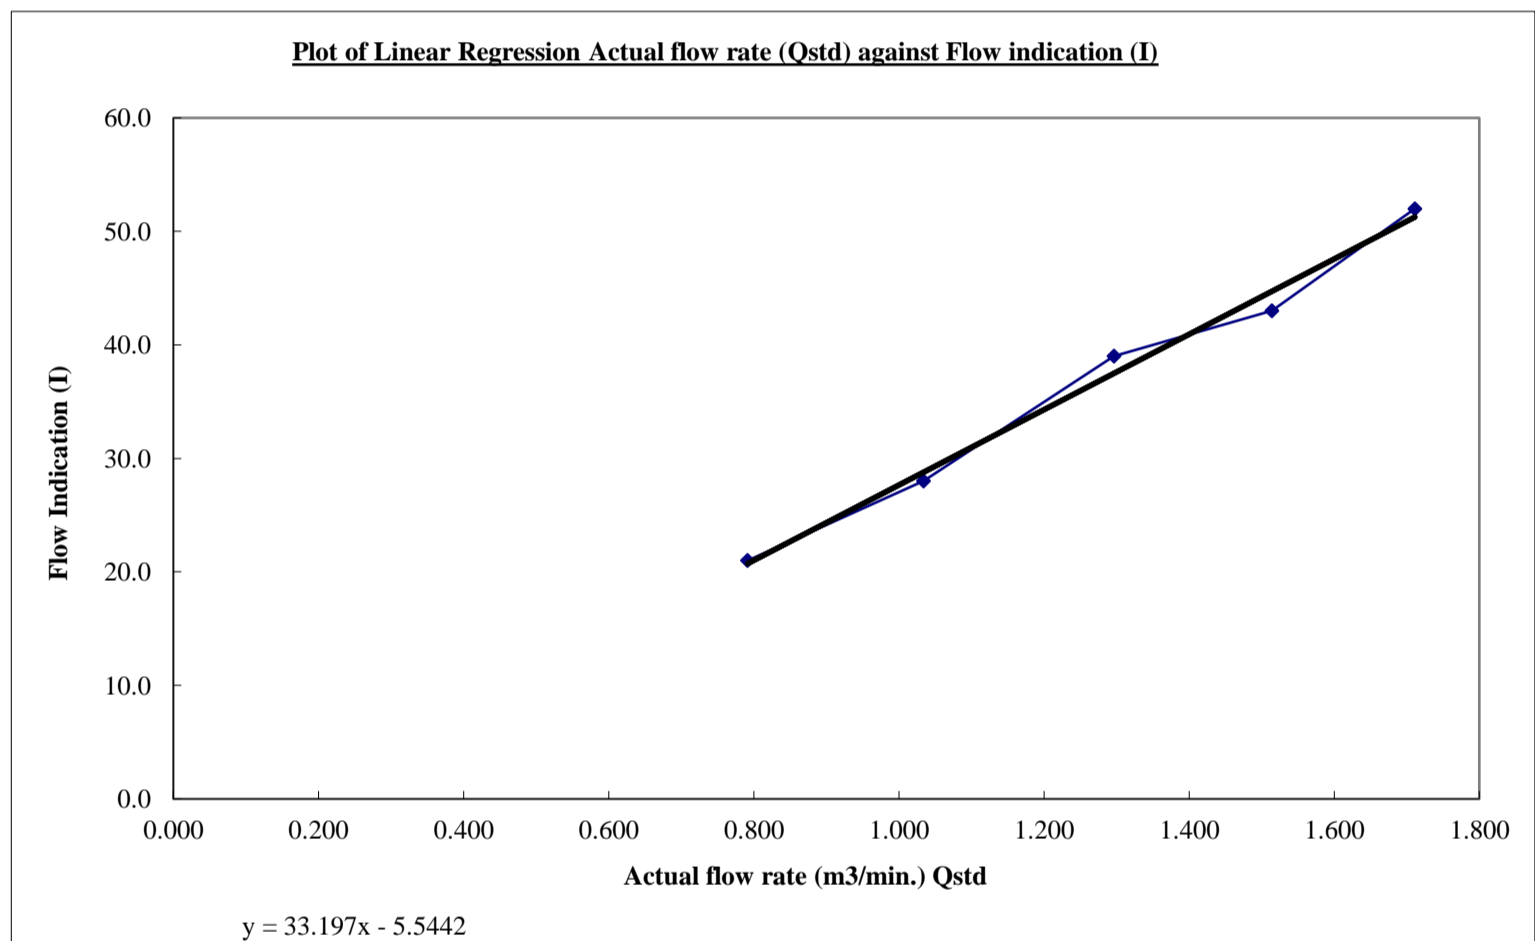
Sample no.	Pressure Drop (H), inch	Flow (corrected), m ³ /min	Actual flow rate (Qstd), m ³ /min	Flow indication (I), arbitrary
1	11.9	3.404	1.711	52.0
2	9.3	3.009	1.514	43.0
3	6.8	2.573	1.297	39.0
4	4.3	2.046	1.034	28.0
5	2.5	1.560	0.792	21.0

Correlation Coefficient : 0.9946
