MONTHLY REPORT (FEBRUARY 2017)

MTRCL Contract C3840-13C

Tsim Sha Tsui Station Carnarvon Road Subway
and Entrances Modification Works

Report No EB001340R0491

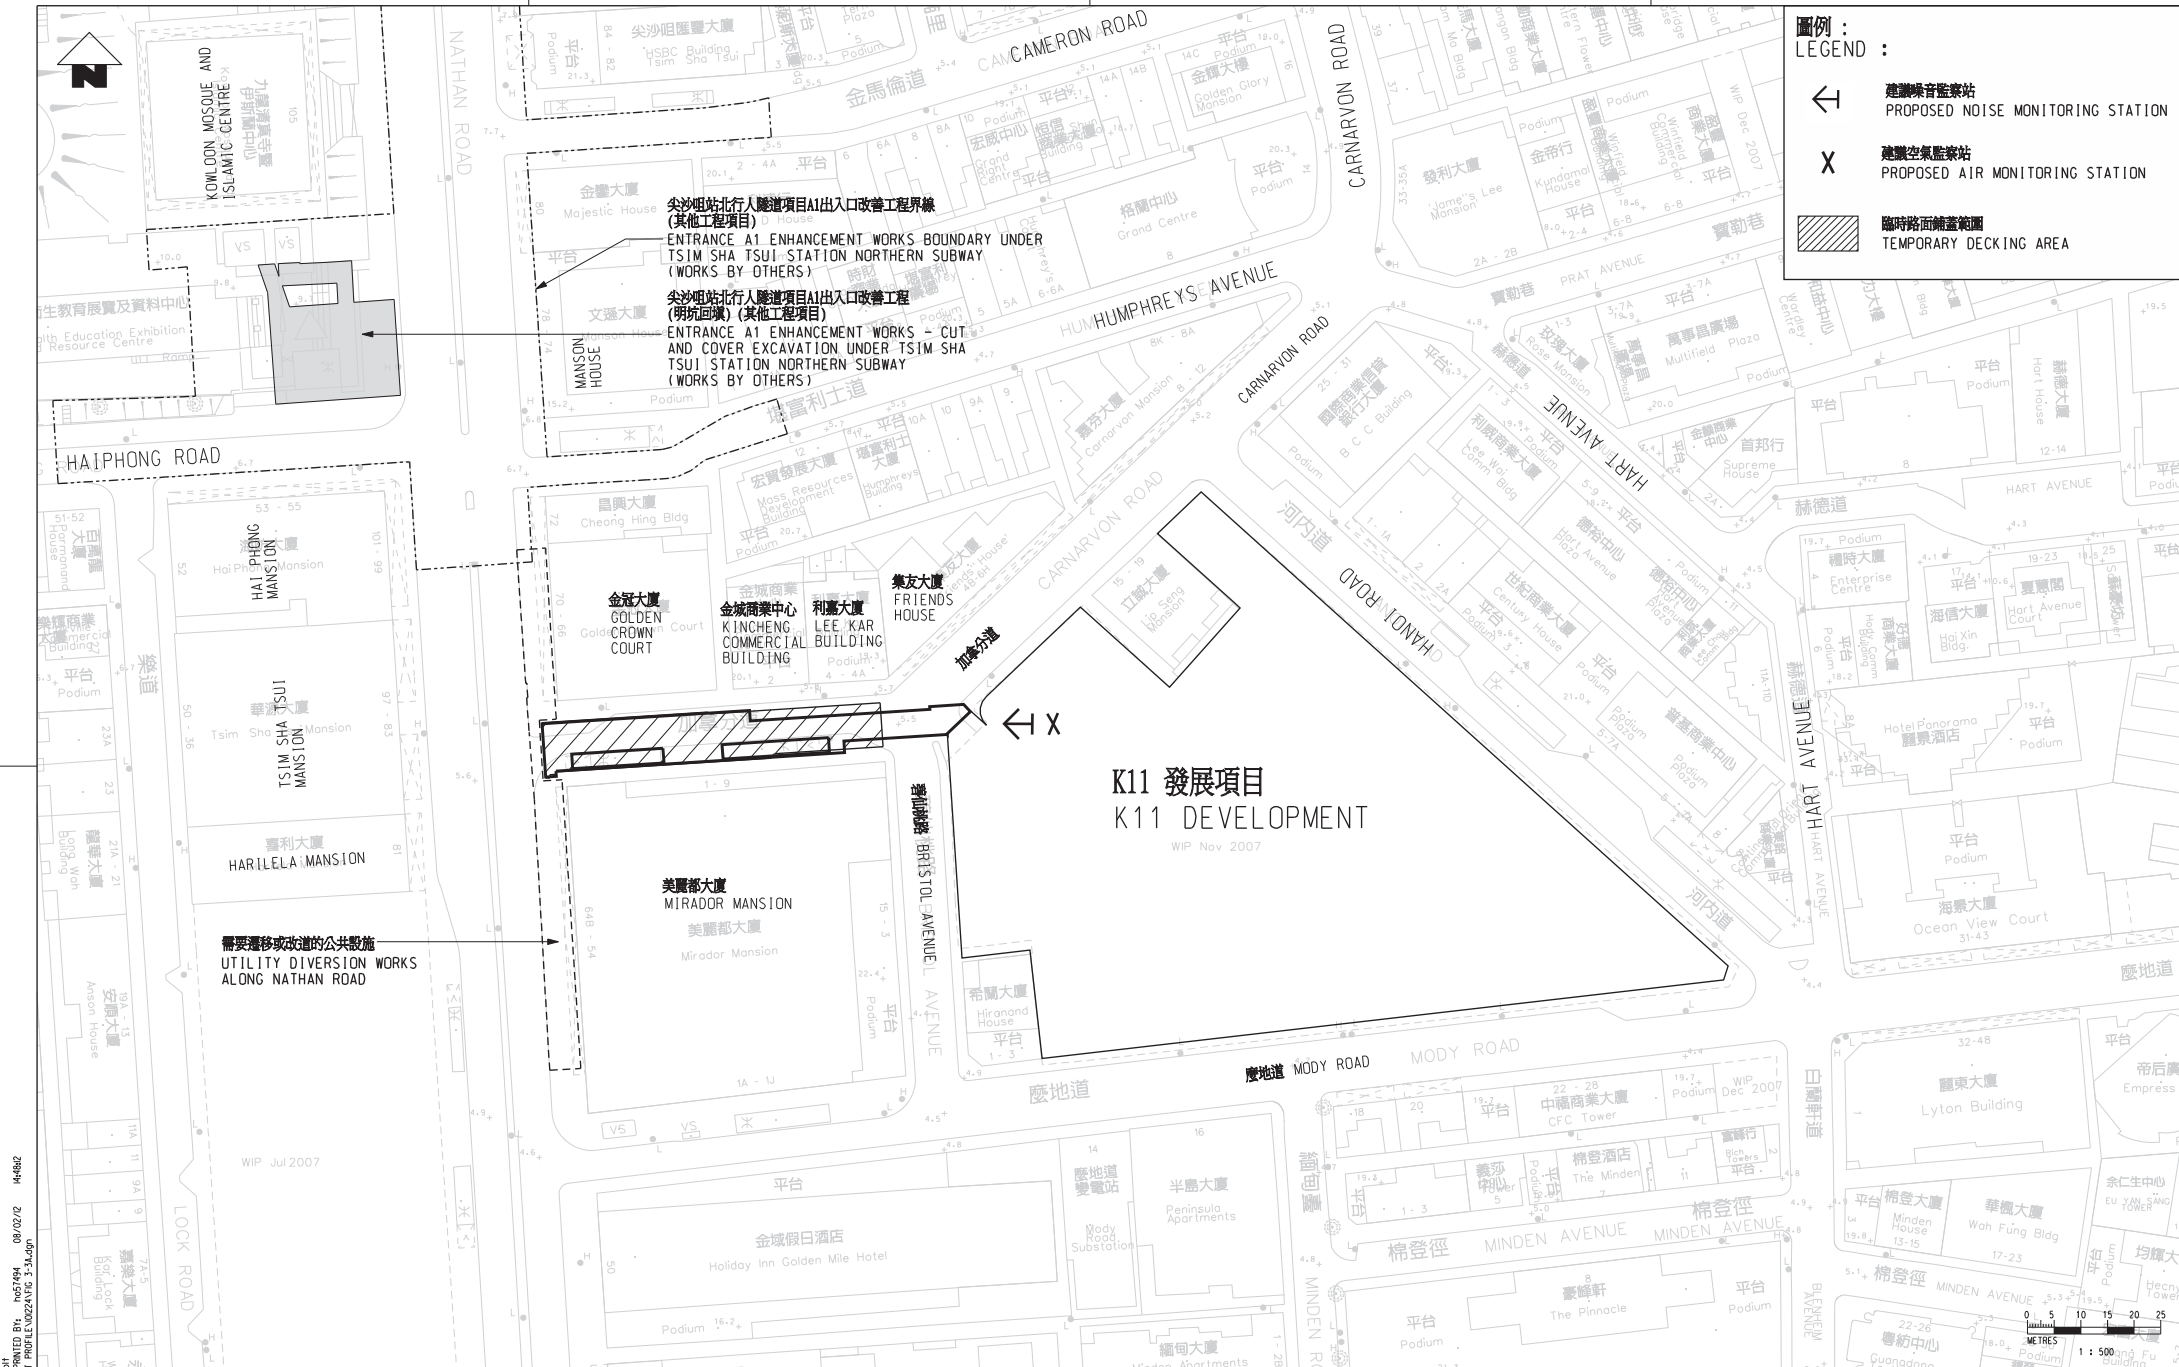
APPENDIX A
SITE LOCATION PLAN

← 建議噪音監察站
 PROPOSED NOISE MONITORING STATION
