MONTHLY REPORT (OCTOBER 2017)

MTRCL Contract C3840-13C

Tsim Sha Tsui Station Carnarvon Road Subway
and Entrances Modification Works

Monthly EM&A Report (OCTOBER 2017)

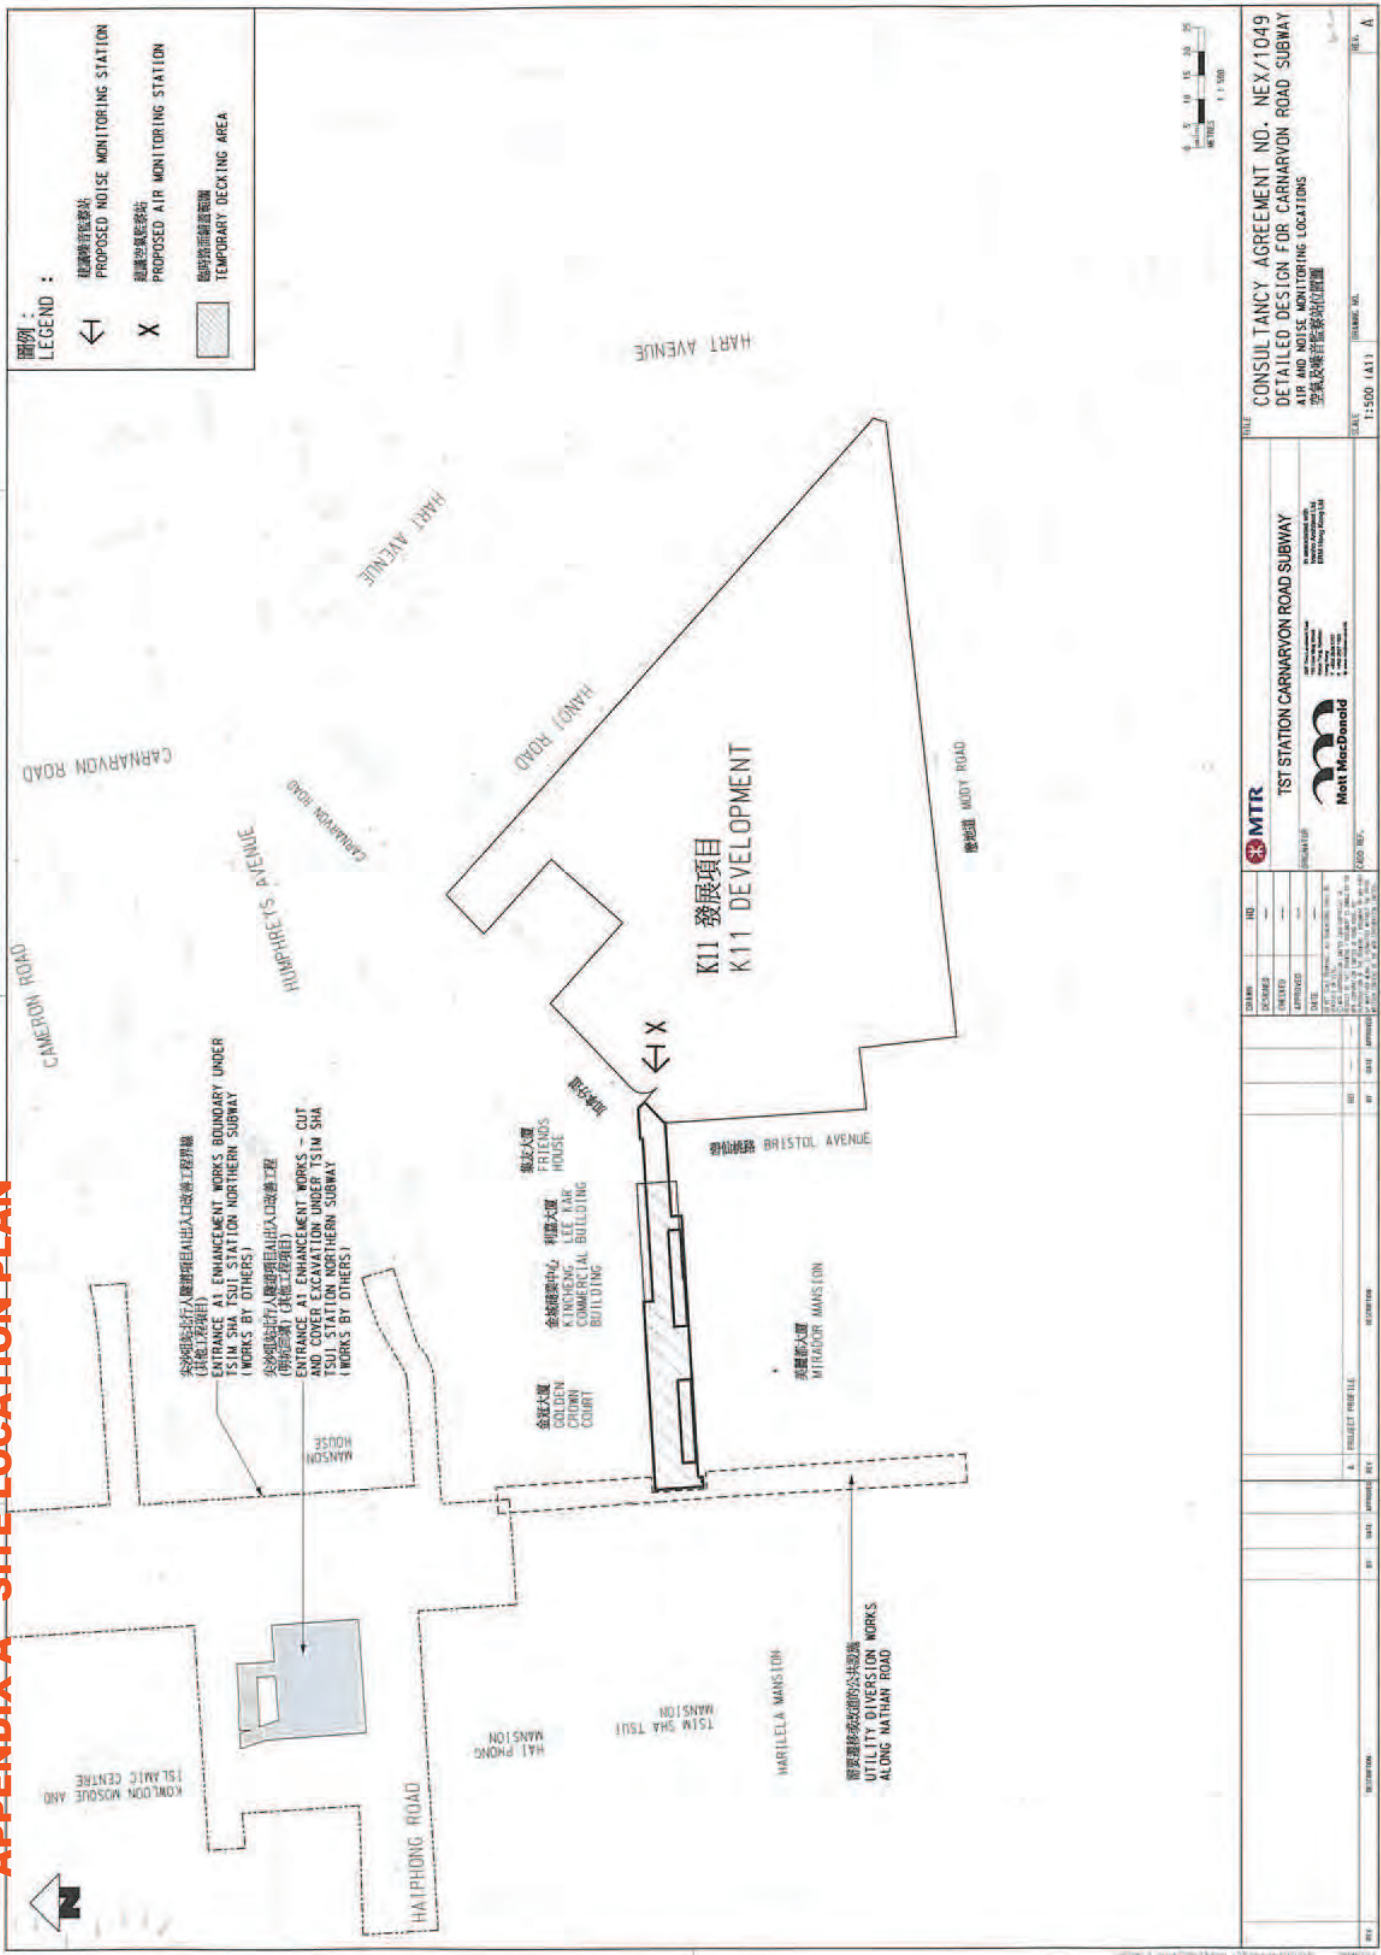
APPENDIX A SITE LOCATION PLAN

- 圖例：
- LEGEND :
- 建議噪音站
PROPOSED NOISE MONITORING STATION
 - 建議空氣站
PROPOSED AIR MONITORING STATION
 - 臨時路面設置範圍
TEMPORARY DECKING AREA

2.2.5 **Table 2-2-3** summarizes the recommended alternative noise monitoring location, which is illustrated in **Appendix A**.

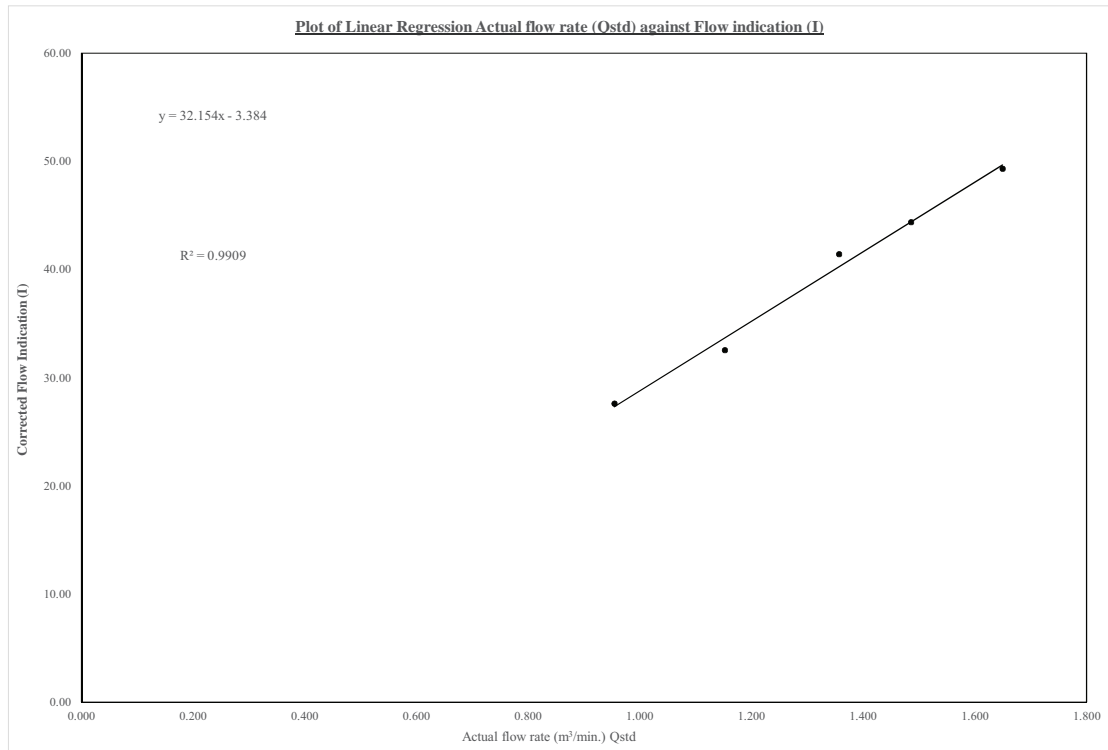
$$IC = I(\sqrt{(Pa/Pstd)(Tstd/Ta)})$$

Qstd = actual flow rate as indicated by the calibrator orifice
H₂O = orifice manometer reading during calibration
Ta = ambient temperature during calibration, K = 273 + °C
Tstd = standard temperature, a constant that never changes, 298 K
Pa = ambient barometric pressure during calibration, mmHg
Pstd = standard barometric pressure, a constant that never changes, 760 mm Hg
m = Qstandard slope of orifice calibrator relationship
b = Qstandard intercept of orifice calibrator relationship
IC = continuous flow recorder readings corrected to current Ta and Pa
I = continuous flow recorder readings during calibration

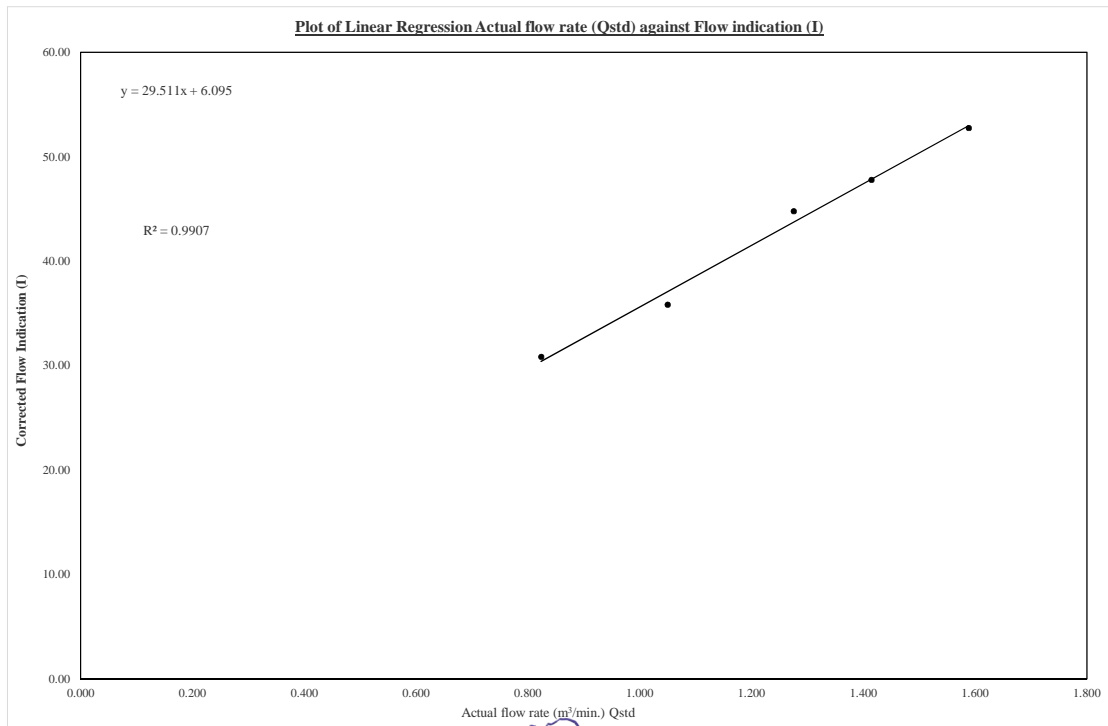
$$IC = I[\text{Sqrt}((Pa/Pstd)(Tstd/Ta))]$$

Qstd = actual flow rate as indicated by the calibrator orifice
 H2O = orifice manometer reading during calibration
 Ta = ambient temperature during calibration, K = 273 + °C
 Tstd = standard temperature, a constant that never changes, 298 K
 Pa = ambient barometric pressure during calibration, mmHg
 Pstd = standard barometric pressure, a constant that never changes, 760 mm Hg
 m = Qstandard slope of orifice calibrator relationship
 b = Qstandard intercept of orifice calibrator relationship
 IC = continuous flow recorder readings corrected to current Ta and Pa
 I = continuous flow recorder readings during calibration

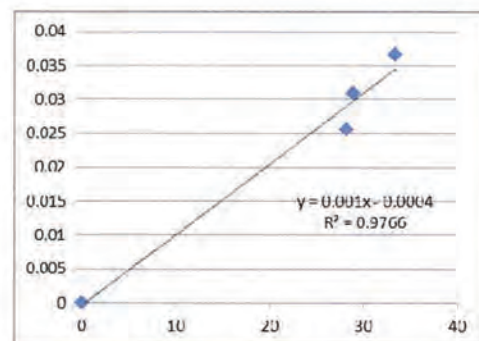
Linear Regression of Y or X

Slope (K-factor): 0.0010
Correlation Coefficient 0.9882
Date of Issue 20 March 2017

- Strong** Correlation ($R > 0.8$)
 - Factor 0.0010 should be apply for TSP monitoring
- *If $R < 0.5$, repair or re-verification is required for the equipment

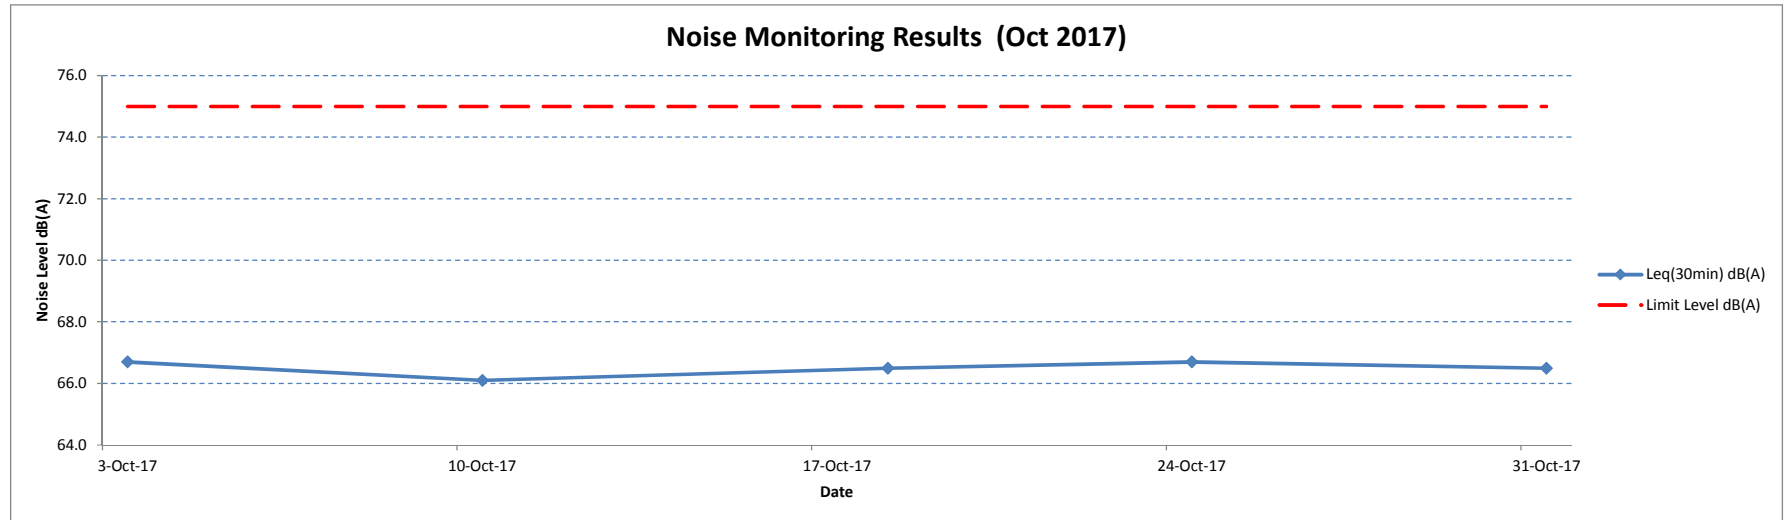
Monitoring Locations	Date	Weather Conditions	Wind Speed (m/s)	Start Time	End Time	Background Level dB(A)	Limit Level dB(A)	Leq(30min) dB(A)	L10(30min) dB(A)	L90(30min) dB(A)
K11 Art Mall	3-Oct-17	Fine	0.0	10:04	10:34	65.3	75	66.7	68.5	64.0
	10-Oct-17	Fine	2.1	10:18	10:48	65.3	75	66.1	67.0	64.5
	18-Oct-17	Fine	0.1	10:12	10:42	65.3	75	66.5	68.0	64.5
	24-Oct-17	Fine	0.3	10:03	10:33	65.3	75	66.7	67.5	65.0
	31-Oct-17	Fine	3.4	9:47	10:17	65.3	75	66.5	68.0	63.5

Red Bold indicates an exceedance of Limit Level

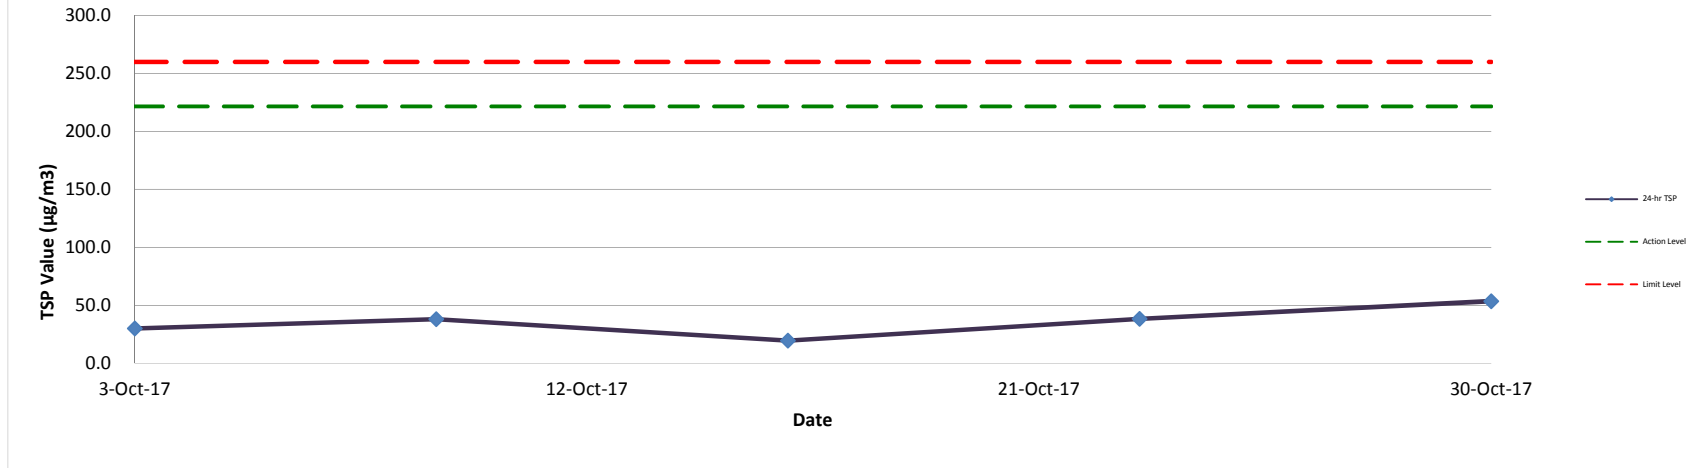
24-hours TSP Monitoring (Oct 2017)

Impact Air Quality Monitoring : 24-hour TSP at K11

Location	Monitoring Date	Start Time	Weather Conditions	Temperature	Elapse Time		Flow Rate (CFM)			Average Flow Rate	TSP Concentration (µg/m3)	Action/Limit Levels
					Initial	Final	Sampling Hours	Initial	Final			
K11 Art Mall	3-Oct-17	8:30	Fine	29.2	8615.09	8641.39	26.3	37	37	37	30.1	221.6/260
	9-Oct-17	8:20	Fine	29.0	8641.39	8668.19	26.8	30	36	33	38.2	221.6/260
	16-Oct-17	8:30	Overcast	26.2	8668.19	8694.96	26.8	29	30	30	19.6	221.6/260
	23-Oct-17	8:40	Fine	22.3	8694.96	8721.81	26.9	30	30	30	38.5	221.6/260
	30-Oct-17	8:45	Fine	20.5	8721.81	8748.65	26.8	23	28	26	53.7	221.6/260
