Trunk Road T2

Monthly Environmental Monitoring and Audit Report

(under EP-451/2013)

May 2022
(Version 1.0)

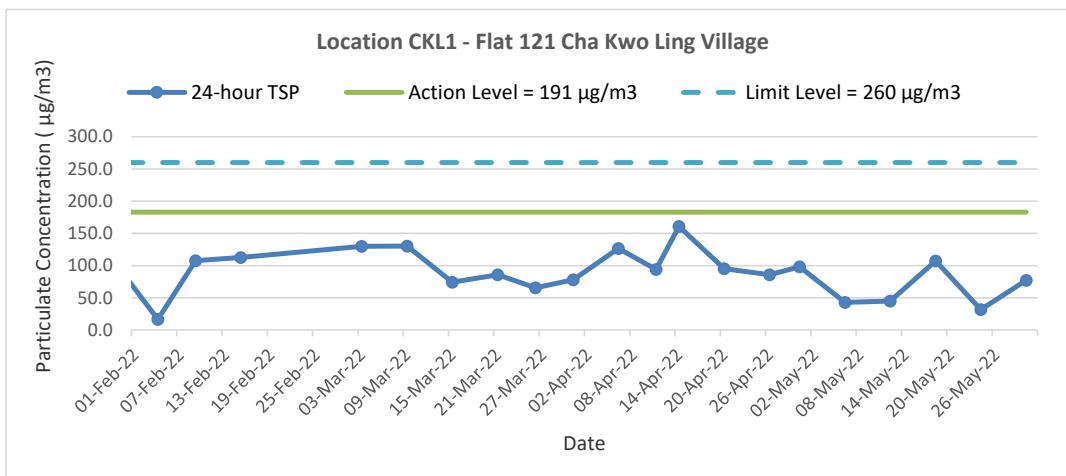
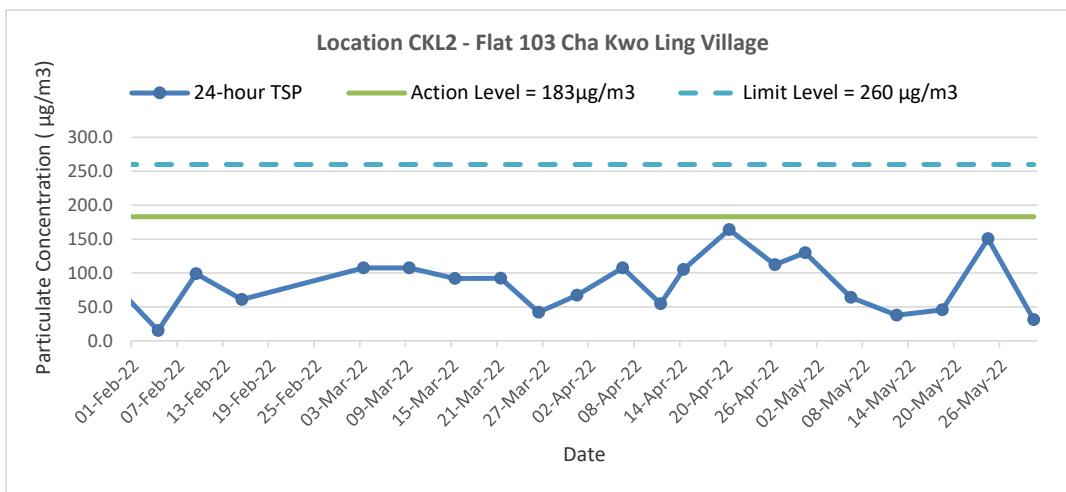
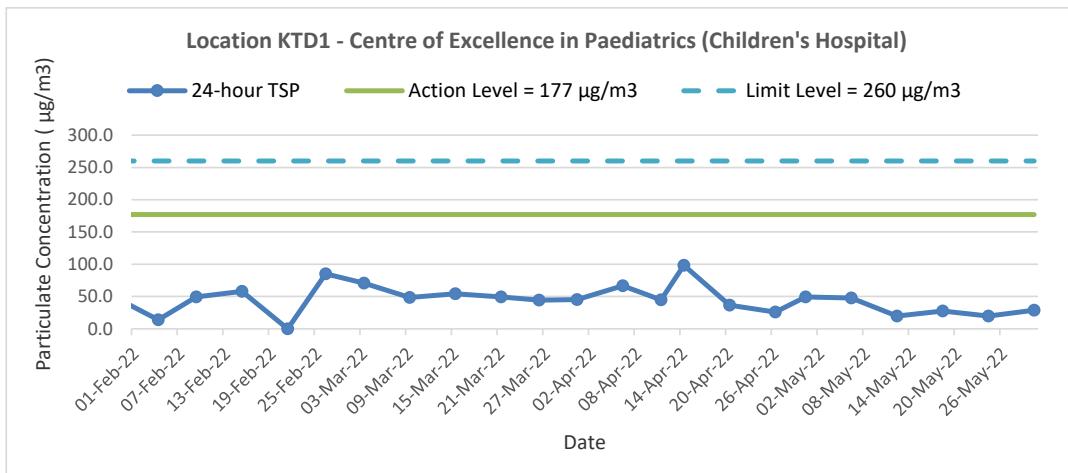
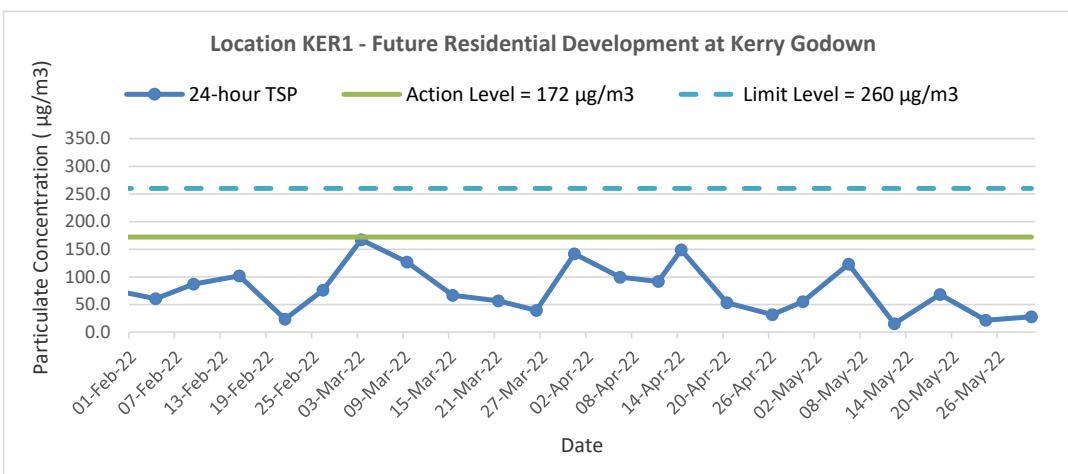
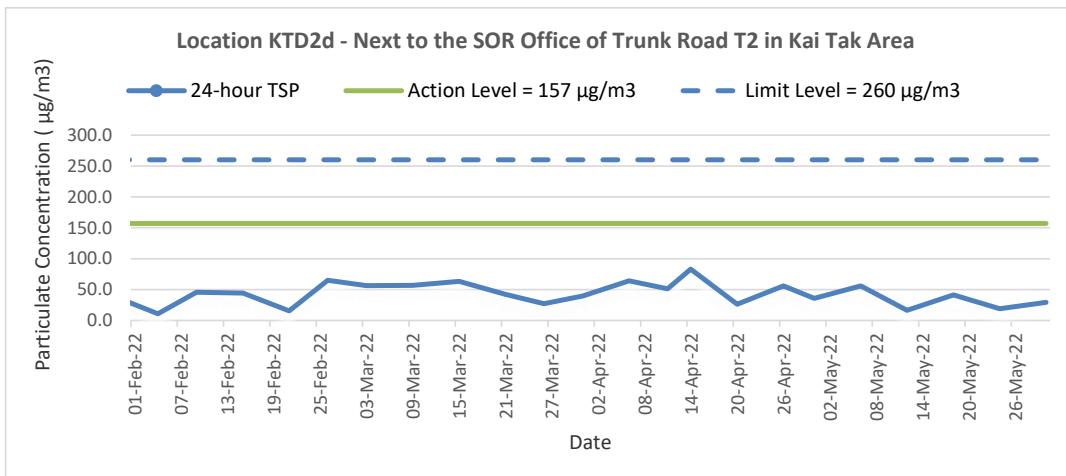
24-hr TSP Concentration Levels

Due to the site closure at CKL portion during the period from 20 Feb 2022 to 27 Feb 2022, monitoring works at station CKL1 and CKL2 were temporary suspended.

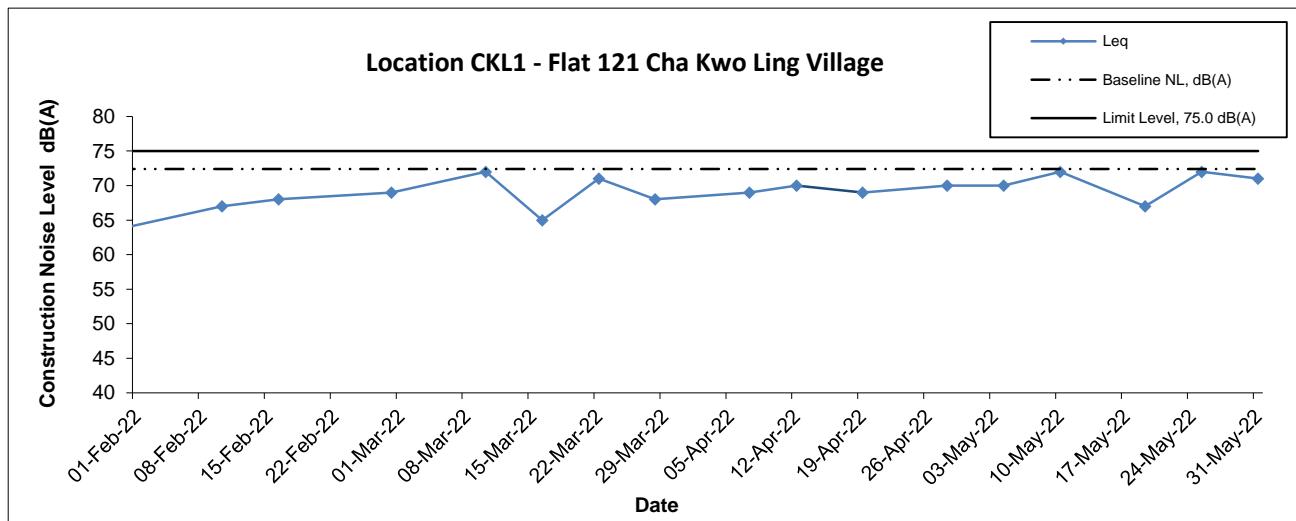
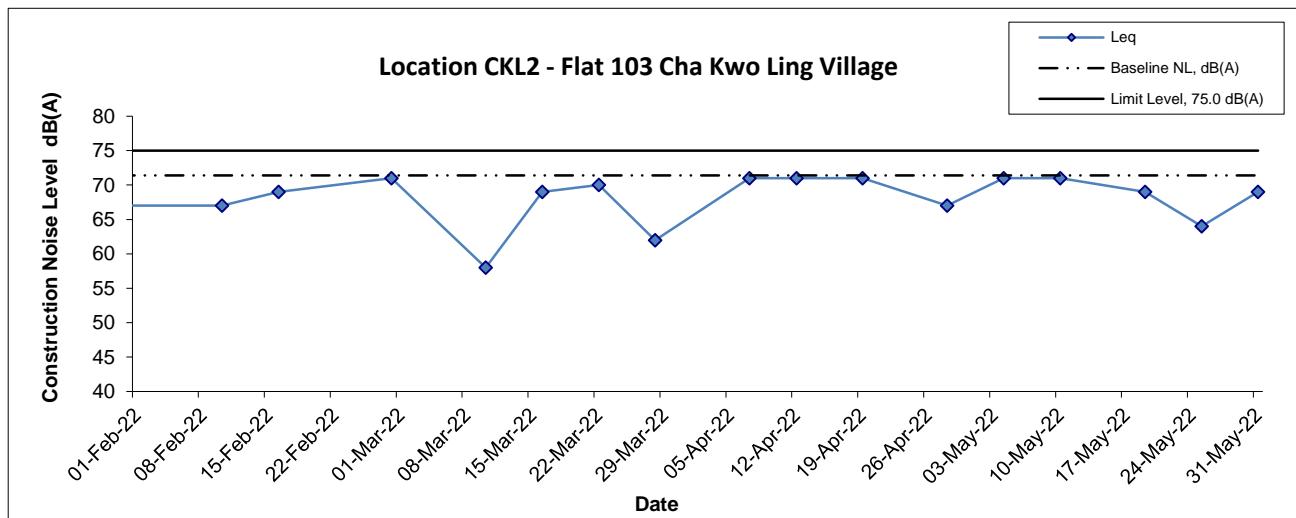
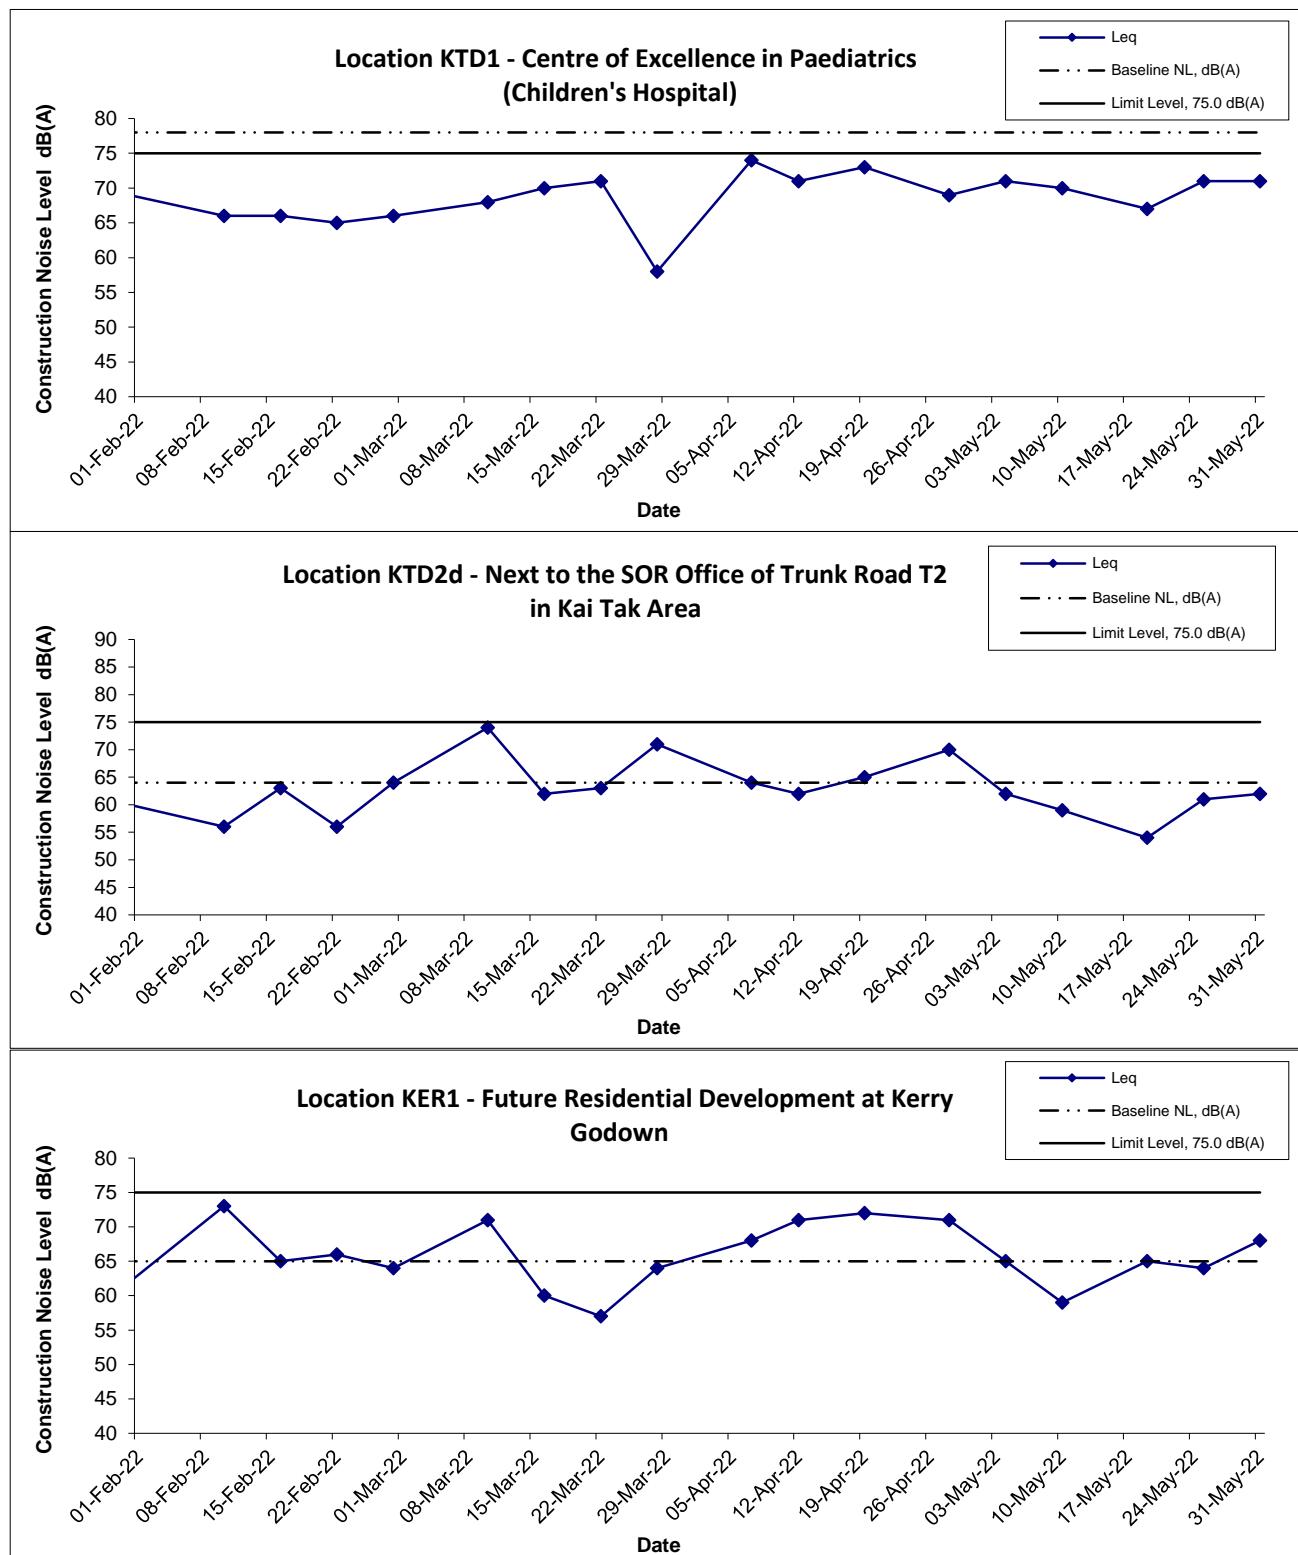
Noise Levels

Due to the site closure at CKL portion during the period from 20 Feb 2022 to 27 Feb 2022, monitoring works at station CKL1 and CKL2 were temporary suspended.
