Trunk Road T2 Monthly Environmental Monitoring and Audit Report (under EP-451/2013)

April 2023

**Re: Agreement No. EDO 01/2019
Independent Environmental Checker for
Contract No. ED/2018/04 – Trunk Road T2 and Infrastructure Works for
Developments at the Former South Apron**

Monthly EM&A Report (April 2023) for EP-451/2013

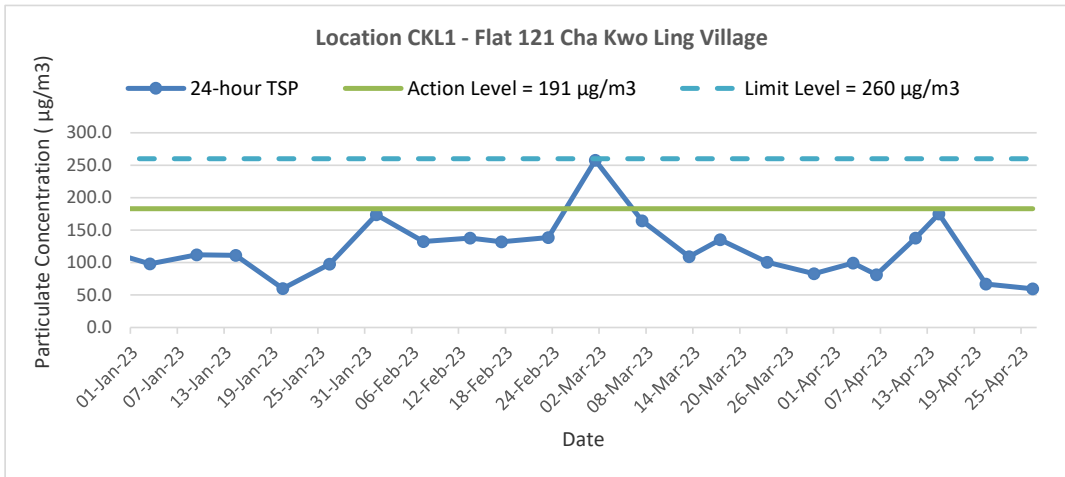
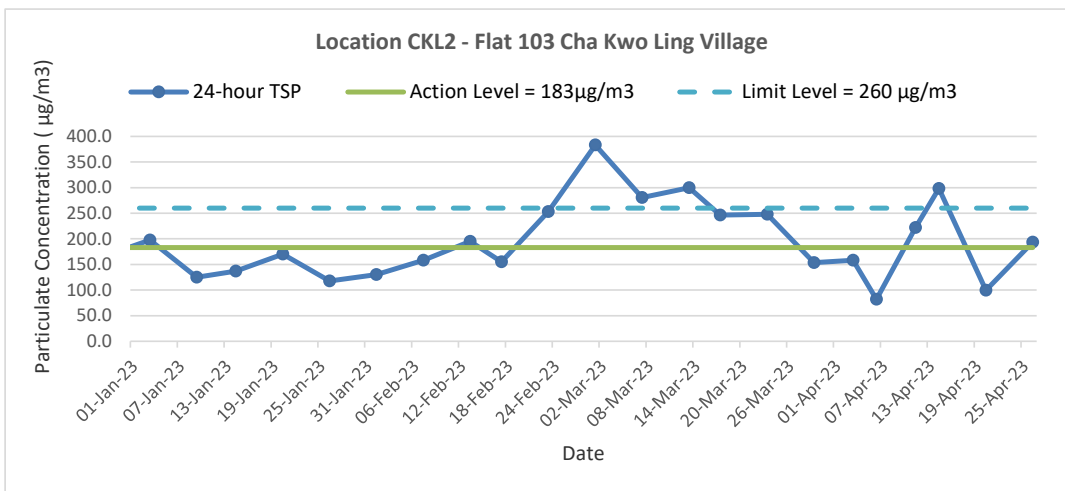
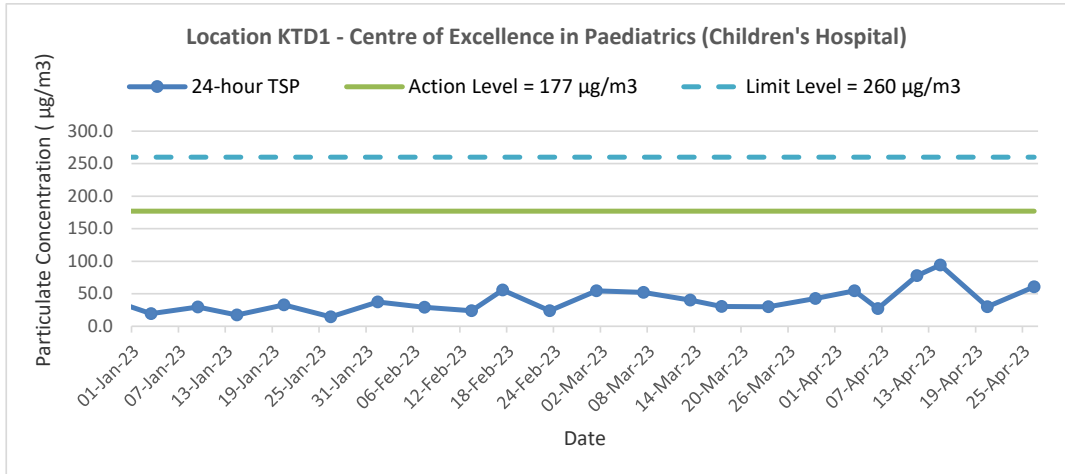
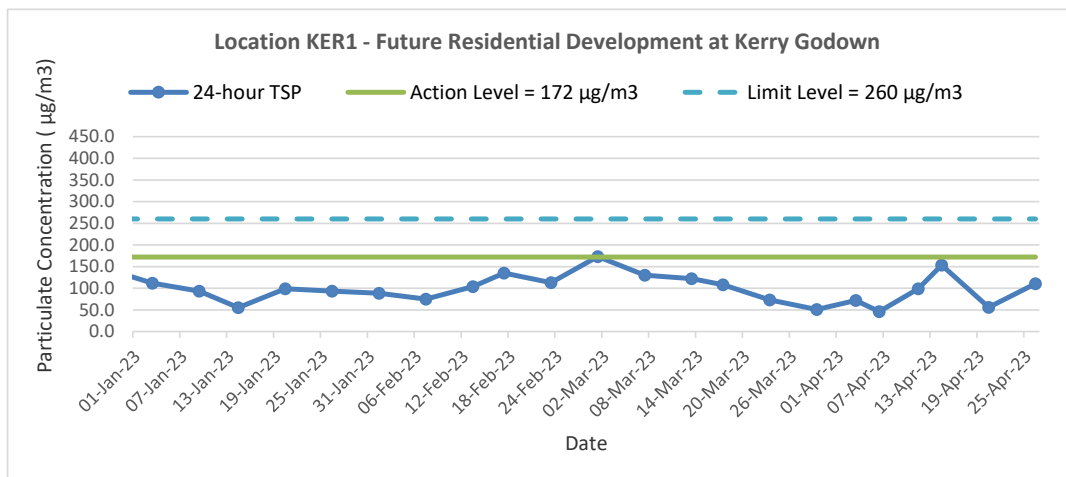
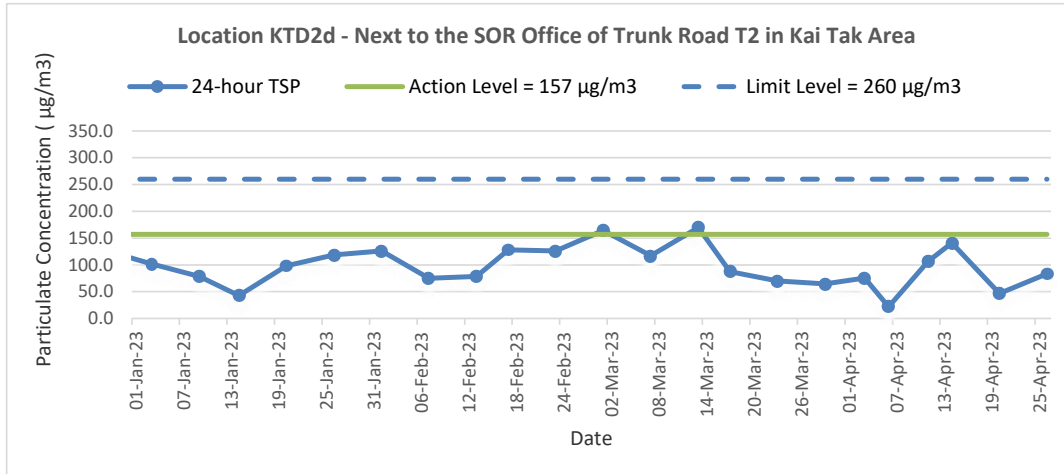
24-hr TSP Concentration Levels

- 2.17 The monitoring data and graphical presentations of 24-hour TSP monitoring results are shown in **Appendix F**.
- 2.18 According to field observations observed in the reporting period, the major dust source identified at the designated air quality monitoring stations are as follows:

Title Trunk Road T2 and Infrastructure Works for Developments at the Former South Apron Graphical Presentation of 24-hour TSP Monitoring Results	Date Apr-23	Project No. MA20003	
	Appendix F

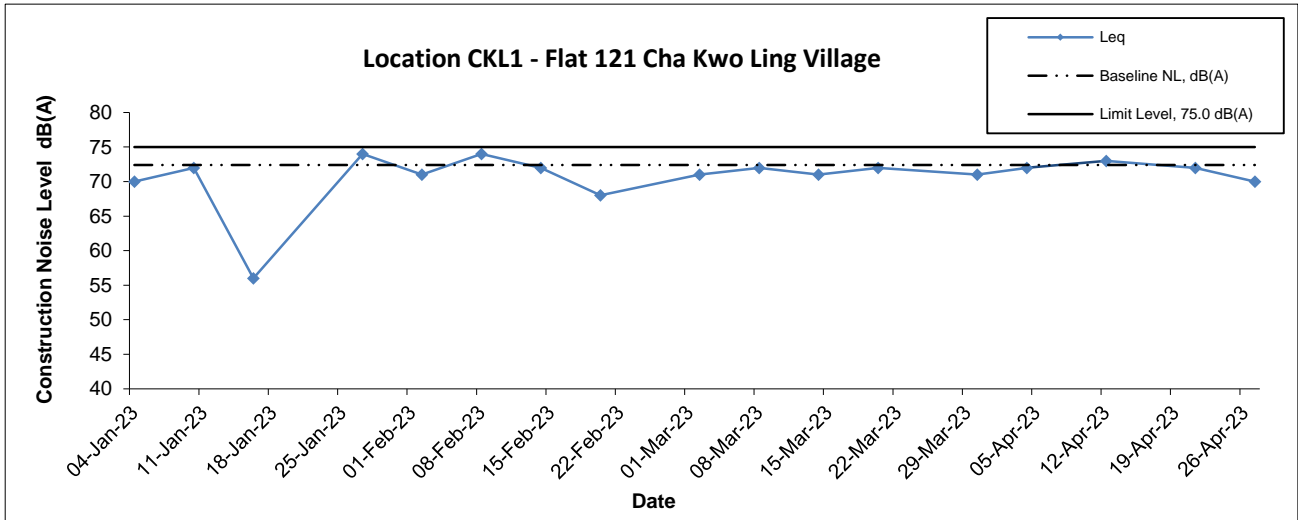
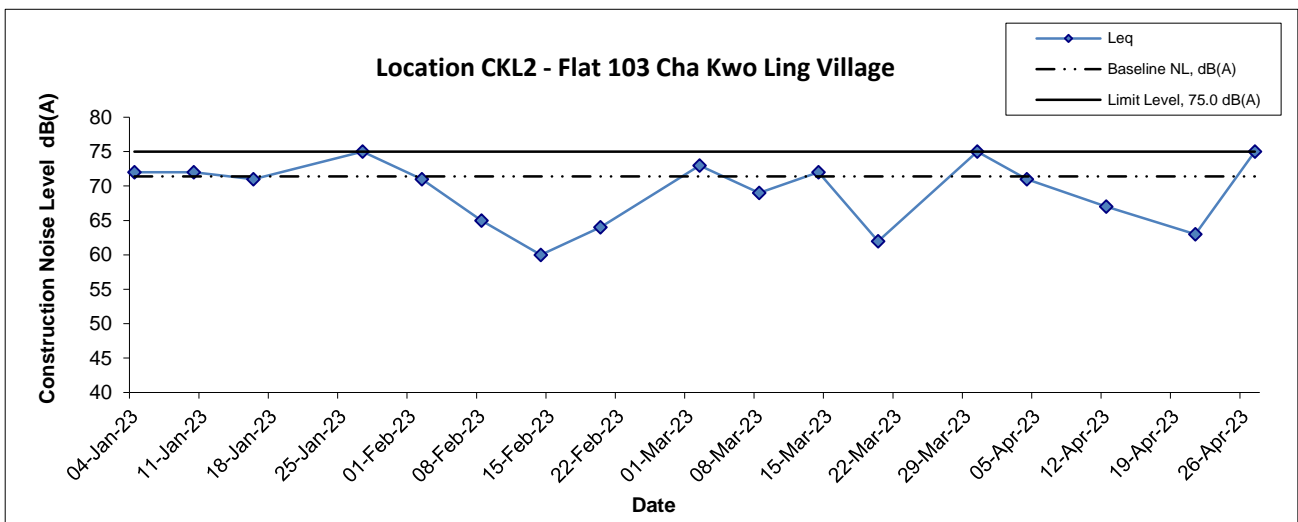
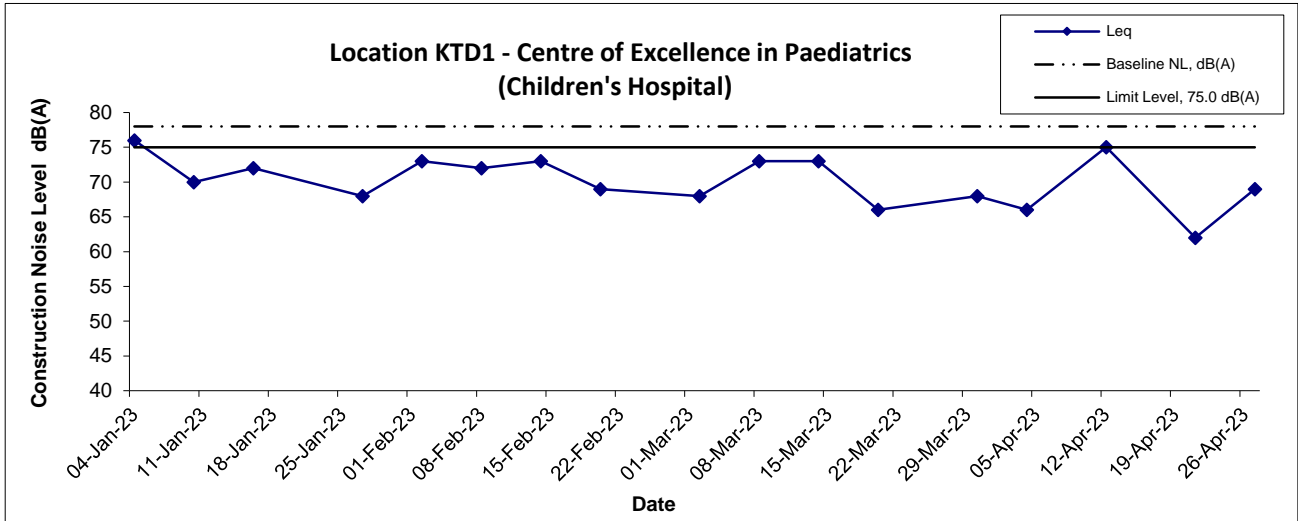
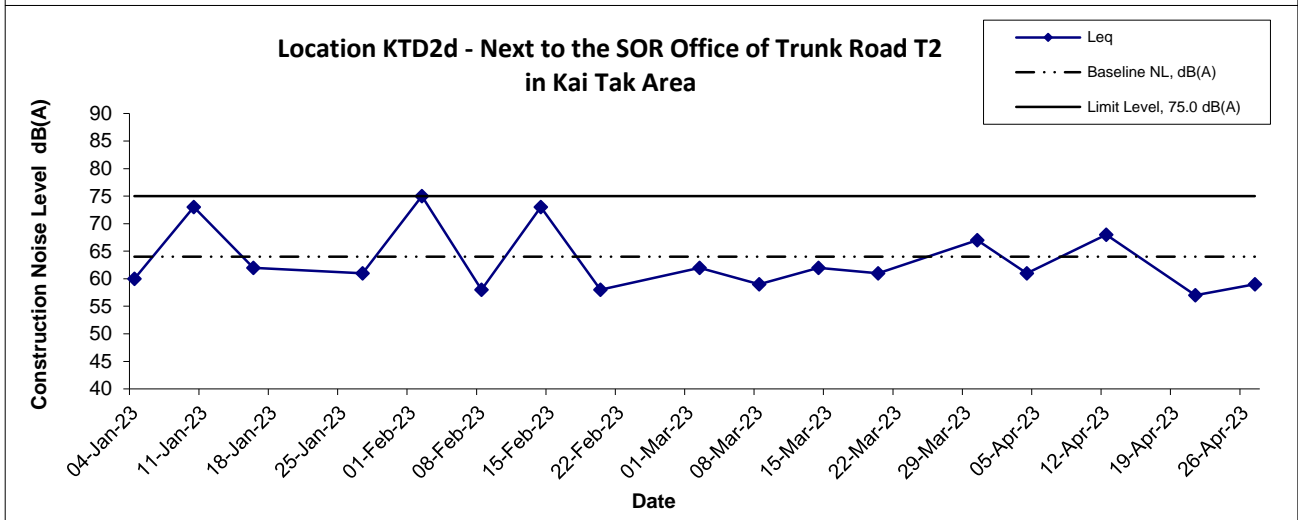
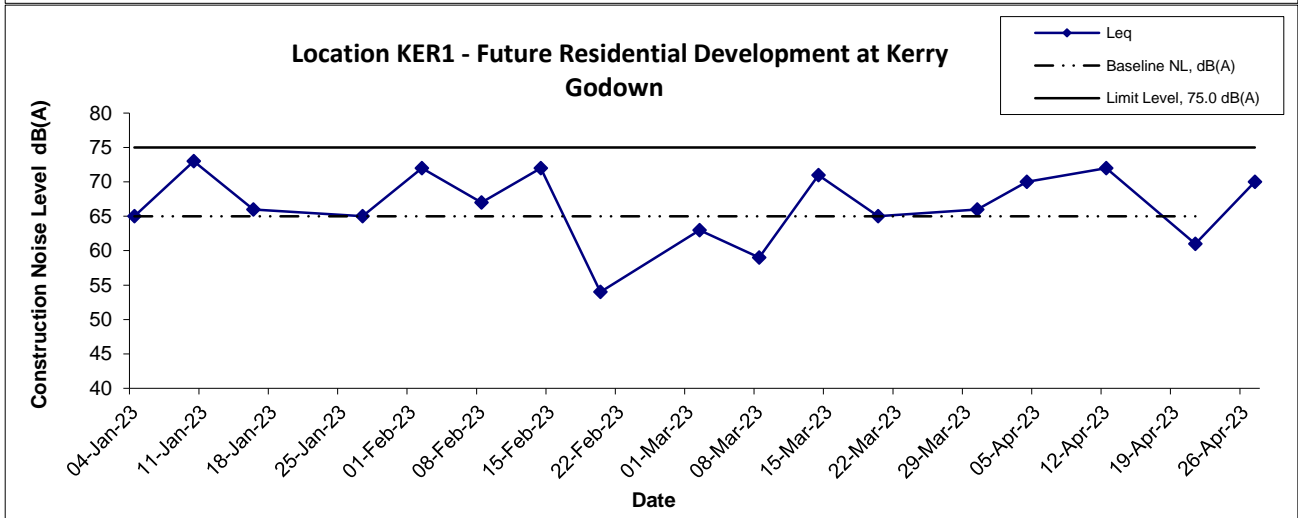
Noise Levels

Title Kai Tak Development – Trunk Road T2 and Infrastructure Works at the Former South Apron Graphical Presentation of Construction Noise Monitoring Results	Date	Project	CINOTECH
	Apr 23	No. MA20003	
		Appendix H
